FULL-SCALE TESTING AND ANALYSIS OF FUSELAGE STRUCTURE

M. Miller, M. L. Gruber, K. E. Wilkins, R. E. Worden
The Boeing Company, Seattle, Washington 98124

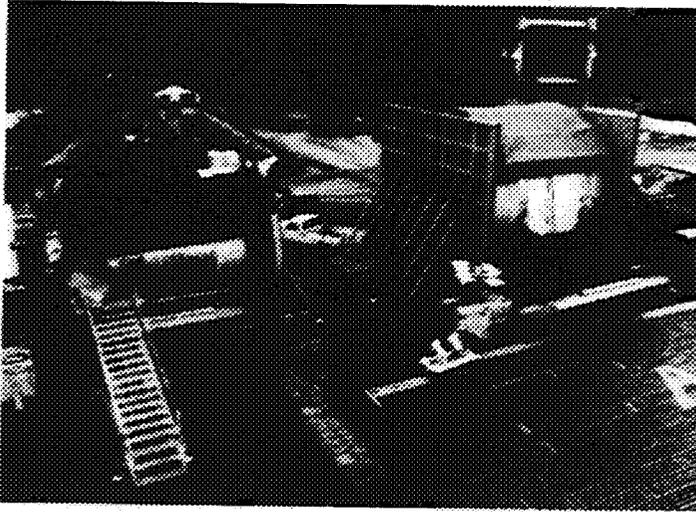
Figure 1. Pressure test site.

The test facility, illustrated in Figure 1, consists of two cylindrical fixtures.

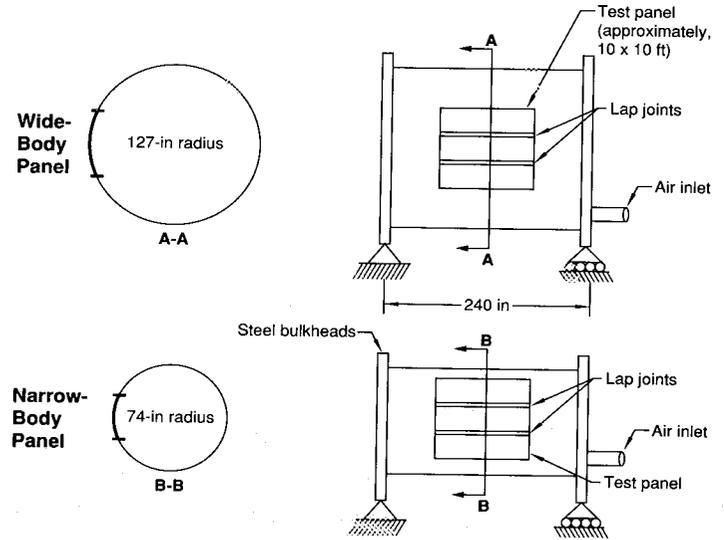
Figure 2. Schematic of pressure test fixtures.

The first fixture has a radius of 74 inches (1.88 m) to match Boeing's typical narrow-body airplanes, and the second has a radius of 127 inches (3.23 m) to match the wide-body airplanes. Both fixtures are 20 feet (6.1 m) in length as shown in Figure 2. The overall geometry of the fixtures is consistent with typical fuselage design: 7075-T6 frames at a 20 inch (508 mm) pitch and 2024-T3 clad stringers at a 9.25 inch (235 mm) pitch. The frames are attached to the stringers by means of stringer clips, but are otherwise not connected directly to the skin. The skin, frame and stringer gages are thicker than typical minimum gage fuselage structure but have been selected to maintain realistic fixture stiffness. All fastener holes in the skin are cold-worked and protruding head fasteners are used to provide maximum fixture longevity. External 2.8 inch (71 mm) wide circumferential tear straps of 2024-T3 clad sheet are riveted to the skin at a 20 inch (508 mm) spacing. The end bulkheads are steel, one of which is fixed and the other on rollers to permit axial expansion during pressurization.

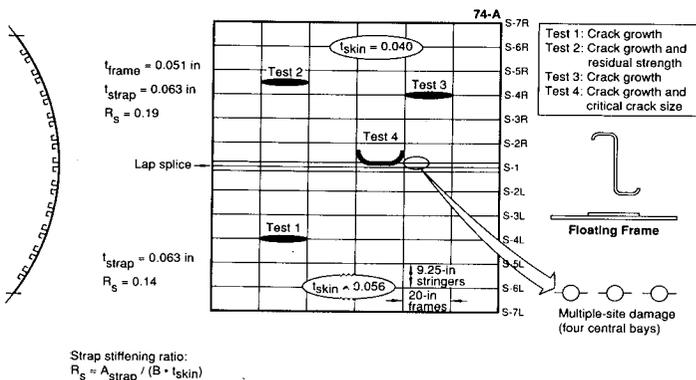
Figure 3. Initial damage locations on narrow-body panel 74-A.

Four tests were conducted on narrow-body panel 74-A shown in Figure 3. In general, the test procedure consisted of inserting a 5 inch (127 mm) sawcut at the selected test location and pressure cycling until either test termination or the crack reached a length at which a residual strength test was performed. Each crack was repaired before inserting the next sawcut. The test panel is divided into two halves by a single longitudinal lap joint. All frames are “floating,” connected to the stringers only by means of stringer clips. In the upper half of the panel the skin is 0.040 inch (1.02 mm) thick, and in the lower half of the panel the skin is 0.056 inch (1.32 mm) thick. All longitudinal cracks are parallel to the longitudinal grain direction of the 2024-T3 clad skin. Internal bonded tear straps are installed at each frame location. The tear strap dimensions are defined in terms of a strap stiffening ratio:

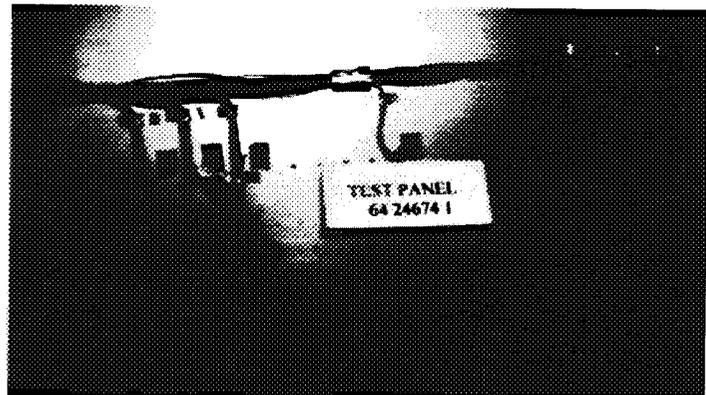
Figure 4. Final failure of Test 1 on panel 74-A.

Test 1 on this panel consisted of a longitudinal 5 inch (127 mm) sawcut adjacent to stringer 4L in the 0.056 inch (1.32 mm) skin. The strap stiffness ratio R_s was 0.14. The panel was subjected to a cyclic differential pressure of 8.6 psi (.059 MPa) with a stress ratio of zero. As is typical with sawcuts at such a location, the direction of fatigue crack growth gradually diverged from longitudinal. In this case, failure consisted of a controlled decompression as shown in Figure 4. Figure 5 shows that 5400 pressure cycles were required to grow the crack to its final length.

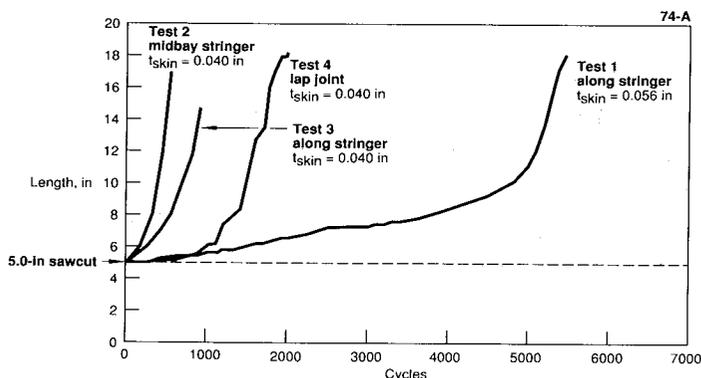
Figure 5. Crack growth test results for panel 74-A.

Test 3 consisted of a longitudinal five inch (127 mm) sawcut adjacent to stringer 4R in the 0.04 inch (1.02 mm) gage skin. The direction of crack growth was similar to test 1 and resulted in a controlled decompression after 950 cycles. Comparison of the data in Figure 5 shows that the midbay crack of test 2 has a shorter crack growth life than the crack in test 3. This is consistent with data presented in Reference 1. The crack length at instability for Test 3 of 14.8 inches (380 mm) can be compared with a crack length at instability of 18 inches (460 mm) in Test 1, attributable in part to the stresses associated with the different skin gages.

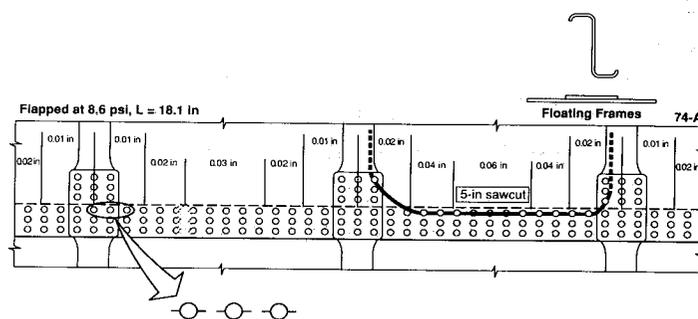
Figure 6. Multiple site damage test on panel 74-A lap joint.

Test 4, the final test in panel 74-A, consisted of a five inch (127 mm) sawcut in the upper row of fasteners in the lap joint of the 0.04 inch (1.02 mm) skin. Each fastener hole ahead of the initial sawcut had two small diametrically opposed longitudinal sawcuts introduced during original panel assembly as shown in Figure 6. The dimensions of these sawcuts varied as a function of location along the lap joint and were smaller at the tear strap locations as indicated by fleet experience. Although these small sawcuts had experienced approximately 7000 prior pressure cycles, it is unlikely that there would have been any appreciable growth prior to inserting the 5 inch sawcut in the lap joint. Initially the crack growth from the 5 inch sawcut remained in the rivet line during pressure cycling, although reference to Figure 7 shows the tendency of the crack to deviate from the longitudinal direction only to be pulled back to the rivet line at the next fastener hole. The crack finally began to grow significantly away from the rivet line as it approached the adjacent tear straps. Final failure was a controlled decompression as shown in Figure 8. Comparison of the crack growth rates in Figure 5 shows that the crack in the lap joint grew more slowly than the midbay crack of Test 2 and the crack adjacent to Stringer 4R in Test 3.

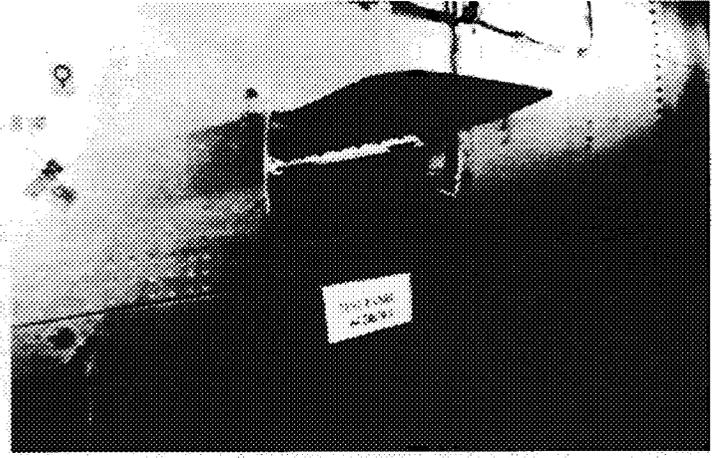
Figure 8. Final failure of multiple site damage test on panel 74-A lap joint.

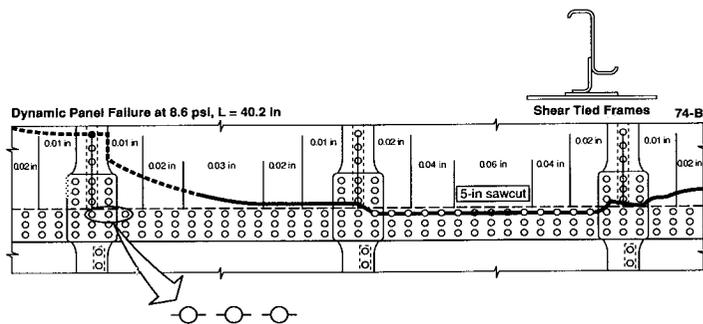
Figure 9. Multiple site damage test on panel 74-B lap joint.

A single test was conducted on Panel 74-B. This panel differed from panel 74-A by the use of shear-ties to attach the frame directly to the skin and bonded tear strap as shown in Figure 9. In this test, the tear strap stiffening ratio R_s was 0.12. The initial condition consisted of a five inch (127 mm) sawcut along the upper fastener row of the lap joint. Again, each fastener hole ahead of the initial sawcut had two small diametrically opposed longitudinal sawcuts introduced during the original panel assembly. The secondary sawcut lengths were varied in a manner similar to those in panel 74-A. However, the panel had not been subjected to prior fatigue cycling before introduction of the 5 inch sawcut. Review of the lap joint following final failure

illustrated in Figure 9, the crack remained sub-critical throughout this phase of the test. The tear straps failed in fatigue when the skin crack was 24.5 inches (620 mm) in length. At this point, the opening mode stress intensity factor in the skin was calculated to be $82 \text{ ksi}\cdot\text{in}^{1/2}$ ($90 \text{ MPa}\cdot\text{m}^{1/2}$), again well below the material toughness. The opening mode stress intensity factor is predicted to remain well below the material toughness with an intact frame. Following frame failure at a crack length of 40.2 inches (1.02 m), the opening mode stress intensity factor rises to $200 \text{ ksi}\cdot\text{in}^{1/2}$ ($220 \text{ MPa}\cdot\text{m}^{1/2}$), now well above the toughness of the material. The sliding mode stress intensity factor is presented for an assumed straight crack. This can be seen to remain fairly constant at around $25 \text{ ksi}\cdot\text{in}^{1/2}$ ($28 \text{ MPa}\cdot\text{m}^{1/2}$) for cracks longer than 10 inches (250 mm) in length, but rises significantly following frame failure.

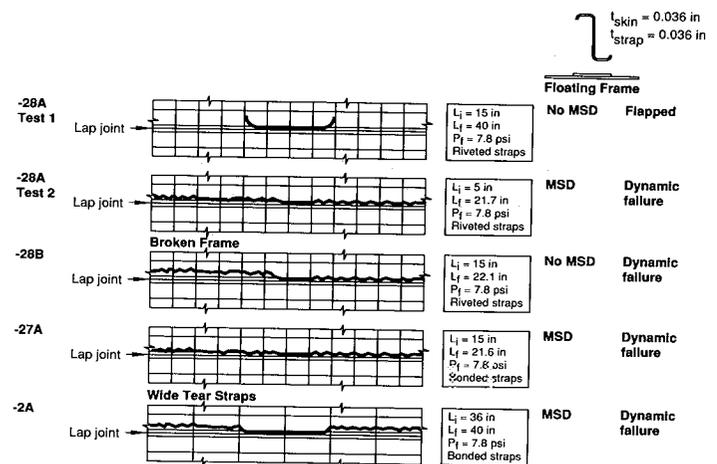
Figure 12. Summary of miscellaneous narrow-body lap joint crack growth tests.

A number of additional tests of cracks in lap joints in narrow-body panels are summarized in the chart in Figure 12. The data expand on results previously presented in Reference 2. All pressure cycling was at a differential pressure of 7.8 psi (.054 MPa). The illustrations in the figure describe schematically the behavior of the cracks. Some of the tests, as noted on the figure, contained multiple site damage (MSD) in the fastener holes ahead of the lead crack. A controlled decompression occurred during the first test on panel 28A only. This panel did not include any MSD. In all other cases, the lead crack continued to grow in an essentially longitudinal direction throughout the test. However in several cases, similar to Test 74-B discussed above, the crack grew out of the lap joint into the basic skin before final panel failure. No clear trends emerge from these results. However, it does appear that MSD forces the lead crack to stay in the upper fastener row of the lap joint for a longer period of time. Comparison of Test 2 on panel 28A and the test on panel 27A shows that panel behavior is independent of the method of attaching the tear strap to the skin. However, it should be noted that the tear strap is spliced using rivets at the lap joint location in such a way that both the riveted and bonded designs are locally similar.

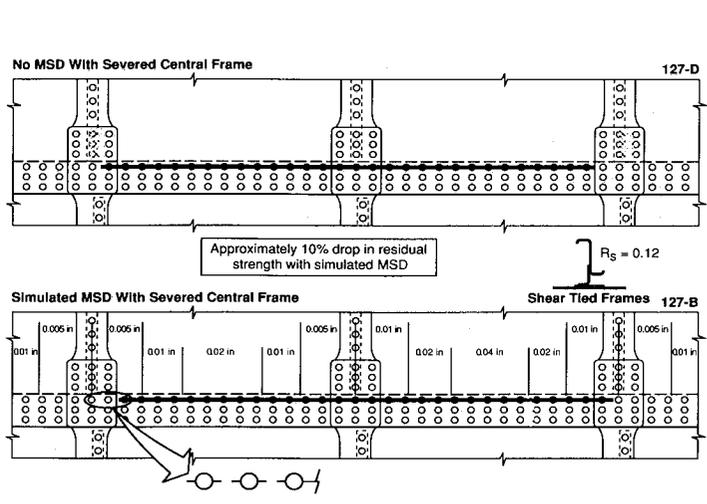
Figure 13. Effect of multiple site damage in lap joint on residual strength of wide-body panels.

A comparison of the effects of MSD on two wide-body panels is presented in Figure 13. The panels (127-B and 127-D) are 127 inch (3.23 m) in radius with frames and tear straps at a 20 inch (508 mm) spacing. The tear straps are bonded to the skin and have a stiffness ratio R_s of 0.12. The skin is 0.063 inch (1.6 mm) 2024-T3 clad sheet with the lap joint parallel to the longitudinal grain direction. The frames are shear-tied to the skin as illustrated in the figure. In each test, an initial sawcut of 5 inches (127 mm) was introduced into the upper row of fasteners in the lap joint and into the central tear strap. The central frame initially remained intact. In one case, MSD of the lengths shown in the illustration was introduced ahead of the lead crack. Each panel was subjected to fatigue cycling at a differential pressure of 8.6 psi (.059 MPa). When the cracks reached a length of 37 inches (940 mm), a differential pressure of 9.5 psi (.066 MPa) was applied. In each

case, this resulted in a small amount of crack extension. The central frame was cut and the pressure increased until panel failure. The panel with the MSD ahead of the lead crack failed at a differential pressure of 9.4 psi (.065 MPa), approximately 10% below the maximum differential pressure applied to the panel without MSD.

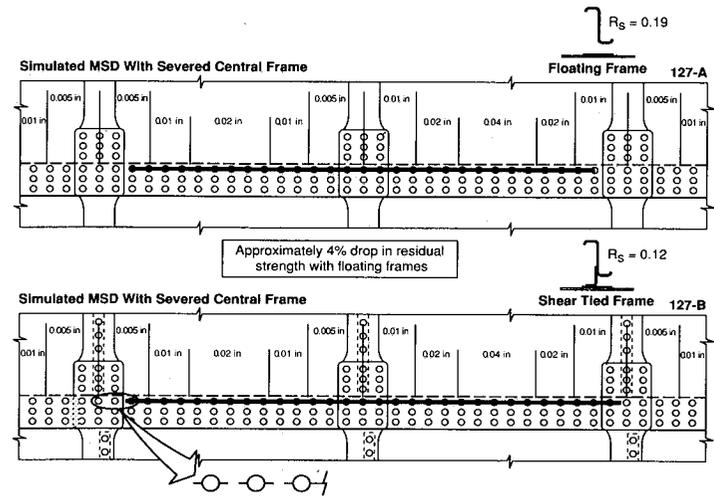
Figure 14. Effect of frame detail design on residual strength of wide-body panels with multiple site damage in lap joints.

The different capability of shear-tied against floating frame designs is illustrated in Figure 14. Test panel 127-B is as described in the previous paragraph. Test panel 127-A is similar with the exception that the frames are not shear-tied to the skin. The tear straps are bonded to the skin and have a stiffness ratio R_s equal to 0.19. The test procedure for panel 127-A was similar to 127-B with MSD introduced into the panel ahead of the lead crack as shown in the figure. This panel was subjected to fatigue cycles at a differential pressure of 8.6 psi (.059 MPa). When the crack reached a length of 37 inches (940 mm), a differential pressure of 9.5 psi (.066 MPa) was applied. Following this, the central frame was cut and the panel pressurized to failure. The condition of the panel prior to the final pressurization cycle and following the final cycle is illustrated in Figures 15 and 16.

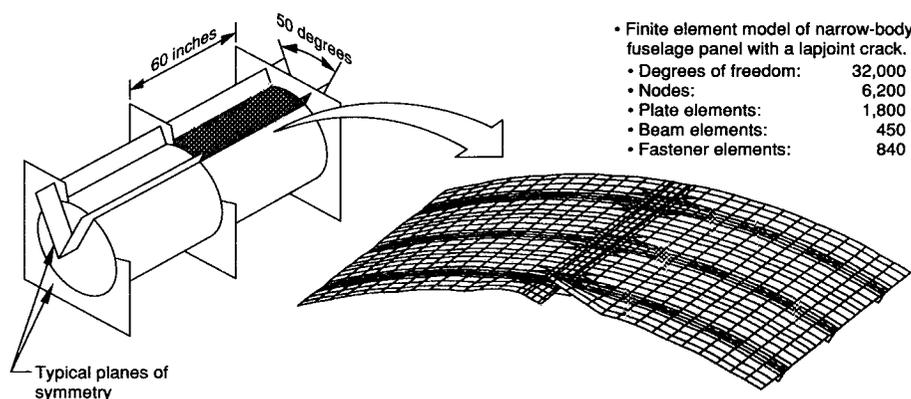
Figure 19. Finite element model of narrow-body test panel with lap joint.

A typical mesh for a narrow-body test panel containing a lap joint is shown in Figure 19. Only half of the test panel is modelled; a plane of symmetry is assumed at the crack centerline. Cylindrical symmetry is assumed at all boundaries. The circumferential boundary at the crack centerline is fixed in the longitudinal direction while the circumferential boundary away from the crack is allowed to displace uniformly in the longitudinal direction. The resultant of the pressure load in the longitudinal direction is applied at a node on this boundary.

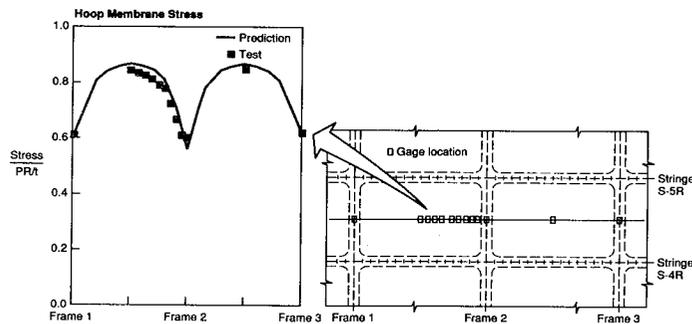
Figure 20. Test and analysis correlation for intact narrow-body panel 45-2A.

A comparison between measured and predicted membrane hoop stresses for a narrow-body panel with floating frames is given in Figure 20. Bonded tear straps of stiffness ratio R_s equal to 0.15 coincide with the

frame locations. The data are for locations along an axial line midway between stringers and are presented in terms of the nominal hoop stress in an unstiffened cylinder of the same radius and skin thickness. The peak stress is observed to be about 85% of nominal and occurs midway between frames. The stress in the vicinity of the bonded tear straps falls to 60% of nominal. A good comparison of stresses can be observed at all locations.

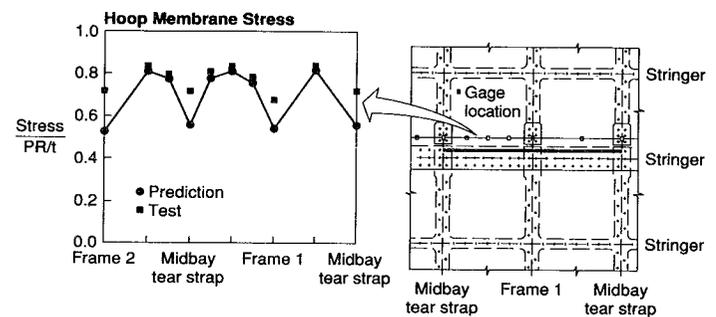
Figure 21. Test and analysis correlation for intact narrow-body panel 28-A adjacent to a lap joint.

A comparison between measured and predicted membrane hoop stresses in the vicinity of a lap joint in a narrow-body panel is given in Figure 21. The structure consists of floating frames at a 20 inch (508 mm) pitch and riveted tear straps at a 10 inch (254 mm) pitch. The tear strap stiffness ratio R_s is equal to 0.15. The data are for locations along an axial line adjacent to the lap joint. The data are presented in terms of the nominal hoop stress in an equivalent unstiffened cylinder of the same radius and lap joint skin gage thickness. The maximum stress of 80% of nominal occurs midway between the tear straps. A good comparison between test and analysis is obtained at this location. The stresses do not compare well at the tear straps. This may be caused by local bending at the skin and tear strap interface, or the influence of local stress concentrations around the fastener holes in the tear strap. The geometry of this panel model is similar to the test panels shown in Figure 12. Analysis results for this panel containing a 21.4 inch (540 mm) longitudinal crack show that the residual strength of the panel would be exceeded if the tear strap was broken.

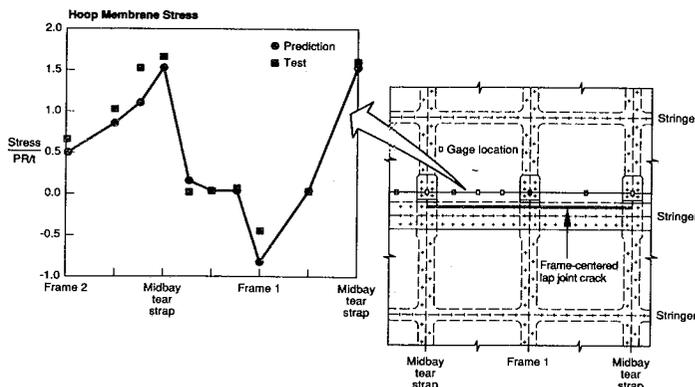
Figure 22. Test and analysis correlation for intact narrow-body panel 28-A containing a lap joint crack.

A similar comparison of stresses is given in Figure 22 for the same panel containing a 20 inch (508 mm) crack in the upper row of fasteners in the lap joint and a broken central tear strap. As expected both measured and predicted hoop stresses behind the crack tips are close to zero. There are significant compressive membrane hoop stresses in the skin at the location of the broken tear strap. This is caused by local bending at the skin and tear strap interface. High tension stresses exist in the skin just ahead of the crack tip. Comparison with the data in Figure 21 shows the stresses are close to typical for the uncracked structure by the adjacent frame location (Frame 2 in the figure).

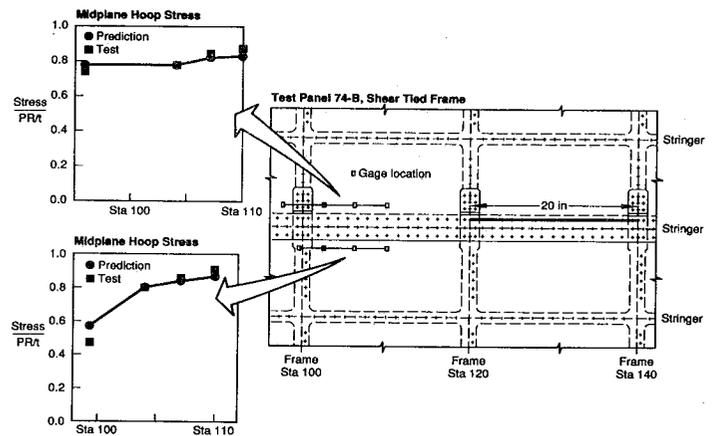
Figure 23. Test and analysis correlation for narrow-body panel 74-B containing a bay-centered lap joint crack.

Panels 74-A and 74-B, discussed at length in the previous section, have also been the subjects of extensive analysis. A comparison of membrane stresses in the vicinity of the lap joint is given in Figure 23 for panel 74-B. The lap joint contains a 20 inch (508 mm) crack centered on the adjacent frame bay. The data are again presented in terms of the nominal hoop stress in an equivalent uncracked, unstiffened cylinder of the same radius and lap joint skin gage. The stresses are observed to be close to those for uncracked structure at the same locations.

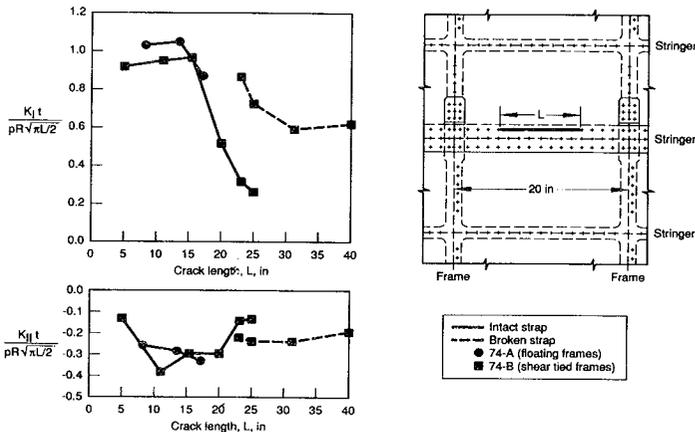
Figure 24. Non-dimensional stress intensity factors for narrow-body panels containing lap joint cracks.

Membrane stress intensity factors, non-dimensionalized with respect to the nominal membrane stress in an equivalent unstiffened cylinder, are presented in Figure 24 for panels 74-A and 74-B. Although the crack is along a lap joint, the fasteners and fastener holes are modeled only as point connections. Therefore, the stress intensity factors must be considered an approximation for lap joint configurations. It should be noted that the tear strap stiffening ratio R_s for the floating-frame panel is 0.19 and for the shear-tied panel, 0.12. Opening and sliding mode stress intensity factors are shown in the figure. In general, the opening mode stress intensity factor for the floating-frame panel is higher than for the shear-tied panel, even with the higher strap stiffness ratio. It is evident that the shear-tie helps to minimize the effect of out-of-plane displacements and to redistribute the loads around the crack. The effect of the broken tear strap is significant, causing a factor of three increase in opening mode stress intensity factor for cracks around 25 inches (635 mm) in length.

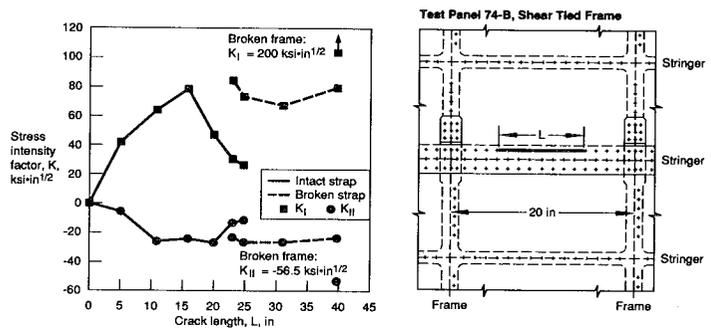
Figure 25. Stress intensity factors for narrow-body panel 74-B containing a lap joint crack.

The same data are presented as total opening and sliding mode stress intensity factors in Figure 25 for Panel 74-B. The opening mode stress intensity factor reaches a maximum of $78 \text{ ksi}\cdot\text{in}^{1/2}$ ($86 \text{ MPa}\cdot\text{m}^{1/2}$) when the skin crack is around 15 inches (380 mm) in length, before dropping as the tear strap is approached. The plane-stress fracture toughness for 0.04 inch (1.02 mm) clad 2024-T3 skin with cracks in the T-L orientation is in the range $120\text{-}130 \text{ ksi}\cdot\text{in}^{1/2}$ ($130\text{-}140 \text{ MPa}\cdot\text{m}^{1/2}$). As indicated in the discussion of the test results for this panel and as

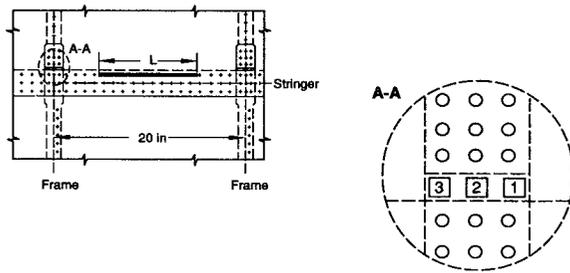
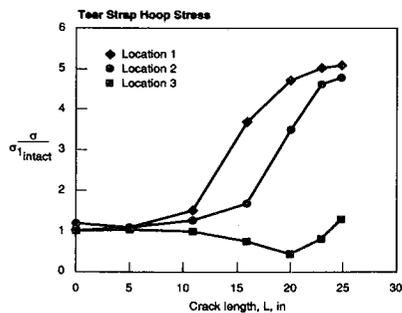
Figure 26. Stress concentration factors in tear strap for panel 74-B containing a lap joint crack.

The predicted tear strap stresses as a function of crack length, non-dimensionalized with respect to the stresses in the intact structure, are presented in Figure 26 for Panel 74-B. At short skin crack lengths, the stresses are uniform across the tear strap. As the crack approaches, the tear strap is subject to considerable bending in its plane. One side of the tear strap commences to yield when the skin crack is around 18 inches (460 mm) in length. In the test, the first fatigue crack was found in one of the straps when the skin crack was 20 inches (508 mm) in length. Insufficient data are available to reliably predict the fatigue life under such circumstances; however the tear straps failed in about 100 cycles during the test. Since the tear straps failed when the skin crack was 24.5 inches (620 mm) in length, no attempt was made to evaluate the tear strap stress concentration factors at longer skin crack lengths.

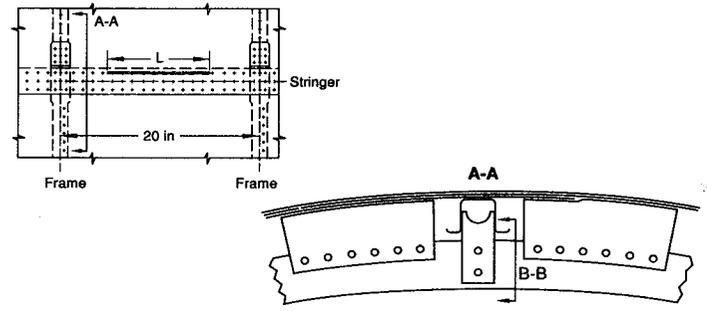
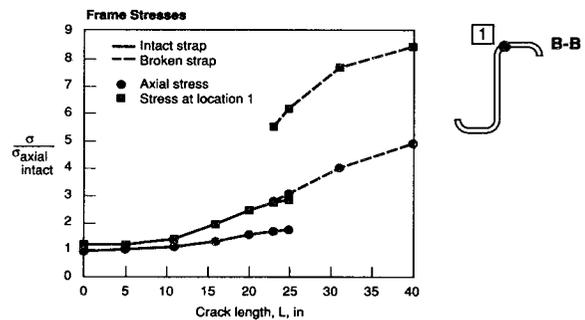
Figure 27. Stress concentration factors in frame for panel 74-B containing a lap joint crack.

The predicted frame stresses as a function of crack length, non-dimensionalized with respect to the frame stresses in the intact structure are presented in Figure 27 for Panel 74-B. The stresses are provided at two locations. The first represents the average axial stress in the frame and the second represents the peak fiber stress in the outer chord of the frame just beyond the last shear-tie attachment fastener. At short skin crack lengths, the increase in stress in the frame is small. As the crack length increases, the stresses in the frame at both locations steadily increase but remain well below yield for the 7075-T6 frame material. Following tear

strap failure, the axial stress in the frame increases by about 50% but the peak fiber stress increases by 100%, indicating a significant increase in frame bending. The stresses remain below yield in the material (a yield stress of 68 ksi (470 MPa) was assumed in the analysis) until the skin crack exceeds about 35 inches (890 mm) in length. When the skin crack length is 40 inches (1.02 m), close to final panel failure, the nominal peak fiber stress in the frame exceeds 70 ksi (480 MPa). Final failure, illustrated in Figure 10, was through the last shear-tie attachment fastener. The peak fiber stress coupled with the stress concentrating effect of the fastener hole may have been sufficient to precipitate a static failure, or in a fashion similar to the tear strap, a very low-cycle fatigue failure. No observations of any fatigue cracks in the frame were recorded during the test.

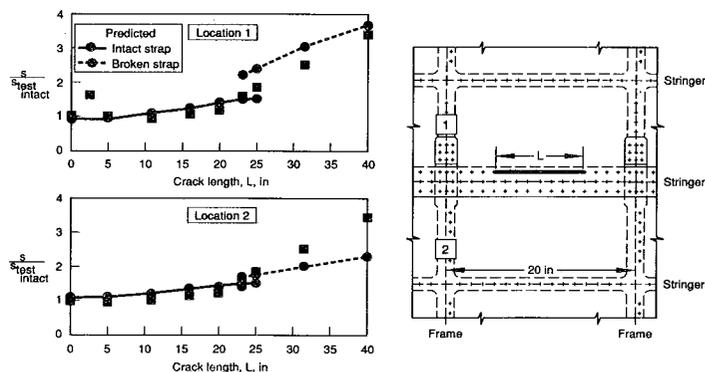
Figure 28. Comparison between test and predicted axial stresses in frame for panel 74-B as a function of skin crack length.

A comparison between predicted and measured frame stresses in Panel 74-B is given in Figure 28. Axial stresses near the center of the frame channel, midway between two stringers are provided for two locations. The first is in the bay containing the crack and the second is in the adjacent bay, as illustrated in the figure. Stresses compare favorably while the tear strap is intact. Following tear strap failure, analysis stresses tend to be high in the bay containing the crack and low in the adjacent bay. Review of the analysis suggests that since the stringer clip attaching the stringer to the frame is modeled as a rigid connection, inaccurate predictions of load transfer into the frame result.

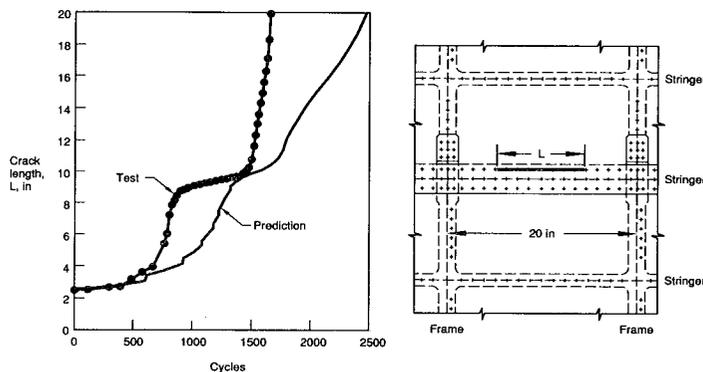
Figure 29. Comparison between test and predicted crack growth for panel 74-B containing a lap joint crack.

A comparison of skin fatigue crack growth lives for Panel 74-B is shown in Figure 29. In general, the prediction follows the test but tends to overestimate the life by about 50%. The analysis assumed fasteners behaved elastically at all times. In view of the high stresses calculated for the tear straps and frames, it is certain that several fasteners would have exceeded their yield strength. As a result, the stress intensity factor in the skin is likely to be greater than shown in Figure 25, especially for cracks beyond 20 inches (508 mm) in length. This may account for the observed differences between predicted and measured crack growth rates at the longest crack lengths.

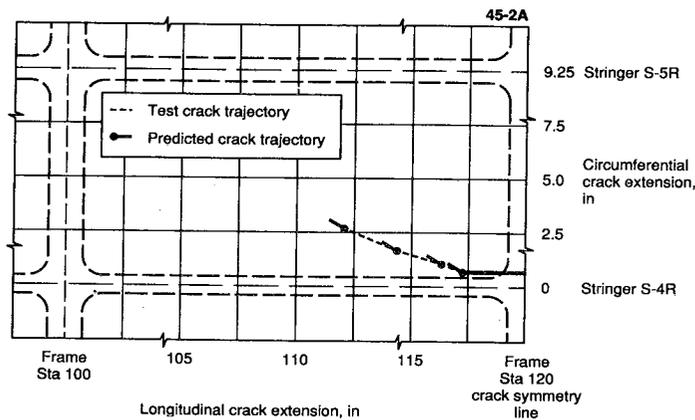
Figure 30. Comparison between test and predicted crack trajectory for narrow-body panel 45-2A containing a longitudinal crack.

Fully automated remeshing schemes for curving cracks are not yet available within Boeing although such a capability is under development such as the effort described in Reference 3. As a result, only a few attempts to predict crack trajectories have been made. One such attempt was made on Panel 45-2A. This narrow-body panel consisted of .036 inch (0.9 mm) 2024-T3 skin with 3 inch (76 mm) wide bonded tear straps, R_s equal to 0.15, at a 20 inch (508 mm) pitch. The panel had floating frames coincident with the tear straps. The initial damage in the panel consisted of a 5 inch (127 mm) sawcut across and including a broken tear strap. Predicted

crack trajectories are based on the maximum strain energy release rate. The predicted and measured crack trajectories are shown in Figure 30 to be in good agreement at all crack lengths. Final failure in this panel was by means of a controlled decompression. It can be observed that this failure mode can occur without the beneficial influence of nearby tear straps.

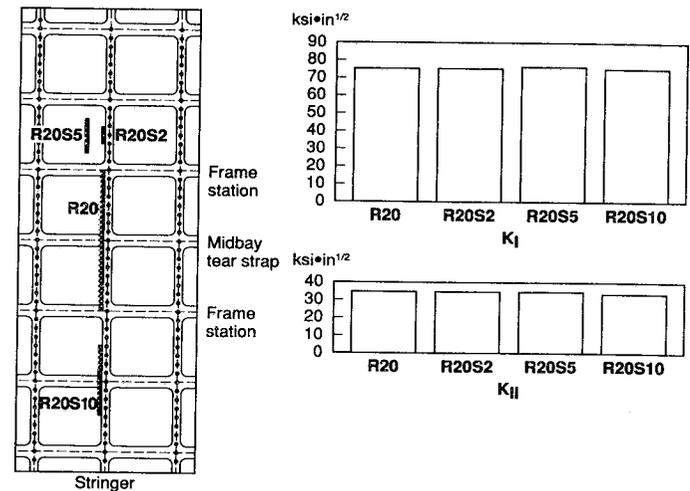
Figure 31. Effect on stress intensity factors of large interacting longitudinal cracks in a narrow-body panel.

An analysis of the interaction of large cracks in adjacent bays is given in Figure 31. The narrow-body panel consists of .036 inch (0.9 mm) thick 2024-T3 clad skin, tear straps with an R_s of 0.15 at 10 inch (254 mm) pitch, and floating frames at 20 inch (508 mm) pitch. An axial crack of length 20 inches (508 mm) centered on a broken tear strap is introduced into the structure adjacent to a stringer. An analysis is conducted for each of the different length secondary cracks located as shown in the figure. Because of the symmetry of the analysis model, each secondary crack occurs twice. Thus analysis R20S10 describes a 10 inch (254 mm) crack 5 inches (127 mm) ahead of each tip of the 20 inch (508 mm) crack. The opening and sliding mode stress intensity factors for the lead crack are shown in bar chart form for each of the crack configurations. In every case, the influence of the secondary cracks on the primary crack is negligibly small.
