AN ARTIFICIAL CORROSION PROTOCOL FOR LAP-SPLICES IN AIRCRAFT SKIN*

SUMMARY

This paper reviews the progress to date to formulate an Artificial Corrosion Protocol for the Tinker AFB C/KC-135 Corrosion Fatigue Round Robin Test Program. The project has provided new test methods to faithfully reproduce the corrosion damage within a lap-splice by accelerated means, the rationale for a new laboratory test environment and a means for corrosion damage quantification. The approach is pragmatic and the resulting Artificial Corrosion Protocol lays the foundation for future research in the assessment of aerospace alloys. The general means for quantification of corrosion damage has been presented in a form which can be directly applied to structural integrity calculations.

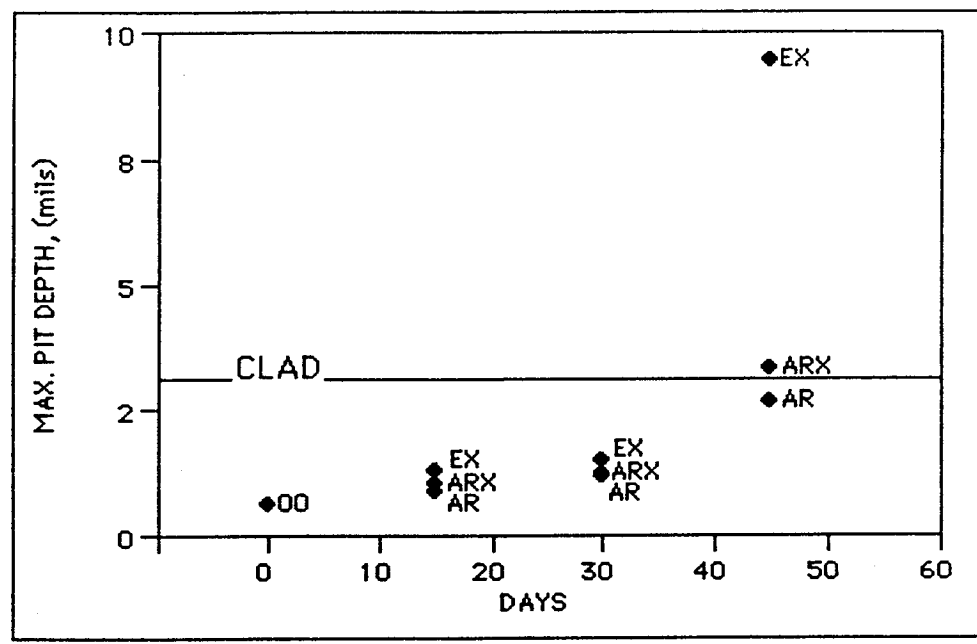
7075-T6 AT FILLET

2024-T3 AT FILLET

Figure 3. The average maximum pit depth at the fillet for Type #1 (Alclad 7075-T6) and Type #3 (Alclad 2024-T3) lap-splices as a function of the number of days exposure . The test solutions are indicated by AR, artificial acid rain + H₂O₂, ARX, concentrated artificial acid rain + H₂O₂ and EX, EXCO + H₂O₂.

In this paper one example, Fig. 3, showing the effect of the test solutions and time at the fillet (Y=0) and another, Fig. 4, showing the effect of time and distance from the fillet (Y=Y_n) on the average maximum pit depth serve to represent the general trends found in the experiments. (See Ref. 2 for more detailed treatments.) In general, the corrosion damage rate for EX>ARX>AR, though ARX and AR are not as clearly separated as EX and ARX. Note that the zero day damage is the natural damage found in the "as-received" condition. The effect of time and distance from the fillet on the average maximum pit depth shows the expected trends that

Figures 3 and 4 show that in the AR environment the damage barely exceeds the depth of the clad within the faying area whereas the penetration of damage beyond the clad is significant in both ARX and EXCO.
