COMBINED INVESTIGATION OF EDDY CURRENT AND ULTRASONIC TECHNIQUES FOR COMPOSITE MATERIALS NDE

C. W. Davis
US Army ATCOM *PL 25, 28, 32*
M/S 231, NASA LaRC
Hampton, VA 23681-0001

(NASA-TM-110599) COMBINED
INVESTIGATION OF EDDY CURRENT AND
ULTRASONIC TECHNIQUES FOR COMPOSITE
MATERIALS NDE (NASA. Langley
Research Center) 7 p

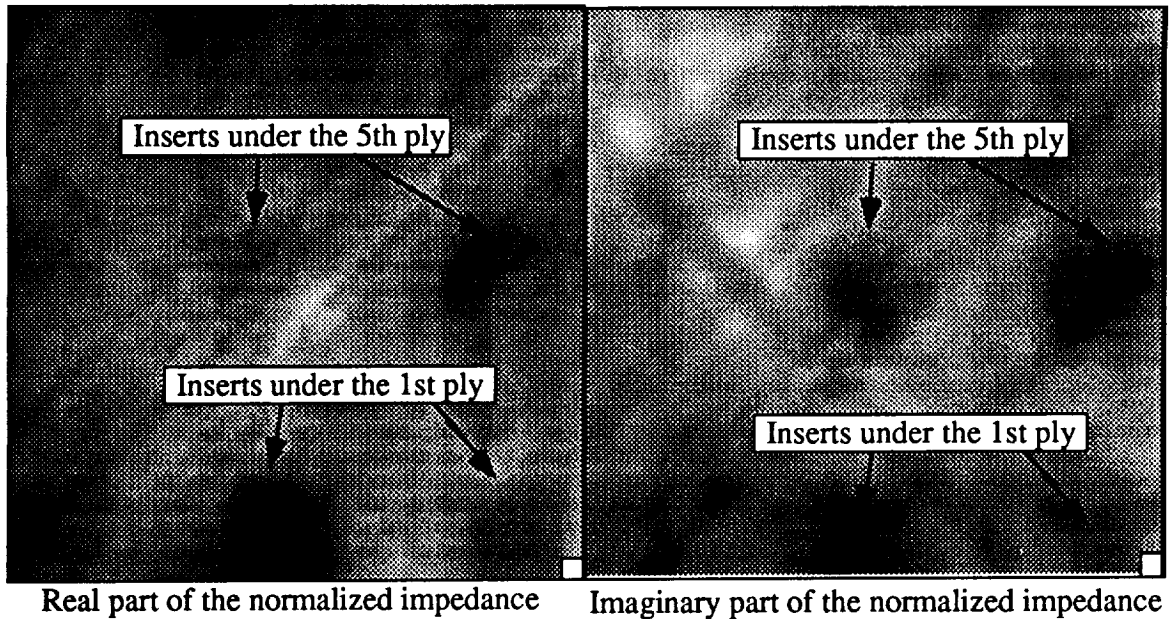
Fig. 5. Image of the probe impedance of a 2.5MHz eddy current probe scanned over a composite sample containing non-conductive inserts. The scan region is 7.6 cm² (3 in²).

In Fig. 5 we show eddy current images of non-conducting inserts in a gr/ep composite panel. This is significant as it shows a sensitivity in the EC response to delaminations and not just to broken fibers. Surface roughness measurements of the same specimen show significant variations corresponding to the locations of the non-conducting inserts. A line scan of the variations is shown in Fig. 6. The changes in the eddy current signal due to the inserts are attributed to fiber displacement. This effect is similar to thickness change variations observed using eddy currents in isotropic conductors. This result should be considered when interpreting the images of delamination patterns, particularly from impact, a major cause of fiber displacement.

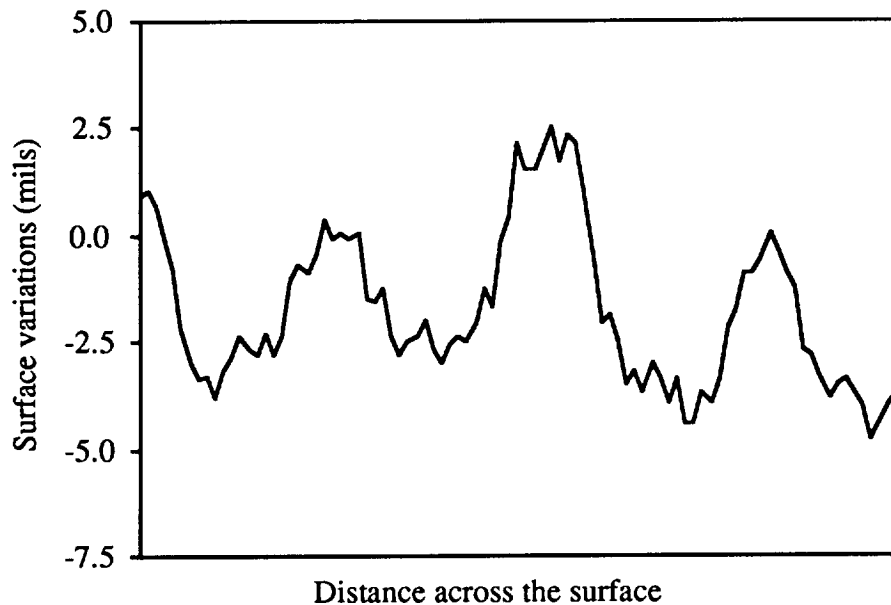
Fig. 6. Surface roughness variations along a line containing three inserts located at the fifth ply in the composite sample.
