**EVALUATION OF THIN KEVLAR-EPOXY FABRIC PANELS
SUBJECTED TO SHEAR LOADING**

Donald J. Baker
Vehicle Structures Directorate
U. S. Army Research Laboratory
Langley Research Center
Hampton, VA

Presented at the 37th AIAA/ASME/ASCE/AHS/ASC
Structures, Structural Dynamics, and Materials Conference
Salt Lake City, UT
April 15-17, 1996

AIAA Paper 96-1367

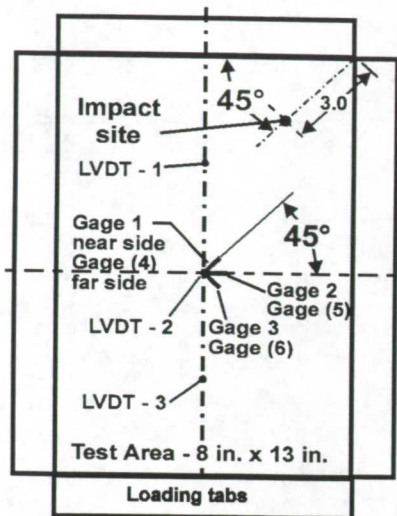
Figure 1. - Location of strain gages, impact site, and displacement transducers (LVDT).

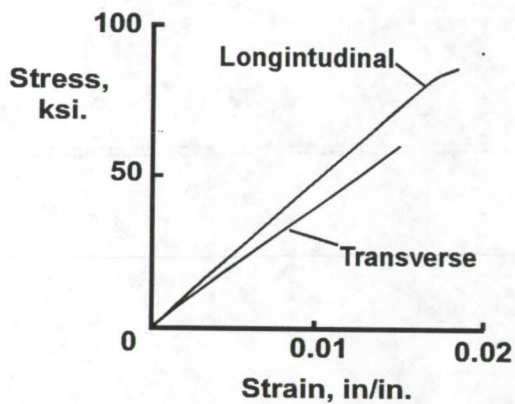
Figure 2. - Stress-strain curves for Kevlar-49-epoxy material used for the panels.

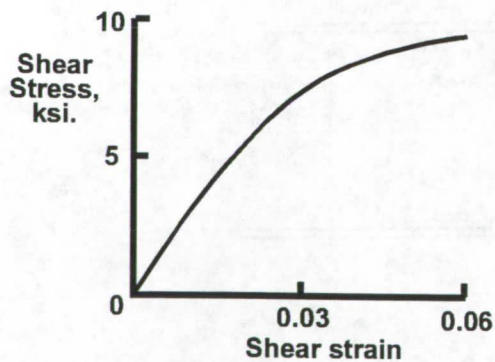
Figure 3. - Shear-stress-shear-strain curve for Kevlar-49-epoxy material used for the panels.

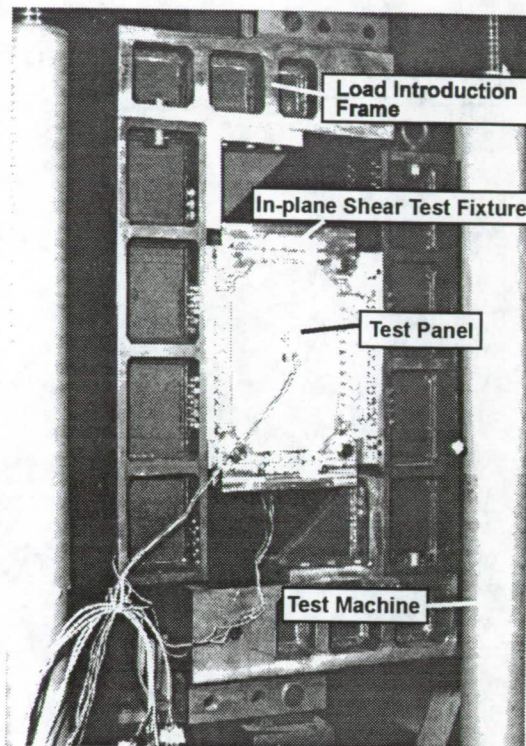
Figure 4. - Test setup with panel.

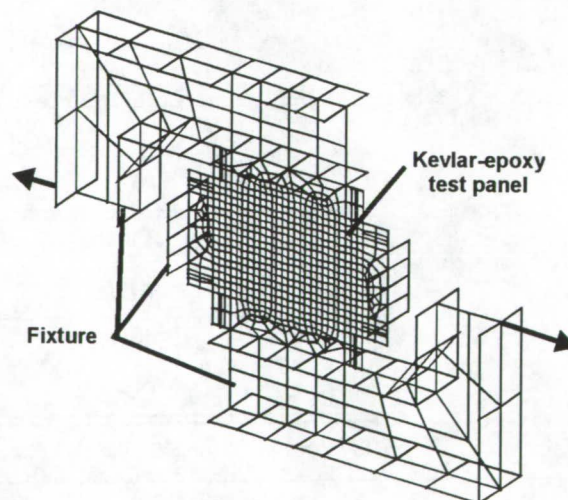
Figure 5. - STAGS finite element model of Kevlar-epoxy panel and loading frame.

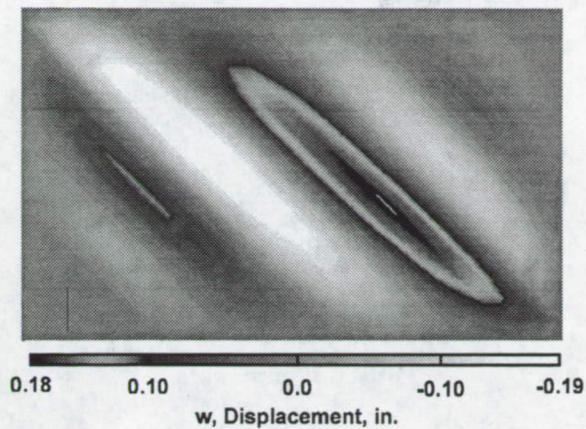
Figure 6. - Out-of-plane displacement predictions for $N_{xy} = 850$ lbs/in.

$N_{xy} = 850$ lbs/in. The maximum strain is .013 in/in along the crest of the deepest buckles.

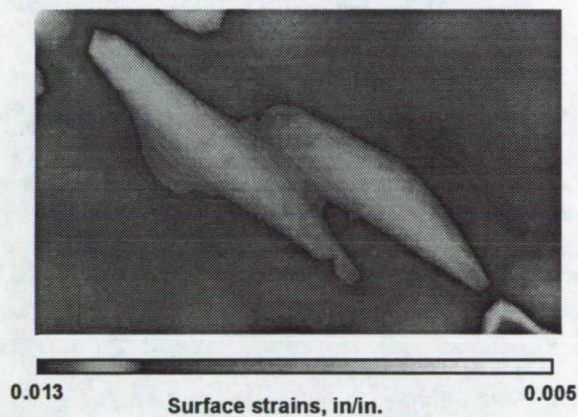
Figure 7. - Surface strain predictions, parallel to the buckle pattern for $N_{xy} = 850$ lbs/in.

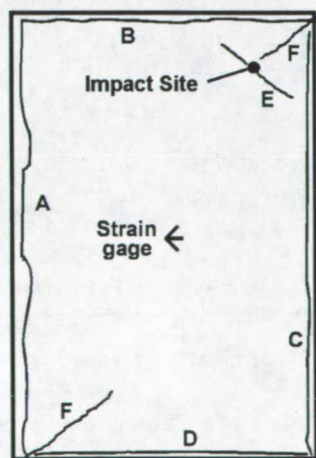
Figure 8. - Location of failure sites.

Generally, the solid panels failed by tearing along the load introduction tabs as shown in figure 8. The failure modes for each solid panel are summarized in Table 2 as a combination of letters shown in figure 8. Photographs of two failure modes are shown in figures 21 and 22. Laminate failure occurred in the laminate shown in figure 21, which is typical of a diagonal tension failure. Failure of a damaged panel is shown in figure 22 and extends along two sides and through the impact damage site.

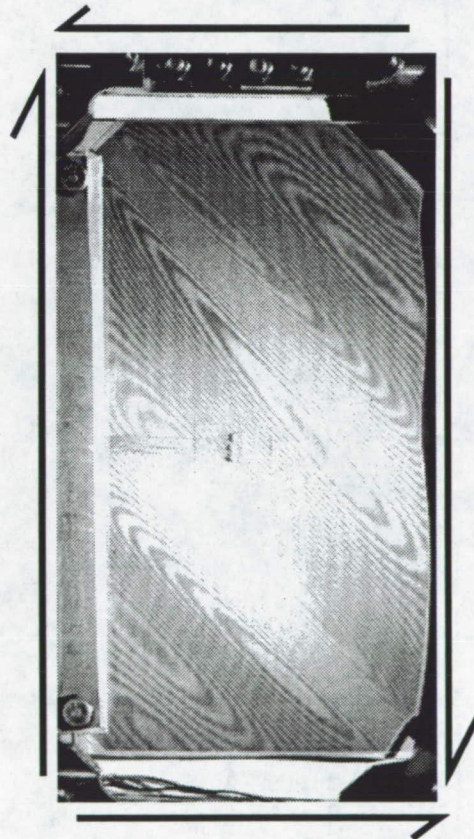
Figure 11. - Out-of-plane deflections as determined from moire pattern for $N_{xy} = 851$ lbs/in.

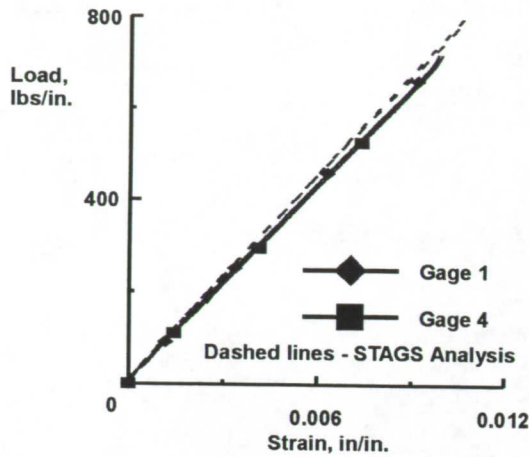
Figure 12. - Comparison of experimental and predicted strain, parallel to the buckle pattern.

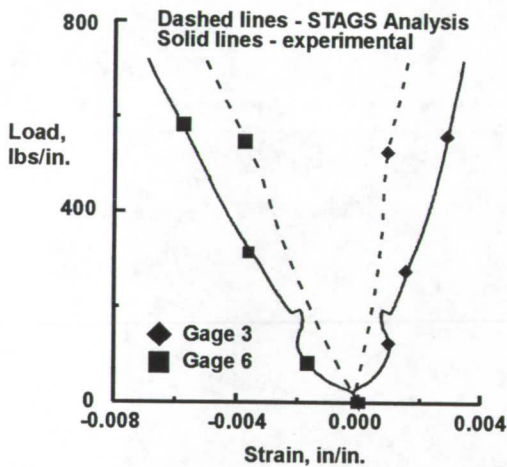
Figure 13. - Comparison of experimental and predicted strain normal to the buckle pattern.

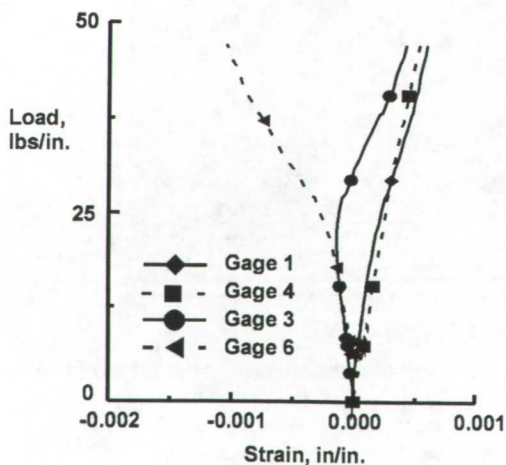
Figure 14. - Detail of experimental strain to a load of 45 lbs/in.

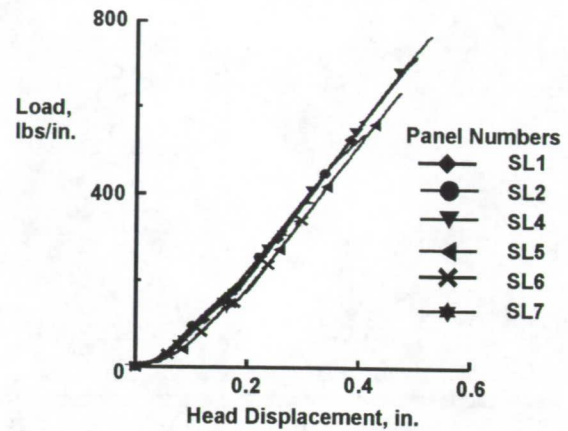
Figure 15. - Comparison of head displacements for solid panels.

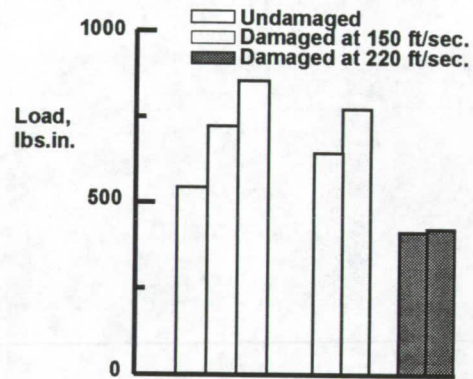
Figure 16. - Summary of failure strengths for solid panels.

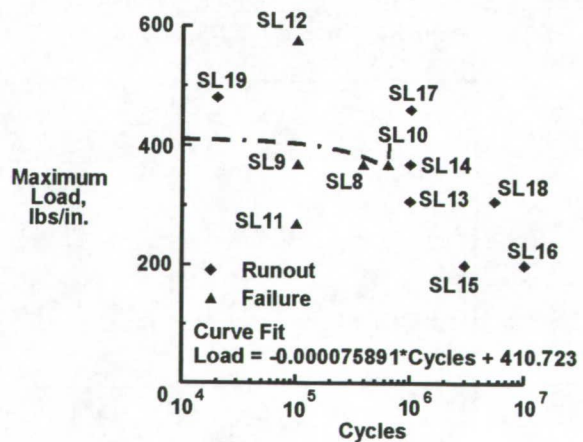
Figure 17. - Load as a function of load cycles for solid laminates.

A summary of the results for the solid panels that were cyclically loaded is shown in Table 2 and the maximum load as a function of load cycles is shown in figure 17. The diamond symbols are considered runout values and the panels were tested for residual strength. The residual strength results are shown in Table 2. A linear curve fit to the data from the five failed panels is

shown as a dashed line in figure 17. The coefficients for the curve fit equation are also shown in figure 17. More test results are needed in the low-load high-cycle region of the plot to complete the fatigue life curve. The average residual strength of the five undamaged solid panels that did not fail after one to three million load cycles is 763 lbs/in. This average residual strength is 107 percent of the baseline strength for the undamaged solid panels. Experimental and analytical out-of-plane deflections at the panel center and quarter point locations for a solid panel (SL12) are shown in figure 18. The calculated out-of-plane deflections have the same general trends as the experimental data but do not have the same magnitudes. This set of experimental curves indicates that a change has occurred in the panel response as indicated by the sudden change in the load-displacement curve when the load is approximately 180 lbs/in. The change in the curve could be caused by a change in mode shape or by a local failure. The out-of-plane deflections are repeatable for the different panels that have not been cyclically loaded. The out-of-plane deflections change in a panel as the number of cycles increases as can be seen in figure 19. The change in center deflection as the number cycles increase to 500,000 cycles is indicated in figure 19. This change in center deflection is typical for all solid panels. It appears as though the material stiffness decreased with increasing number of cycles thus changing the out-of-plane deflection shape. This decrease in material stiffness did not have a significant effect on the overall panel stiffness as shown in figure 20. The test-machine head displacement is shown in figure 20 as a function of load for a different number of load cycles applied to panel SL16, which was loaded with 10 million load cycles. All panels started to crack on the crest of the buckle at the panel corners soon after the testing was initiated, and the rate of crack growth varied for the panels. For the damaged panels, the crack propagated to the damage site and stopped for a period of time before continuing to propagate past the damage site. Crazing of the matrix occurred at various locations adjacent to the steel load introduction tabs.

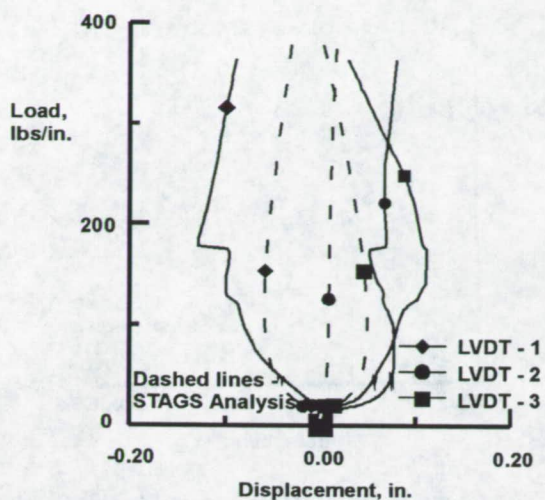
Figure 18. - Comparison of out-of-plane displacements with analysis on solid panels.

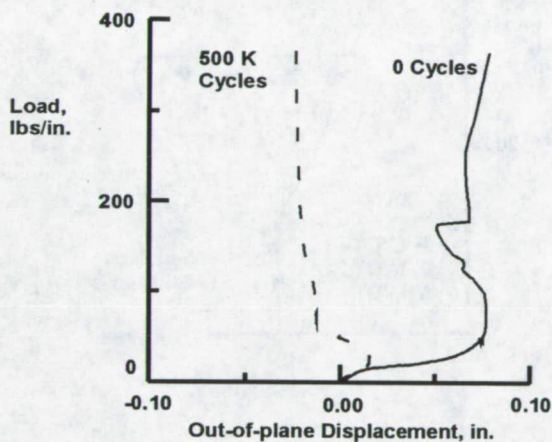
Figure 19. - Comparison of center out-of-plane displacements for different cycle accumulation on a solid panel.

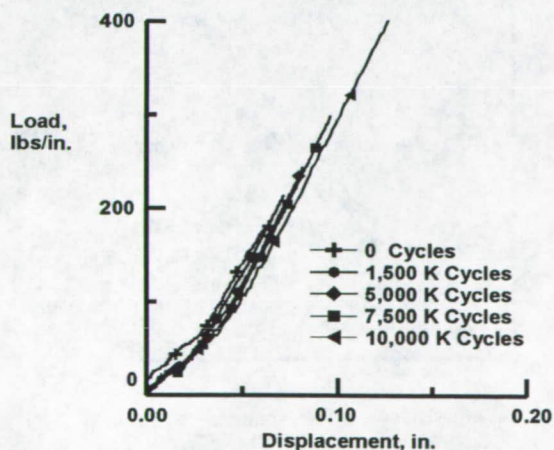
Figure 20. - Comparison of head displacements for different number of cycles on panel SL16.

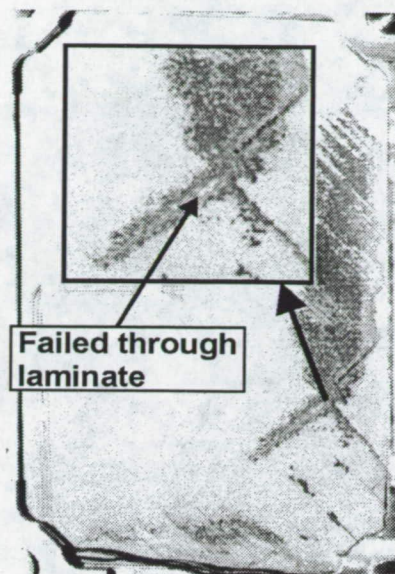
Figure 21. - Photograph of failed panel SL3.

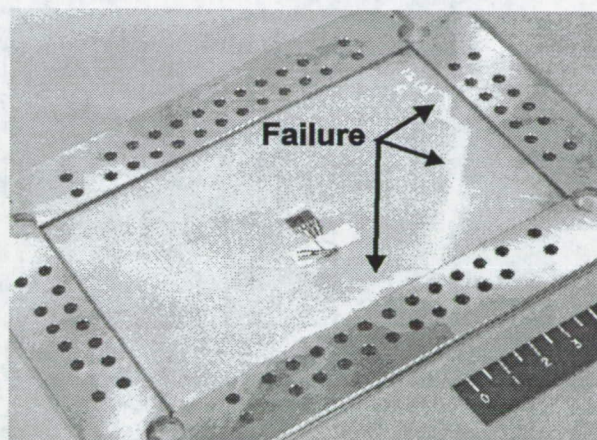
Figure 22. - Failure of damaged panel SL5.

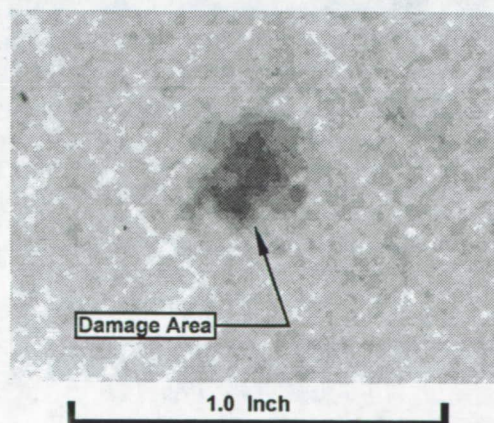
Figure 23. - Damaged sandwich panel impacted at 150 ft/sec.

Selected sandwich panels were subjected to low-velocity impact damage and photographs of the damaged sandwich panels are shown in figures 23 and 24 for impact velocities of 150 ft/sec and 220 ft/sec, respectively. The damaged areas for the 150 ft/sec impact are less than 0.25 square inches. The damage areas for the panels that were perforated with a 0.50-inch-diameter sphere are less than 0.6 square inches.

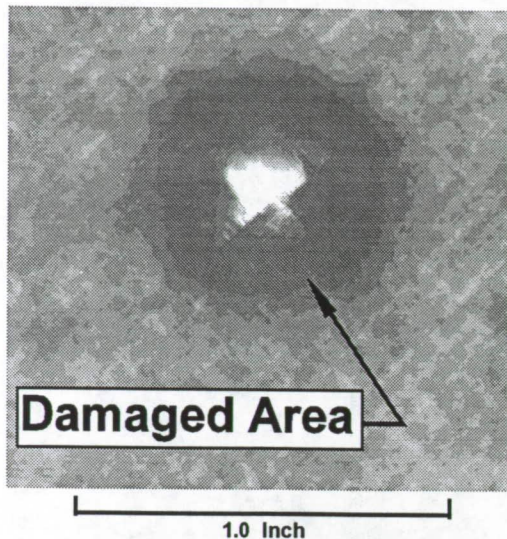
Figure 24. - Damaged sandwich panel impacted at 220 ft/sec.

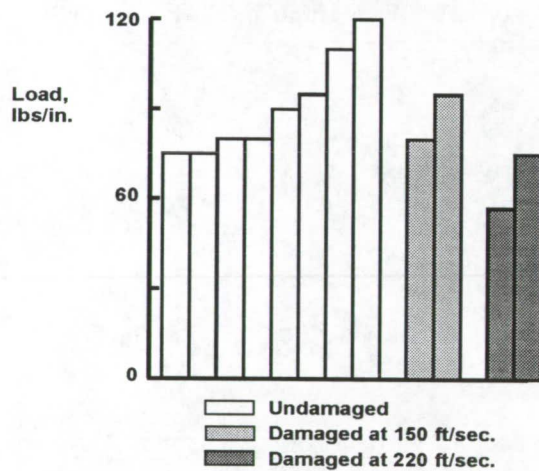
Figure 25. - Summary of initial buckling loads for sandwich panels.

The initial buckling loads are better defined for the sandwich panels than for the solid panels. A summary of the sandwich panel buckling loads is shown in figure 25. The average buckling load for the undamaged panels is 91 lbs/in and the average buckling load for the panels damaged at 150 ft/sec is 88 lbs/in. Panels damaged at 220 ft/sec buckled at 66 lbs/in or a 27 percent lower load than the undamaged panels. The 91 lbs/in buckling load for the undamaged panels is 58 percent of the buckling load predicted by the STAGS linear buckling analysis. The strain gage results for panel SW1 are shown in figures 26 and 27. Gages 1 and 4 (figure 26) are parallel to the buckle pattern and indicate a tensile strain until failure. The results of the STAGS nonlinear analysis are shown by the dashed lines in figure 26 and 27. Strains shown in figure 27 are for gages 3 and 6 which are normal to the buckle pattern. The strains start diverging at approximately 80 lbs/in which is considered to be the buckling load. At 225 to 240 lbs/in and 550 lbs/in this panel appears to change buckling modes. The STAGS analysis predicted a mode change at 270 lbs/in as shown in figure 27. The predicted strain normal to the buckle pattern has the same trends as the experimental strain. These strain results are typical of all of the static tests of the sandwich panels. The experimental and predicted out-of-plane deflections for the center (LVDT 2) and the quarter points (LVDT 1 and 3) of sandwich panel number SW8 are shown in figure 28. The experimental results are from the first static load prior to the start of cyclic loading. A mode change appears to occur at approximately 300 lbs/in for panel SW8. The analysis predicts a mode change at 270 lbs/in as indicated by the dashed curves in figure 28. Good correlation with the analysis is observed up to 60 lbs/in. Plots of the test-machine head displacement are shown in figure 29 as a function of load. Panels SW1 and SW2 are undamaged and have nearly the same response, while the damaged panel SW6 has larger displacements but its stiffness appears to match the undamaged panels. A load decrease is present in all of the curves and corresponds to the mode change observed in the strain gage data. A summary of the

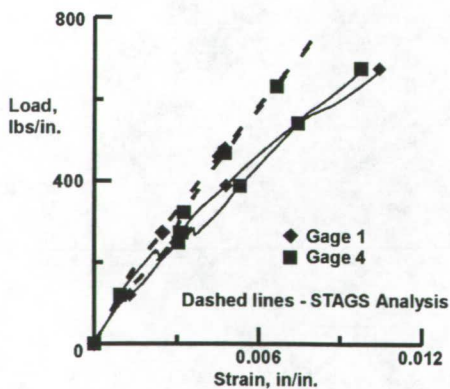
Figure 26. - Comparison of strain parallel to the buckle pattern for Panel SW1.

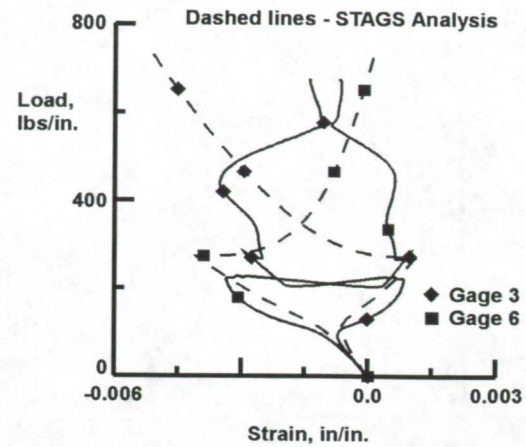
Figure 27. - Comparison of strain normal to the buckle pattern for Panel SW1.

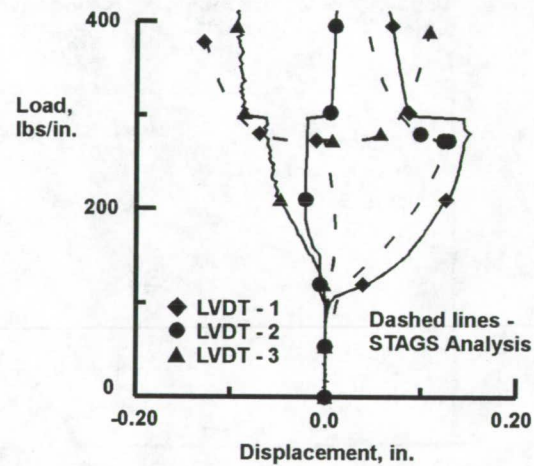
Figure 28. - Comparison of out-of-plane displacements for Panel SW8.

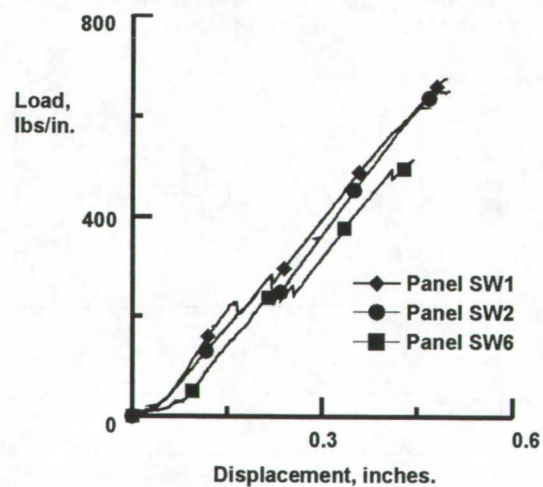
Figure 29. - Comparison of head displacements for sandwich panels.

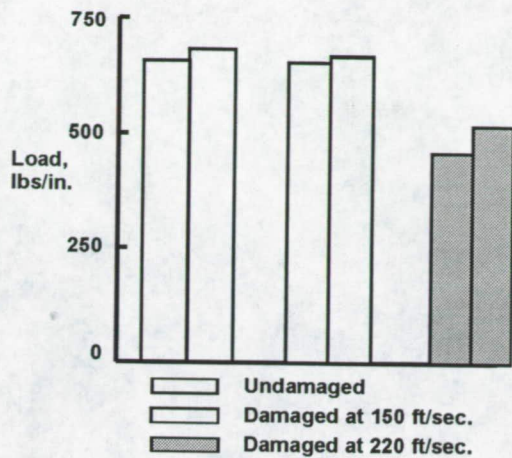
Figure 30. - Summary of ultimate strength for sandwich panels.

static strengths of the panels are shown in figure 30. The average strength of the panels impacted at 150 ft/sec is 661 lbs/in while the average strength of the undamaged panels is 670 lbs/in. The average strength of the panels impacted at 200 ft/sec is 489 lbs/in or 73 percent of the undamaged panel strength. The strength of the undamaged sandwich panels is 95 percent of the strength of the undamaged solid panels while the sandwich panels impacted at 150 ft/sec are 93 percent as strong as the solid panels. The sandwich panels impacted at 220 ft/sec are 16 percent stronger than the solid panels.

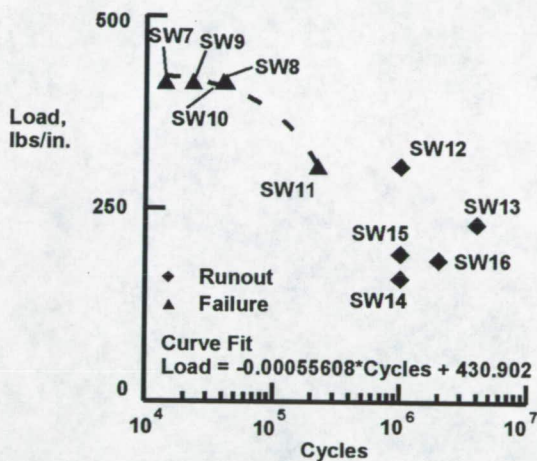
Figure 31. - Load as a function of load cycles for sandwich laminates.

A summary of the sandwich panels that were cyclically loaded is shown in Table 3 and the maximum loads at failure are shown in figure 31 as a function of number of load cycles to failure. A linear curve fit to the data from the five failed panels (triangle symbols) is shown as a dashed line in figure 31. The coefficients for the curve fit equation are also shown in figure 31. The diamond symbols represent runout values and these panels were tested for residual strength. The residual strength results are also shown in Table 3. More test results are needed in the low-load high-cycle range of the plot to produce a full fatigue life curve for the sandwich panels. The average residual strength of the four undamaged sandwich panels with one to four million load cycles is 749 lbs/in. This residual strength is 112 percent of the baseline strength of the undamaged sandwich panels. A comparison of the sandwich panel results in figure 31 with the solid panel results in figure 17 indicates the sandwich panels have a shorter fatigue life than the solid panels. The out-of-plane deflections for the sandwich panels also change as the number of cycles increases as they did for the solid panels (see figure 32). All sandwich panels cracked and failed in a manner similar to the solid panels and most of the sandwich panels exhibited a fold as shown in figure 33 which was set permanently in the panel. A summary of all the failure modes is given in Table 3 using the notation of figure 8. A photograph of a failed sandwich panel is shown in figure 34 where a crack extends along the panel edge and another crack extends from the corner parallel to the fiber direction.

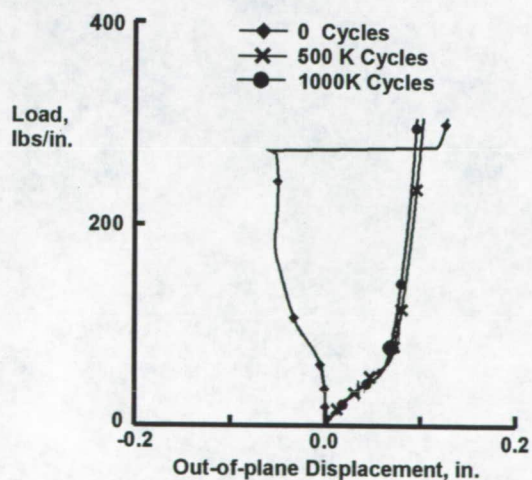
Figure 32. - Comparison of out-of-plane deflections for sandwich Panel SW11.

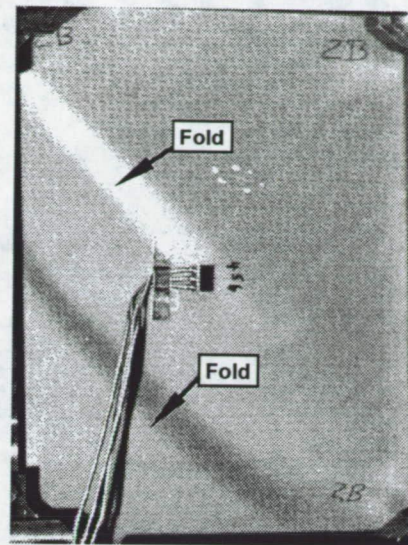
Figure 33. - Photographs of folds in sandwich panel.

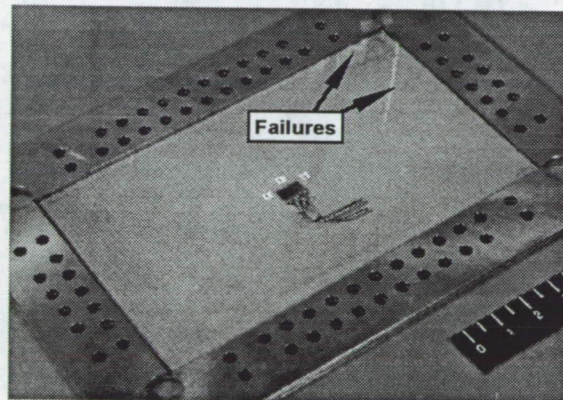
Figure 34. - Failures in sandwich panel.

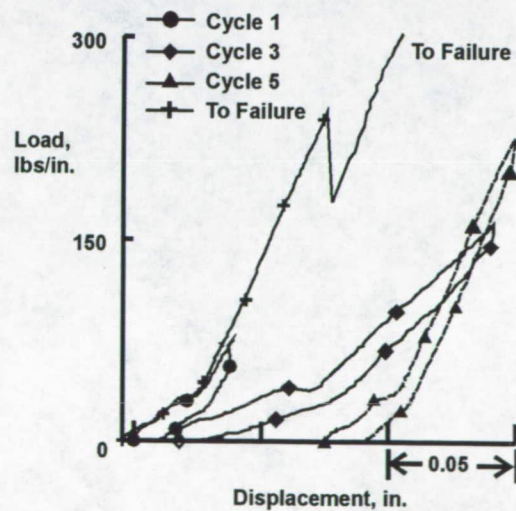
Figure 35. - Comparisons of head displacements for Panel LCF1 with no damage.

is given in Table 4. The strain gage and LVDT data for these panels were recorded for both the load and unload cycles. All strain gage and LVDT response curves returned to their starting point for each load cycle. The load as a function of stroke for three cycles, and load to failure for the undamaged panel and the panel damaged at 220 ft/sec are shown in figures 35 and 36. The hysteresis in the data shown in figures 35 and 36 is considered insignificant since all of the strain gage response curves returned to their starting points. Some of the variation in the data shown in the figures could be the result of tolerances in the in-plane test fixture and load frame. There is no obvious reason for the slopes of the curves to be different in figures 35 and 36.

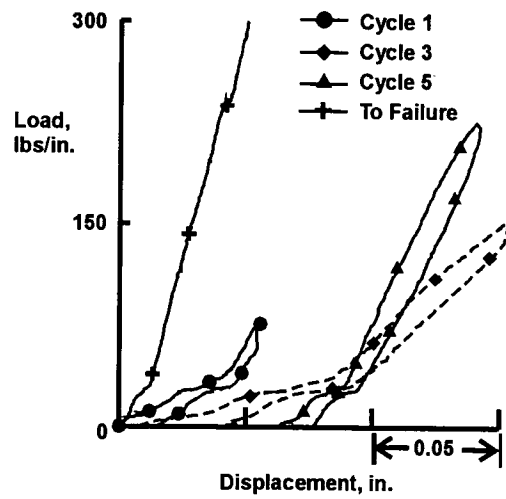
Figure 36. - Comparison of head displacements for Panel LCF3 that was damaged at 220 ft/sec.
