NASA Technical Memorandum 110302

Compression Response of a Sandwich Fuselage Keel Panel With and Without Damage

David M. McGowan and Damodar R. Ambur
Langley Research Center, Hampton, Virginia

February 1997

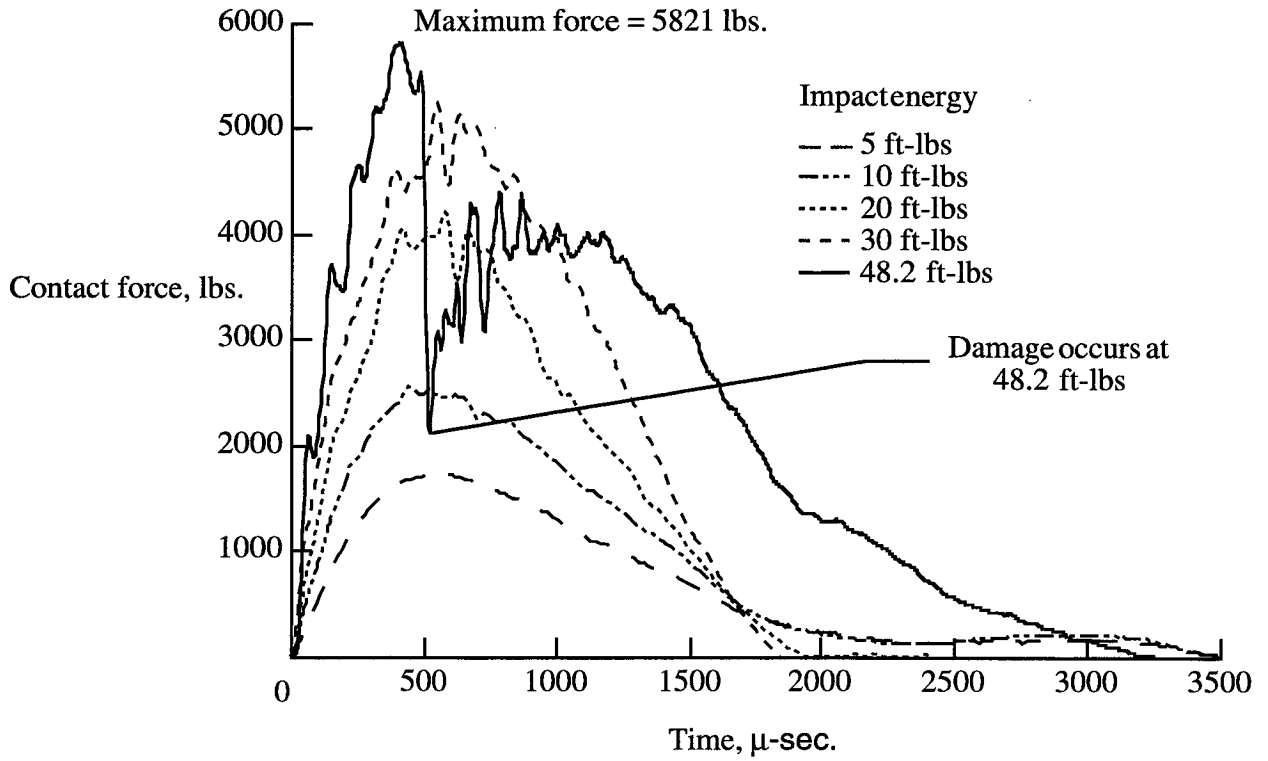
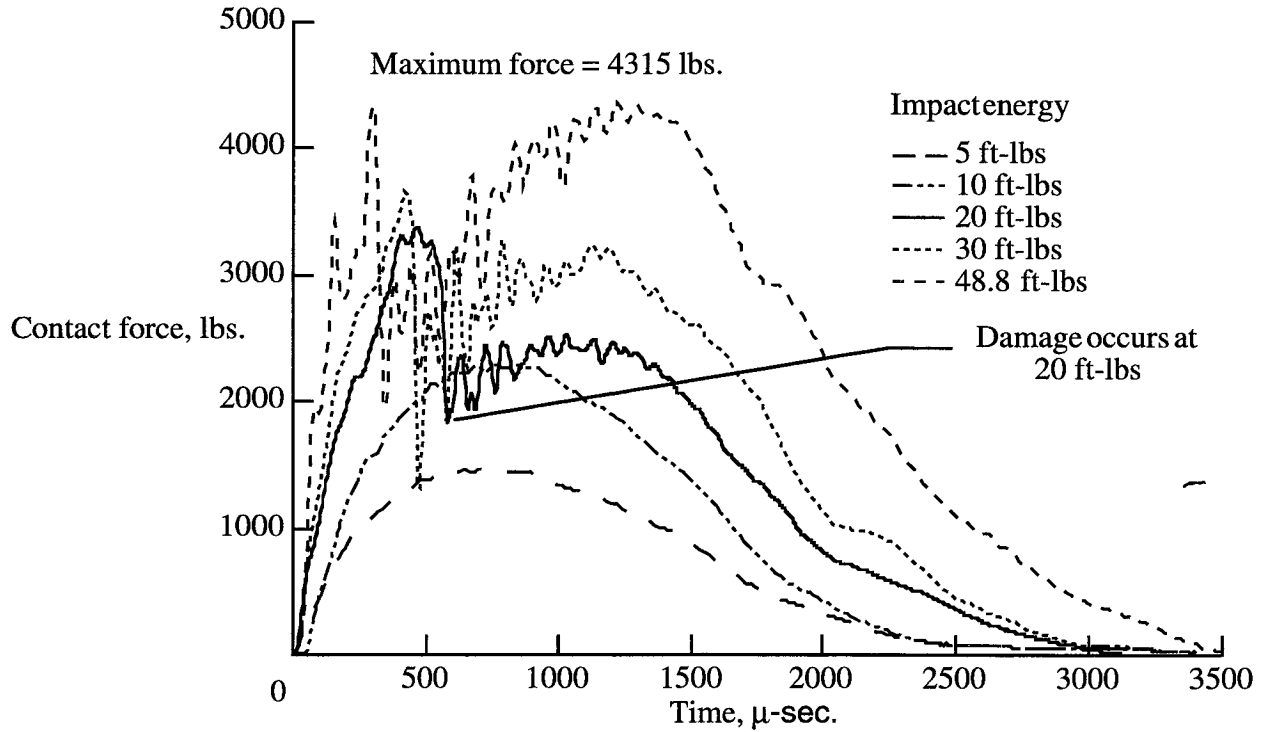
(a) Thick end (50 plies).

(b) Thin end (36 plies).

Figure 9. Contact-force profiles for impacts at the thick and thin ends of the FK1 remnant.

Contact-force profiles for impact energies up to 48.2 ft-lbs are shown in Fig. 9(a) for the thick (50-ply) end of the remnant. The measured contact force in pounds is plotted in this figure as a function of time in micro-seconds for several impact-energy levels ranging from 5 ft-lbs to 48.2 ft-lbs. Damage initiation is indicated in the figure when the contact-force magnitude at a particular impact-energy level is reduced significantly. Damage first occurred at an impact energy of 48.2 ft-lbs as indicated by the solid line in Fig. 9(a). The maximum value of the contact force for this impact energy is 5,820 lbs. Contact-force profiles for impact energies up to 48.8 ft-lbs are shown in Fig. 9(b) for the thin (36-ply) end of the remnant. Although the shapes of the profiles are similar to those for the thick end, the first indication of damage occurred at an impact energy of 20 ft-lbs for the thin end. Furthermore, the maximum value of the contact force for the thin end is 4,500 lbs. These results are consistent with those presented in references 3-7 where delaminations are shown to occur in sandwich structures at impact-energy levels that are much lower than the impact-energy levels for damage initiation in monolithic laminates.

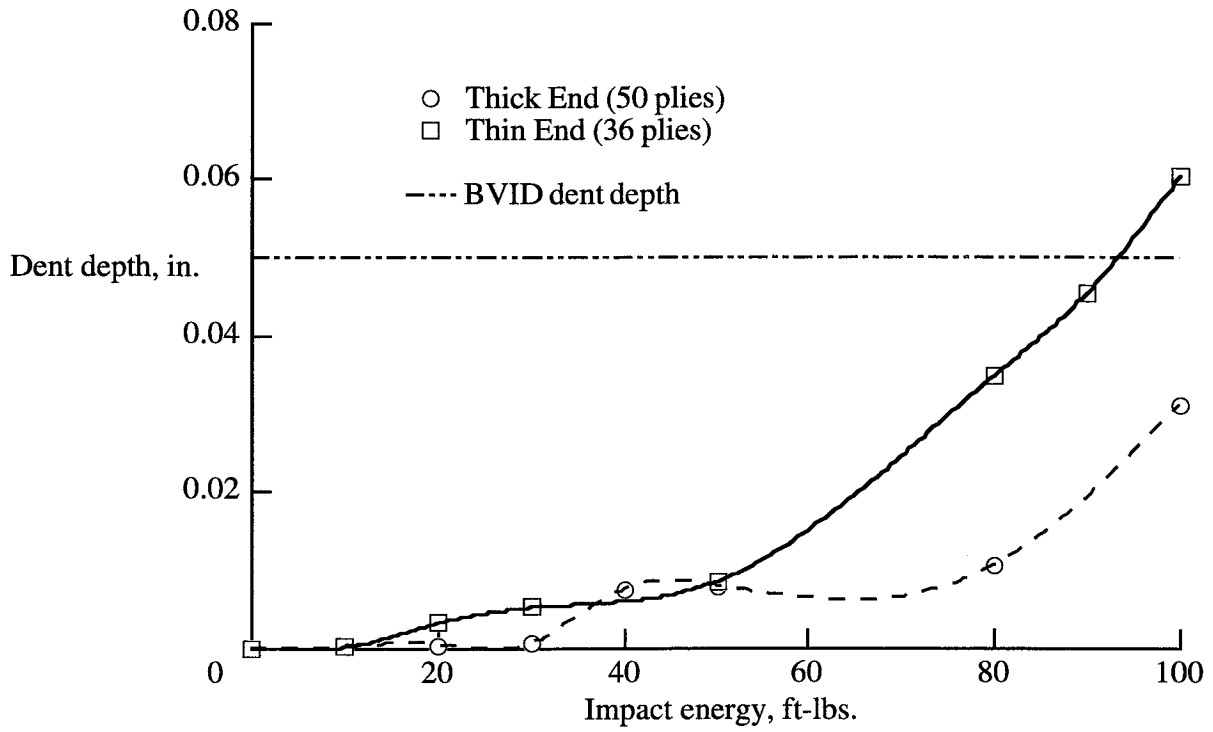
Figure 10. Residual dent depth values measured at the impact sites on the FK1 remnant.

Measured values of the residual dent depth at the impact sites are plotted as a function of the impact-energy level in Fig. 10 for the thick and thin ends of the remnant. The measured values are represented by the open symbols, and cubic splines fit through these data points are represented by curves. The horizontal line at 0.05 inches represents the dent depth value at which BVID is considered to have occurred. The cubic splines fit through the measured data are intended to assist the reader in visualizing the general trends of the data and are not intended to predict accurately the trends between the data points. As shown in Fig. 10, a dent depth value of 0.05 inches is only obtained at the thin end of the panel for impact-energy levels below 100 ft-lbs of impact energy. The dent depth at the thick end is only 0.038 inches for an impact-energy level

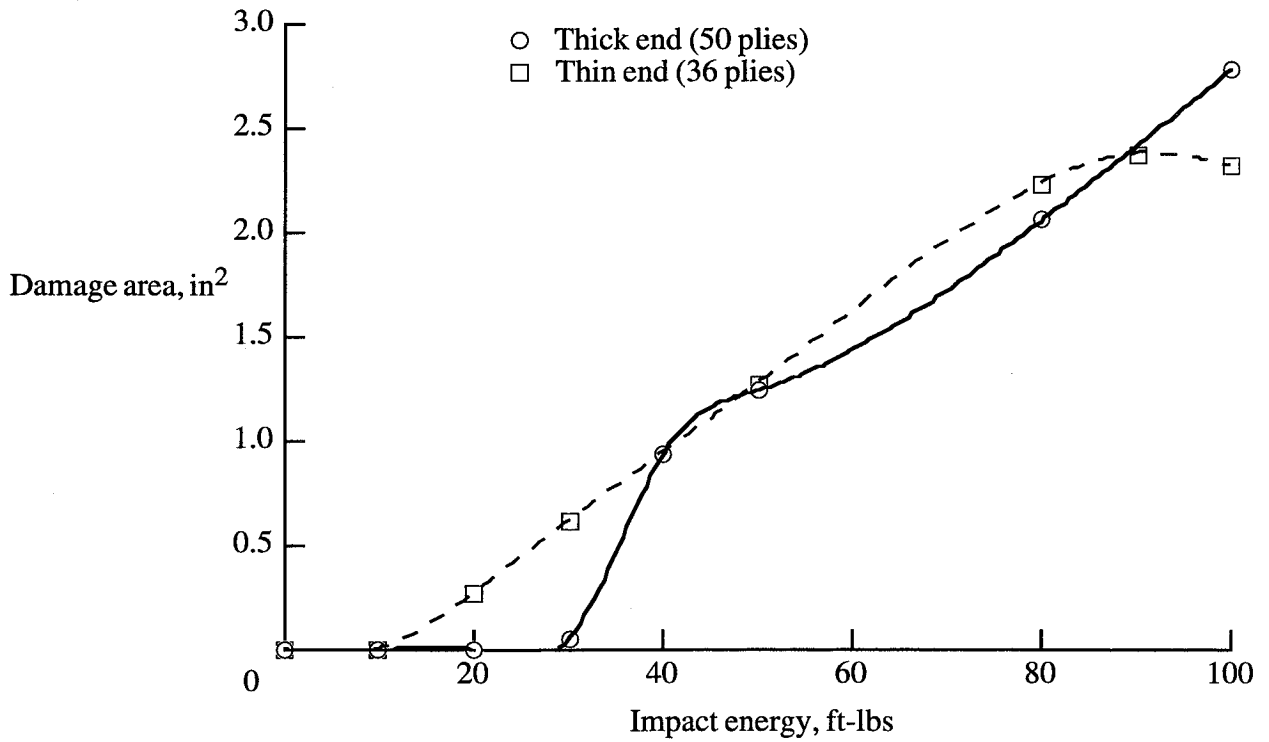
Figure 12. Area of impact damage sites as measured by ultrasonic C-scan inspections of the FK1 remnant.

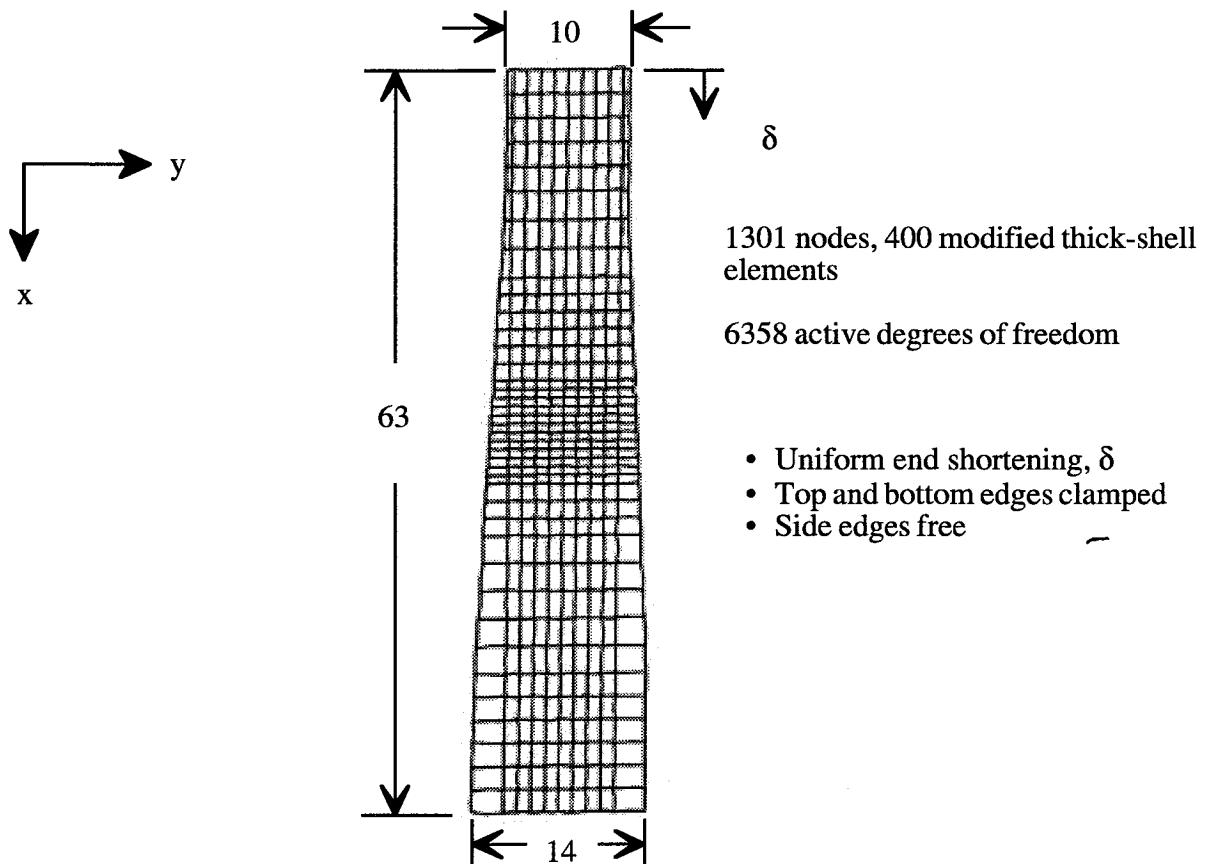
Figure 13. Analytical model of undamaged panel. Dimensions are in inches.

The sandwich panel was analyzed using the DIAL finite element code.⁹ The panel was modeled as a combination of several sandwich plates each having different face-sheet stacking sequences and sandwich core thicknesses. The dropped plies and variations in core thicknesses in the test panel were therefore accounted for. An eight-node modified thick-shell element was used for modeling the plate. These elements are shear deformable and account for the large shear deformations associated with sandwich construction. The finite element model of the undamaged panel is shown in Fig. 13. This model has a total of 400 elements and a total of 6,358 active degrees of freedom. Load is applied to the model by specifying a uniform end shortening, δ , at the thin end of the panel. The potted ends of the panel are not modeled; thus, the total length of the model is 63 inches. The effect of the potting is simulated by clamping the top and bottom edges of the model. The side edges of the model are free, and the wide-column buckling load is predicted to be 170 kips. The finite element model of the notched panel is shown in Fig. 14. This model has a total of 416 elements and a total of 6,507 active degrees of freedom. As shown in the figure, additional elements are used in the region of the notch to improve the mesh refinement in that region. Simple support boundary conditions are specified along the line of nodes specified in Fig. 14 to represent the edge supports used in the impacted- and notched-panel tests.

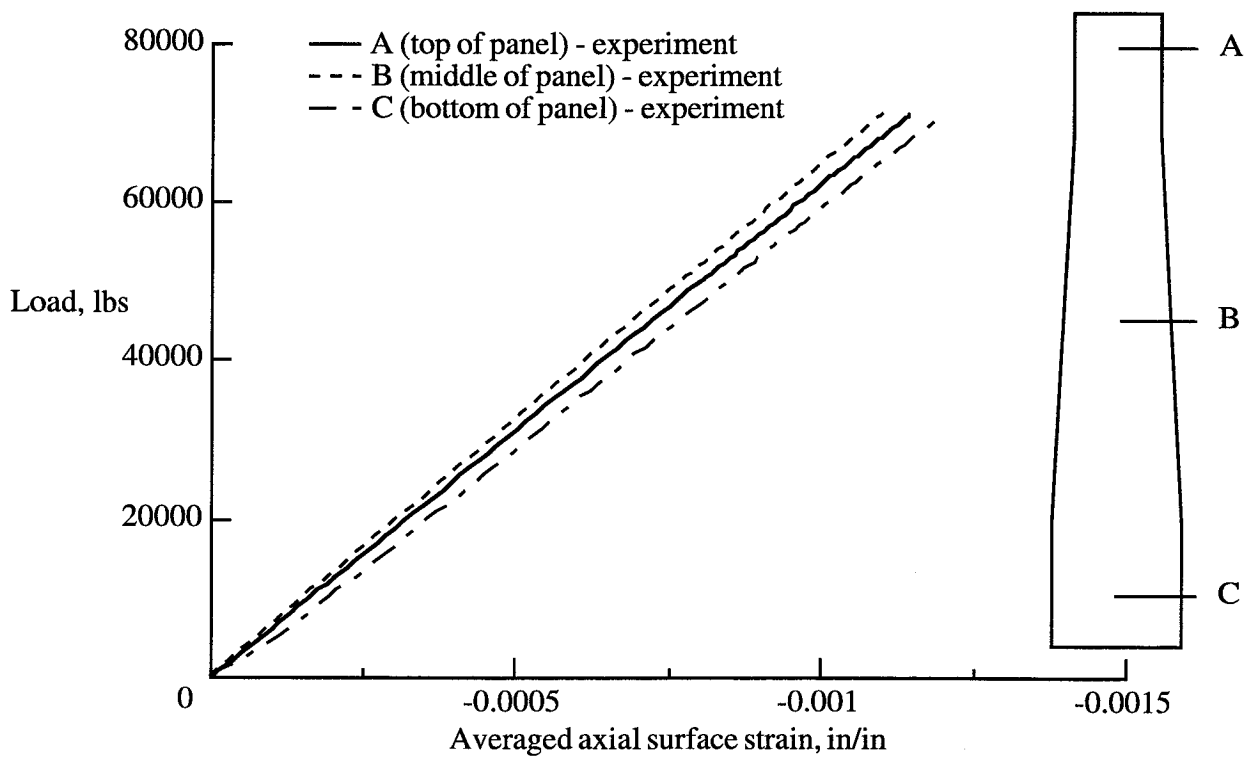
Figure 15. Experimental surface strain results for the undamaged panel.

The test of the undamaged panel was performed to study the strain distribution in the face sheets of the test panel and to confirm that the design goal of maintaining a relatively uniform laminate stiffness along the length of the panel was met. Experimental surface strains in the face sheets of the test panel are shown in Fig. 15. This figure presents the applied load as a function of an averaged axial surface strain for locations

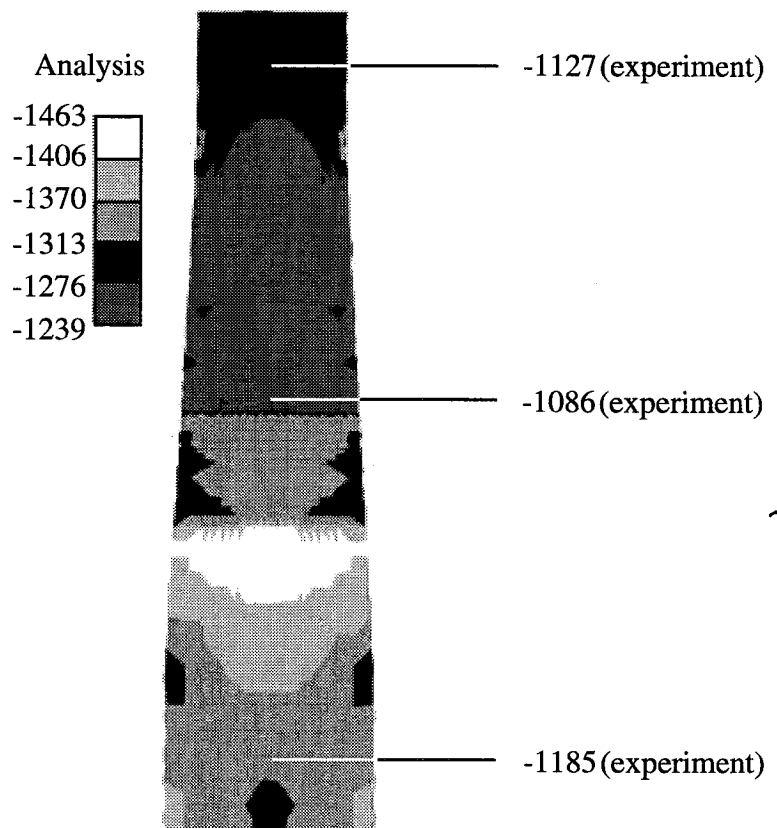
Figure 16. Experimental and analytical surface strain results for the undamaged panel with an applied load of 70 kips. All strain values are in micro-in./in.

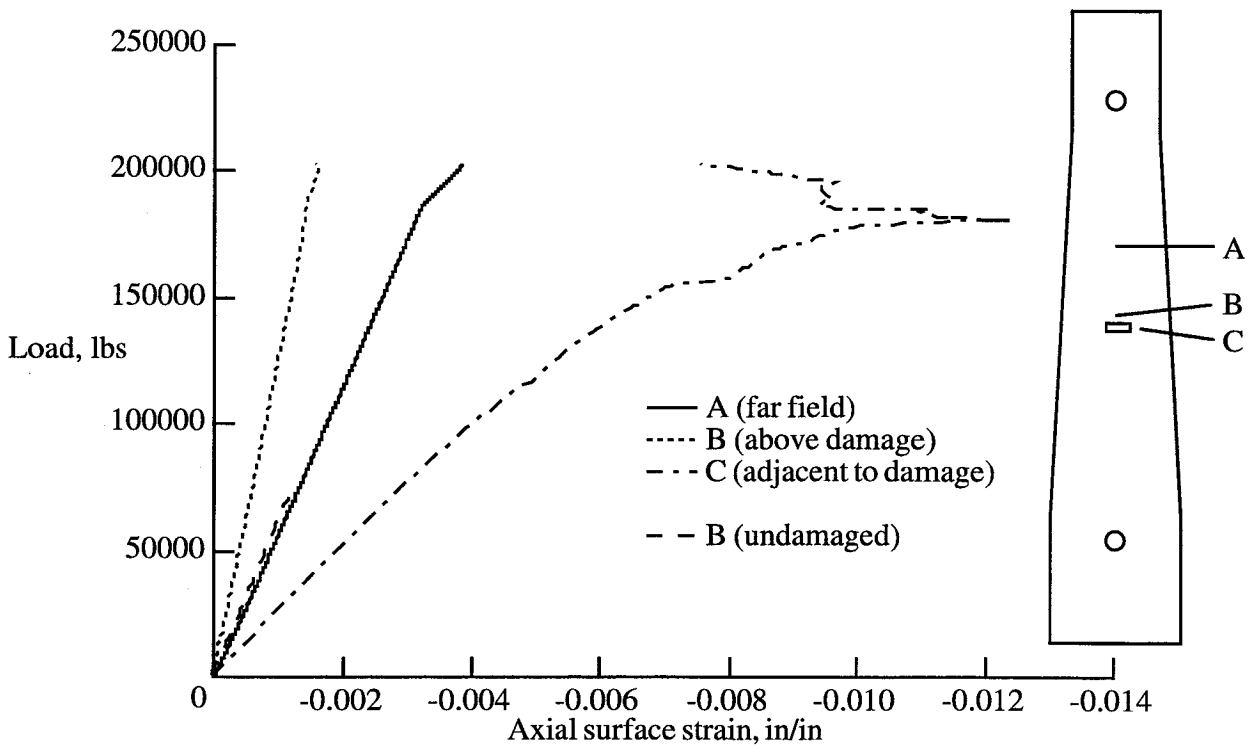
(b) Notch location.

Figure 19. Experimental surface strain results for the notched panel.
