Advanced Technology Composite Fuselage—Repair and Damage Assessment Supporting Maintenance

*B. W. Flynn, J. B. Bodine, B. Dopker, S. R. Finn, K. H. Griess, C. T. Hanson, C. G. Harris, K. M. Nelson,
and T. H. Walker*
The Boeing Company • Seattle, Washington

Advanced Technology Composite Fuselage

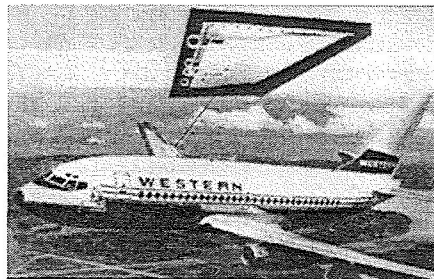
727 elevator

737 horizontal stabilizer

737 spoilers

Figure 3-1: Prototype Commercial Applications of Composite Primary and Secondary Structures

Assessing airline experience with composite structure is, taken as a whole, an extremely difficult task. Depending on who is consulted from the airlines, the responses vary from horror stories to outstanding success. Given these limitations, the facts and data that are currently available are the detailed reports that were received from the airlines on parts involved in the NASA-sponsored Advanced Composites Energy Efficiency (ACEE) program, which supported the design and fabrication of composite parts such as those shown in Figure 3-1 to replace metal parts. Five shipsets of 727 elevators have accumulated more than 331,000 hrs. and 189,000 cycles; 108 737 spoilers have accumulated more than 2,888,000 hrs. and 3,781,000 cycles. Also included were five shipsets of 737 horizontal stabilizers which incorporated laminate torque boxes and sandwich ribs. These stabilizers have amassed over 133,500 flight hours and 130,000 landings as of May, 1995. The service exposure data collected for these parts has not indicated any durability or corrosion problems. (Some minor corrosion pitting was found in fastener holes of 737 stabilizer aluminum trailing edge fittings — this due to an obsolete sealing practice.) Several repairs have been satisfactorily performed on the 727 elevators and 737 horizontal stabilizers.

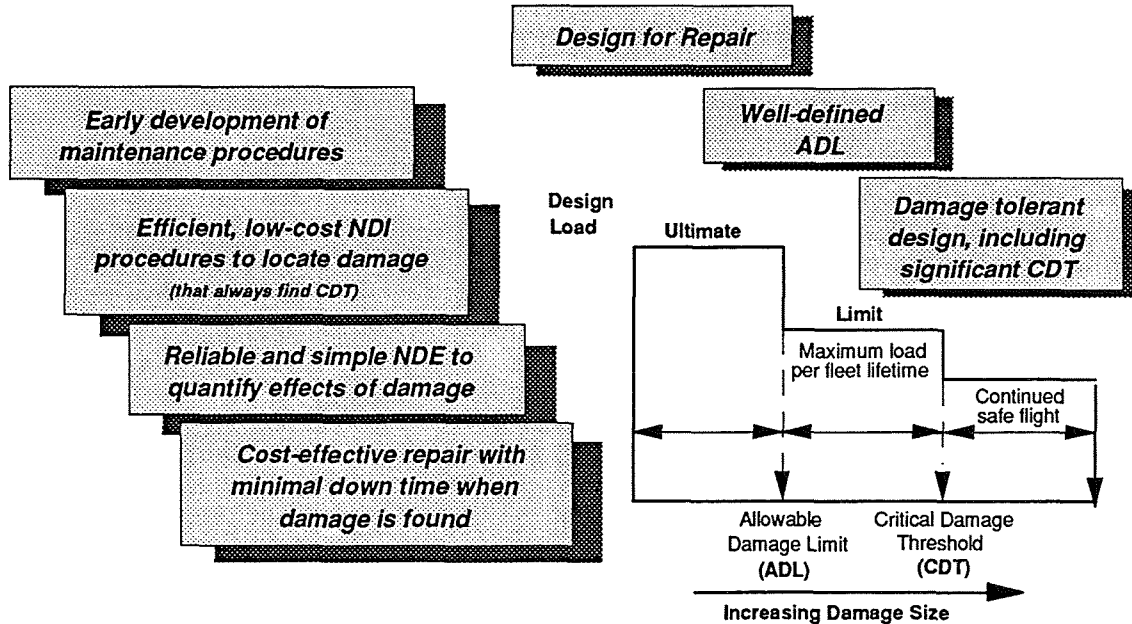
Figure 3-2 shows maintenance development philosophy established during Phase B of the ATCAS composite fuselage program. Maintenance procedures such as inspection and repair, which are applicable to a service environment, must be considered during design selection. Closed hat-section stringers, for instance, are compatible with inexpensive manufacturing techniques, but pose difficulties relative to inspection and attachment in repair applications. Material choices may also be affected. The designer should avoid the use of different material systems with different curing temperatures on one part. For instance, skins and stiffeners are sometimes precured at 350°F and then, for manufacturing

Figure 3-2: Rules for Maintainable Composite Structures

Another important aspect of concept development critical to maintenance is damage tolerant design practices. The allowable damage limits (ADL) and critical damage thresholds (CDT) defined in Figure 3-2 must be established to support the structural repair manual and inspection procedures. The former allows rapid determination of the need for repair during scheduled inspection, while the latter should be sufficiently large to allow safe aircraft operation between inspection intervals. Knowledge of residual strength and inspection capabilities should allow determination of both ADL and CDT as a function of structural location.

Returning to Figure 3-2, another requirement for maintainable composite structure is the establishment of nondestructive inspection (NDI) and evaluation (NDE) procedures for practical damage location and quantitative assessment, respectively, during scheduled maintenance. The latter, which may require ultrasonic methods, should only be required to assess the effects of damage found by more easily performed procedures (e.g., visual).

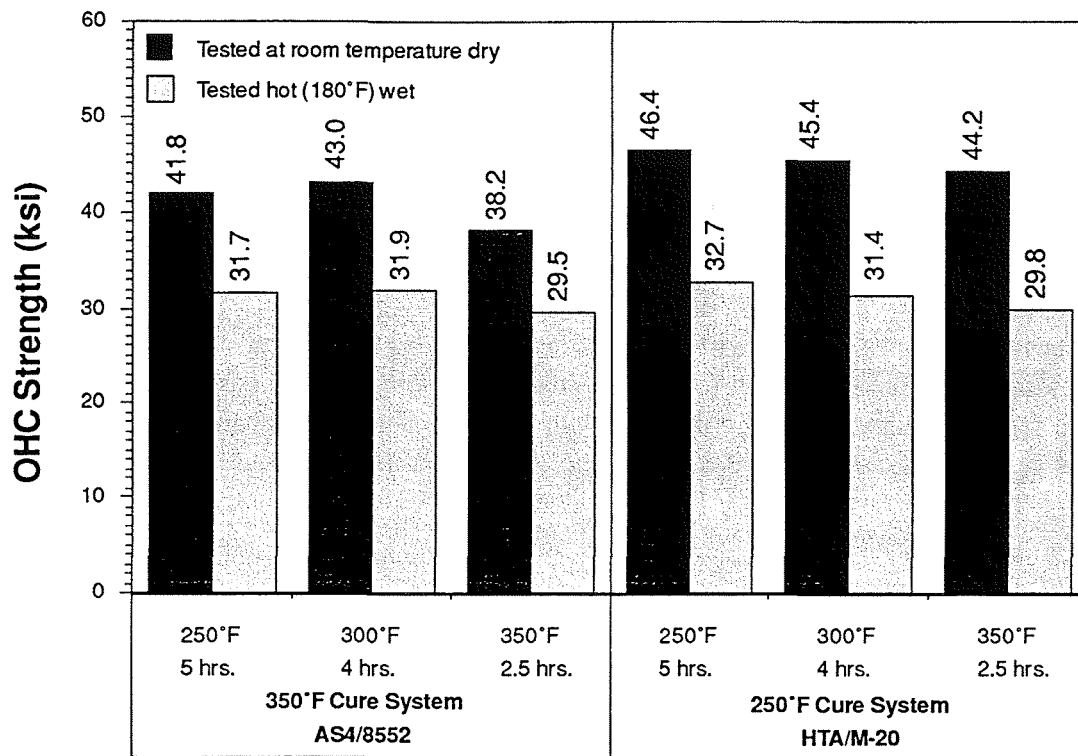
Two materials were evaluated: AS4/8552, the baseline system for the keel; and HTA/M-20 (formerly known as HTA/DLS1194). Both of these prepreg systems are typically cured in an autoclave at 40 to 80 psig. The M-20 is an epoxy normally cured at 250°F, while the 8552 is normally a 350°F cure epoxy. The laminates were evaluated for OHC under room temperature dry (RTD) and hot/wet (H/W) conditions. Little difference was found between the OHC strengths of HTA/M-20 and AS4/8552, whether cured at 250°F, 300°F, or 350°F. An extended 250°F cure cycle produced essentially the same hot/wet properties as higher temperature processes (Figure 5-1). Furthermore, laminates cured at the lower temperatures for longer times produced lower porosity than those cured at higher temperatures for shorter times (0% vs. 1% for HTA/M-20, 1% vs. 3% for AS4/8552).

Figure 5-1: Open Hole Compression Strengths of Patch Laminates

Initially, an effort was undertaken to understand the cure kinetics and mechanical properties of candidate patch materials. Laminates representative of patches were cured under vacuum to evaluate different prepreg materials and determine the effects of processing on patch quality. As a means of assessing patch quality, cross-sections were taken and porosity was either measured or estimated. Patch porosity raises concerns about loss of strength and the potential for moisture ingress. Strength was assessed with open hole compression (OHC) tests.

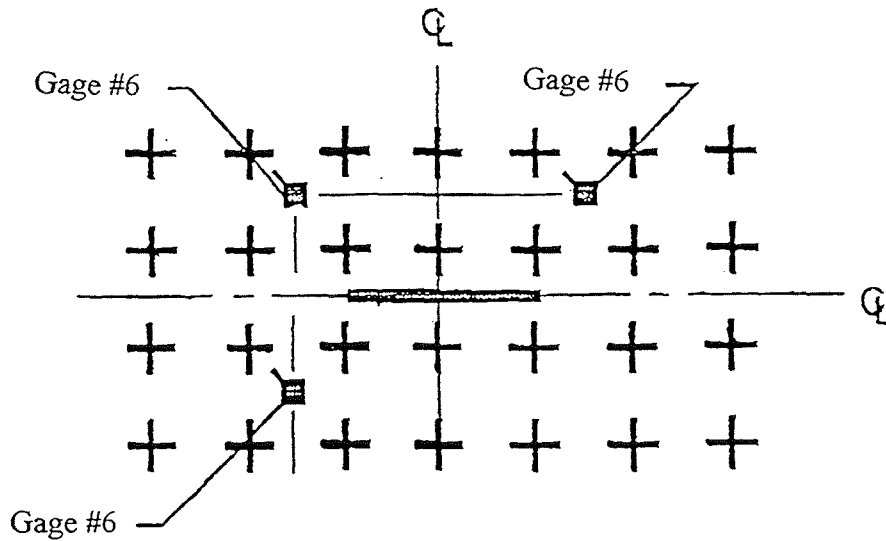
Figure A2-26: Strain Gages Below Repair on Specimen

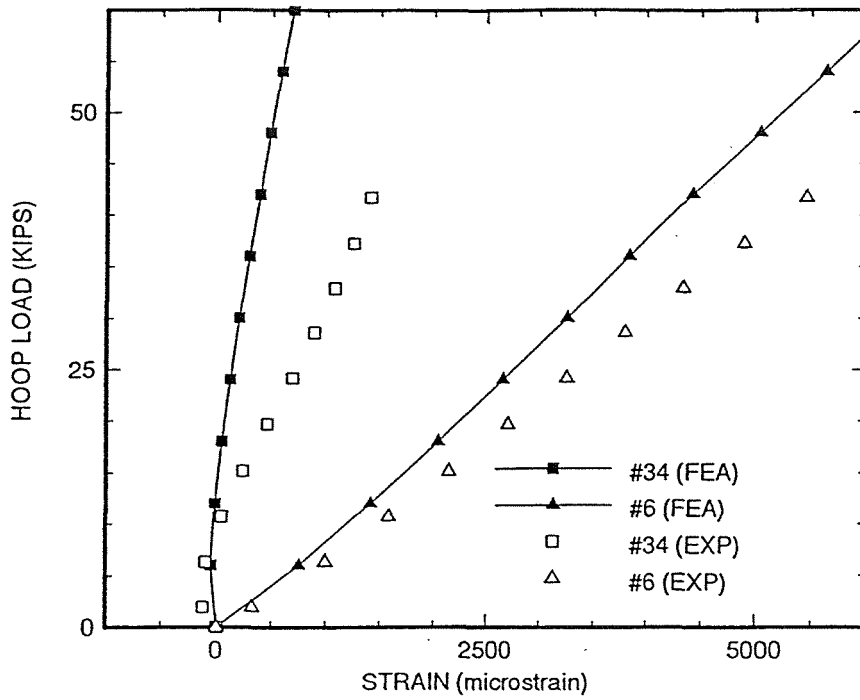
Figure A2-27: Comparison of Nonlinear Finite Element Analysis Predictions (FEA) and Experimental Results (EXP) for Averaged Gages #34 and #6

Measured and predicted (nonlinear analysis) strains as a function of load were compared. The agreement between nonlinear theory and experiment ranged from excellent to marginal, with excellent agreement at gage locations outside of the patch area. In the outer area little flexure was realized, and a pronounced peaking of in-plane strain in front of the patch was in contrast with linear analysis predictions. This suggests that alignment of the repair section with the plane of loading generated bending local to the repair area. Within the repair area the general agreement in the trend of strain development was found between nonlinear analysis predictions and experimental results. However, only marginal agreement on the actual values was obtained. Locations of several gages within the repair are shown in Figure A2-25 and A2-26. All identified gages are of axial orientation, parallel to the notch. Gages #6 and #34 represent average values of the three symmetric locations indicated. Plots of the nonlinear prediction versus experiment for the gages are shown in Figures A2-27 and A2-28 (Test Run No. 4, $P_{hoop}/P_{axial} = 0.52$). From examination of the experimental values, it is evident that strain on the top surface of the patch increases at greater distances toward its center. This behavior, a product of shear lag, was expected and was predicted by the nonlinear analysis. Although nonlinear analysis agreed with trends of the strain development, actual strain values showed poor correlation. Surprisingly the repair area realized higher strain than predicted. This suggests a coupling between patch and specimen that is more stiff than that modeled. This phenomena could in part be explained by friction between the fayed surfaces. This behavior was also realized in the uniaxial tests but to a much lesser extent.
