THERMOGRAPHIC QUALIFICATION OF GRAPHITE/EPOXY INSTRUMENTATION RACKS

James L. Walker¹, Samuel S. Russell² and Gary L. Workman¹

ABSTRACT

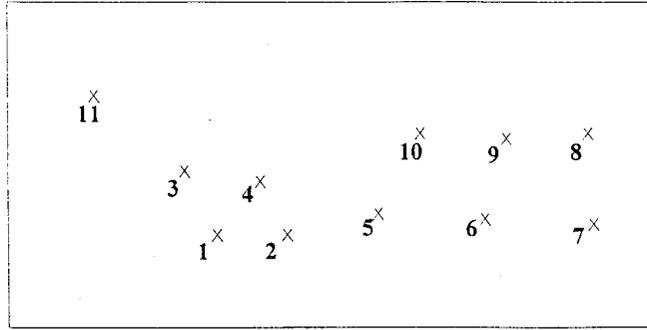
Figure 1. Impact locations for level determination.

Selection of the impact energy level was determined by performing a series of tests with different impact tups, drop heights and boundary "panel support" conditions on a section of the instrumentation rack. Table 1 outlines the thirteen impact levels used to determine the correct drop height and Figure 1 shows their locations on the sample rack section. Figure 2 contains the resulting thermograms produced by flash heating the impacted panel. Note that in Figure 2, none of the 9 and 12 inch drop height impacts (impact numbers 5, 6, 9 and 10) produced any detectable thermal indications. These impacts also produced no visual indications and when tested ultrasonically gave no sign of damage. The smallest detectable impact level was produced from a 13.5 inch drop (impact number 3 and 4) using a rubber mat to support the panel at the impact site.

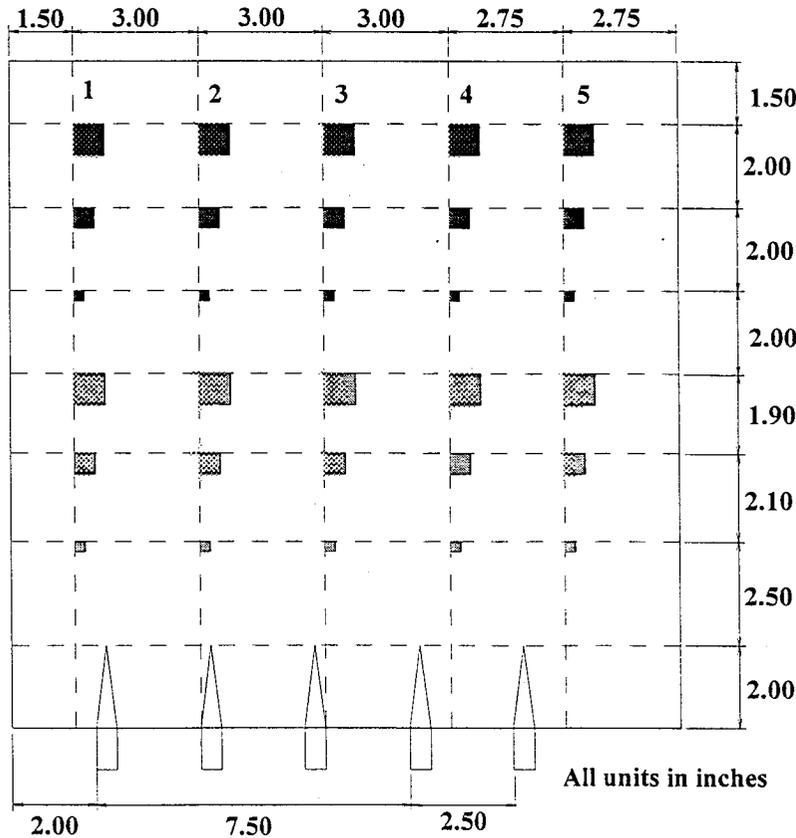
. Fabricated test panel.

to determine the limits of thermographic NDE for detecting porosity two tests were performed. First, a section of a rack own porosity documented through an ultrasonic map was thermographically examined. Second, a 24 ply monolithic el was created with simulated porosity of known size and depth into the laminate. The panel was constructed from onal graphite/epoxy (22 plies) and E-Glass (2 cover plies) similar to that of the actual racks. The simulated defects ed around the critical area by using 0.25, 0.50, 0.75 inch square regions yielding areas of 0.0625, 0.25 and 0.5625 he pattern of planned defects is shown in Figure 3.

at gray regions in Figure 3 depict where the simulated porosity "microballons" (7.0 nm diameter fused silica SiO₂ ere placed in the panel. The dark Gray regions in Figure 3 are folded plastic backing material (0.001 inch thick ylene), used to simulate inclusions and disbond areas. Wedge shaped stainless steel shims (0.006 inch thick) ere inserted into the laminate to create void regions when they were removed after cure and are visible at the bottom of the . The defects were placed in five columns so that the depth of inspectability could be investigated. The defects ere between plies (2-3), (5-6), (11-12), (16-17) and (21-22).
