MECHANICAL BEHAVIOR OF A HI-NICALON™/SiC COMPOSITE HAVING A POLYCARBOSILANE DERIVED MATRIX

Frances I. Hurwitz and Anthony M. Calomino, NASA Lewis Research Center,
Cleveland, OH 44135

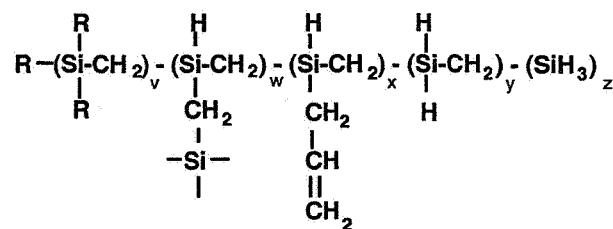
Figure 1: Nominal structure of AHPCS

Allylhydridopolycarbosilane (AHPCS), whose structure is shown in Figure 1, produces near-stoichiometric SiC with char yield of greater than 75% on pyrolysis

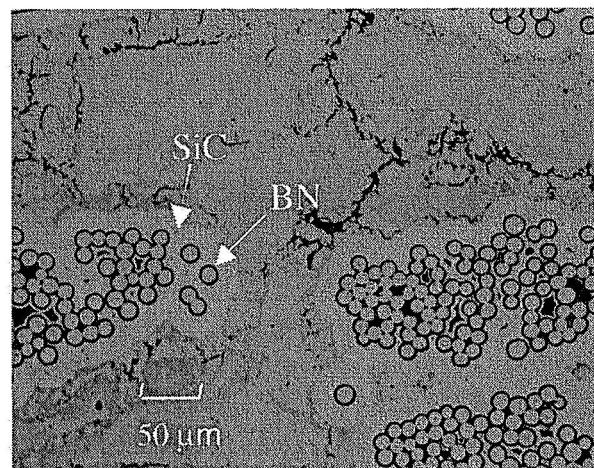
Figure 2: As fabricated composite.

A polished cross-section of the as fabricated composite is shown in Figure 2. The BN interphase is seen as the dark gray area surrounding individual fibers. Fiber tows are encapsulated with 20-30 μm of CVI SiC. Porosity within the tow

bundle is closed off from the composite surface. Between tow bundles are matrix rich areas having large blocks of material from the first infiltration cycle which are uncracked. Regions between the large matrix blocks are filled with material from successive infiltrations. The matrix derived from these later infiltrations differs in

gray level, and probably density, from the initially infiltrated material, and appear more microcracked. The different gray levels correspond to differences in relative oxygen content of the Si-C-O matrix, as determined by energy dispersive spectroscopy (EDS), with the darker shaded areas having the relatively higher oxygen concentrations, and presumably, the lower densities, as they have experienced fewer pyrolysis cycles. Oxygen level in the starting polymer is extremely low; incorporation of more oxygen in later cycles is the result of moisture pick-up during handling.

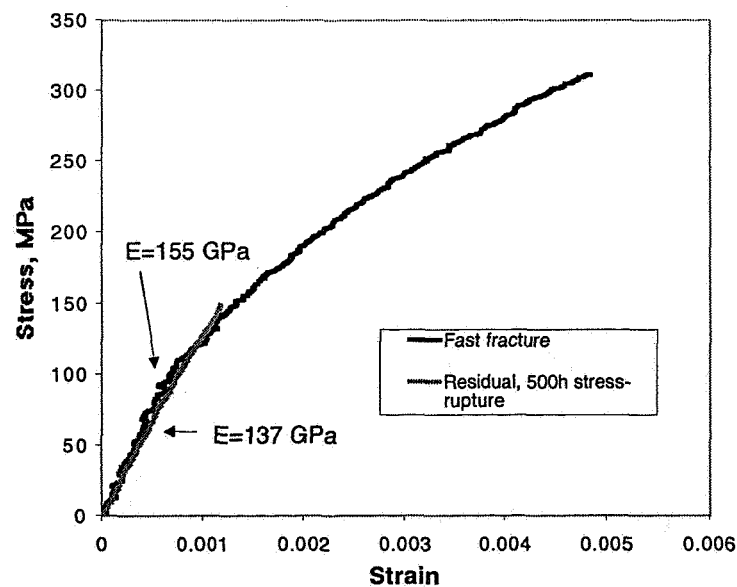
Figure 3: Representative tensile stress-strain curve, 1204°C showing fast fracture of as-received material and residual strength after 1093°C exposure.

A representative stress-strain curve is shown in Figure 3. Loading is linear to a level of about 80 MPa, where a decrease in modulus occurs. This point traditionally is considered to indicate the “matrix cracking” stress, even though the polymer-derived portion of the matrix is microcracked on fabrication. The

observation of an initial linear region may be explained by stiffening of the composite from the SiC over layer, which also is a component of the matrix. Although the polymer-derived matrix component is microcracked, it maintains enough integrity to transfer load among the SiC coated fiber bundles.

Ultimate stress in fast fracture in air at 1204°C is nominally 310-315 MPa, at a strain of slightly less than 0.5 percent. Fracture surfaces exhibited significant fiber pullout.

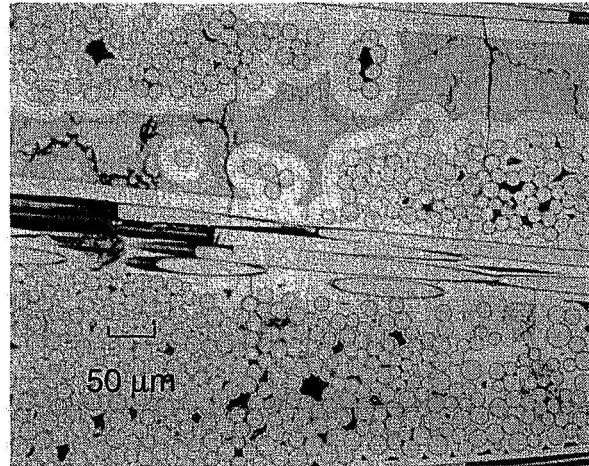
Figure 4: Specimen following 1093°C, 500h exposure, 130 MPa.

Based on the fast fracture data, an autoclaved sample (008-3) was tested in tensile stress rupture at 1093°C and a stress level of 130 MPa, just beyond the first matrix cracking stress. The rupture test was stopped after 500 hours, and the sample fast-fractured to determine residual strength. The residual strength was found to be 148 MPa, or 48 percent of the initial strength (Figure 3). Polished cross sections of the sample taken at the mirror point from the fracture site show mechanically induced cracks running transverse to the loading direction which breach the CVI SiC layer and extend into the fiber bundles (Figure 4). Some of

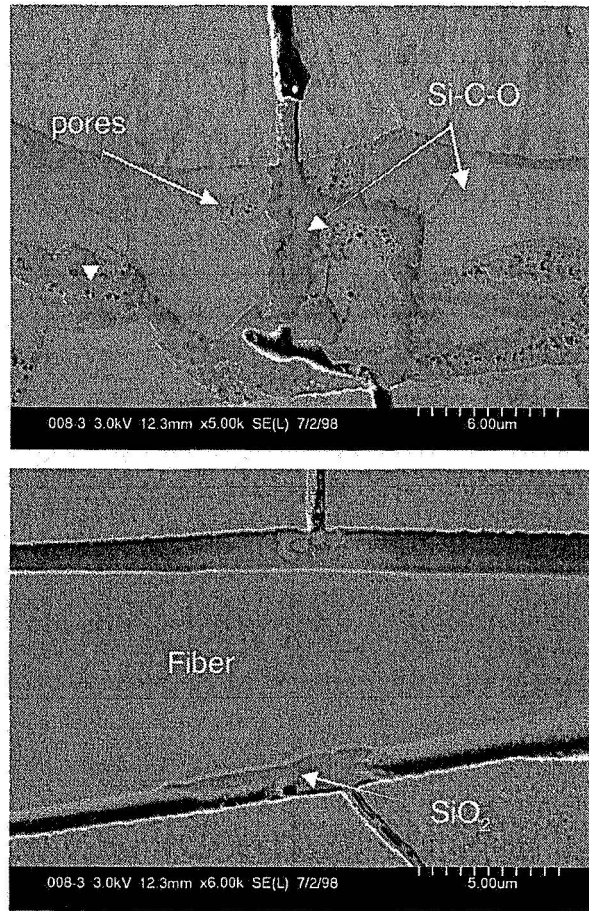
Figure 5: Sample following 1093°C, 500h exposure, 130 MPa.

the polymer-derived matrix regions also appear to be more porous than in the as-fabricated specimens (Figure 5), suggesting possible evolution of SiO or CO from the silicon oxycarbide, while other areas remain intact. In a few areas the BN interface has disappeared, and a gap remains; in a very few areas, small regions of SiO₂ are found adjacent to the fiber.

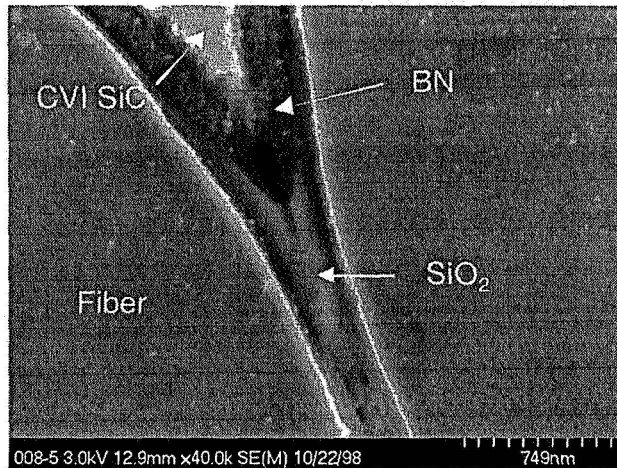
Figure 6: Polished section of sample failed in stress-rupture at 1204°C, 145MPa.

breakdown. The fracture surface was characterized by an extensive delamination parallel to the load direction. SEM analysis of polished sections revealed oxidation of the BN layer, with SiO₂ formation in the interface region (Figure 6), while analysis of the fracture surface showed glassy SiO₂ “caps” on broken matrix fragments (Figure 7).

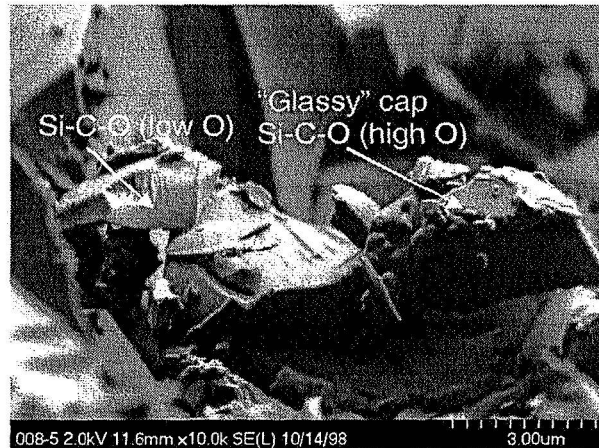
Figure 7: Fracture surface of 1204°C, 145 MPa stress-rupture sample.
