Radiation Effects on Advanced Flash Memories[†]

D. N. Nguyen, S. Guertin, G. M. Swift and A. H. Johnston
Jet Propulsion Laboratory
California Institute of Technology
Pasadena, California

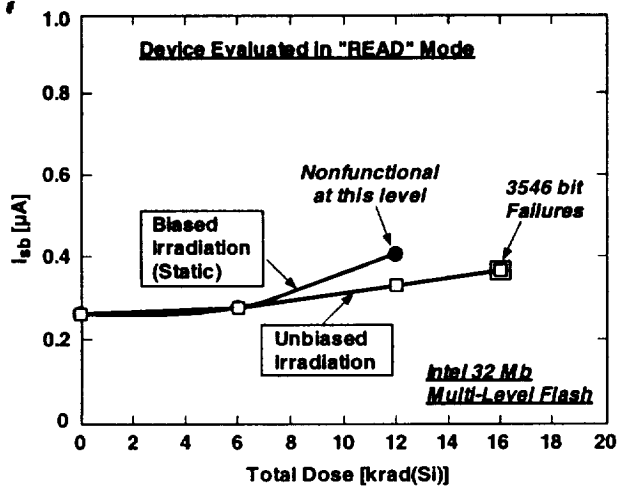
Figure 2. Total dose test results for the Intel 32-Mb flash memory (evaluated in read mode only).

Figure 2 shows test results for the 32-Mb Intel multi-level flash memory for statically biased and unbiased conditions. With bias applied, the standby current increased slightly during irradiation, and the device ceased to function at all after the second irradiation level [12 krad(Si)]. When it was tested without bias, the device continued to operate at somewhat higher levels. After 16 krad(Si) approximately 3,000 of the 32 million bits failed.

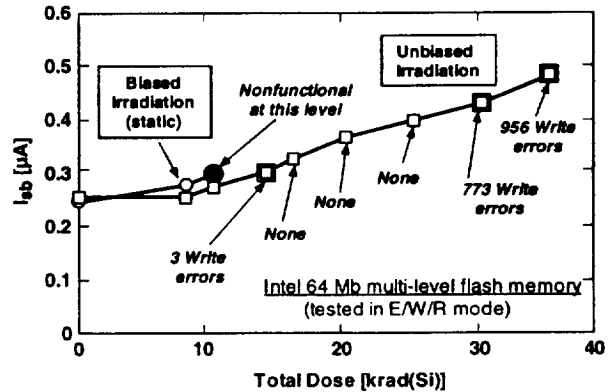
Figure 4. Total dose test results for the Intel 64-Mb flash memory with full functional tests between radiation levels.

Test results for the 64-Mb Intel device in the fully operational mode are shown in Figure 4. With biased irradiation the device became nonfunctional at 12 krad(Si), in contrast to the tests in "read" mode (Figure 3) where the device continued to operate to levels about twice as great. Without bias, the device also failed at much lower levels when fully operational tests were done between irradiations. Small numbers of write errors occurred between 30 and 40 krad(Si). Three write errors were also observed at 15 krad(Si), but were not present at the next irradiation level.

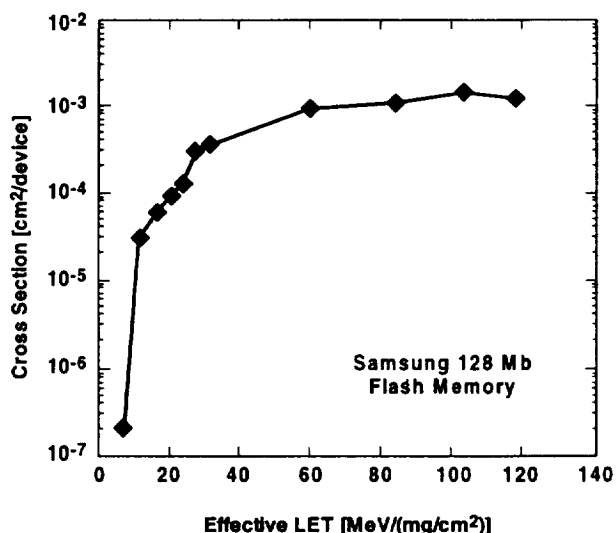
Figure 6. Single-event upset cross section for the Samsung 128-Mb flash memory.

Just as for the older flash memories [6], errors did not occur in individual memory cells in the Samsung device, but occurred as a result of functional changes in the controller or registers. An example of these results is shown in Figure 6.

Errors associated with control or address upsets are very difficult to evaluate with high precision even in the read mode because of the finite time required to do a complete test of the memory contents (about 50 seconds). The results in Figure 6 were obtained by continually cycling through the address space, and thus are somewhat dependent on the operating frequency and ion flux for the run. In this case the device was tested by dynamically reading the contents of the memory at an access rate of approximately 3 MHz, with a flux of $\sim 10^4$ ions/(cm²-sec).
