# Nondestructive Evaluation of Aircraft and Spacecraft Wiring

## ABSTRACT

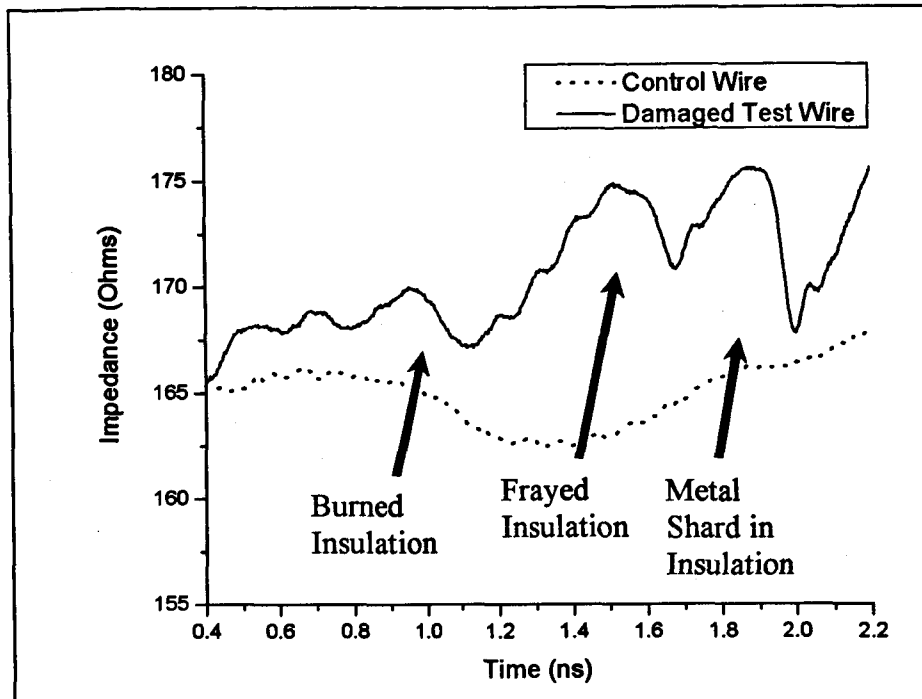
Figure 7 – TDR results of metal object in wire insulation

In Figure 6, the connection to the test wire, the defects in the insulation and the end of the wire were described schematically as positive changes in impedance. In fact, the change in impedance is very likely to be negative if the defect in the wire lowers its overall capacitance. As an example, Figure 7 shows the results of a metal shard imbedded in the Kapton® insulation of a braided conductor wire. The wire specimen is a 250 mm (10 in.) section of 18 AWG wire. The metal does not penetrate through to the conductor, but its presence is easily detected on the time domain reflectometer as a reduction in impedance.

Other damage to the insulation can be detected due to the difference between the relative dielectric constant of air and the insulation. Nicks, scrapes, cuts, chafes and frays are then detectable by a trained operator using this technique. Figure 7 also demonstrates a noticeable change in the impedance in an area where the insulation was stuck with a pin multiple times until frayed. Also visible is a decrease in impedance where the wire insulation was burned with a soldering iron over an area of about one cm in length along the wire insulation surface.

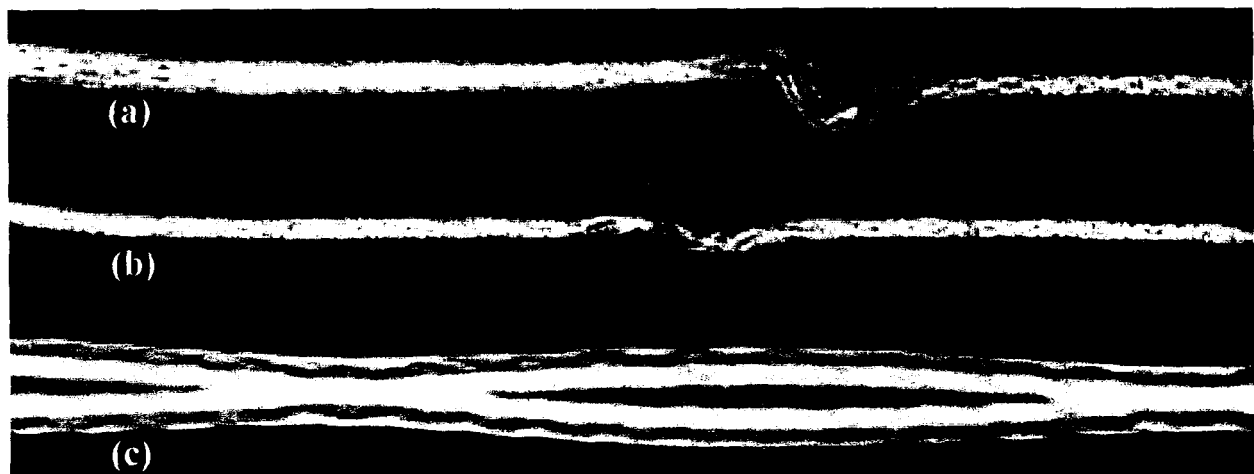
*Figure 10 – Pulse x-ray radiographs: (a) Burnt Wire; (b) Crimped Wire; (c) Undamaged Metallic Braided Wire*

All of the specimens shown in Figure 10 were dosed with 10 pulse x-rays and each of the specimens was set back 250 mm (10 in.) from the pulser. The pulse x-ray radiograph in Figure

10a is of a wire that had experienced extensive charring damage. The segment of wire featuring the dramatic kink corresponds directly with the extent of the scorched area. The brightness of the wire rapidly fades in this burnt section and is consistent with an observable decrease in the amount of insulation present in this portion of the wire. Moreover, upon closer examination of the radiograph, only a few spindly threads of conductor are visible suggesting a possible degradation, or even loss, of copper wire in the damaged region. In Figure 10b, a wire that had been crimped was analyzed with pulse x-rays. Again, it is possible to demarcate the portion of the wire that has been impaired. Likewise, the individual strands of copper are also obvious; hence, a significant discontinuity in the conductor is clearly discernible in the contorted region that was crimped. Finally, a prominent decrease in light intensity in the crimped region is indicative of a loss of insulation and potentially wiring. An undamaged metallic braided wire was studied using the pulse x-ray system as well, as depicted in Figure 10c. Not surprisingly, the two insulated copper conductors buried beneath the metallic braiding are easily identifiable. The imaging system also uncovers the presence of the actual interwoven metallic braiding pattern.
