Ballistic Impact of Braided Composites With a Soft Projectile

Gary D. Roberts, J. Michael Pereira, and Duane M. Revilock, Jr.
Glenn Research Center, Cleveland, Ohio

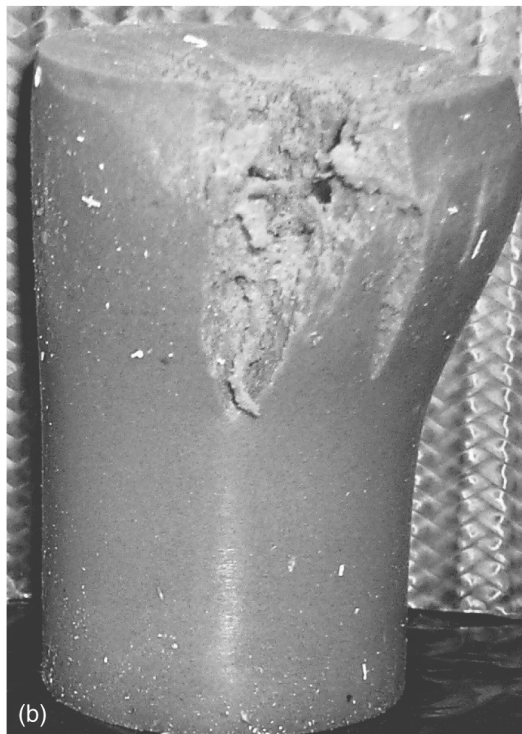
Figure 3.—Gelatin projectile. (a) Before impact.
(b) After impact.

diameter. Figure 3 shows an example of a projectile before and after impact. For impact testing a projectile is mounted in a sabot and shot into a target using a 20.3 cm (8 in) diameter gas gun. The axis of the cylindrical projectile is aligned along the line of flight, so that the flat end of the cylinder makes first contact with the target. Impact velocity is measured digitally using a high speed video camera with a view perpendicular to the line of flight. During a test the projectile initially flattens into a disk approximately 25.4 cm (10 in) in diameter before rebounding to the “after impact” shape shown in Figure 3(b). At low velocities the projectile can be recovered in the form shown in Figure 3(b), but at high velocities the projectile is disintegrated into small pieces.
