Shuttle Primary Reaction Control Subsystem Thruster Fuel Valve Pilot Seal Extrusion - A Failure Correlation

Jess Waller
Honeywell Technology Solutions Inc.
NASA Johnson Space Center
White Sands Test Facility
Las Cruces, New Mexico
(505) 524-5249
jwaller@wstf.nasa.gov

Regor L. Saulsberry
NASA Johnson Space Center
White Sands Test Facility
Las Cruces, New Mexico
(505) 524-5518
rsaulsbe@wstf.nasa.gov

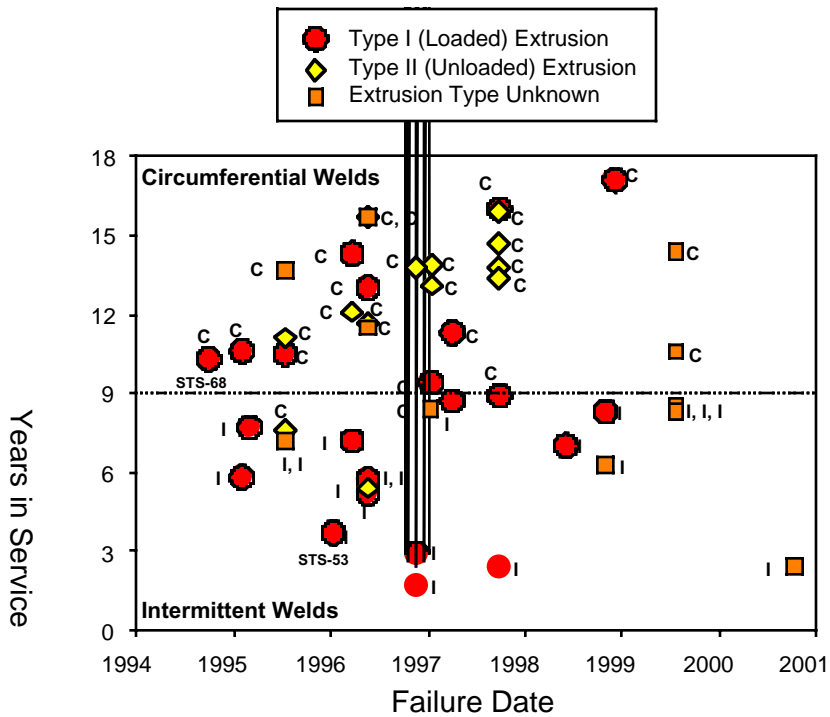
Figure 4
 Distribution of Extrusion Type and Retainer Geometry
 (NOTES: C = circumferentially welded (old design); I = intermittently welded (new design); failure date based on last mission service)

Only one of 13 Type II extrusion cases had an intermittently welded pilot seat assembly, while about half (12 of 23) of Type I extrusion cases had intermittently welded assemblies. Intermittently welded assemblies are thought to be more prone to fuel migration through the pilot seal cavity, leading to an increased likelihood that fuel could react with oxidizer vapor downstream of the pilot seal, thus generating heat and causing extrusion. Therefore, it is tempting to categorize Type I cases as oxidizer-induced extrusion (more fuel migration), and Type II cases as thermal extrusion (less fuel migration). It must be noted, however, that weld type probably has less influence on fuel migration or leakage than pilot seal flaws, or poor fit between the pilot seal and pilot seal poppet. Also, comparison of years in service for all extrusion cases shows that Type II cases are slightly older (Figure 4), consistent with the presence of a deeper poppet footprint. Although the age difference is small (12.5 ± 3.0 years service on average for valves exhibiting Type II extrusion versus 8.9 ± 4.1 years service on average for valves exhibiting Type I extrusion), this difference suggests that extrusion type is influenced more by pilot seal age than retainer weld type.

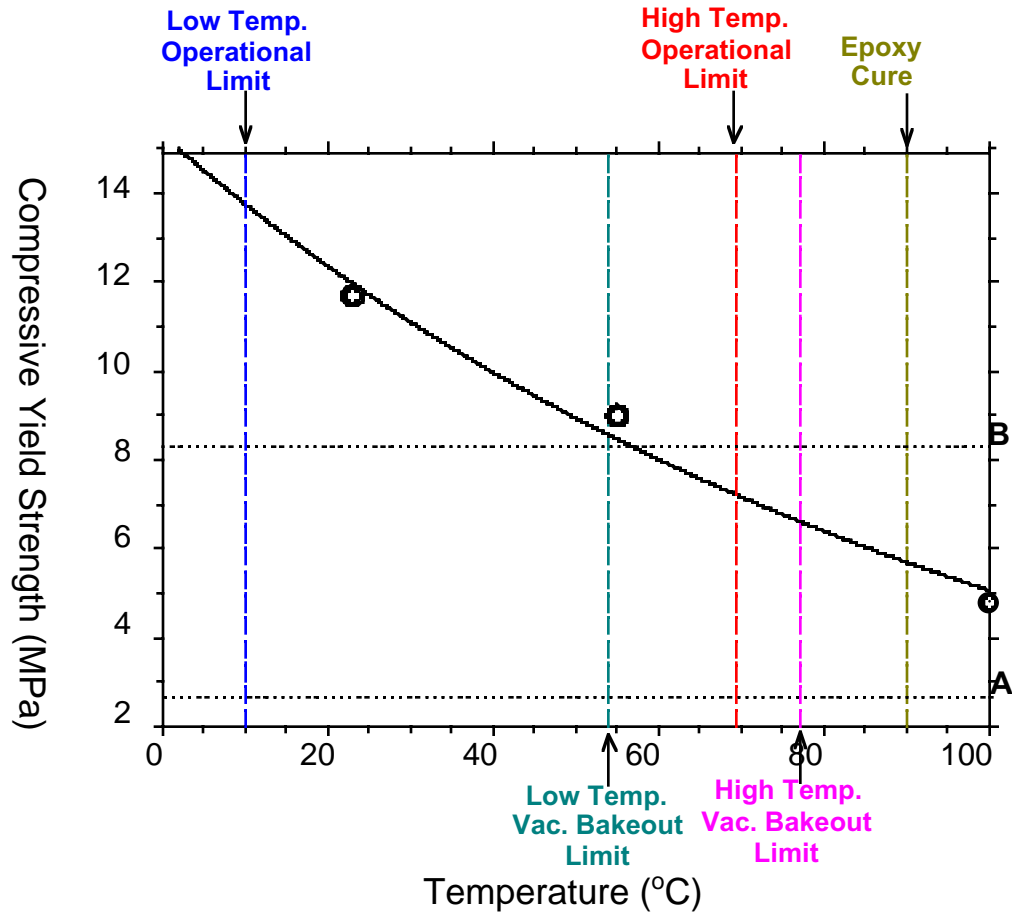
Figure 8

Drop in Compressive Yield Strength¹ of PTFE with Respect to Operational and Ground Temperature Limits

By comparison, the older bakeout procedure performed by Marquardt entailed shorter times (3 h during initial decontamination and subsequent acceptance tests), and opening of the valve using a mechanical fixture to facilitate water removal [8]. There may be an added advantage to opening the valve during vacuum bakeouts. During vacuum bakeouts, the compressive force of the pilot poppet on the pilot seal is equal to the poppet spring force of 1.8 lb_f (2.6 MPa).⁵ Valve opening during bakeout lessens the possibility that the compressive yield strength of the PTFE pilot seal could be exceeded (Figure 8).
