NASA/TM-2004-213262
ARL-TR-3233

Experimental Results From Stitched Composite Multi-Bay Fuselage Panels Tested Under Uni-Axial Compression

Donald J. Baker
U.S. Army Research Laboratory
Vehicle Technology Directorate
Langley Research Center, Hampton, Virginia

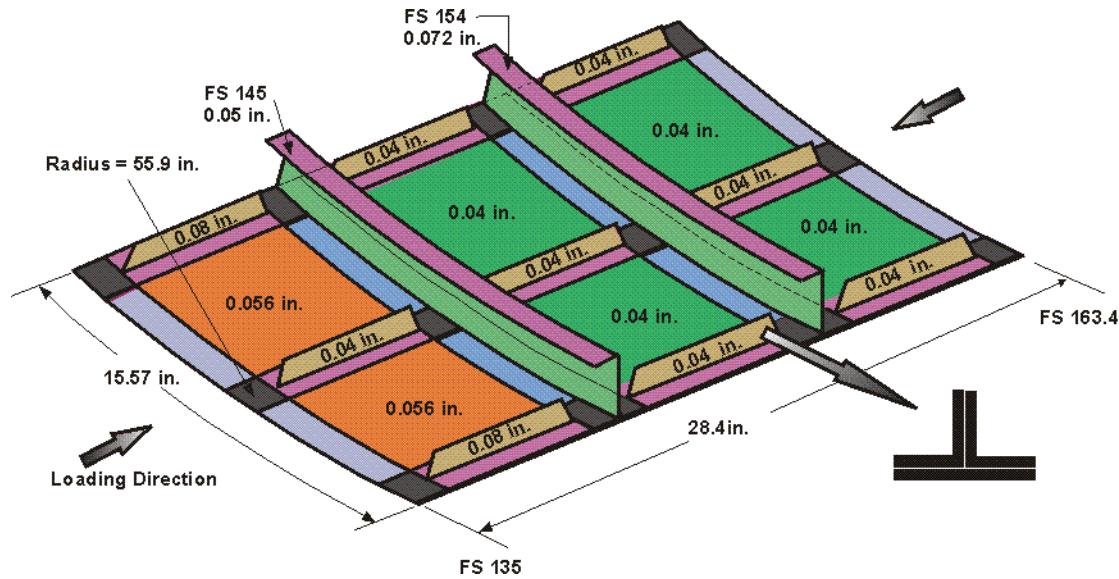
Figure 1. - Details of Panel C-1.

Details of the stitched VARTM composite *Panel C-1* supplied by Boeing are shown in Figure 1. The skin is stitched together and the frame and stringer flanges are stitched to the skin. The panel is 15.57-inches wide with a 55.9-inch radius in the width direction. The stringer leg terminates before the frame flange of each frame while the flanges from the stringer continues under the frame flange. The panel ends were potted with 1-inch thick filled epoxy and were machined flat and parallel to the 28.4-inch dimension shown in Figure 1. A 1-inch long section of the frame flange located at FS 145 and 154 was removed from each end. A 1-inch square, 0.062-inch thick, aluminum plate was bonded to each side of the web for reinforcement for frame to resist the out-of-plane displacement at the frame ends.

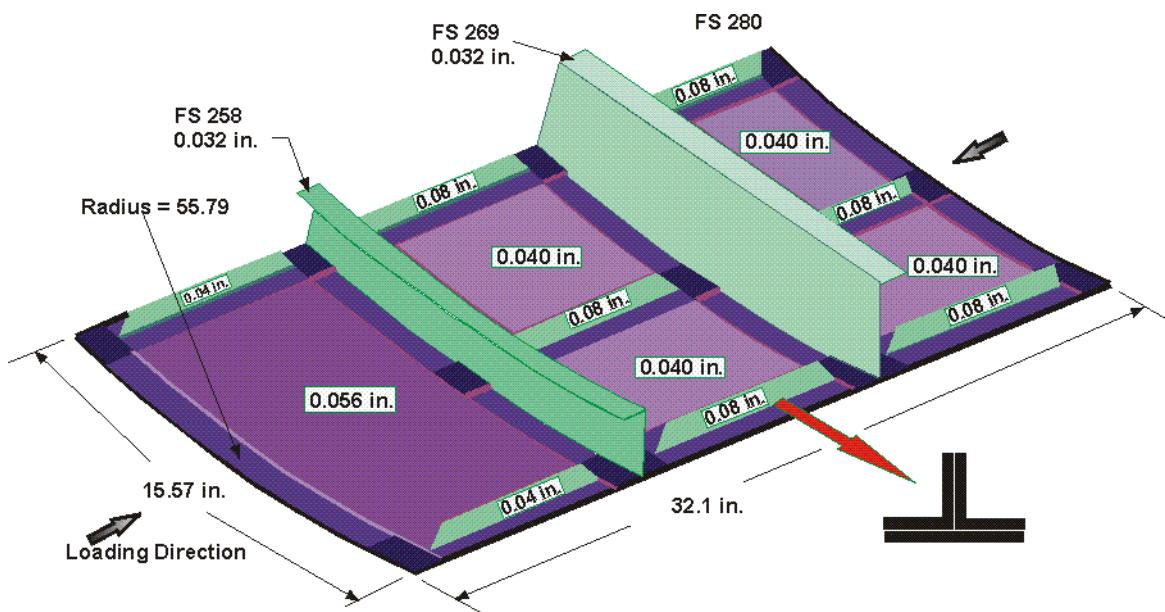
Figure 2. Panel C-2 details.

Test Panel C-2 is very similar to Panel C-1 with an overall length of 32.1-inches between the potted ends as shown in Figure 2. The middle stringer does not extend between FS 247.7 and FS 258 thus producing a panel with five bays. Also note that Frame 269 is much deeper than frame FS 258. The specimen was prepared for test the same as for Panel C-1.

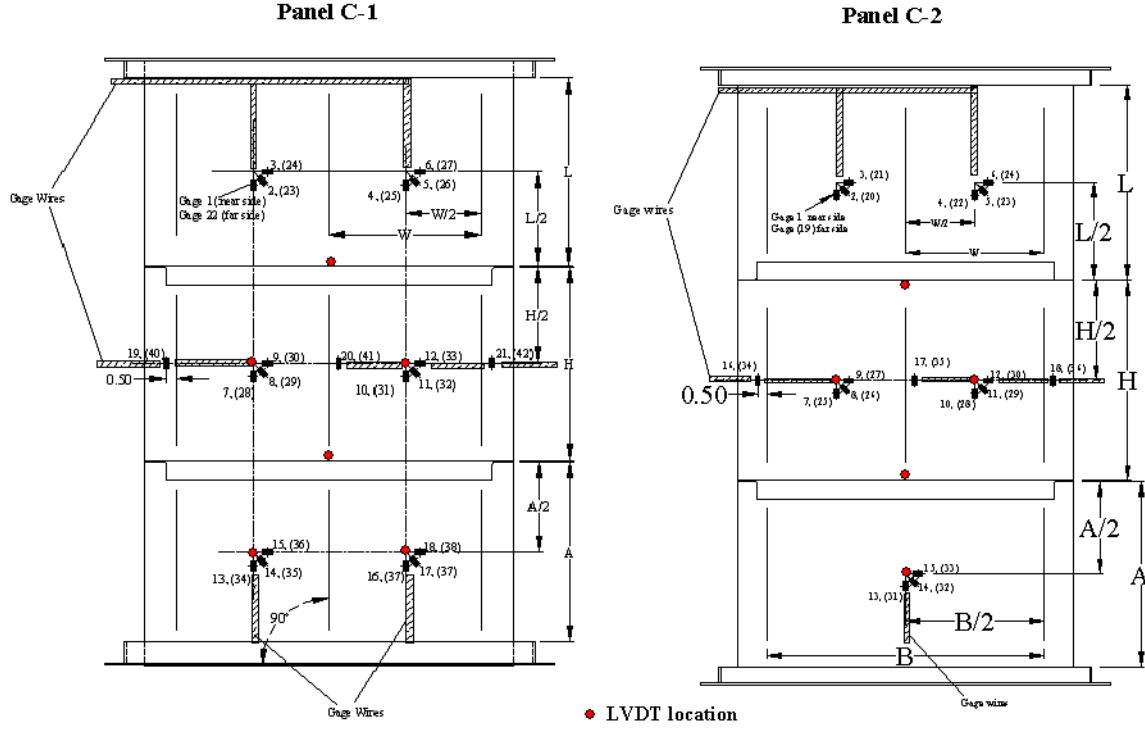
Figure 3. Strain gage and DCDT locations.

Strain gages – Common off the shelf axial and rosette strain gages were used on the panels. *Panel C-1* contained 42 strain gages – back-to-back rosettes in the center of each bay and back-to-back axial gages across the center of the specimen as shown in Figure 3. *Panel C-2* contained 36 strain gages – back-to-back rosettes in the center of each bay and back-to-back axial gages across the center of the specimen as shown in Figure 3.

Displacement transducers – Linear variable displacement transducers (LVDT) were utilized to measure the displacements at selected locations shown in Figure 3. In addition to the LVDT shown in Figure 3 two LVDT's were used to measure the panel end shortening.

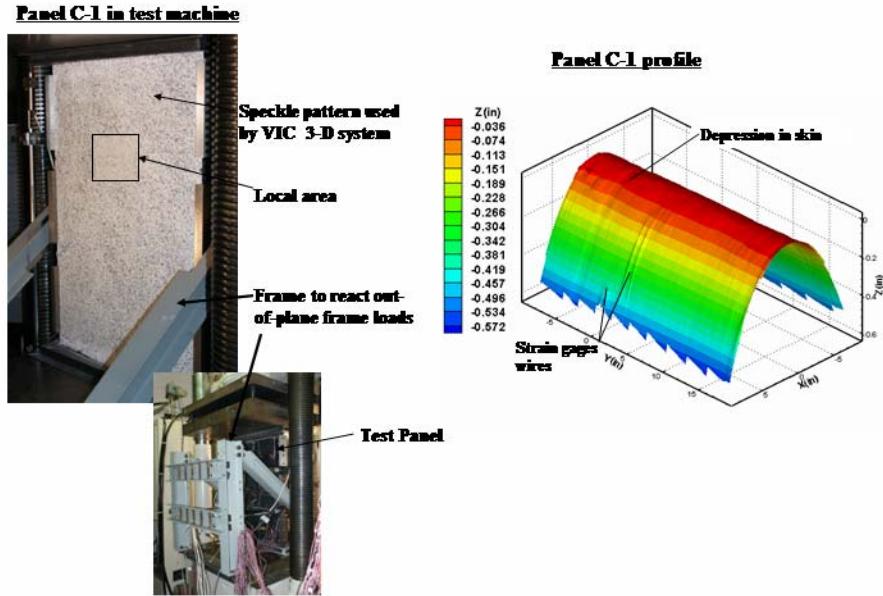
Figure 4. - *Panel C-1* in test machine and profile view of panel.

The left hand side of Figure 4 shows *Panel C-1* installed in the test machine. The frame to react the out-of-plane panel frame loads is shown. This frame is attached to the test machine lower platen and reacts the panel frame out-of-plane loads but not frame rotations. The linkage from the panel allows the test specimen frames to rotate but not translate.

The speckle pattern used for the VIC 3-D system can be seen in the L/H side of Figure 4. The skin surface of the test specimen was painted white then the black speckle pattern was applied. Note the different spackle densities can be seen between the local and global area, where the local has smaller speckles and a higher density. The local area location was selected to encompass the future impact site.

The right hand side of Figure 4 shows the profile of *Panel C-1*. The specimen profile is determined from the first image taken by the VIC-3D system before any load application. A best fit flat plane is fit to the data points in the first image. There are usually 8,000 to 10,000 data points used to determine the best fit plane. Then the distance from the best fit plane to the panel surface is determined and a new surface is plotted that reflects any defects. The profile of *Panel C-1* does not indicate any significant defects. A small depression in the skin is indicated. These defects produce very small ripples in lines of constant distance when plotting the contours from the best fit plane. A strain gages and associated wiring can also be seen in the picture.

Panel C-1 was returned to the test machine for testing to failure. The profile of a 4.0-inch by 4.0-inch area around the impact site, taken using VIC-3D local cameras, indicated the impact dent depth to be 0.008 to 0.010-inches deep from the surrounding surface. The surface depression in the skin, noted on Figure 4, is also evident in the profile shown in Figure 7.

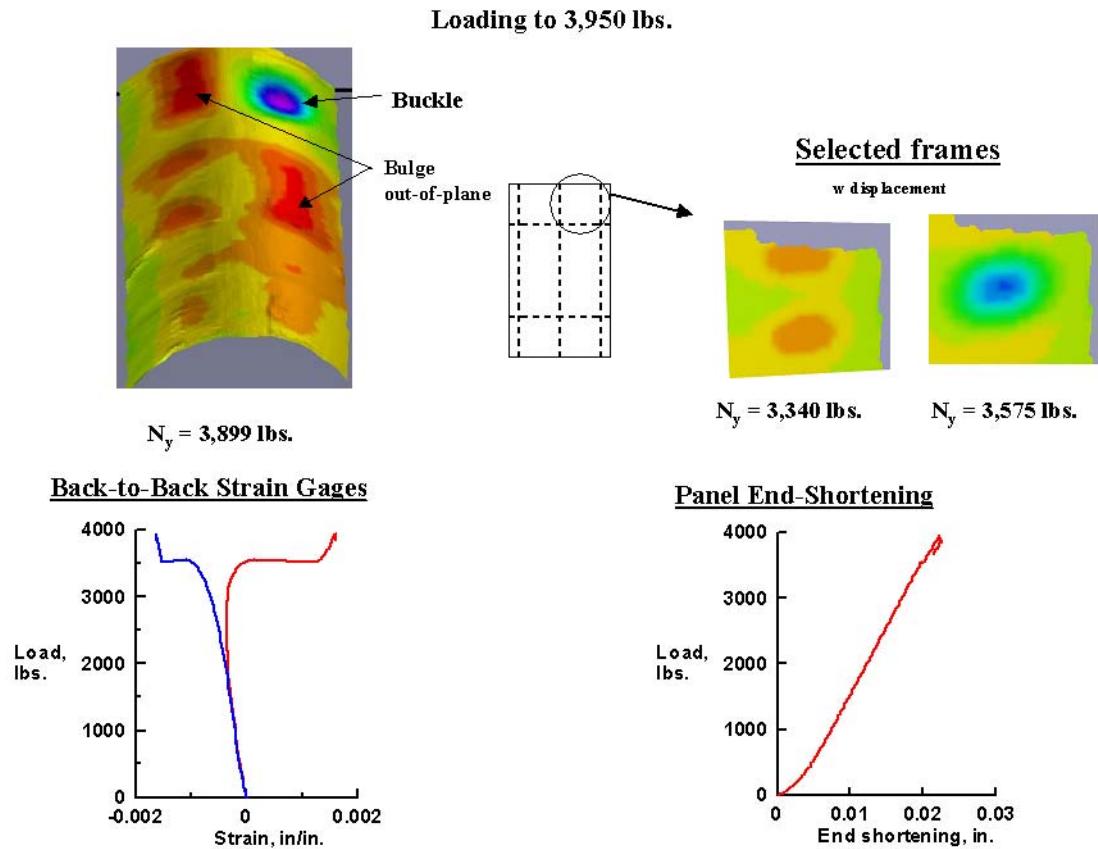
Figure 5. - Results from load Panel C-1 to 3,950 lbs.

Figure 5 summarizes some of the data from the first test on *Panel C-1* where the load was taken to $N_y = 3,950$ lbs, a point just past the predicted first buckle for a specimen with free edges. The perspective view in the upper L/H corner of Figure 5 is the out-of-plane displacements at a load of $N_y = 3,899$ lbs. indicating a buckle in the upper R/H bay and the other bays bulging out-of-plane. For the remainder of this report the bay identifications are located relative to looking at the skin side of the panel and a positive displacement is defined as displacement toward the viewer. The pictures of the w displacement (upper R/H in the figure) have been cropped to show only the upper R/H skin bay. The out-of-plane displacements shown for $N_y = 3,340$ lbs indicates the skin panel is starting to bulge out-of-plane (positive direction) as two bulges prior to going to a single half-wave in the negative direction as shown in the figure for a load of $N_y = 3,575$ lbs.

The results from axial back-to-back strain gages in the center of the upper R/H skin bay are shown in lower L/H corner of the Figure. The strain results indicate skin bending started at approximately $N_y = 2,000$ lbs. and continued until buckling occurred at approximately $N_y = 3,500$ lb.

The panel end shortening as a function of the applied load is shown in the lower R/H corner of Figure 5. The response appears to be linear after initial loading until the skin buckles. After buckling the response appears to be linear but at a lower slope than the initial response.

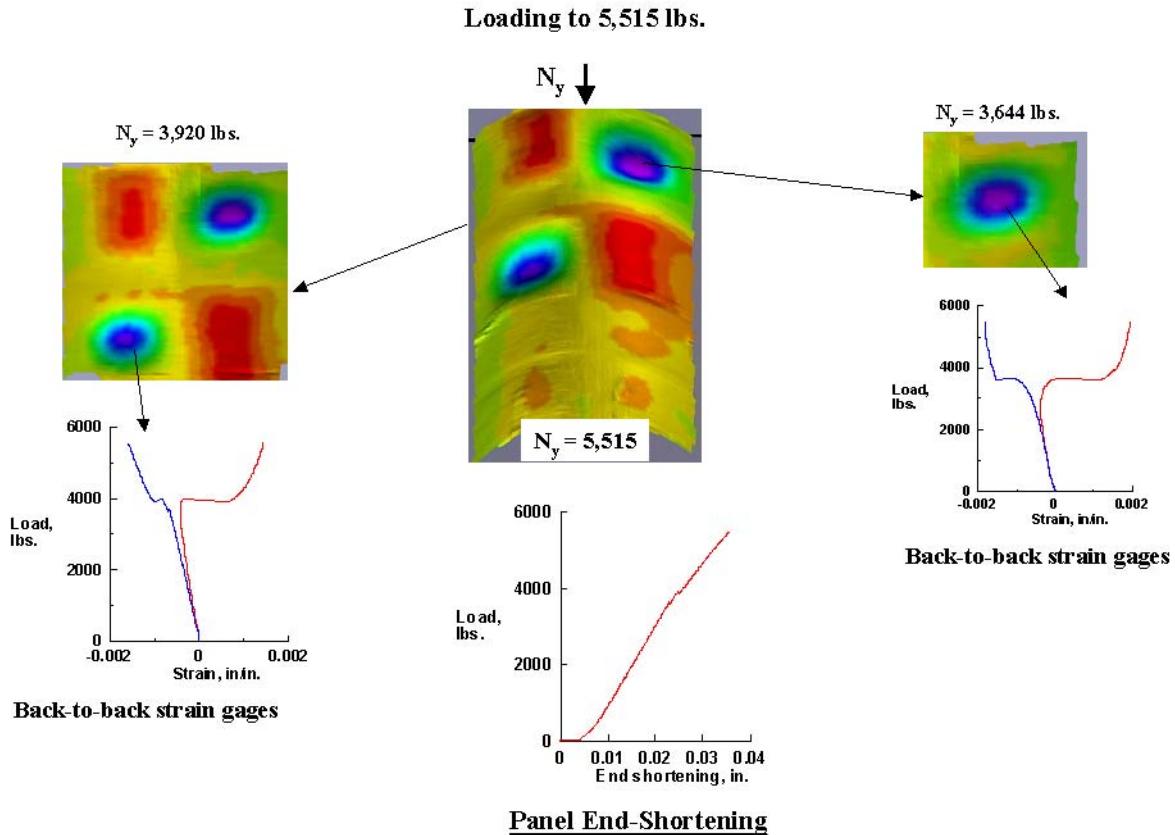
Figure 6. - Results of loading *Panel C-1* to $N_y = 5,515$ lbs.

Knife edges were attached to the free skin edges for the second test on *Panel C-1* and the maximum load was increased to $N_y = 5,515$ lbs, which is more than the predicted buckling load. A buckle develops in the upper R/H corner of the specimen as shown in the upper R/H side of Figure 6. As the load was increased a buckle developed in center bay, L/H side, as shown in the upper L/H side of Figure 6. The first buckle occurred at a load a few pounds higher than in the first test as can be seen when comparing this result with the result on the previous figure. The second buckle occurred at approximately a 200 lbs. higher load than the first buckle.

The load as a function of the end-shortening is shown in the center of Figure 6 and is the same as the curve for the first test with different slopes before and after the skin buckling. The response appears to be linear after initial loading until the skin buckles. After buckling the response appears to be linear but at a lower slope than the initial response. The initial (before first buckle) slope of this curve is approximately 2 percent higher than the slope of the end shortening curve for a panel without knife edges.

The load shortening curve indicates a linear response until initial panel buckling and then linear response after the second panel buckled until near failure. The slope of the curve (from 1,500 lbs to 3,500 lbs) is 4 percent less than the curve shown in Figure 6, indicating that the impact damage has a small effect on the panel axial stiffness. The slope of the curve after the buckling (post buckling stiffness) is 70 percent of the initial slope.

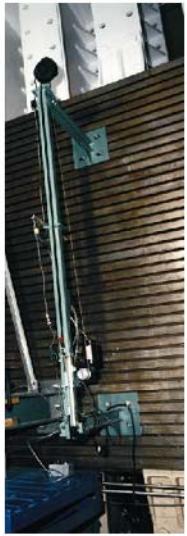
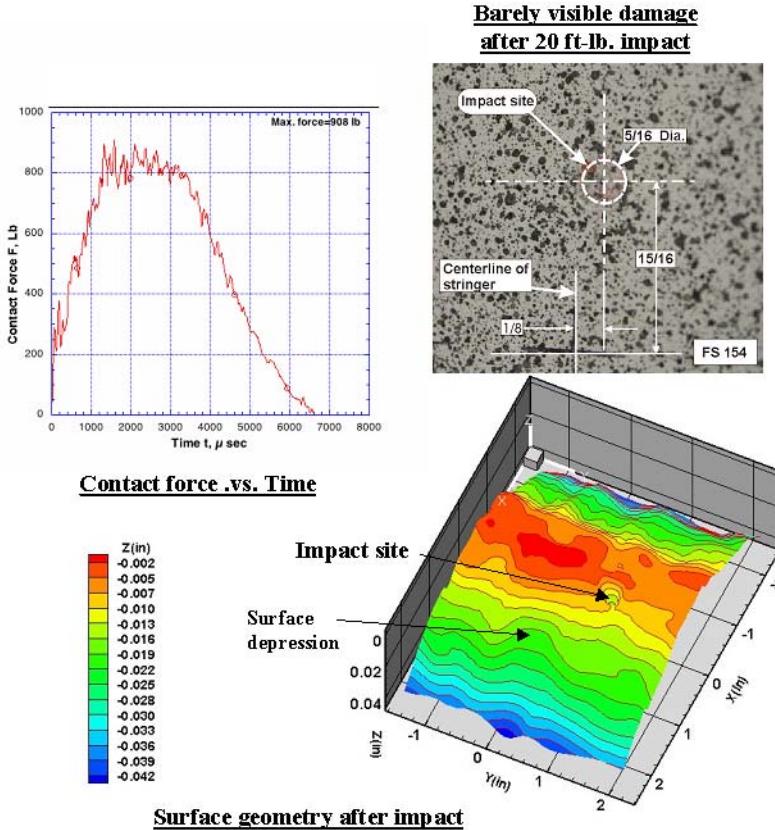
Figure 7. - Impact test results on *Panel C-1*.

Panel C-1 was placed under the impact tower shown in Figure 7 and a 5-lb weight with a 0.5-inch spherical radius indenter was dropped on the specimen. One-hundred pounds of lead shot was placed on and around the specimen to damped the vibrations.

Impact location was to be on panel centerline at the end of stringer 9, in the skin and stringer flange thickness adjacent to FS 154 frame flange. The impactor was dropped 4-ft to give an impact energy of 20 ft-lbs. Barely visible impact damage occurred on the specimen with the 20 ft-lbs of impact energy. A photograph of the impact site with the actual impact location is shown in Figure 7. The contact force profile shown in Figure 7 indicated a loss of stiffness as given by the contact force drop of approximately 150 lbs. after reaching the peak force of 908 lbs. The contact force recovered some but never greater than the peak value of 908 lbs.

Impact tower

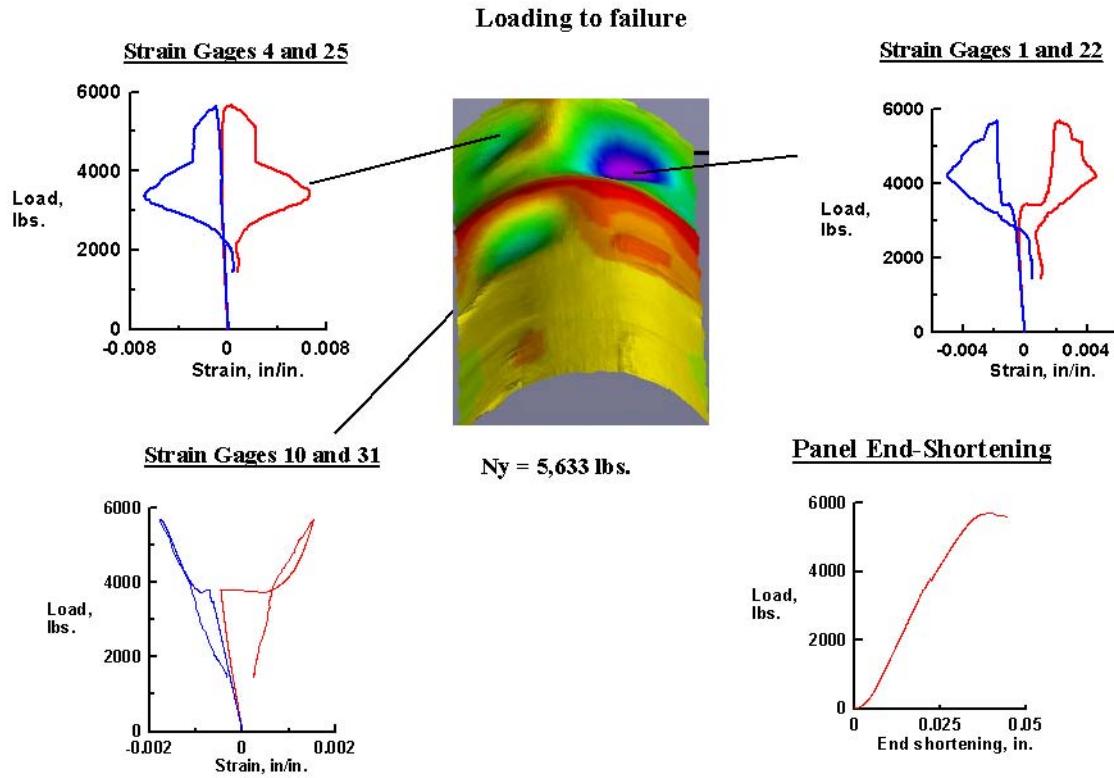
Figure 8. - Test result summary for selected strain gages on *Panel C-1*.

For this test *Panel C-1* was loaded to failure. A view of the out-of-plane displacement (top – center of Figure 8) is shown for $N_y = 5,633$ lbs, near the failure load of $N_y = 5,678$ lbs. Strain gage results for the three panels that buckled during test are shown in Figure 8. The bay on the upper L/H bulged as the

load increased until approximately $N_y = 5,000$ lb. at which time the skin started to bend. The first indication of buckling was in the upper R/H bay with the buckle starting at $N_y = 3,452$ lb. The load dropped to $N_y = 3,421$ lbs before increasing. The second buckle appeared in the middle L/H bay at $N_y = 3,763$ lbs. The load dropped to $N_y = 3,709$ lbs before starting to increase. As the load increased to approximately 5,500 lbs. the buckles get deeper. Selected events from $N_y = 2,000$ lbs. to failure are shown in the next figure.

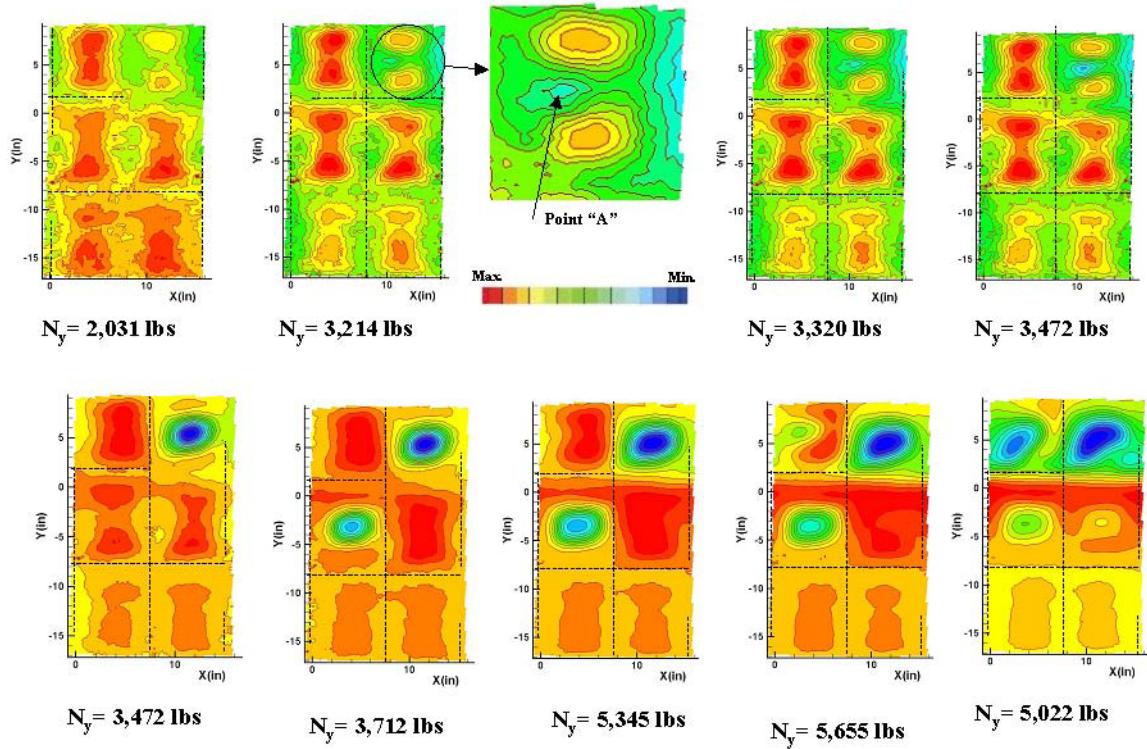
Figure 9. - Out-of-plane displacement history for *Panel C-1*.

Figure 9 presents a series of out-of-plane (w) displacement contour plots as the load is increased. The top L/H picture for $N_y = 2,031$ lbs indicates 5 of the 6 bays with similar w displacements of up to 0.009 inches. The upper R/H bay indicated w displacements of up to 0.004 inches. All bays appear to have 2 bulges. The dashed lines on the pictures are the approximate locations of the frames and stringers. Increasing the load to $N_y = 3,214$ lbs. increases the maximum w displacements to 0.017 inches on 3 of the panels while the other 3 panels increase to 0.010 to 0.013 inches. In addition a negative displace-

ment (-0.002 inch) appears in the upper R/H panel and is shown as Point "A" in the detail in the center of the top row.

Increasing the load to $N_y = 3,320$ lbs. increases the magnitudes of the displacement by 0.001 inch. Increasing the load to $N_y = 3,472$ lbs. increases the w displacements to +0.018 to – 0.008-inches. The next picture (first on the bottom row) is the next frame of data taken (approximately 10 second interval). The upper R/H bay has buckled in a half wave that has a –0.062-inch of displacement. The maximum displacement in the red shaded area is +0.025-inches. A half-wave buckle develops in the middle L/H side bay near $N_y = 3,712$ lbs. Increasing the load increases the out-of-plane deformation as shown by the figure for a load of $N_y = 5,345$ lbs. The deformation range is now +0.047-inches to –0.190-inches. The image at $N_y = 5,655$ lbs. indicates a mode shape change occurring in the upper L/H bay. The upper L/H panel changes into a half wave as shown in the next picture. When this happens the skin loses its load carrying capability and the specimen folds across at the frame. The last picture indicates the specimen has lost approximately 600 lbs in load carrying capability.

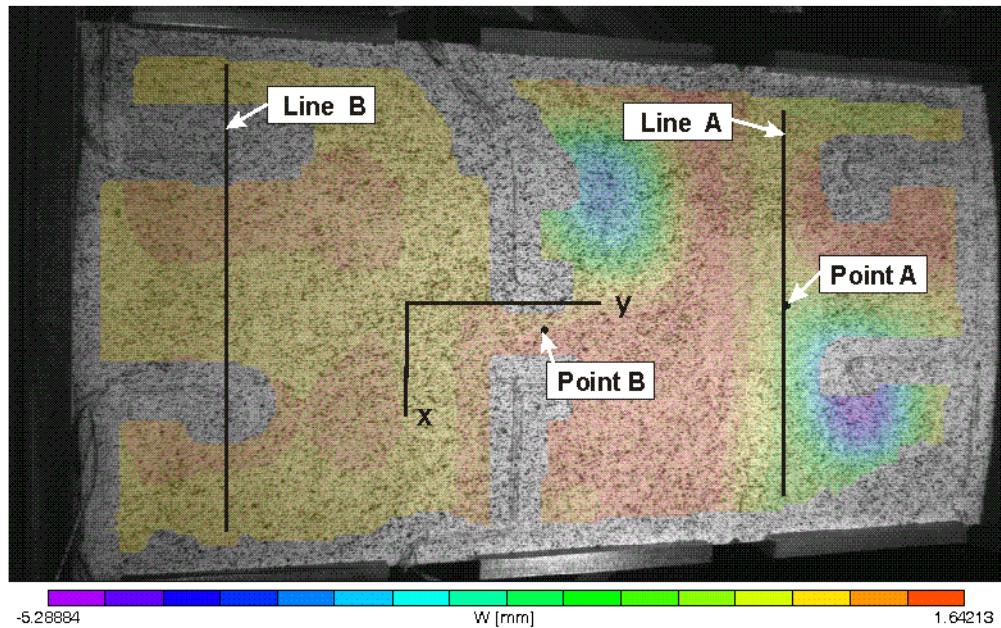
Figure 10. Out-of-plane contour plot and location of selected strain and displacement results for *Panel C-1*.

VIC-3D analysis software also has the capability to extract local data from the recorded images. Options exist that allow extraction of displacement and/or strain results at a point in the image or along a line on the image. The origin of the coordinate system has been selected as the intersection of the center stiffener and FS 145 as shown in Figure 10 on the out-of-plane displacement contour plot of *Panel C-1* for a load of $N_y = 5,345$ lbs. Selecting Line A through the impact site as shown in the Fig. 10 will

VIC-3D software also has the capability of extracting strain from the images at a point or along a line. The first strain to be extracted from the images will be along Line B shown Figure 10. This line crosses at the centers of two bays (lower L/H and lower R/H) at the location of the strain rosettes. The strain results for $N_y = 5,345$ lbs are shown in Figure 14 as a line of blue circles. The missing sections of

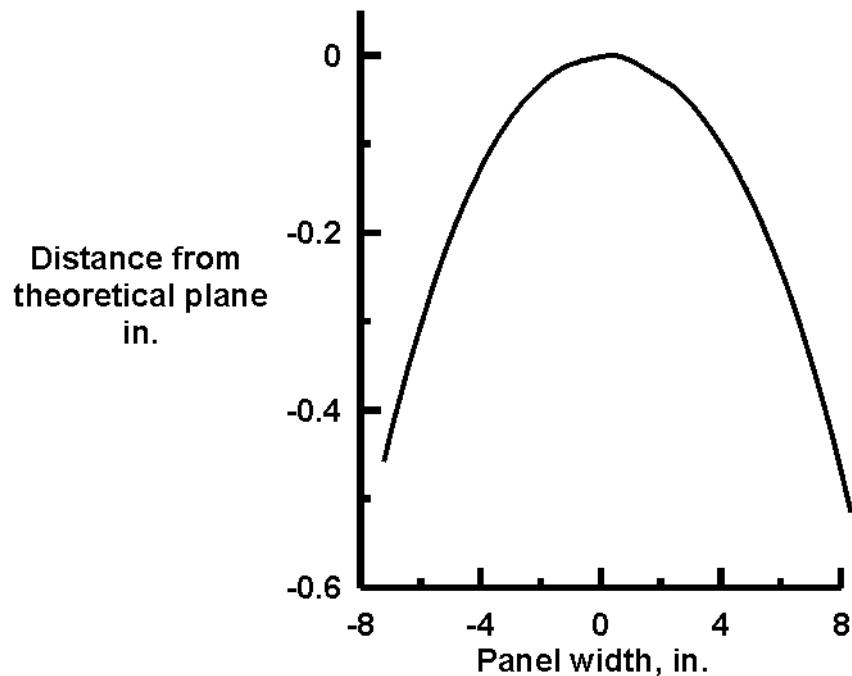
Figure 11. Profile of *Panel C-1* across the panel at Line A.

give the profile of the panel cross-section and the out-of-plane, w , displacements at 100 points (number of points selected by user) across the panel. The location of this line is approximated by selecting two points on the screen. At the present it is not possible to select this line or any point in direct relation to the specimen reference frame. Selecting the points on the screen is the only method. The profile of the panel, at Line A, after impact damage is shown in Figure 11. The distances shown in the Figure are the distance from a theoretical flat plane to the surface of the specimen. The dent from the impact is not obvious in Figure 11. A small variation in the curve near the top is probably the effect from the dent. A dent of 0.008-inch to 0.010-inch deep would not show up as a significant deviation in the curve considering the scale of the y -axis. The out-of-plane displacement results at the location of Line A shown in Fig. 10 are shown in Fig 12 for selected loads that vary from $N_y = 3,009$ lbs. to $N_y = 5,655$ lbs, which is the image near the maximum load. The panel appears to rotate about the side $x = -8.0$ in. where the out-

of-plane displacement varies less than 0.01-in. for the load less than $N_y = 5,345$ lbs. while the side at $x = 8.0$ in. moves approximately 0.03-in. These curves also indicate how the bays deflect with load. The upper L/H bay deflects in the positive direction while the upper R/H bay deflects in the negative direction. Point A (Figure 10) was selected at the impact site. Again this point has been selected from picking a point on the screen which can lead some error in the location. The load-out-of-plane displacement history is shown in Figure 13 for loading before and after impacting the panel. Also included in Figure 13 is the results from the test to failure for LVDT 16 which is located below the impact site and on the flange of the frame. The slope of the load-displacement curves before and after impacting are very similar up to 3,000 lbs. From 3,000 lbs to 3,500 lbs the after impact curve has larger displacement than the before impact curve. The displacement at LVDT 16 follows the same trend as the displacement curves for the impact site.

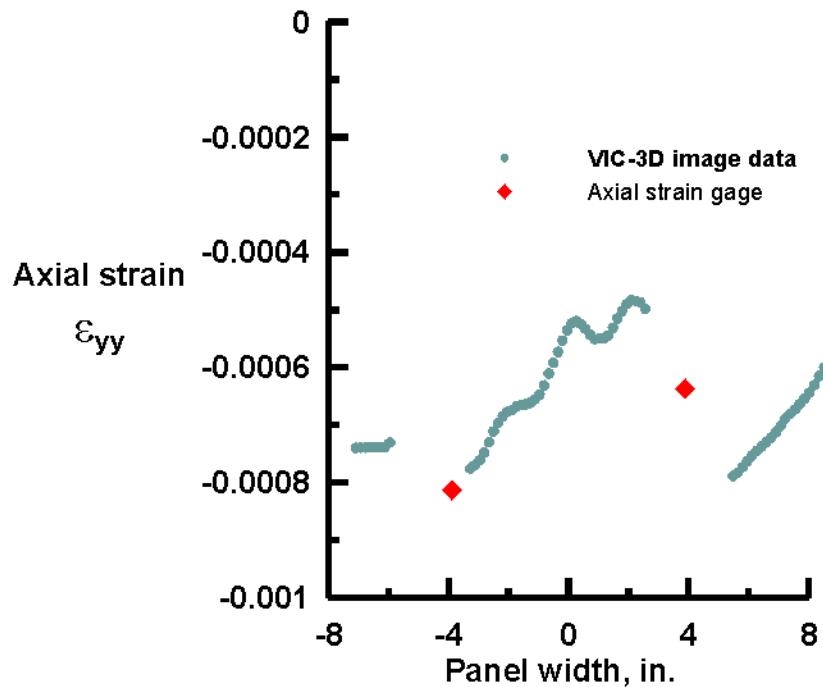
Figure 14. - Strain at Line B in the skin for $N_y = 5,345$ lbs.

the curve shown in Figure 14 are the locations of the rosettes. It is necessary to remove areas in the images where the rosettes are located due to the surface being non-flat from the gages and associated circuitry. The red diamonds shown in Figure 14 are the strain values recorded by the axial gages of the rosettes in the center of each bay. A good comparison exists for the two methods of measuring strain. This analysis software also has the capability of determining the strain at a point as a function of image number or load. Strain in skin at Point B (Figure 10) is shown in Figure 15 as small filled circles. The strain result at gage 20 (Figure 3), which is adjacent to Point B, is also shown in Figure 15. Good comparisons exist between the two strain measuring methods for a loads less than 1,800 lbs and greater than 4,200 lbs.

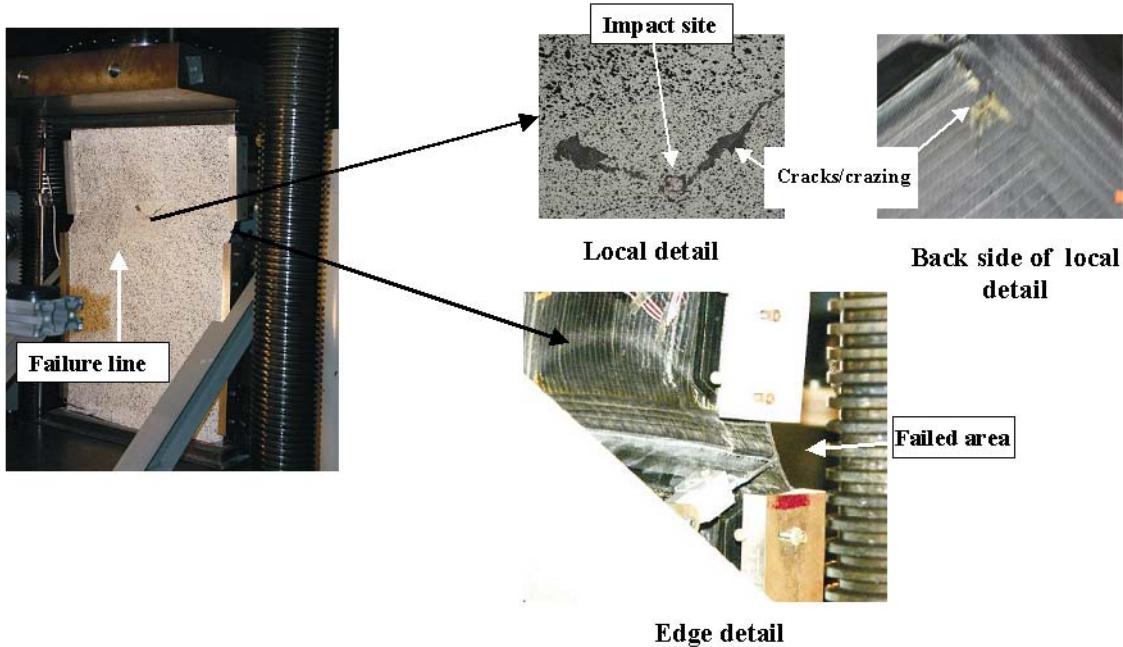
Figure 16. - Failed Panel C-1

A photograph of the failed specimen in the test machine is shown on the L/H side of Figure 16 and is still under some load. It can be seen where the panel folded in the skin adjacent to the flange of the frame at FS 154. The edge view detail shows the out-of-plane displacement. The impact site is in the failure line. Close up photographs of the area at the impact site indicate cracks/crazing radiating from the impact site.

Max load = 5,678 lbs.

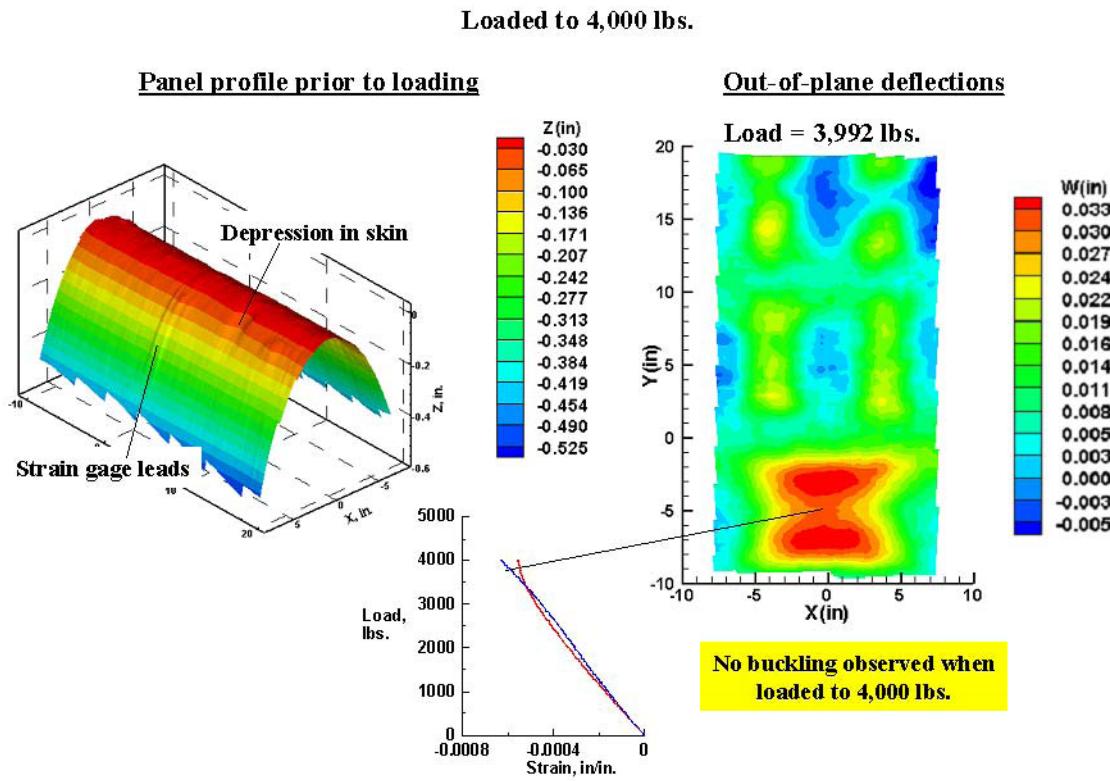
Figure 17. - First test on *Panel C-2*

The first image taken by the VIC-3D system is used to determine the specimen profile. The perspective view of *Panel C-2* shown on the left side of Figure 17 is the profile of the panel before any load is applied. The contours shown are the distances from a theoretical flat plane. The only imperfection that is indicated in the panel is a depression in the skin near FS 269 frame. The imperfection is also extends to the side of the panel not shown in the view. A better local view shown later indicates the imperfection is approximately 0.02-inches below the surrounding surface. A set of strain gage leads also appears in the panel profile.

On the right side of Figure 17 is the out-of-plane displacements on the first loading of *Panel C-2* to determine a buckling load. The image shown was taken at a load of $N_y = 3,992$ lbs. No buckling was observed in the loading to 4,000 lbs. The bottom bay of the specimen bulges as shown by the red area. The image indicates two peaks, 0.030-in. to 0.033-in. high in the bulge. The strain gage results also indicate the lower bay loaded in compression with a small bending, but no buckling.

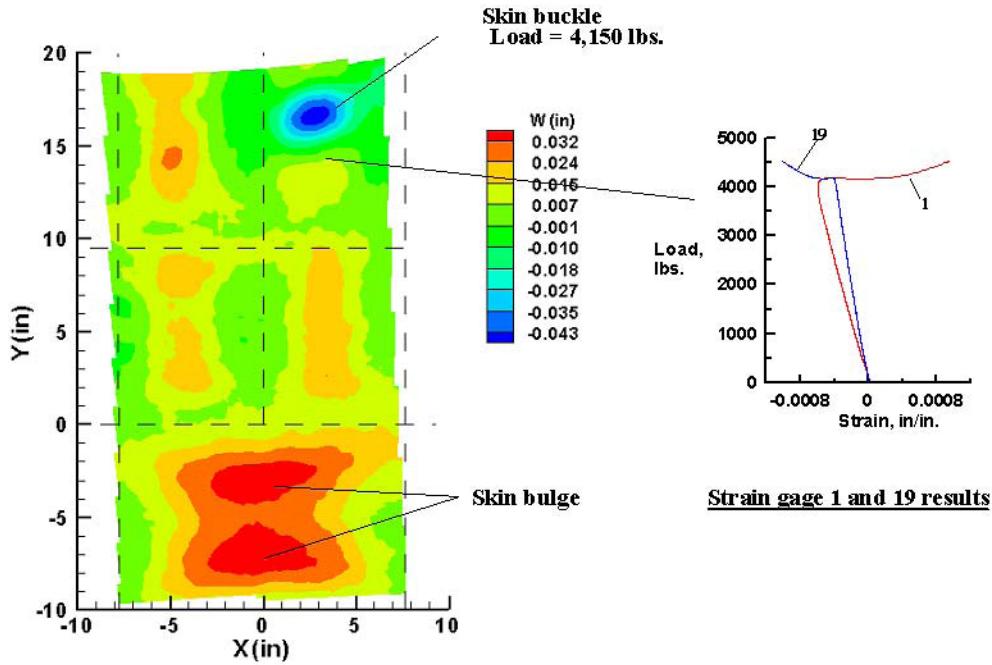
Figure 18. - Loading of *Panel C-2* to $N_y = 4,500$ lbs

Panel C-2 was reloaded to 4,500 lbs. The dashed lines shown on Figure 18 indicate the locations of the frames and stringers. The first buckle appeared at 4,150 lbs in the upper R/H bay as shown on the L/H side of Figure 18. The back-to-back strain gages 1 and 19 located at the upper R/H bay (just below

the buckle) also indicated a strain reversal at the buckling load. The skin in the lower bay bulges as in the first loading to 4,000 lbs. The panel was unloaded and removed from the test machine for impacting, prior to testing to failure.

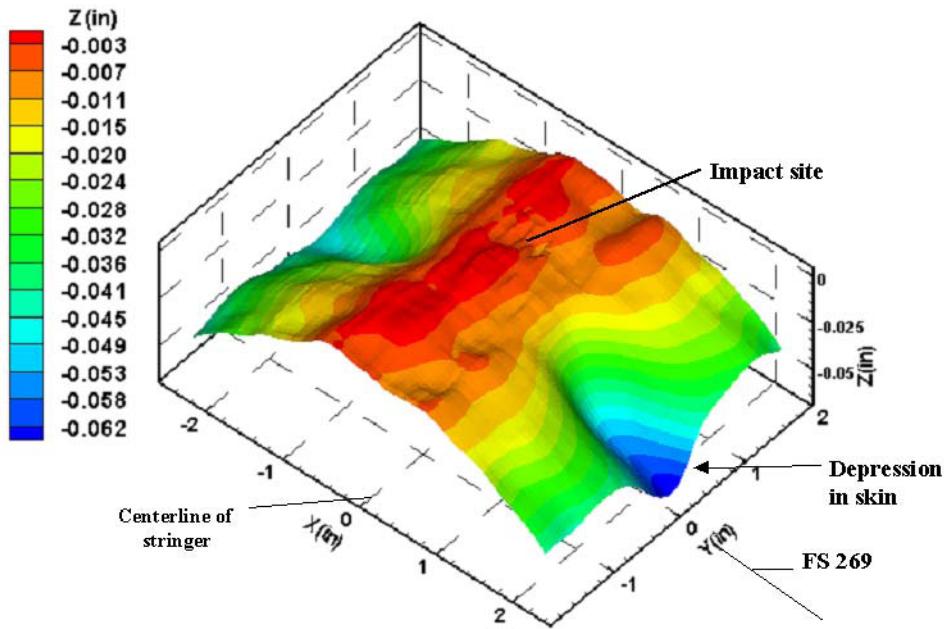
Figure 19. - Local area view after impact.

Figure 19 shows the local VIC-3D system image of the area surrounding the impact site. The panel was impacted with 20 ft-lbs. of energy on the centerline of the panel, between the stringer termination and the frame flange at FS 269. There was no visible damage. The panel was impacted again at the same location with an energy level of 25 ft-lbs. The visible damage was slight compared to the damage of *Panel C-1*. A plot of the contact force versus time for the 25 ft-lb impact event is shown in Figure 20. The first peak of the contact force as a function of time curve occurred at 1,150 lbs. and then dropped to 750 lbs, recovered and reached a peak of 1,244 lbs. This behavior indicates the first contact force drop may be due to initiation of delamination. There was no perceptible stiffness loss as evidenced by the second peak.

The image shown Figure 19 was taken after the panel was reinstalled in the test machine. The image does not indicate any indentation from the two impacts as indicated in a previous figure for *Panel C-1*. It appears that there could be some surface fibers broken from the impacts. The skin depressions which were shown earlier in a profile of the complete panel are shown in more detail. The depressions are over the FS 269 frame and are approximately 0.020 in. below the surrounding surface.

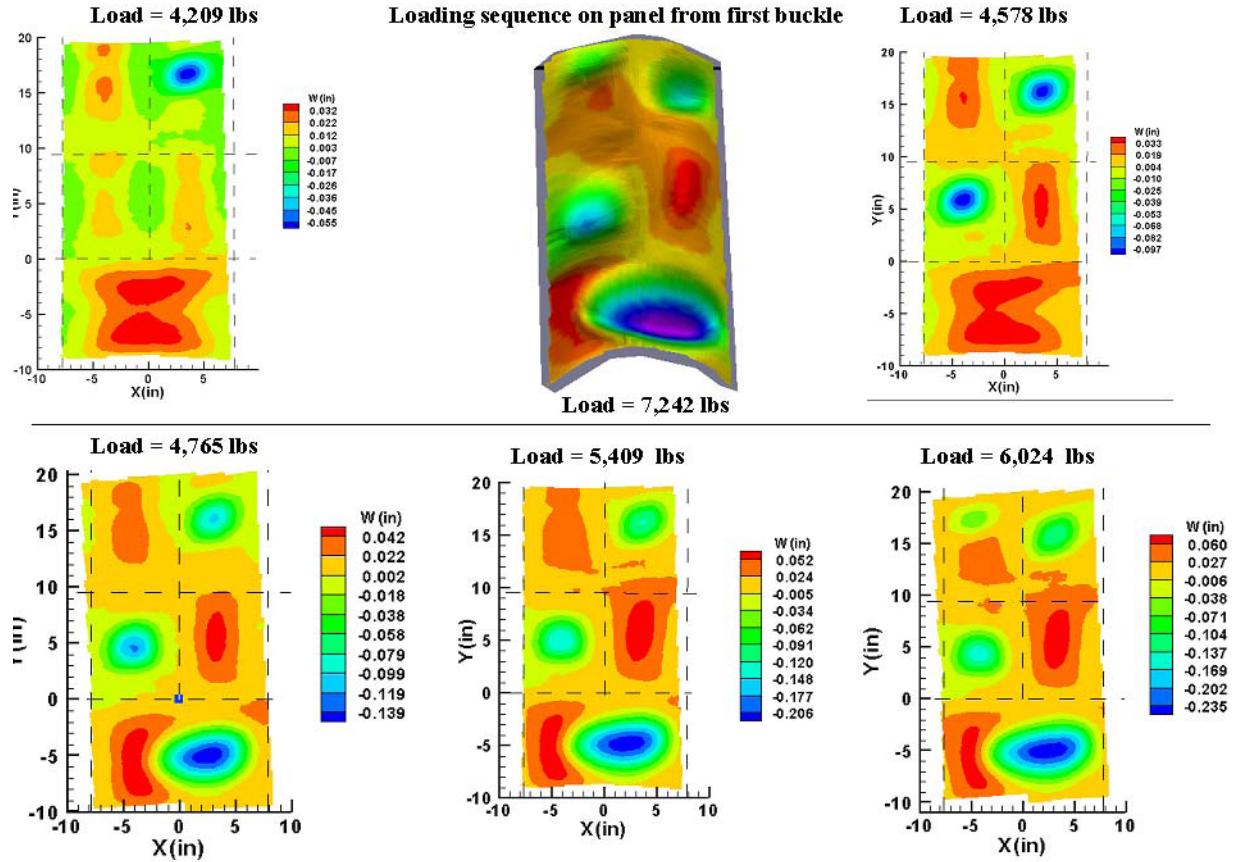
Figure 21. - Changes in the out-of-displacement as load increases on *Panel C-2*.

After impact, *Panel C-2* was loaded in compression to failure. A perspective of the out-of-plane deformations at a load of $N_y = 7,242$ lbs. is shown in the top center of Figure 21. The sequence of events leading to the maximum load is as follows. The first buckle (blue area) developed in the upper R/H bay (see top L/H picture in the figure) at $N_y = 4,150$ lbs as noted earlier. A second buckle developed in the L/H side middle bay (see top R/H picture in the figure) near $N_y = 4,578$ lbs. Next the lower bay which had been bulging changed into an elliptical shaped area that is deflecting in the negative direction and a crescent shaped area deflecting in the positive direction (see lower L/H view in Figure 21) at $N_y = 4,765$ lbs. It would be difficult to call these two half-waves in the usual definition. The middle R/H bay continued to bulge out as the load increased. The upper L/H quadrant also bulged out as load increased until approximately $N_y = 6,000$ lbs. when it snapped into two half-waves. The deflections continued to increase as the load increased until the maximum load resulting in the deformed shape as shown in the top center of Figure 21.

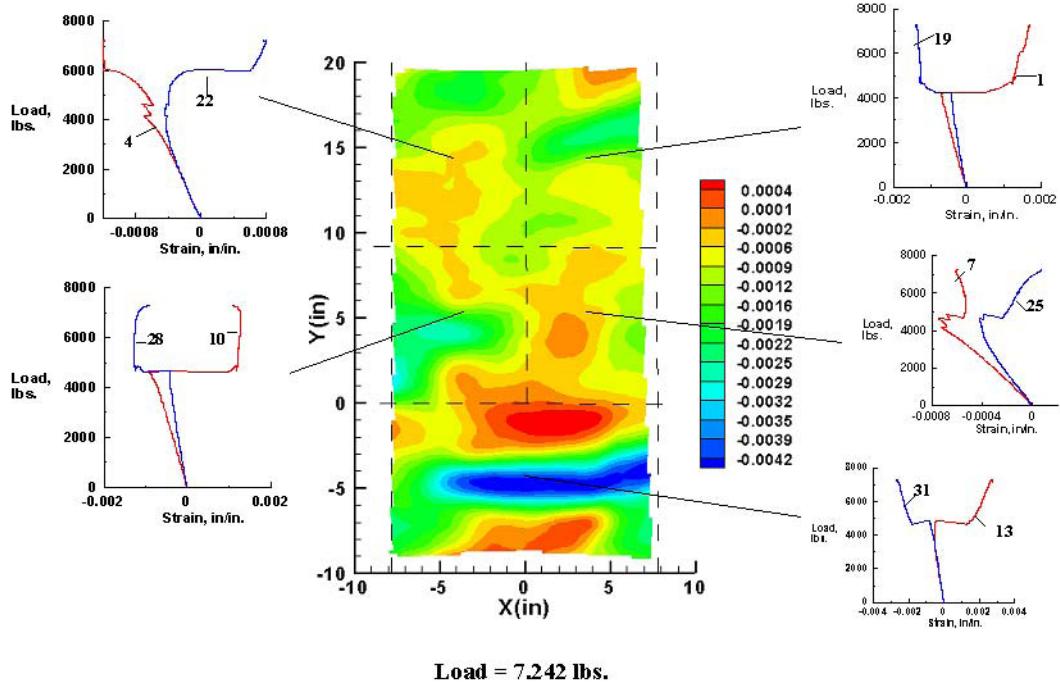
**Comparison of strain gages and strain computed
from data obtained from the VIC 3-D system**

Load = 7,242 lbs.

Figure 22. - Strains results at $N_y = 7,242$ lbs. on *Panel C-2*.

Since the u , v , and w displacements are determined over the viewed area by the VIC 3-D system, it is possible to compute the strain components over the entire viewed surface. The longitudinal strain (ϵ_{yy}) for a load of $N_y = 7,242$ lbs is shown in the center of Figure 22. The snap thorough buckling that was shown in the previous figure in the three areas (upper R/H, middle L/H, and lower bay) is verified by the strain reversals for the same areas shown on this figure. The strains in the upper L/H bay start to diverge at approximately 3,000 lbs. as shown with very little change in the near side gage (22) as the load increases to $N_y = 6,000$ lbs. The jagged appearance of the curve for the far side gage (4) could

Comparison of the strain gage values from the high gage number in each pair of gages with the contours on the center figure indicates very good correlation between the computed strain from the displacement data and the strain gages.

figures. Figure 22 with strain results indicated unusual strain response in the R/H middle bay which could be the results of the frame starting to fail at approximately 4,100 lbs.

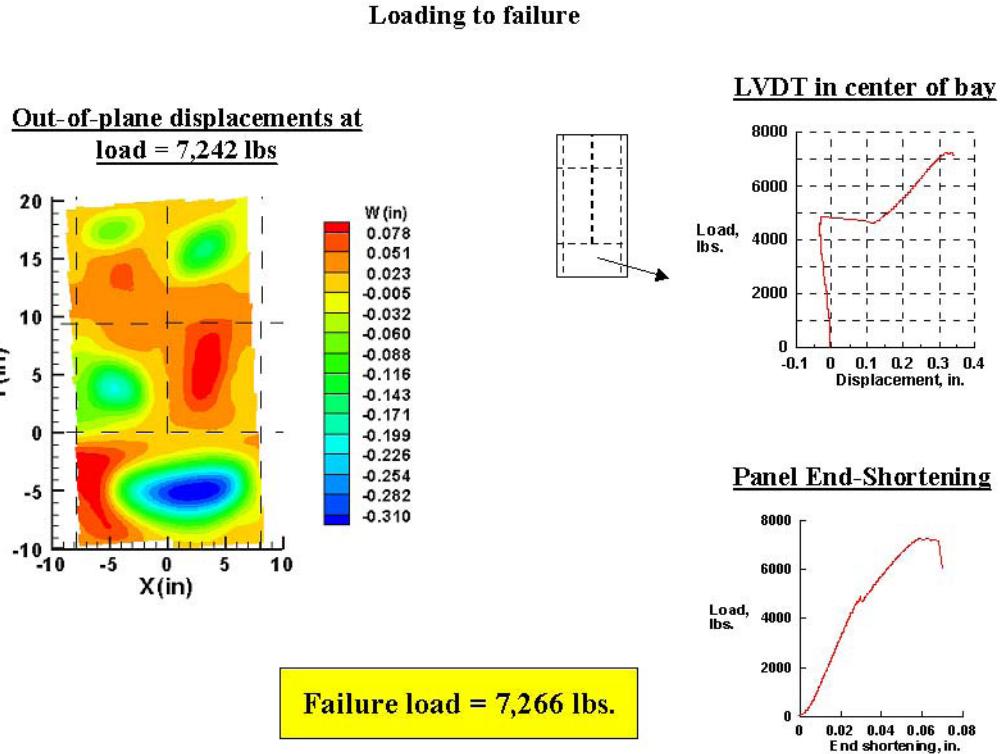
Figure 23. - *Panel C-2* out-of-plane displacement and end shortening.

A summary of some displacement results for *Panel C-2* are shown in Figure 23. The out-of-plane displacements shown on the L/H side of the figure are from a image taken near the failure load. The out-of-plane displacement pattern shown has the same features as the displacement shown previously at a load of 6,200 lbs. only with increased displacement values. The displacement result of a LVDT located in the middle of the lower bay is shown in the upper R/H side of the figure. The displacement reversal at 4,700 to 4,800 lbs. compares well with the VIC-3D system results. The LVDT is located on the panel centerline and near the end of the dark blue area shown in the image and there is good comparison between the results.

The load end shortening curve indicates a linear response until the initial buckle at approximately 4,100 lbs. then a constantly reducing slope (decreasing post-buckled stiffness) until failure. Panel stiffness loss from the impact was less than one percent. Post buckling stiffness of the panel was approximately 52 percent of the prebuckled stiffness.

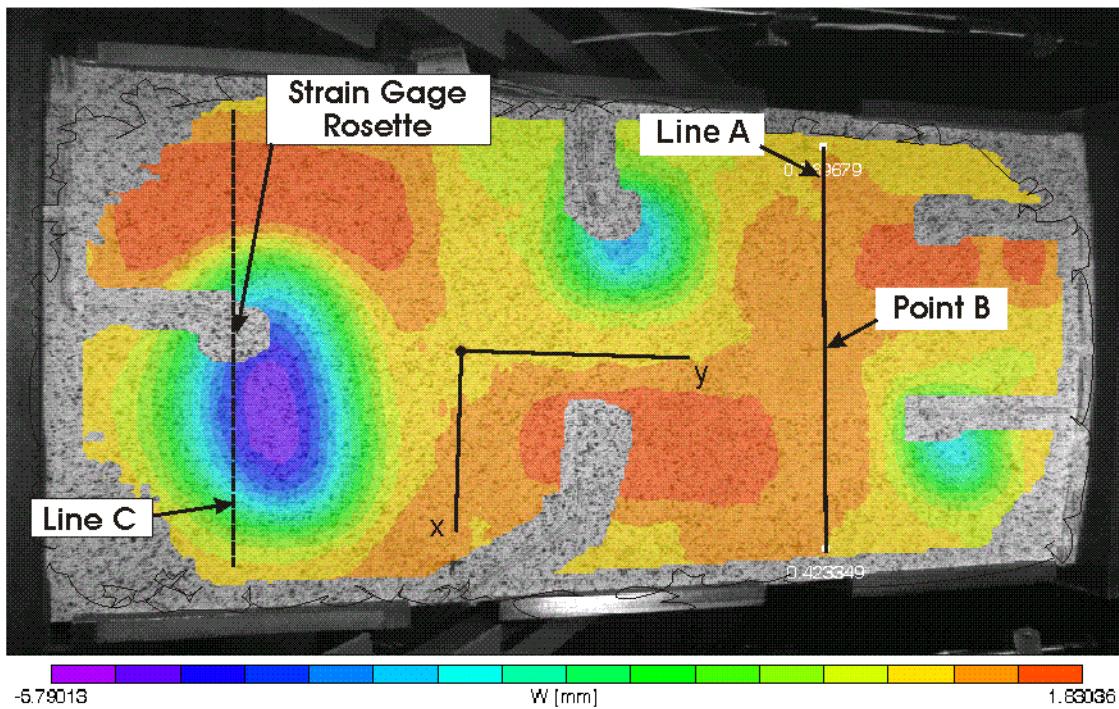
Figure 24. - Out-of-plane contour plot and location of selected strain and displacement results for *Panel C-2*.

local profile view of the panel prior to testing. The out-of-plane displacement results at the location of Line A shown in Figure 24 are shown in Figure 26 for selected loads that vary from $N_y = 3,547$ lbs. to $N_y = 7,242$ lbs., which is the last image taken before failure. The green line with the triangle symbol ($N_y = 7,242$ lbs.) is the displacement from the last frame before maximum load. The line with the blue diamond symbol is at a load of $N_y = 7,136$ lbs. and is an image after maximum load. The curves shown in Figure 26 indicate the out-of-plane displacements vary across the panels which can only be seen with the full field capability of VIC-3D. Displacement transducers would only record a single point. The out-of-plane displacements indicate the panel appears to rotate about the edge at $x = 8.0$ inches until a load of approximately 5,000 lbs. The red curve with no symbols ($N_y = 5,409$ lbs) indicates the panel side at $x = 8.0$ -inches displaced approximately 0.03 inches from the previous curve ($N_y = 4,759$ lbs.) while the side at $x = -8.0$ -inches displaced approximately 0.007 inches. From this load until failure the panel again rotated about the side $x = 8.0$ as shown in Figure 26. Suspected failures at the frame attach points could be contributing to this panel rotation.

In addition the analysis software for VIC-3D allows the selection of a point on the image surface and determine the load-displacement history of the point. The load-displacement history for Point B (Figure 24) at the impact site on *Panel C-2* is shown in Figure 27 for loading to $N_y = 4,500$ lbs and loading to failure. This point is at or very near the impact site since it's location is determined by selecting a point on the screen. The deflection of the point prior to impacting when the panel was loaded to 4,500 lbs. is shown as the red line on Figure 27. Also shown is the load-displacement history of DCDT 16

The VIC-3D software also has the capability of extracting the strain at selected locations on the image. For *Panel C-2* the location selected to determine the strain is Line C as shown in Figure 24. Line C extends across the panel and intersects the strain gage rosette in the center of the bay with the results shown in Figure 28 for various load levels. The experimental results of the axial strain gage are shown for three load levels as symbols for the load levels enclosed by a circle. The gap in each group of symbols is the result of area of the image being removed for the rosette strain gage. The correlation between the strain gage and the VIC-3D curves is reasonable. It appears there is a small rotation in the coordination system since the strain gage results should be near the center of the gap. The strain gage is on the surface which has a high gradient which with a small difference in location can contribute to a large variation in the comparison of the results.
