NASA/TM-2004-213262
ARL-TR-3233

Experimental Results From Stitched Composite Multi-Bay Fuselage Panels Tested Under Uni-Axial Compression

Donald J. Baker
U.S. Army Research Laboratory
Vehicle Technology Directorate
Langley Research Center, Hampton, Virginia

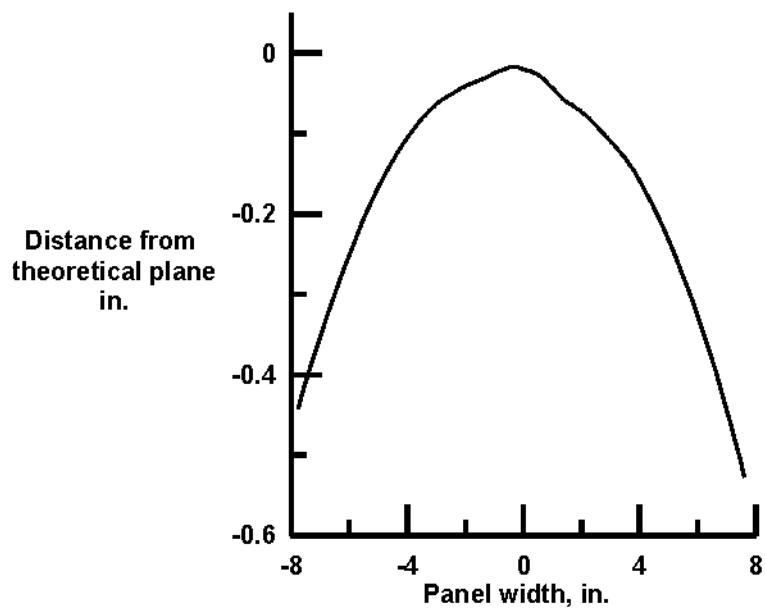
Figure 25. - Profile of *Panel C-2* across the panel at Line A.

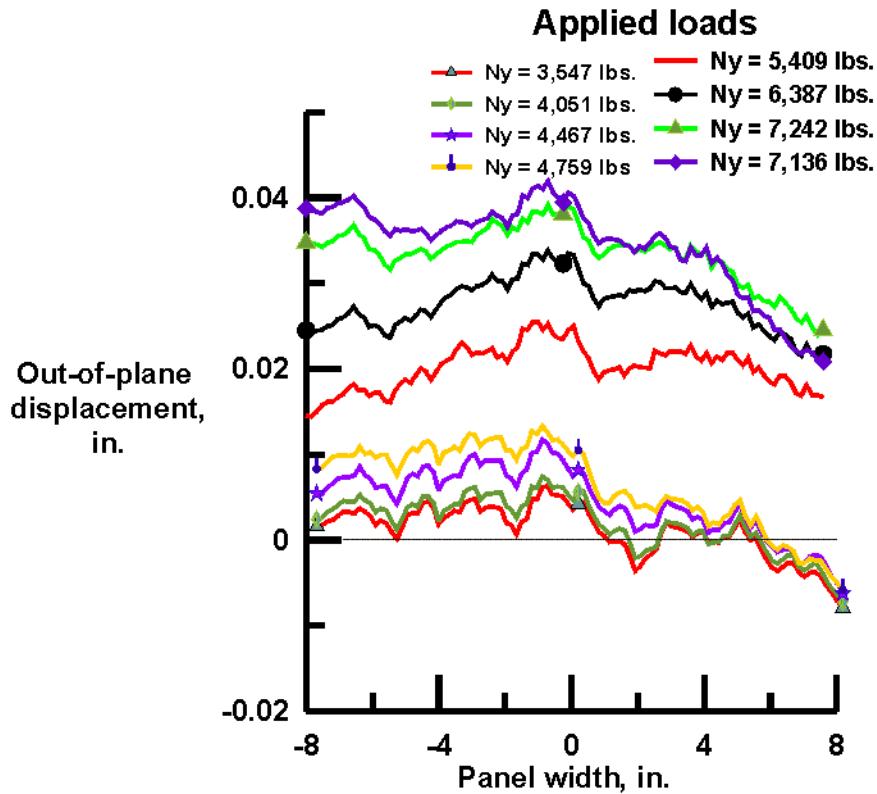
Figure 26. - History of out-of-displacement as a function of applied load.

local profile view of the panel prior to testing. The out-of-plane displacement results at the location of Line A shown in Figure 24 are shown in Figure 26 for selected loads that vary from $N_y = 3,547$ lbs. to $N_y = 7,242$ lbs., which is the last image taken before failure. The green line with the triangle symbol ($N_y = 7,242$ lbs.) is the displacement from the last frame before maximum load. The line with the blue diamond symbol is at a load of $N_y = 7,136$ lbs. and is an image after maximum load. The curves shown in Figure 26 indicate the out-of-plane displacements vary across the panels which can only be seen with the full field capability of VIC-3D. Displacement transducers would only record a single point. The out-of-plane displacements indicate the panel appears to rotate about the edge at $x = 8.0$ inches until a load of approximately 5,000 lbs. The red curve with no symbols ($N_y = 5,409$ lbs) indicates the panel side at $x = 8.0$ -inches displaced approximately 0.03 inches from the previous curve ($N_y = 4,759$ lbs.) while the side at $x = -8.0$ -inches displaced approximately 0.007 inches. From this load until failure the panel again rotated about the side $x = 8.0$ as shown in Figure 26. Suspected failures at the frame attach points could be contributing to this panel rotation.

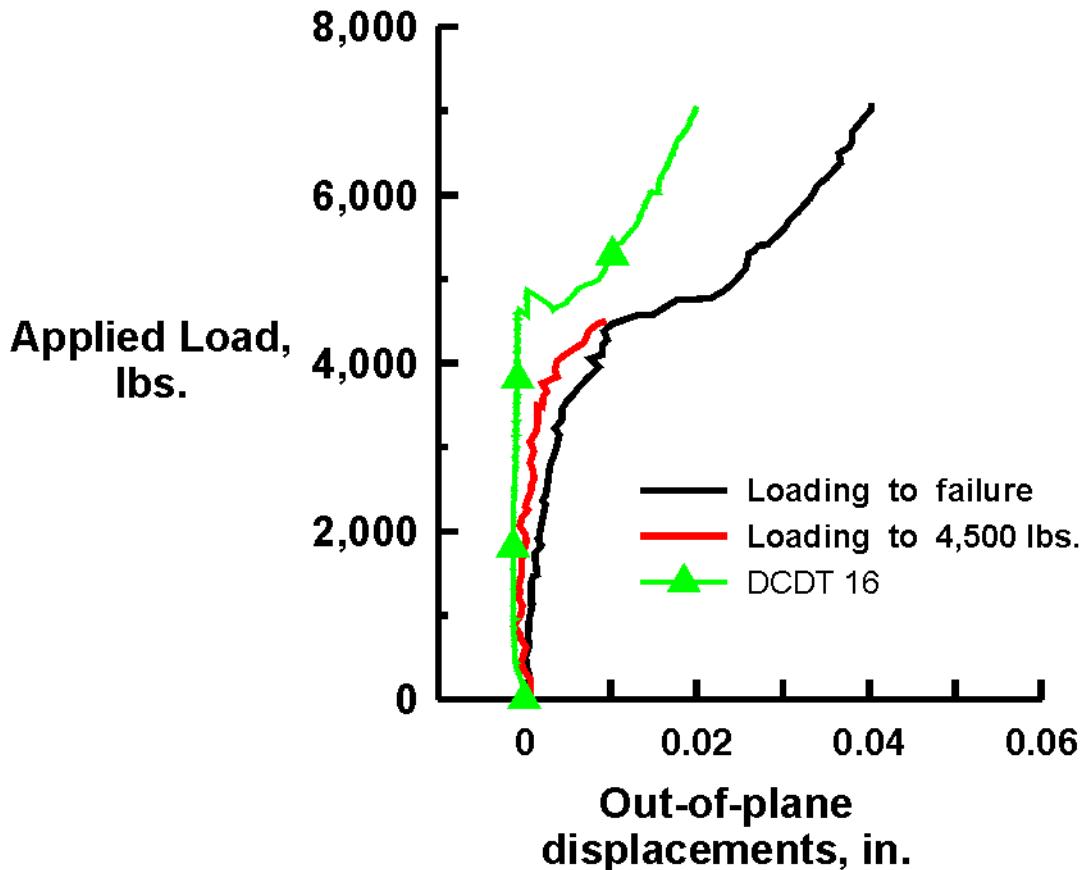
Figure 27. - Out-of-plane displacement at or near the impact point.

In addition the analysis software for VIC-3D allows the selection of a point on the image surface and determine the load-displacement history of the point. The load-displacement history for Point B (Figure 24) at the impact site on *Panel C-2* is shown in Figure 27 for loading to $N_y = 4,500$ lbs and loading to failure. This point is at or very near the impact site since it's location is determined by selecting a point on the screen. The deflection of the point prior to impacting when the panel was loaded to 4,500 lbs. is shown as the red line on Figure 27. Also shown is the load-displacement history of DCDT 16

which is located on the frame flange adjacent to the impact site. The three curves have the same trend, with the as expected lower displacement on a the frame flange which is a stiffer part of the structure. The curves indicate that the impact event has a slight effect on the panel surface deflection by reducing the stiffness.

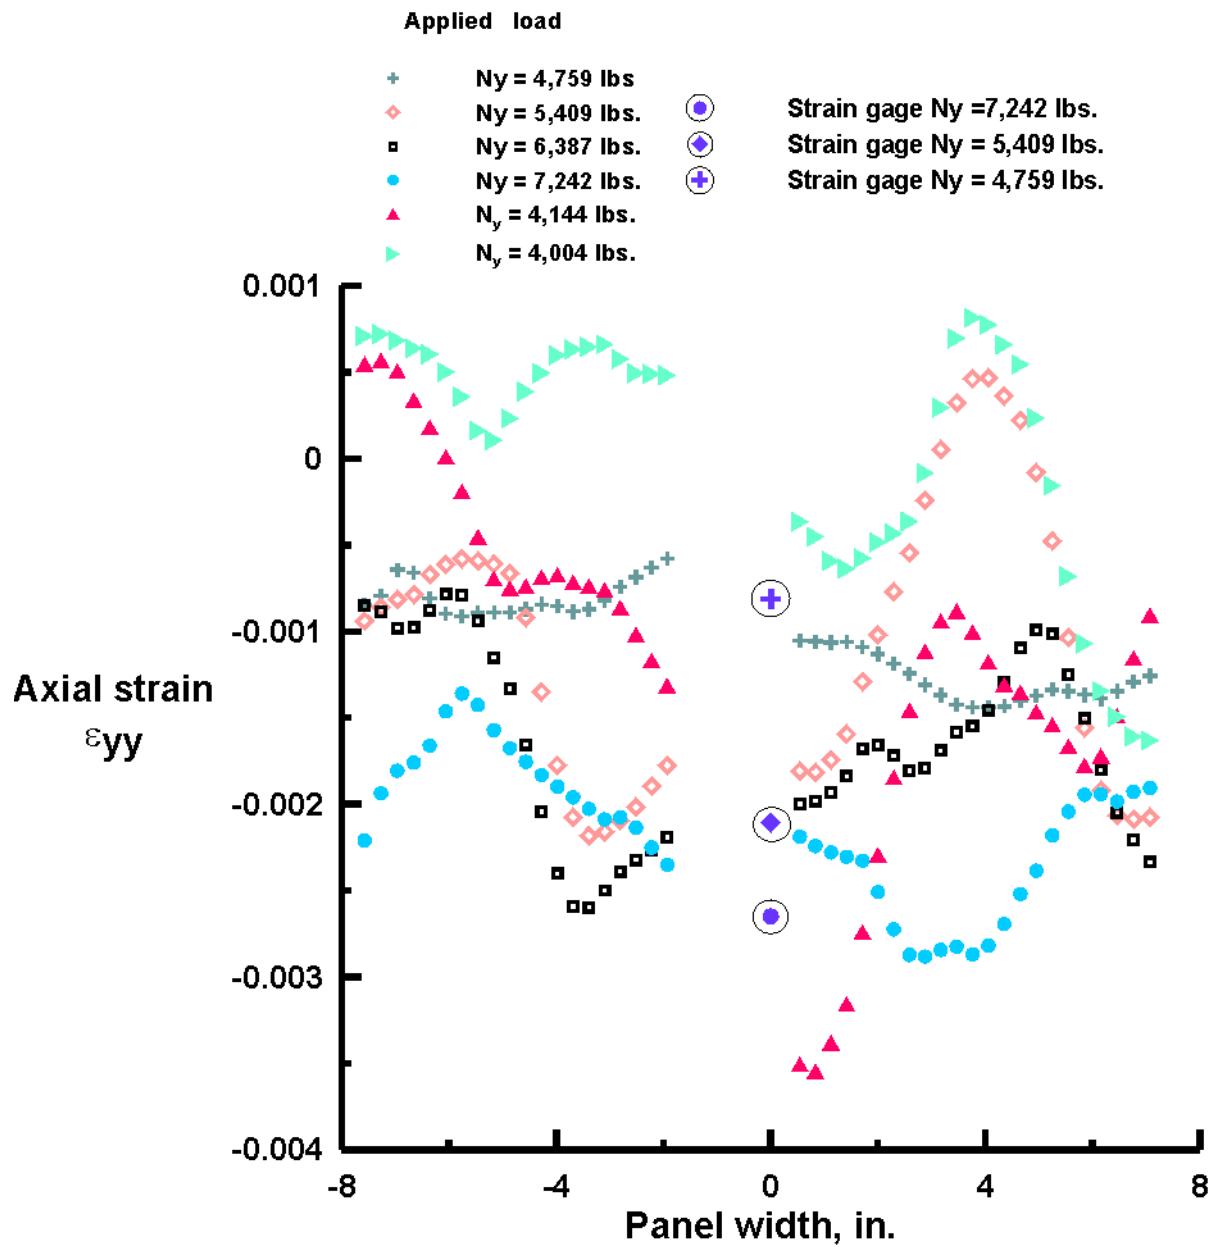
Figure 28. - History of strain distribution across bottom of *Panel C-2*.

The VIC-3D software also has the capability of extracting the strain at selected locations on the image. For *Panel C-2* the location selected to determine the strain is Line C as shown in Figure 24. Line C extends across the panel and intersects the strain gage rosette in the center of the bay with the results shown in Figure 28 for various load levels. The experimental results of the axial strain gage are shown for three load levels as symbols for the load levels enclosed by a circle. The gap in each group of symbols is the result of area of the image being removed for the rosette strain gage. The correlation between the strain gage and the VIC-3D curves is reasonable. It appears there is a small rotation in the coordination system since the strain gage results should be near the center of the gap. The strain gage is on the surface which has a high gradient which with a small difference in location can contribute to a large variation in the comparison of the results.

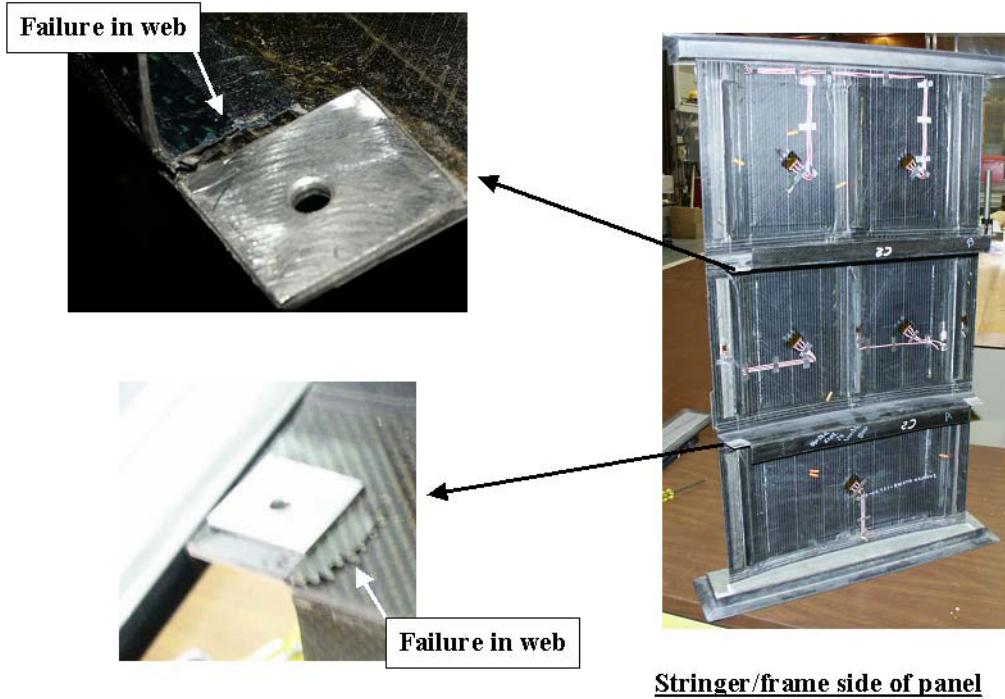
Figure 29 - Failed Panel C-2.

The failed *Panel C-2* is shown Figure 29. Close up views of the failure sites are shown and indicate the failure occurred around the attach points where the load reacting frame attached to the panel. The failures noted in the frame attach points are on the R/H side as shown in the image views on previous

It is impossible to determine if the failure of the frame attach points caused failure or if the bottom bay lost its load carrying ability from buckling allowing the panel to collapse.
