# **In-Space Repair of Reinforced Carbon-Carbon Thermal Protection System Structures**

**James I. Mueller Memorial Award Lecture**

**29<sup>th</sup> International Conference on Advanced Ceramics and Composites  
Cocoa Beach, Florida  
January 24, 2005**

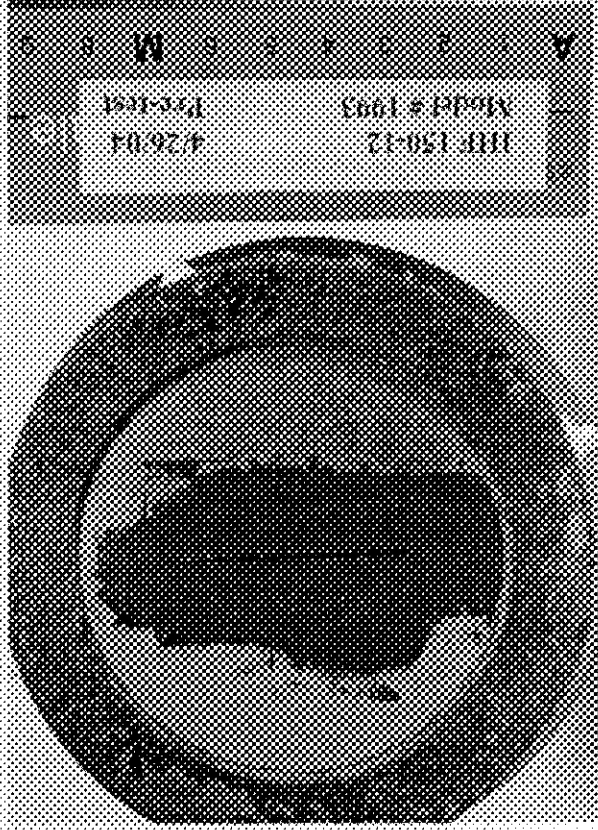
# Pre-Test Photographs of Repaired Specimens

Run 12 – Model 1993

(0.035" or ~0.89 mm wide crack, GRABER-5A)

Percent Argon = 6% @ 2960F condition

Add air = 11.6% @ 2960F condition

Anomaly: water leak from electrode, which allowed water vapor in the stream

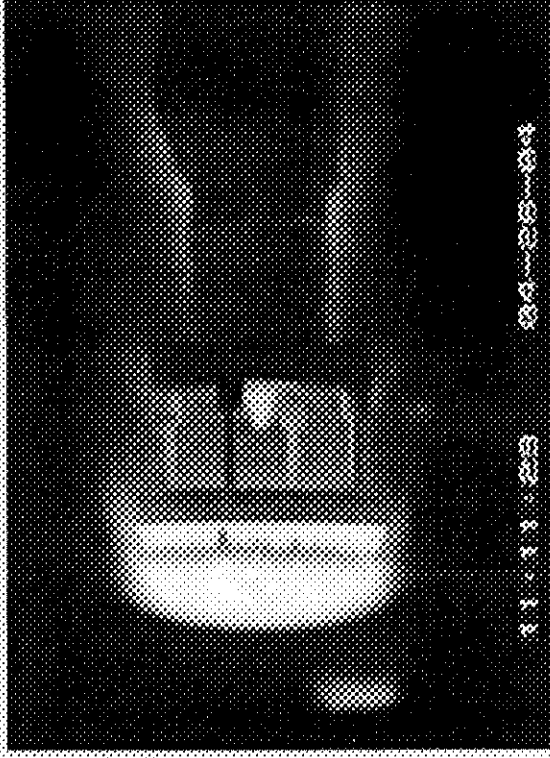
Side View

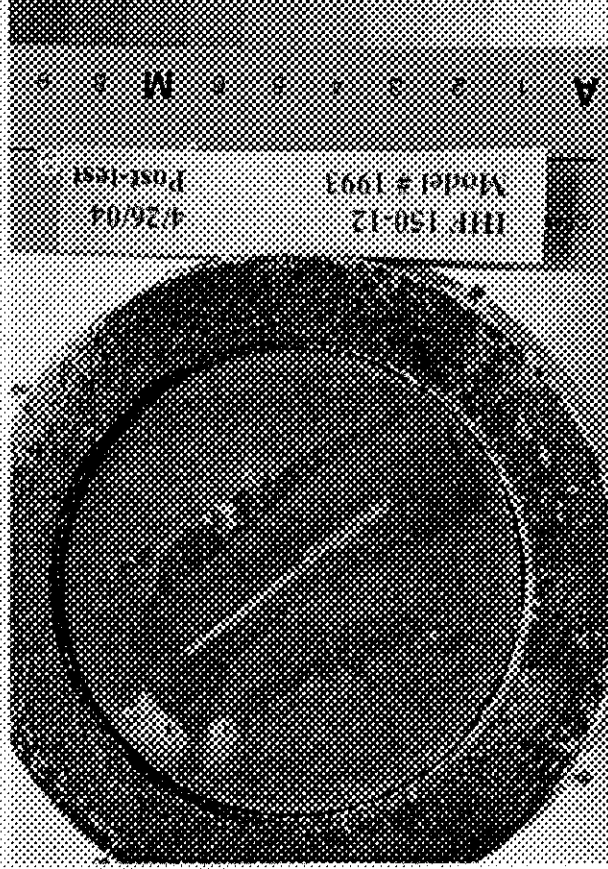
Run 12 – Model 1993

(0.035" or ~0.89 mm wide crack, GRABER-5A)

Post Test- Front Side
