# Thermographic Characterization of Impact Damage in SiC/SiC Composite Materials

## ABSTRACT

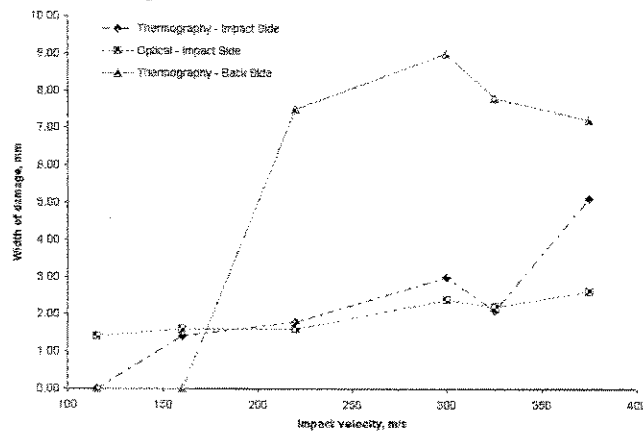
Figure 5 plots width of damage as detected optically and thermally against the impact velocity. In general, the width of damage detected with thermography is greater than the damage that can be detected optically, excluding the surface damage at 115 and 160 m/s. The width of damage detected from the back side with thermography is significantly larger than damage detected optically or with thermography from the impacted side for impact velocities above 220 m/s. Damage is closer to the back surface than the impacted surface of the sample. However, components made from this material may be accessible from a single side only. This observation illustrates the need for defining the limits of detection in SiC/SiC composite material and optimizing the capture of thermal data in this material. In addition, the damage depth information needs to be acquired from the thermal data.

Figure 5. Width of damage for each impact velocity as detected optically from the impacted surface and thermally from the impacted surface and the back surface.

These results illustrate some challenges of defect detection in SiC/SiC composite materials by pulsed thermography. As illustrated in figure 5, surface damage on the level of the surface roughness of the weave was not readily detected with thermography. In addition, damage near the back surface of the composite, although detectable for aspect ratios above 2.5, is not easily resolved due to the two-dimensional heat flow being the dominant heat flow mechanism at the back surface. The lack of resolution for defects near the back surface means that the measurement of width or diameter for a defect may have a significant amount of error associated with it. Depth measurements for near surface flat bottom holes also proved challenging. The SiC/SiC composite material cools at such a high rate, that the time of departure for the flat bottom holes closest to the surface (0.35 mm) was not captured. The highest capture rate the thermal camera from this study was capable of utilizing, without significantly degrading the images, was 613 Hz. There are commercially available IR cameras that are capable of capturing at higher sampling rates that may be able to provide better depth measurements for near surface defects. Also, with respect to delaminations existing at multiple depths in a local thickness, thermography will detect only the defect nearest the interrogation surface. Heat flow will be interrupted by the first defect in the thickness. This is particularly important for the types of damage existing in impacted SiC/SiC samples. In addition, the conical shape of the damage induced by impact can make depth measurement somewhat difficult, as the depth can be changing within a single pixel width.
