TERAHERTZ NDE FOR UNDER PAINT CORROSION DETECTION AND EVALUATION

Robert F. Anastasi¹ and Eric I. Madaras²

¹U.S. Army Research Laboratory, Vehicle Technology Directorate, AMSRD-ARL-VT-SM, Nondestructive Evaluation Sciences Branch, NASA Langley Research Center, Hampton, VA 23681

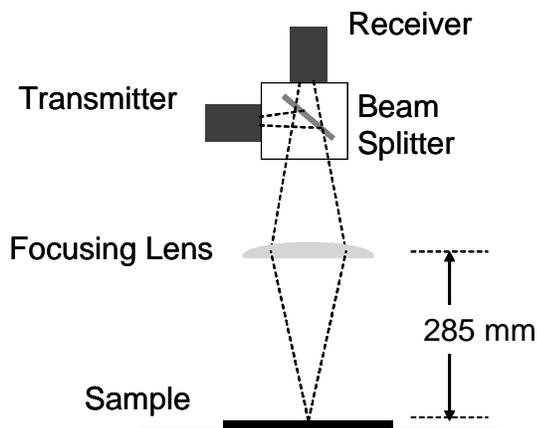
Figure 1. THz transmitter and receiver units in a confocal arrangement focused on the sample.

The THz system used in this work was manufactured by Picometrix, Inc. THz signals are generated and detected using optical excitation of biased semiconductors with 70-femto-second pulses from an 800 nm laser. The resulting digitized time-domain signal is composed of 2048 points and has a duration of 320 ps, which corresponds to a propagation path length in air of 96 mm or approximately 4 inches. The transmitter and receiver units were in a confocal arrangement and used a 15 cm diameter, 285 mm focal length lens to concentrate the THz energy on the sample. The spot size diameter on the sample was approximately 3 mm. This arrangement is shown in Figure 1. This transmit/receive head was scanned in a raster pattern over an inspection sample with spatial increments of 1 mm, while time-domain signals were digitized and stored for later processing.

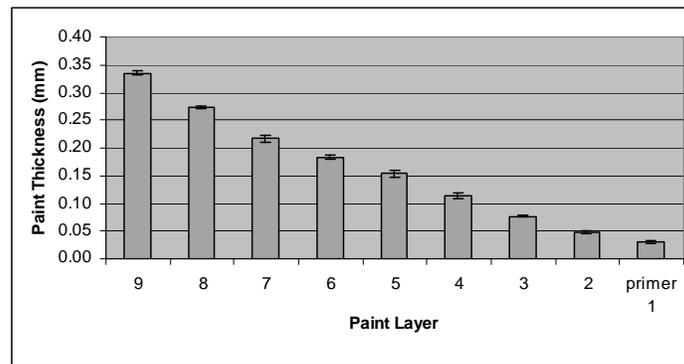
Figure 2. Paint layer thicknesses on an aluminum substrate.

THz response to paint thickness was examined using a sample with a varying thickness layer of paint on an aluminum substrate. An enamel spray paint was used to paint one primer layer and eight top coat layers each approximately 25 mm wide. The bar graph in figure 2 shows the range of paint layer thicknesses on the sample. Figure 3 shows the sample, figure 3a, and THz signals at three different locations. Figure 3b shows the signal for layer-9, paint thickness 0.335 ± 0.0039 mm. In this signal, the first peak of the paint surface echo and aluminum surface echo are resolved. Figure 3c shows the signal for an intermediate paint thickness, layer-6, paint thickness 0.183 ± 0.0039 mm, the individual echoes are not fully resolved in this signal and figure 3d, show a signal from the bare aluminum surface. Using the time between the paint surface echo and aluminum echo a wave velocity in the paint was found to be 0.190 ± 0.013 ps. This corresponds to a refractive index of 1.58 ± 0.11 and a dielectric constant of 2.50 ± 0.36 .

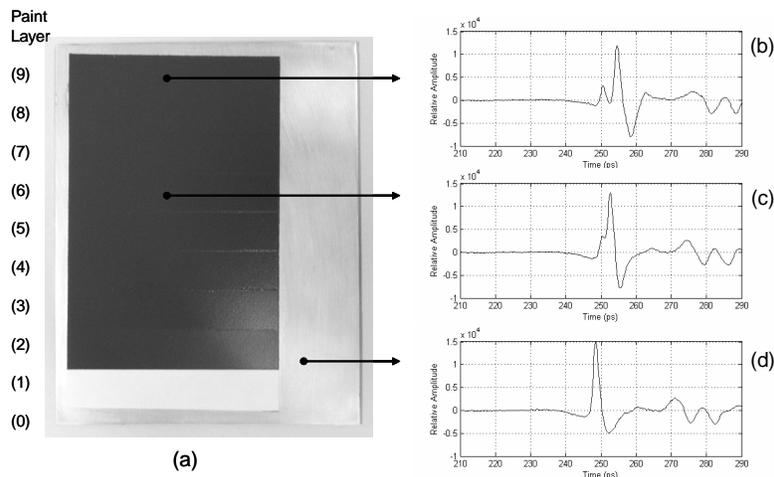
Figure 3. Paint sample (a) and (b) signal through layer-9, (c) through layer-6, and (d) on bare metal.

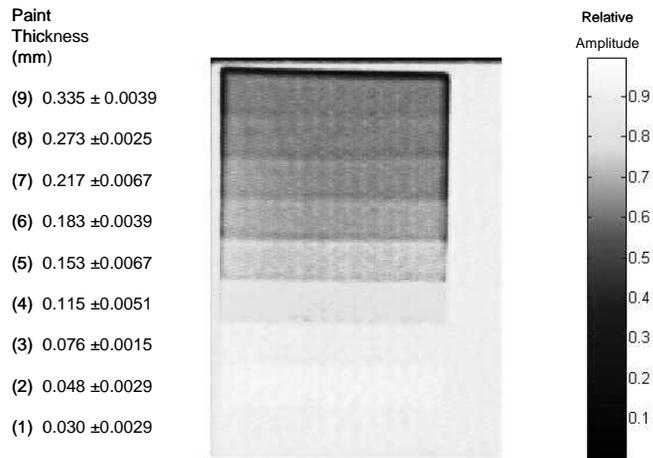
Figure 4. THz Amplitude Image (maximum signal amplitude).

A THz amplitude image is shown in figure 4. It was generated by plotting the maximum signal amplitude at each scan point as a function of gray-level. The image shows how the signal amplitude correlates to paint thickness. The darker gray or lower amplitude corresponds to thicker paint and the lighter gray, higher amplitude to thinner paint. The image also shows that paint thickness can be determined to a thickness of ~ 0.050 mm even though the individual paint surface and aluminum substrate echoes could not be resolved. The influence of the color or paint pigment was not investigated.

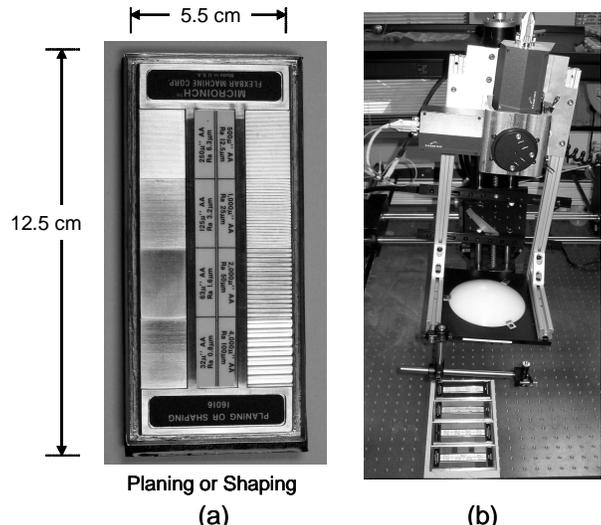
Figure 5. One of the comparator plate used in the surface roughness measurements (a) and the confocal head shown tilted at a 5 degree angle from normal.

Surface Roughness was examined using commercial comparator plates of various roughnesses. Four comparator plates used were standards for Planing and Shaping, Electrical Discharge Machining (EDM), Grit and Shot Blasting, and Casting. These plates covered a range of average roughness (Ra) from 0.04 μm to 100 μm . The ‘Planing and Shaping’ plate is shown in figure 5a. This plate has eight separate areas of roughness. The smoothest area has an average roughness of 0.8 μm and the roughest is 100 μm . The average roughness is the area between the roughness profile and its mean line, or the integral of the absolute value of the roughness profile height over the evaluation length [11]. These plates were inspected with the confocal THz head normal to the sample and at 5°, 10°, 15° and 20° from normal. The angle head arrangement was used to reduce the strong direct reflections from planar surfaces and examine if this arrangement improves surface roughness evaluation, figure 5b show the THz head rotated 5°.

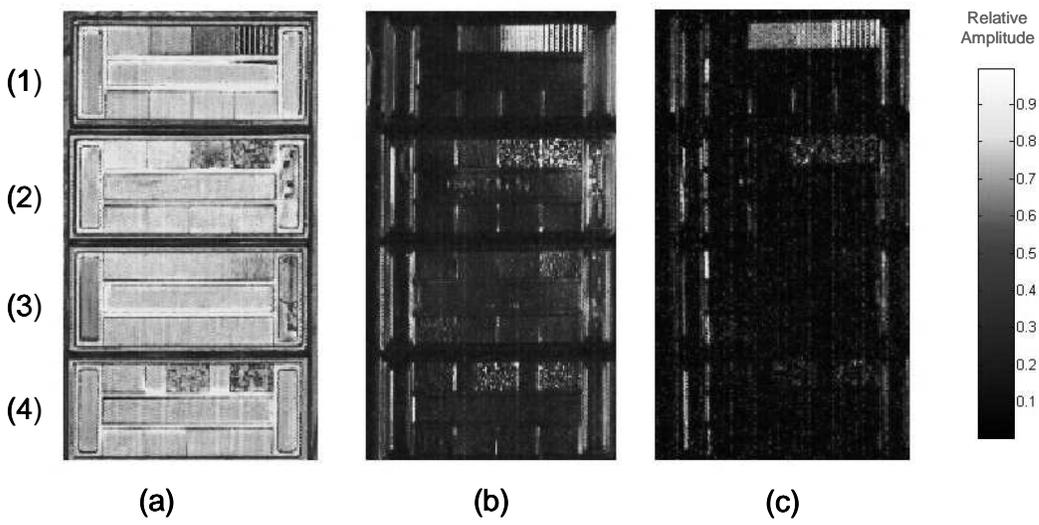
Figure 6. Comparator plate frequency images for the THz head at (a) 0 deg, (b) 10 deg, (c) 20 deg. Plate-1 is the Planning and Shaping, Plate-2 is EDM, Plate-3 is Grit and Shot Blasting, and Plate-4 is Casting.

Amplitude and frequency images were generated from the THz scan data. The frequency image was generated by applying a Fast-Fourier-Transform (FFT) to each signal in the THz scan and then taking the mean amplitude of the spectrum between 0.4 and 0.6 THz. For this data, this was the range of greatest spectral amplitude. The frequency images for 0°, 10°, and 20° are shown in figure 6. These images illustrate that for a normal inspection, figure 6a, the mean frequency amplitude is greater for the smooth areas than the roughest areas, thus the smooth areas reflect energy back to the detector while the rough areas scatter energy away from the detector. For the 10° and 20° angled inspection, figures 6b and 6c, the mean frequency amplitude is greater for the rough areas and less in the smooth areas, thus more THz energy is being detected for the rough area. To quantify the scattering shown in figure 6, an average signal power per area was calculated for the four roughest areas on the ‘Planing and Shaping’ comparator plate. This was done by calculating an average signal for each roughness area and for the total inspection areas and then computing the average signal power for each area. The roughness area result was then divided by the total inspection area result. The outcome for the four areas is shown in figure 7. This shows that the roughest area and largest angle, backscatter had the most average-signal power.

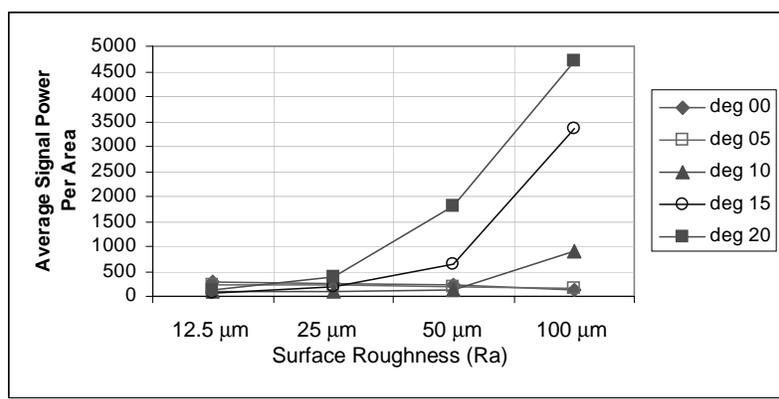
Figure 7. Average Signal Power per Area for four surface areas on the Planing and Shaping plate.

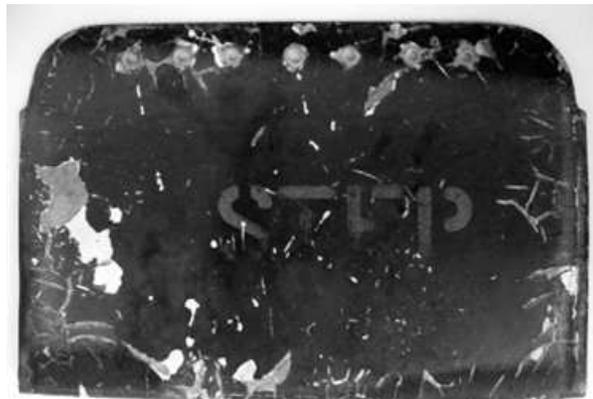
Figure 8. Chinook Fuselage Step Door is shown with flaked, chipped and cracked paint. It is approximately 20 cm by 14 cm

The Chinook fuselage step door, shown in figure 8, is approximately 20 cm by 14 cm and has areas of chipped, flaking and cracked paint. Two THz images are shown in figure 9. Figure 9a shows a maximum signal amplitude image. If the paint-thickness sample results are used as a reference then the areas of thick and thin paint can be identified by signal amplitude correlation, thus, the darker areas in the image maybe caused by thicker paint or potentially corrosion. Figure 9b, is a frequency image of mean amplitude between 0.62 and 0.68 THz, generated at a 10° angle. Using the backscatter results from the surface roughness samples, the brighter colors correspond to rougher areas and maybe potential areas of corrosion.

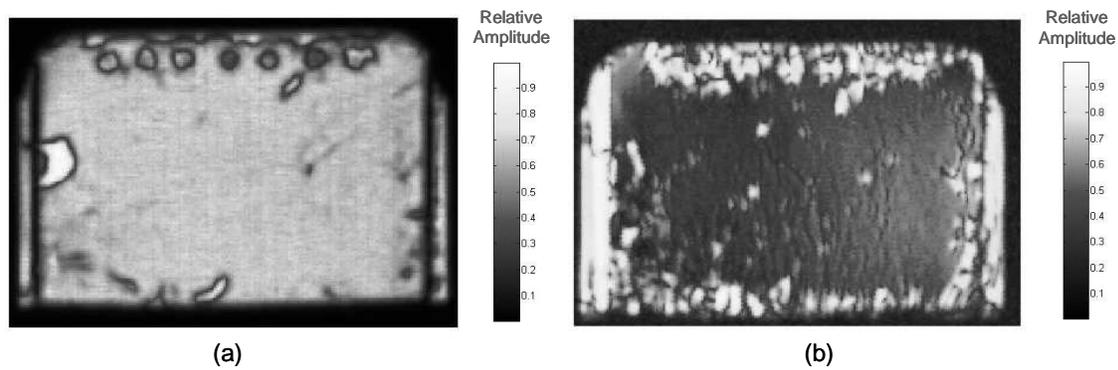
Figure 9. THz images of the Chinook Fuselage Step Door (a) maximum amplitude, normal inspection and (b) mean frequency amplitude between 0.62 and 0.68 THz, 10° angled inspection.

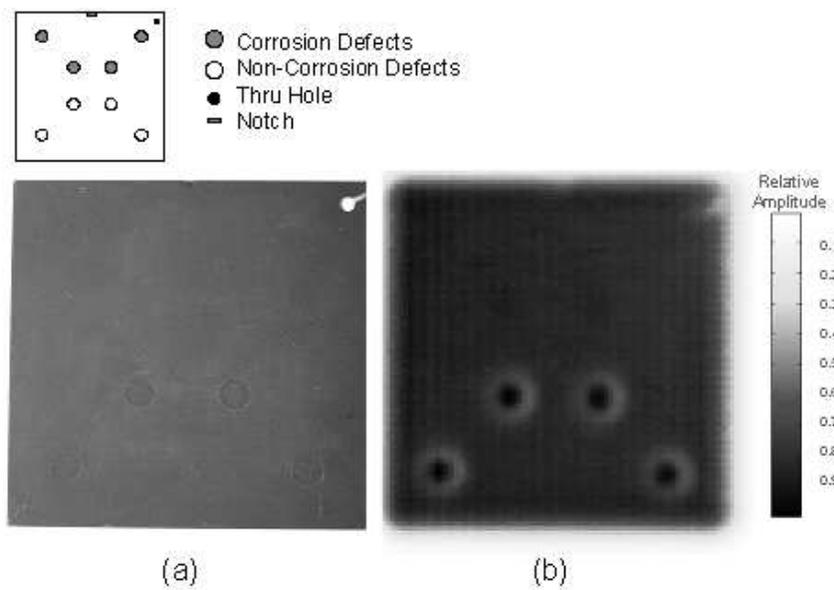
Figure 10. Corrosion sample (a) picture and (b) THz amplitude image, minimum signal amplitude from 257 ps to 273 ps.

The manufactured sample, shown in figure 10a was approximately 15 cm by 15 cm. This sample contained four corrosion areas, each 12.7 mm in diameter, produced by an electrochemical process and four flat bottom holes, 0.15 mm in depth and 12.7 mm in diameter. The sample including the corrosion spots and flat bottom holes were painted with a primer and topcoat. This paint layer was 0.06 mm to 0.07 mm thick. The flat bottom holes were visible by eye but not the corrosion spots. A THz amplitude image of the corrosion sample is shown in figure 10b. The amplitude image was generated by taking the minimum signal amplitude between 257 ps and 273 ps. In this image, the darker gray represents greater signal amplitude and the four non-corrosion defects are shown as dark spots and possible detection of the two corrosion defects are in the central area of the plate. The halos around the flat bottom holes are caused by signal interference at the edges, which distort the waveform. This same effect is seen around the outer edges of the sample. In reference to the paint thickness sample, these dark spots would correspond to thinner paint and in reference to the backscatter measurements at normal incidence, the dark areas correspond to decreased scattering or smoother surface areas.

dissecting and studying small sections, but signal amplitude in normal and angled inspection did vary across the sample and may be indications of corrosion or damage. For the manufactured corrosion sample, the dark areas correspond to two corrosion areas and four flat bottom holes. This may have been caused by variations in paint thickness and surface roughness and may be indications of corrosion. Signal processing methods may be able to improve the imaging of these corrosion defects.
