# **Oxidation Microstructure Studies of Reinforced Carbon/Carbon**

*Keywords:* Carbon/carbon composites, Oxidation, Coating, Reactivity, Graphitic carbon

Laboratory oxidation studies of reinforced carbon/carbon (RCC) are discussed with particular emphasis on the resulting microstructures. This study involves laboratory furnace (500-1500°C) and arc-jet exposures (1538°C) on various forms of RCC. RCC without oxidation protection oxidized at 800 and 1100°C exhibits pointed and reduced diameter fibers, due to preferential attack along the fiber edges. RCC with a SiC conversion coating exhibits limited attack of the carbon substrate at 500, 700 and 1500°C. However samples oxidized at 900, 1100, and 1300°C show small oxidation cavities at the SiC/carbon interface below through-thickness cracks in the SiC coating. These cavities have rough edges with denuded fibers and can be easily distinguished from cavities created in processing. Arc-jet tests at 1538°C show limited oxidation attack when the SiC coating and glass sealants are intact. When the SiC/sealant protection system is damaged, attack is extensive and proceeds through matrix cracks, creating denuded fibers on the edges of the c

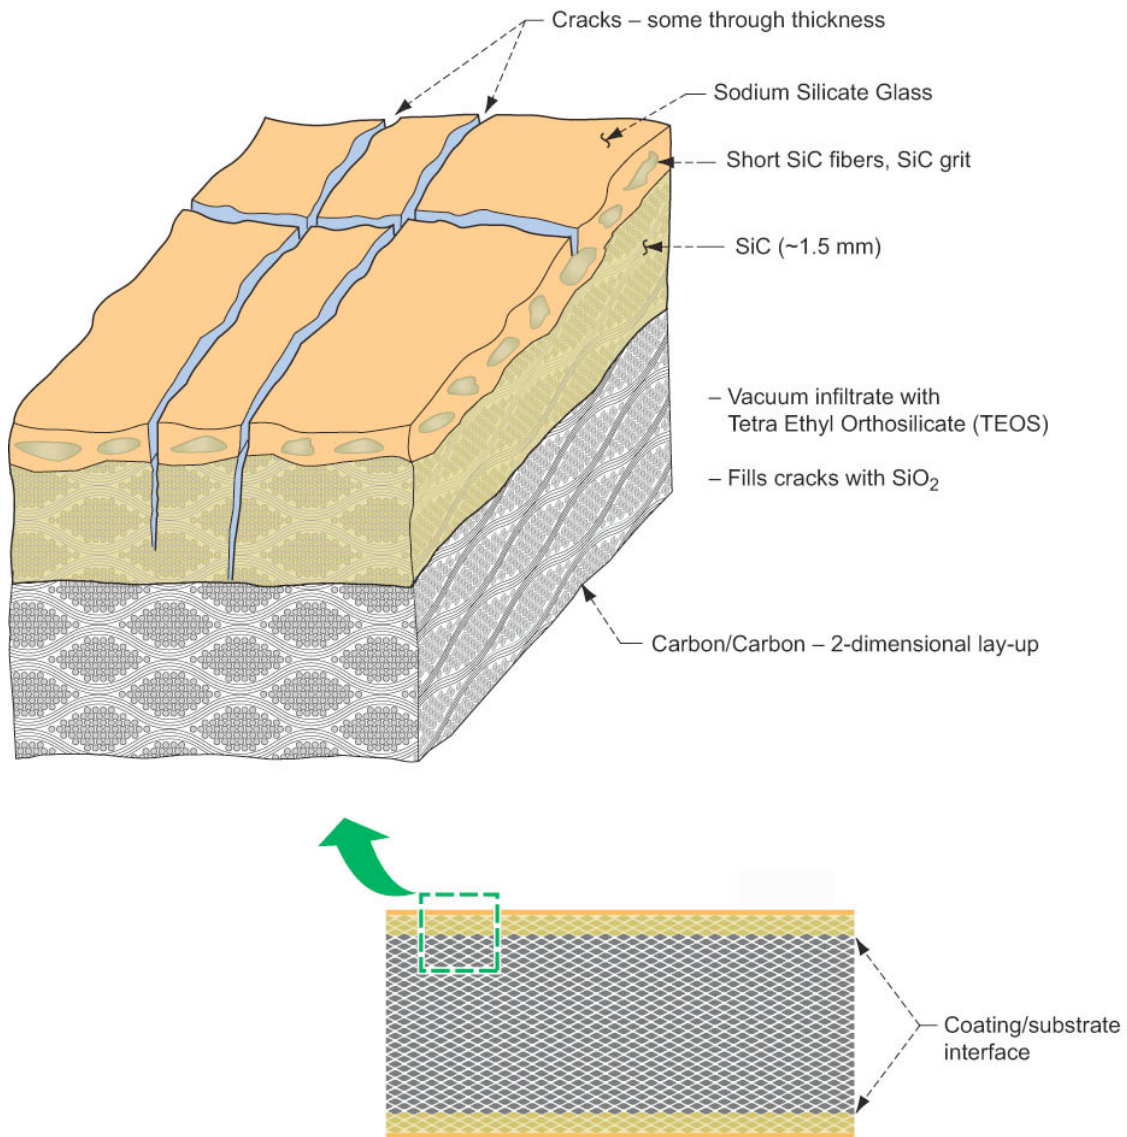
Figure 1. Schematic of RCC.

A schematic of RCC is shown in Fig. 1. The substrate consists of a two-dimensional lay-up of rayon-derived carbon fabric. Fibers perpendicular to the direction of the particular cut are referred to as ‘longitudinal’ and the fibers parallel to the direction of the cut are referred to as ‘transverse’. Porosity in the carbon/carbon substrate is filled with repeated application of a liquid carbon precursor [10, 11]. As noted, oxidation protection is afforded by the formation of a SiC conversion coating. The cracks in the SiC are sealed with a vacuum infiltration of tetra-ethyl silicate (TEOS), which decomposes to SiO<sub>2</sub> on heating. Two applications of an outer coating of a sodium silicate-based glass (Type A Sealant) are applied for additional protection.

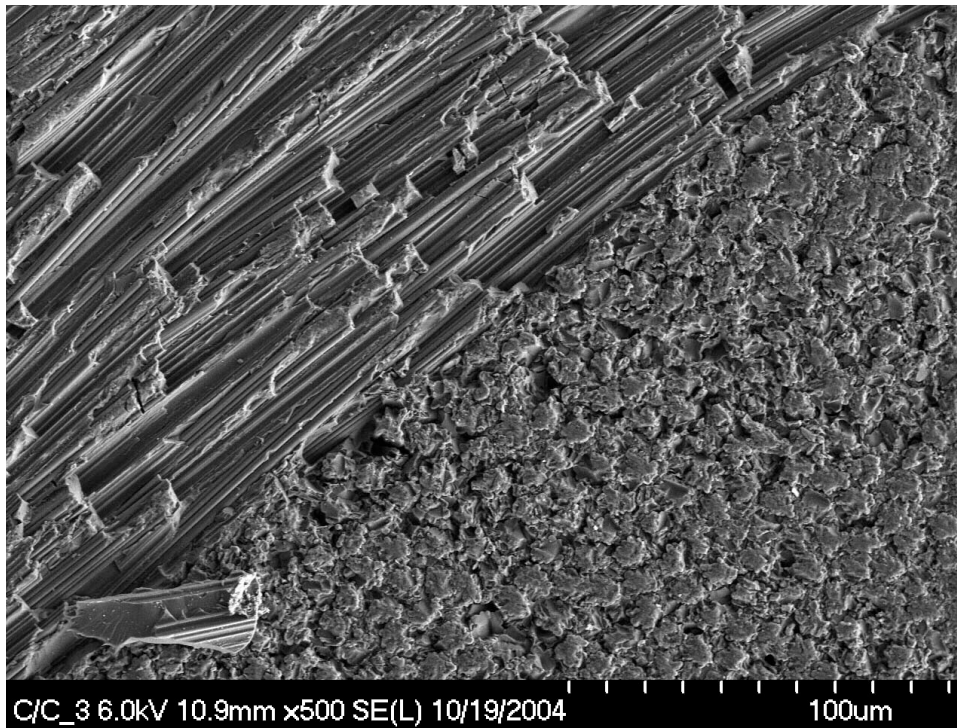
Figure 2(a). RCC-P3 before oxidation, showing both transverse and longitudinal fibers.

Figs. 2(a)-(c) illustrate the appearance of the as-fabricated material. Fig. 2(a) is an electron micrograph of the as-cut RCC P-3, showing both transverse and longitudinal fiber bundles. Fig. 2(b) is an optical micrograph of the RCC P-3/SiC material, illustrating typical voids and cracks through the fiber bundles produced in processing. Fig. 2(c) is a higher magnification photo illustrating a void from processing. Voids form from incomplete compaction and shrinkage of the matrix material.

Figs. 4-6 show views of the carbon/carbon after each treatment. After the 500°C treatment, the sample showed limited oxidation, as indicated by the small weight change. The surface after oxidation (Fig. 4) is similar to the surface before treatment (Fig. 2(a)).

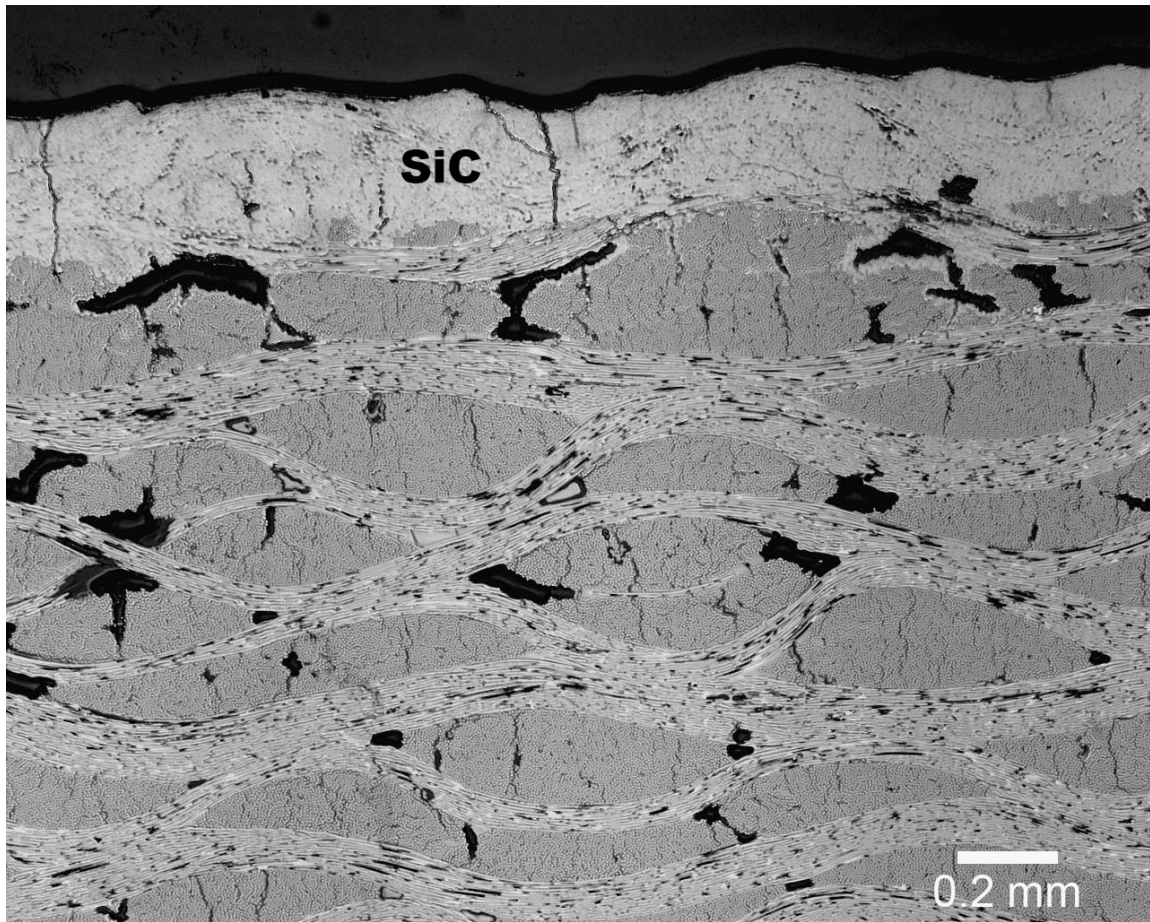
Figure 2(b) Cross-sectional view of as fabricated RCC P-3/SiC.

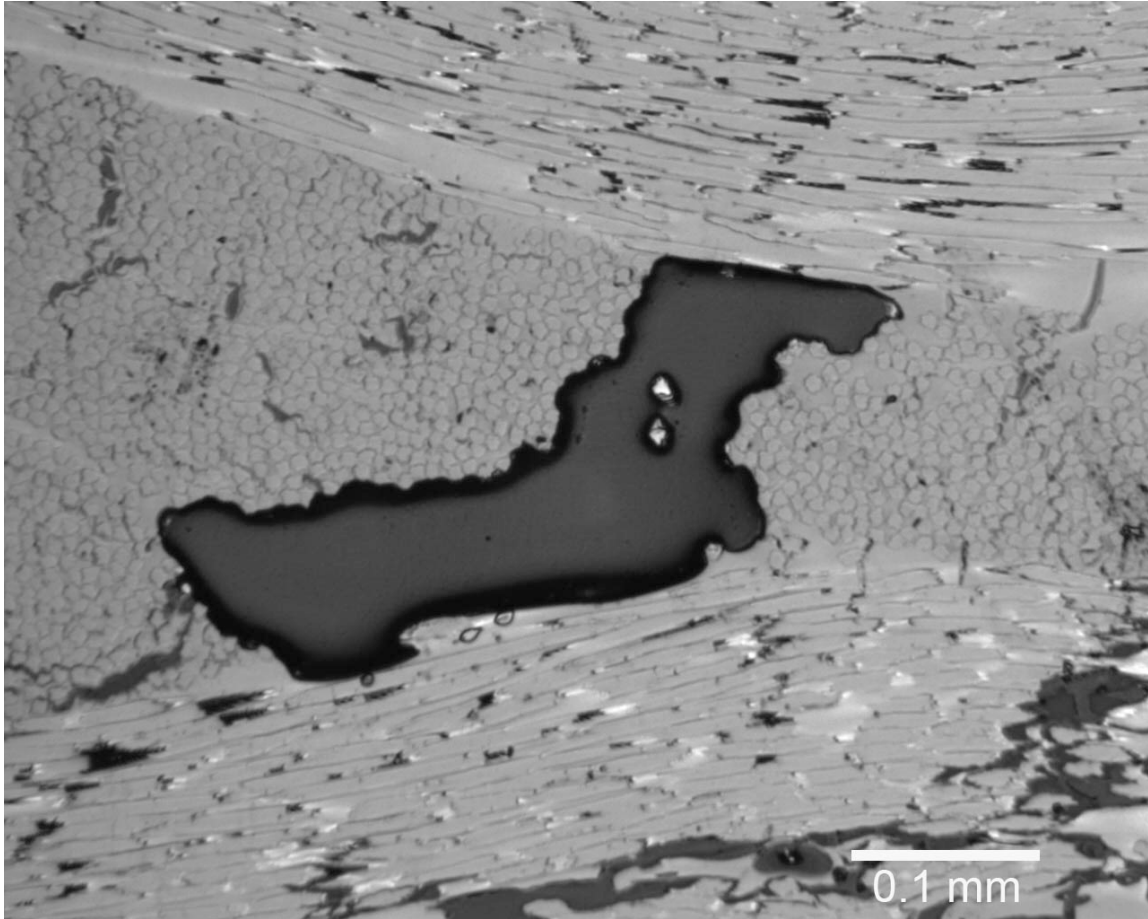
Figure 2(c). Cross-sectional view of a pore from fabrication in RCC P-3/SiC + TEOS.

The specimen oxidized at 900°C showed only one clear cavity, as shown in Fig. 11. The oxidation voids observed in Figs. 9-11 differ significantly from the processing void in Fig. 2(c). First the oxidation voids are associated with a crack/path to the surface and located at the SiC/carbon-carbon interface. Second the oxidation voids have ‘rough’ edges due to selective attack of bordering fibers.

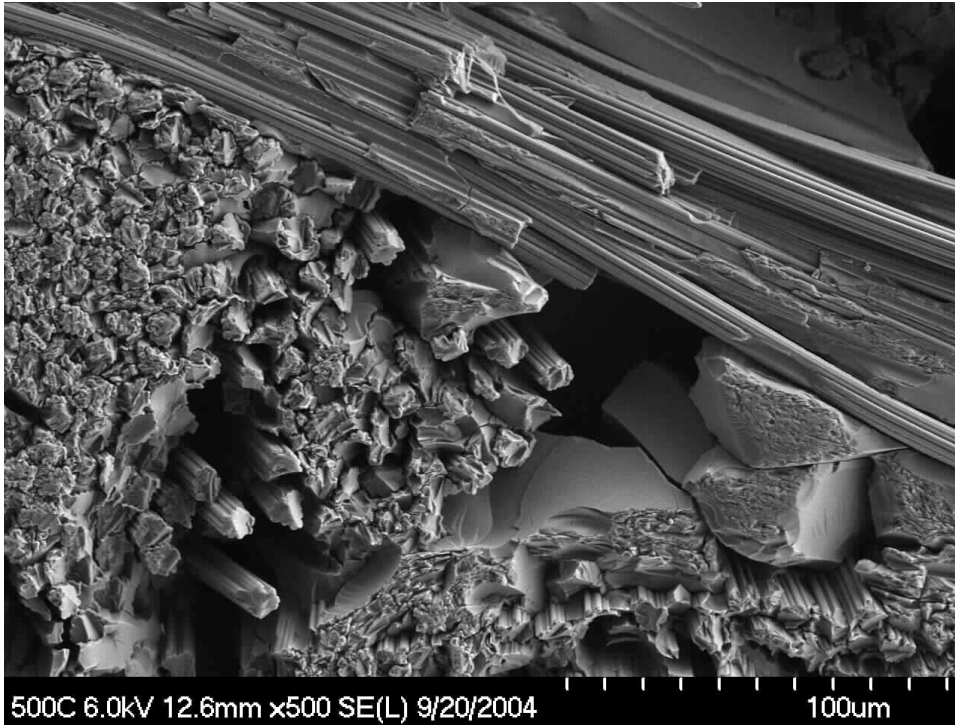
Figure 4. Exposed edge of RCC-P3 oxidized at 500°C for 0.5 hr

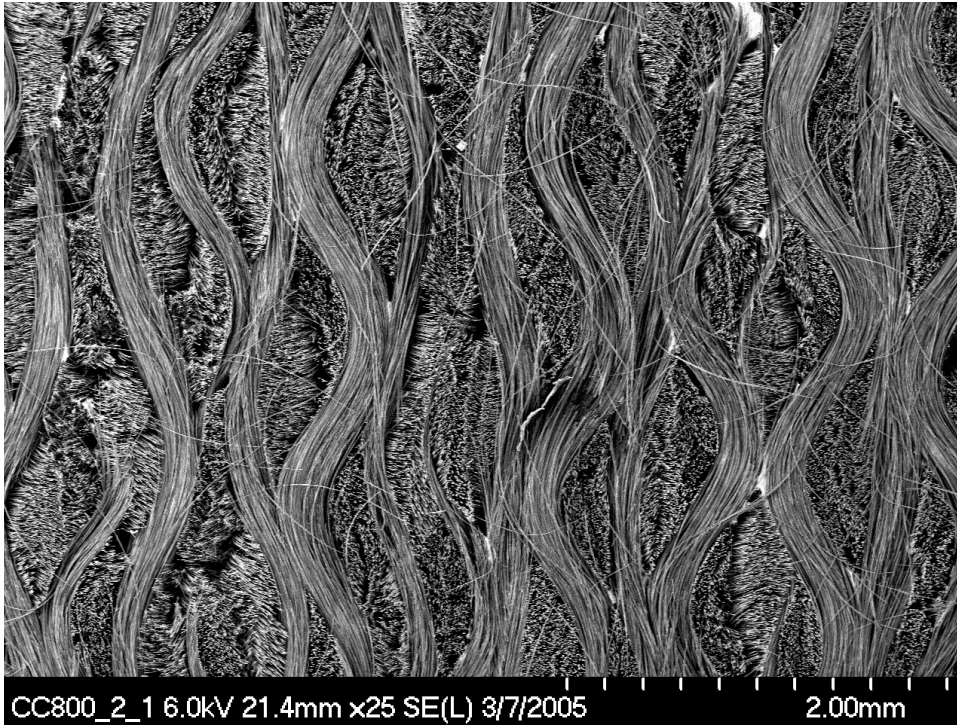
Figure 5(a). Overall view of RCC-P3 after oxidation for 0.5 hr at 800°C. This view includes roughly the entire width of the specimen. Note the uniform attack throughout the specimen.

At 800°C and 1100°C, substantial oxidation occurs as indicated by the weight loss (Table 2) and microstructure. These samples exhibited considerable macroscopic shrinkage. An overall view of the specimen oxidized at 800°C is shown in Fig. 5(a). Note that attack, as evidenced by thinning of the fiber bundles, is uniform throughout the entire width of the specimen, suggesting reaction control of the oxidation process [9]. Fig. 5(b) is a higher magnification view of the fibers. Both longitudinal and transverse fibers exhibit a reduced diameter (denuded) as compared to the fibers before oxidation (Fig. 2(a)). Cut fibers in the longitudinal direction show the ‘pointed morphology’ due to preferential oxidation at the fiber/matrix interface as opposed to the center or bulk of the fiber [5, 6]. Note also the matrix carbon is absent, suggesting preferential oxidation of the matrix over the fibers.

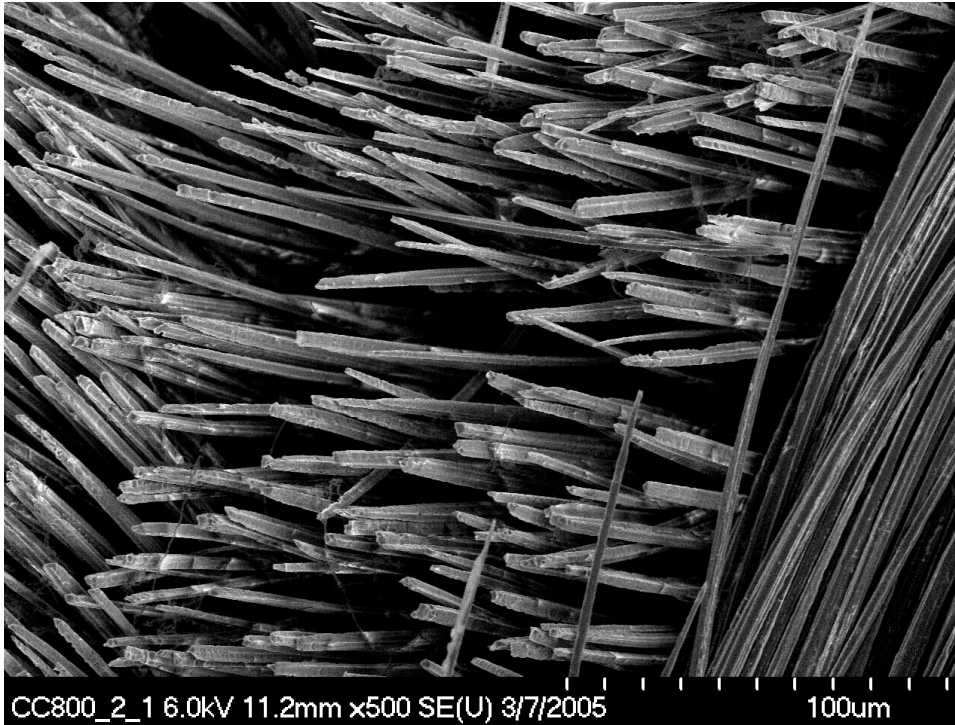
Figure 5(b). RCC-P3 after oxidation at 800°C for 0.5 hr. Note the denuded fibers and pointed ends.

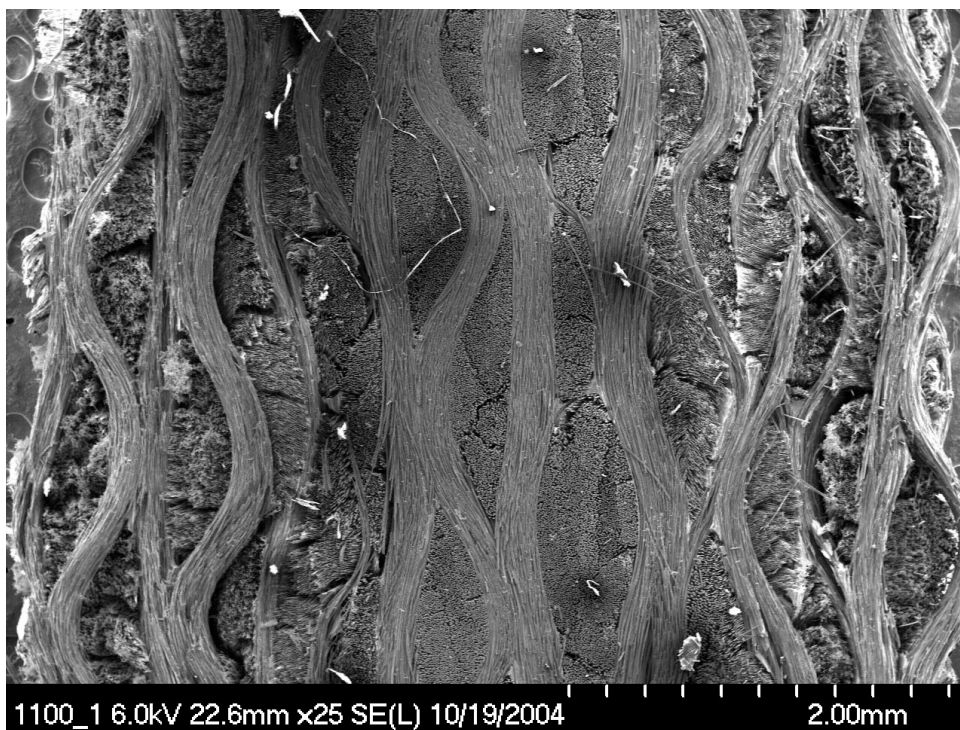
Figure 6(a). Overall view of RCC-P3 after oxidation for 0.5 hr at 1100°C. This view includes roughly the entire width of the specimen. Note the more localized attack on the two sides of the specimen.

Fig. 6(a) is an overall view of the specimen oxidized at 1100°C. Note the sample appears denser in the center and oxidative damage appears concentrated at the edges, which suggests diffusion control of the oxidation process [9]. Fig. 6(b) shows the denuded and pointed fibers. It may be that that the more pronounced points on the 1100°C sample (Fig. 6(b)) as compared to the 800°C sample (Fig. 5(b)) are due to the higher temperatures. Fig. 6(c) shows a high magnification photo of the transverse fibers near an edge. Note that fibers are denuded, pointed at the ends, and also exhibit some degree of pitting. Again it appears the matrix carbon is removed via oxidation.

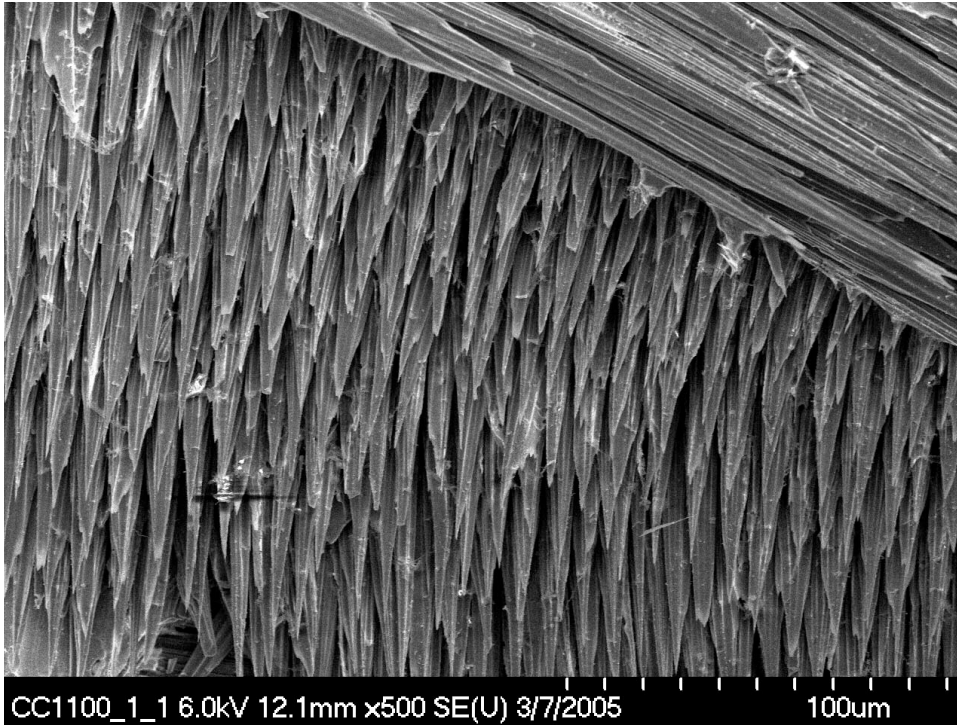
Figure 6(b). RCC-P3 after oxidation at 1100°C for 0.5 hr. Note clear points on the ends of the longitudinal fibers.

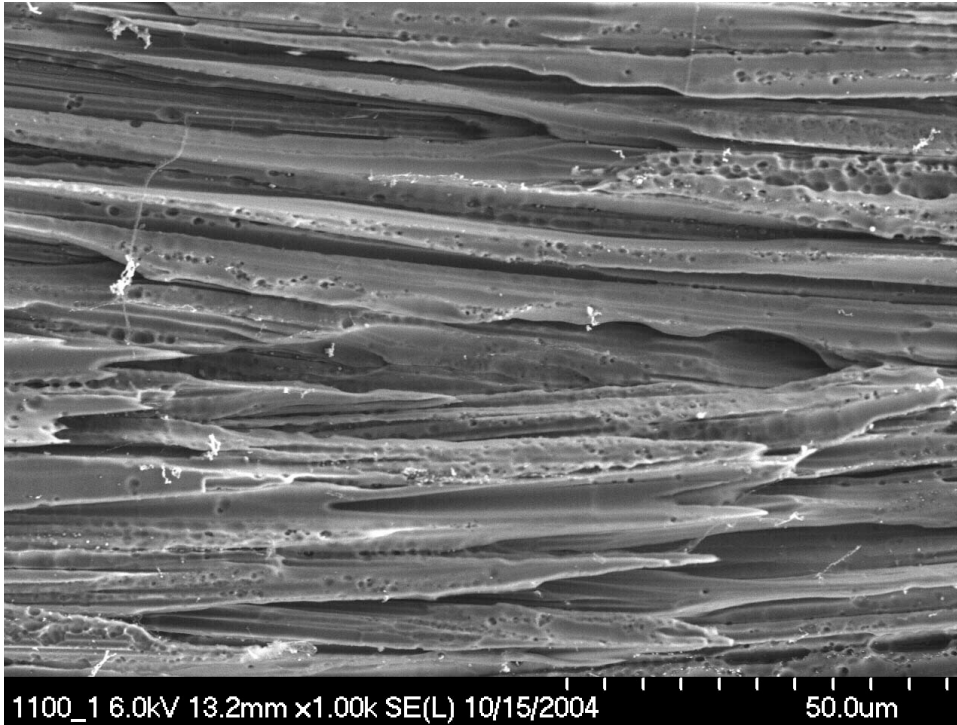
Figure 6(c). RCC-P3 after oxidation at 1100°C for 0.5 hr. Note the points at the fiber ends and pitting of the fibers.

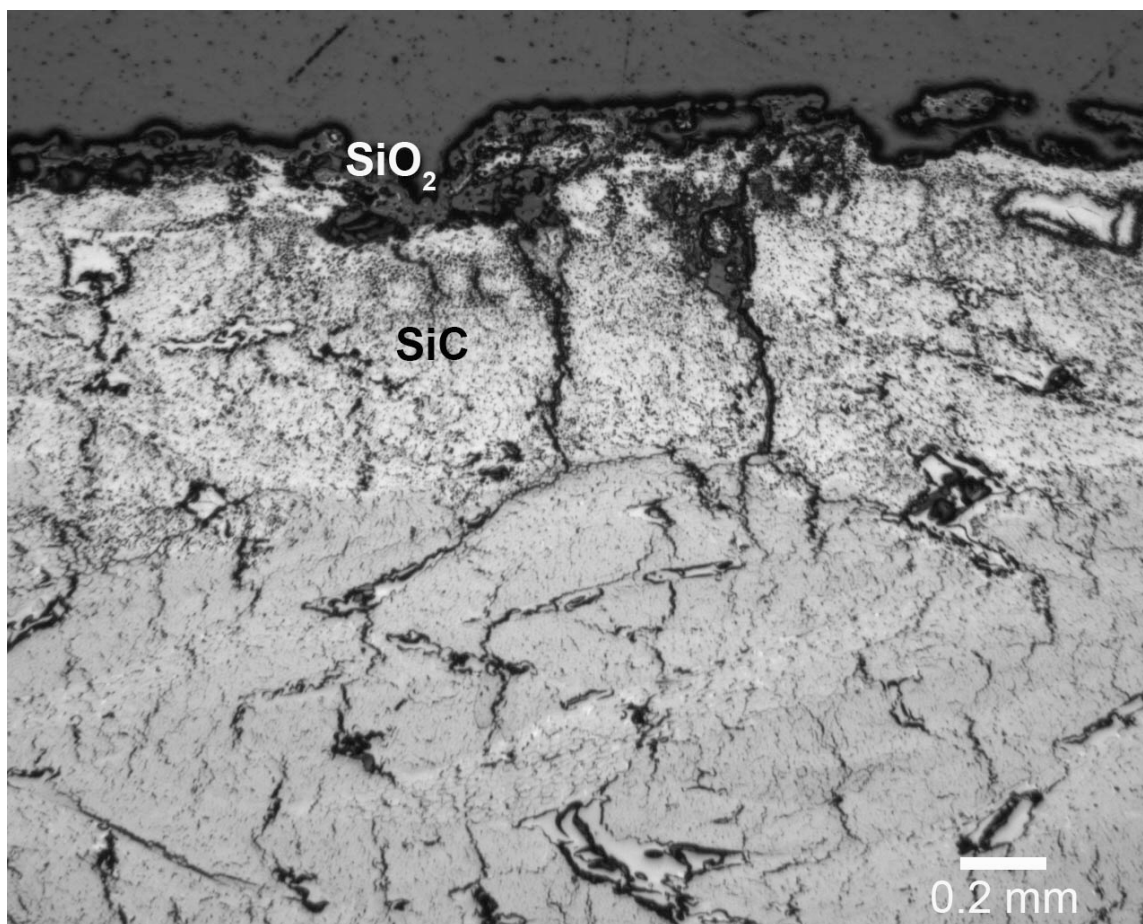
Figure 7. Through-thickness cracks in the RCC-P3/SiC sample oxidized at 1500°C for 1 hr. Note the thick silica layer on the surface.

First consider the 1500°C samples. The large weight loss shown in Table 3 suggests oxidation of the carbon substrate. Yet microstructural examination of cross sections of two specimens oxidized under these conditions indicated limited oxidation. Most of the through-thickness cracks did not lead to any clear oxidation damage, as shown in Fig. 7. On each cross section there were only one or two through-thickness cracks which led to limited evidence of oxidation. This is illustrated in Fig. 8, where a few denuded carbon fibers were found near the base of crack. No large oxidation cavities were observed. It is likely that the 1500°C sample shows very limited oxidation due to (1) Growth of a protective silica layer (2) Closure of SiC cracks due to the CTE differences.

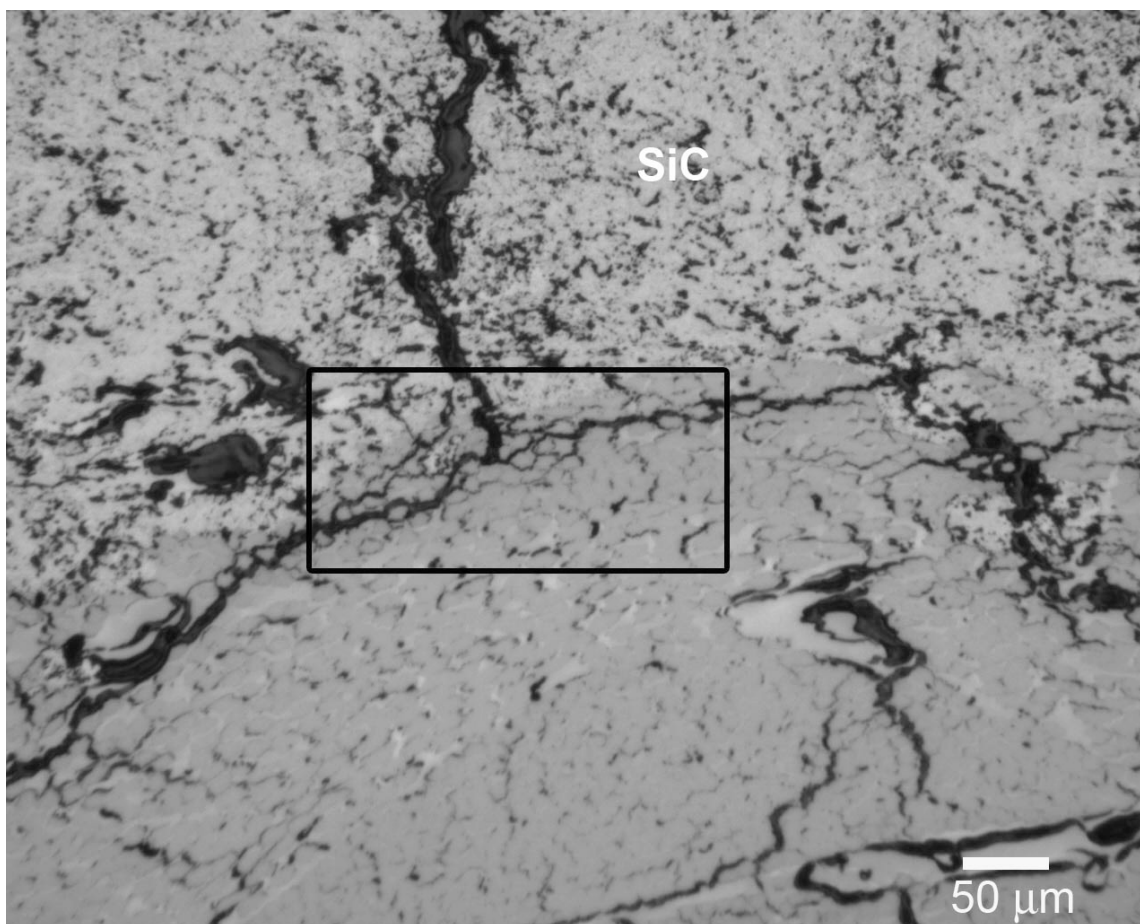
Figure 8. Possible oxidation attack from through-thickness crack in the RCC-P3/SiC sample oxidized at 1500°C for 1 hr.

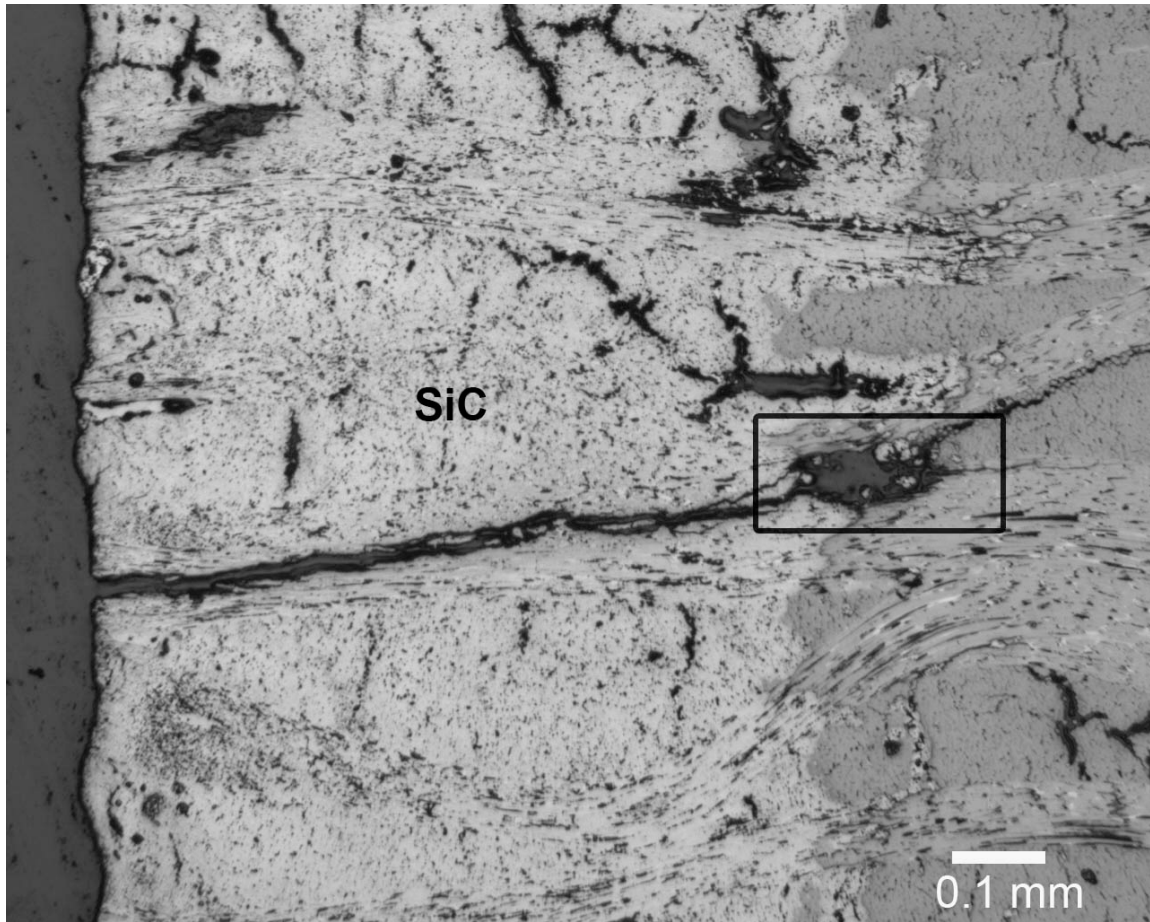
Figure 9(a). Oxidation cavity formed below through-thickness crack in SiC coating in RCC-P3/SiC oxidized for 1 h at 1300°C.

The 1300°C sample showed more oxidation effects. Here there were three through-thickness cracks which led to oxidation cavities. These are shown in Figs 9(a)-(d). Fig. 9(a) shows an oxidation cavity in both the transverse and longitudinal fiber bundles. In Figs. 9(b) and 9(c) the oxidation cavity is in the transverse fibers and a small cavity is formed with attack along the walls of the fibers. Finally Fig. 9(d) shows a cavity formed in a transverse fiber bundle in line with the crack. Note the wedge-shaped appearance of the cavity, which may be due to the SiC through-thickness crack (oxidation path) corresponding to the portion of the weave where the transverse fiber bundle splits.

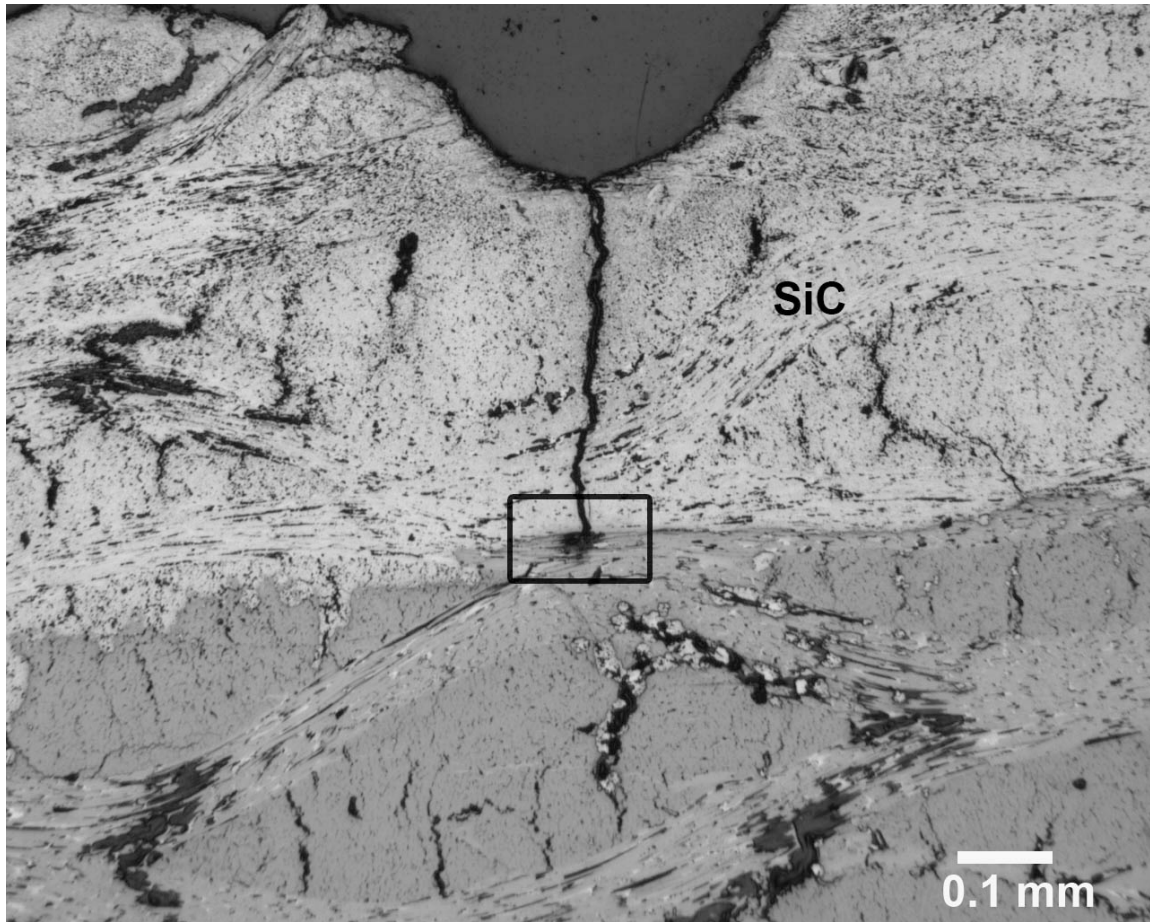
Figure 9(b). Oxidation cavity formed below through-thickness crack in SiC coating in RCC-P3/SiC oxidized for 1 h at 1300°C.at 1300°C.

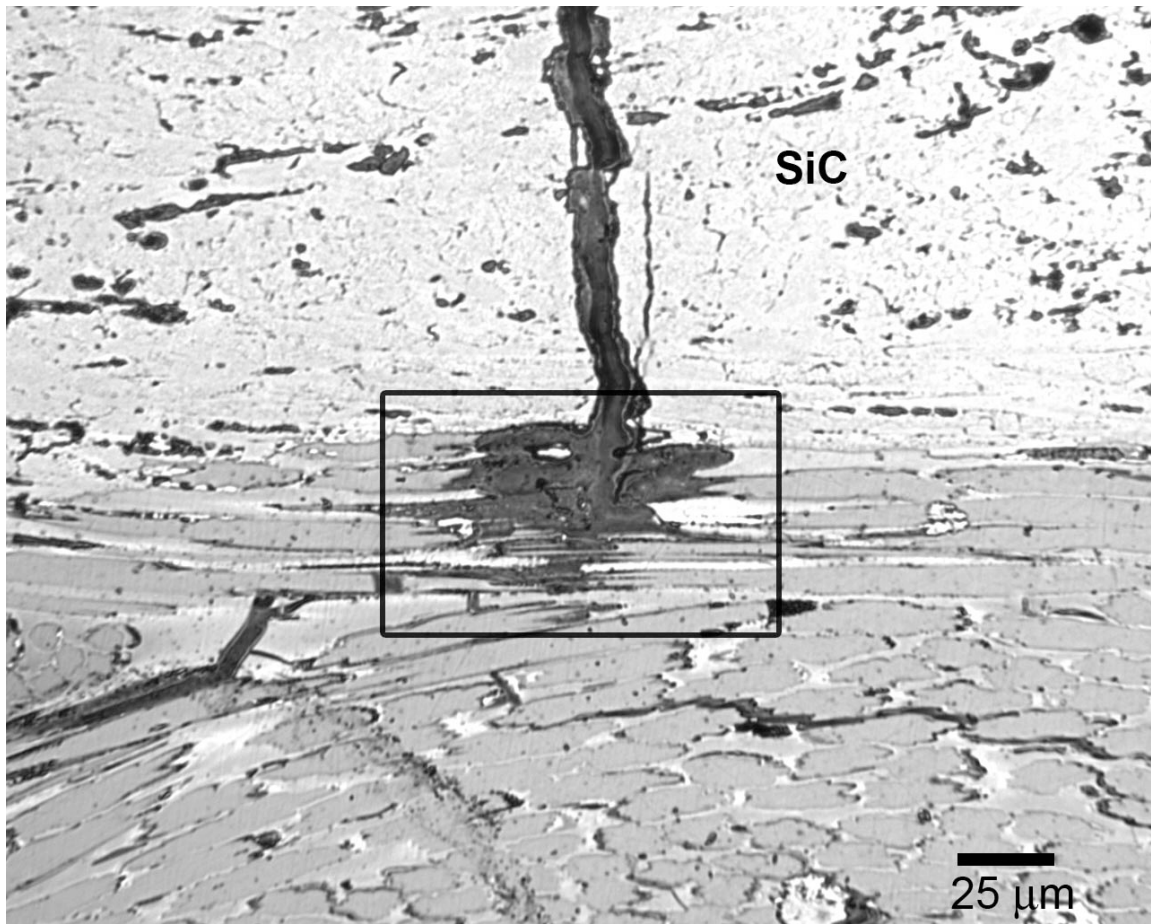
Figure 9(c). Enlargement of oxidation cavity in Fig. 9(b) formed below through-thickness crack in SiC coating in RCC-P3/SiC oxidized for 1 h at 1300°C..

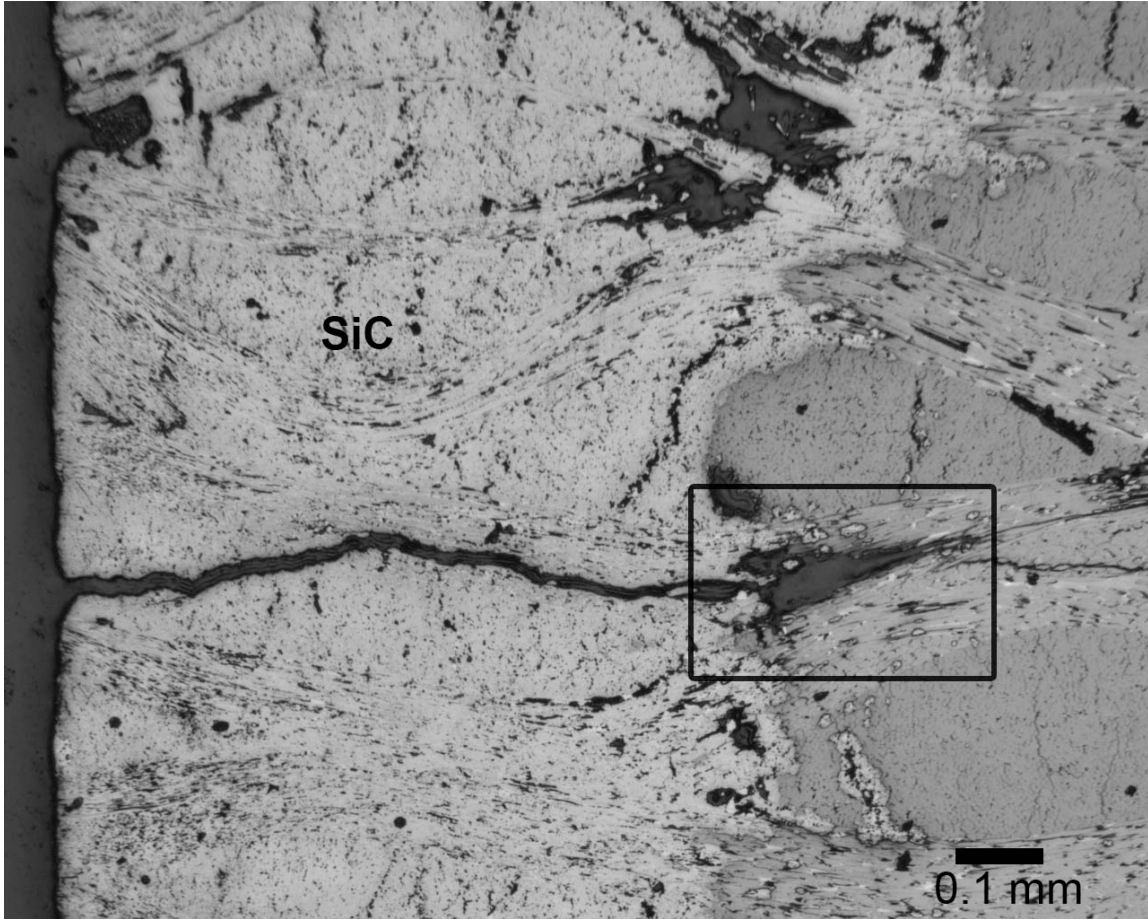
Figure 9(d). Oxidation cavity formed below through-thickness crack in SiC coating in RCC-P3/SiC oxidized for 1 h at 1300°C.

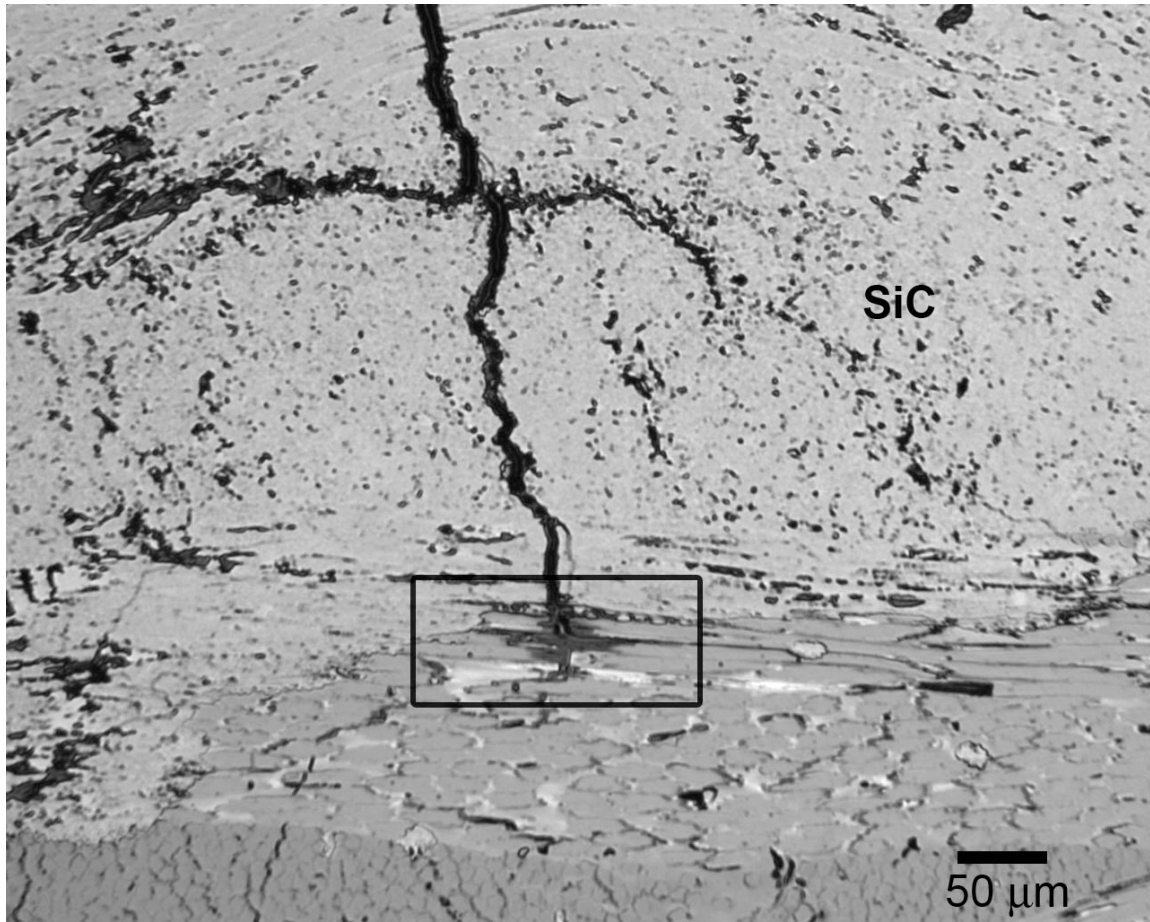
Figure 10(a). Oxidation cavity in a transverse fiber bundle for RCC-P3/SiC oxidized at 1100°C for 1 h.

The sample oxidized at 1100°C also showed oxidation cavities below through-thickness cracks. These are shown in Figs. 10(a)-(c). Note in Fig. 10(a) there is some oxidation along the edges of the fiber. Fig. 10(b) shows the outlines and reduction in diameter of individual fibers, as discussed previously.

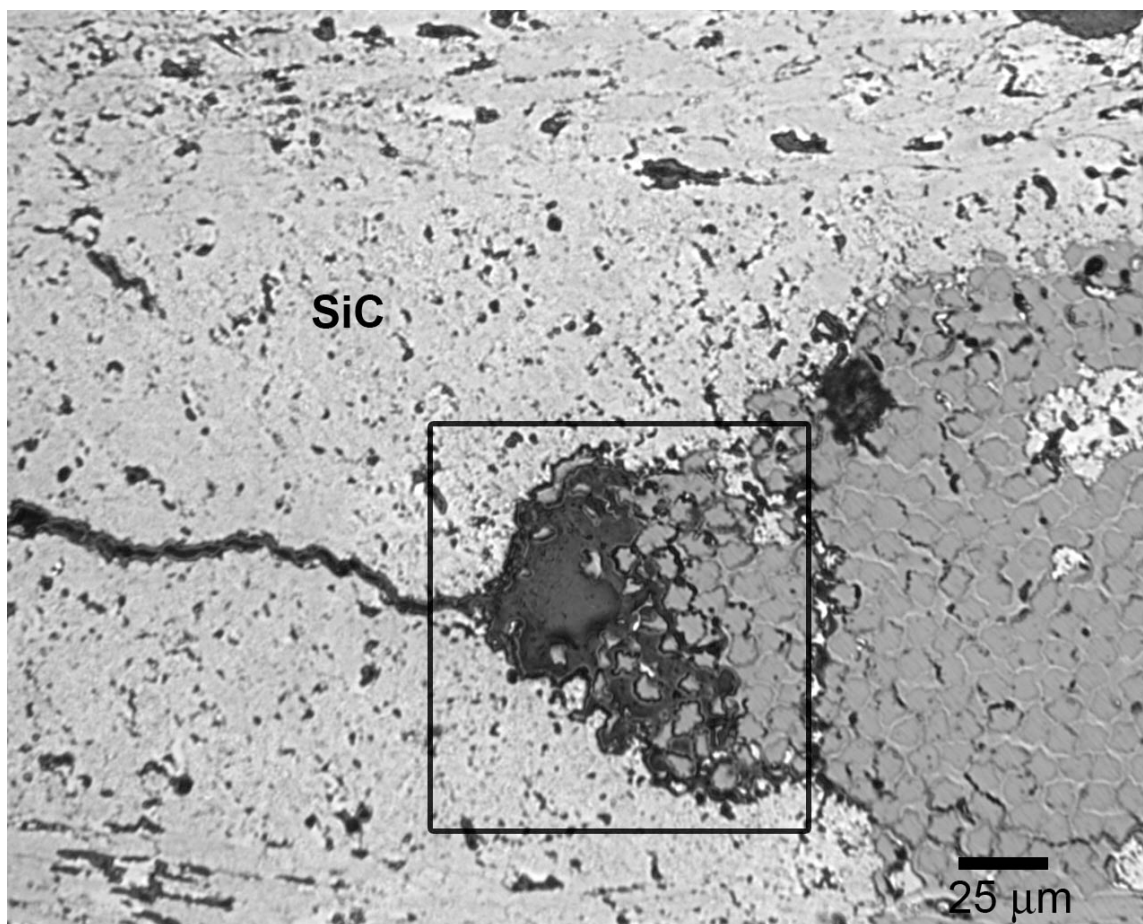
Figure 10(b). Oxidation cavity in a longitudinal fiber bundle for RCC-P3/SiC oxidized at 1100°C for 1 h.

Figs. 10(b) and 11 show regions of unoxidized matrix. It appears that in the RCC P-3/SiC samples, the matrix is not attacked preferentially to the fibers, as opposed to the RCC P-3 samples. A possible explanation for this is that the high temperature necessary for forming the SiC conversion coating further graphitizes the matrix material, giving it a similar oxidation resistance to the fibers.

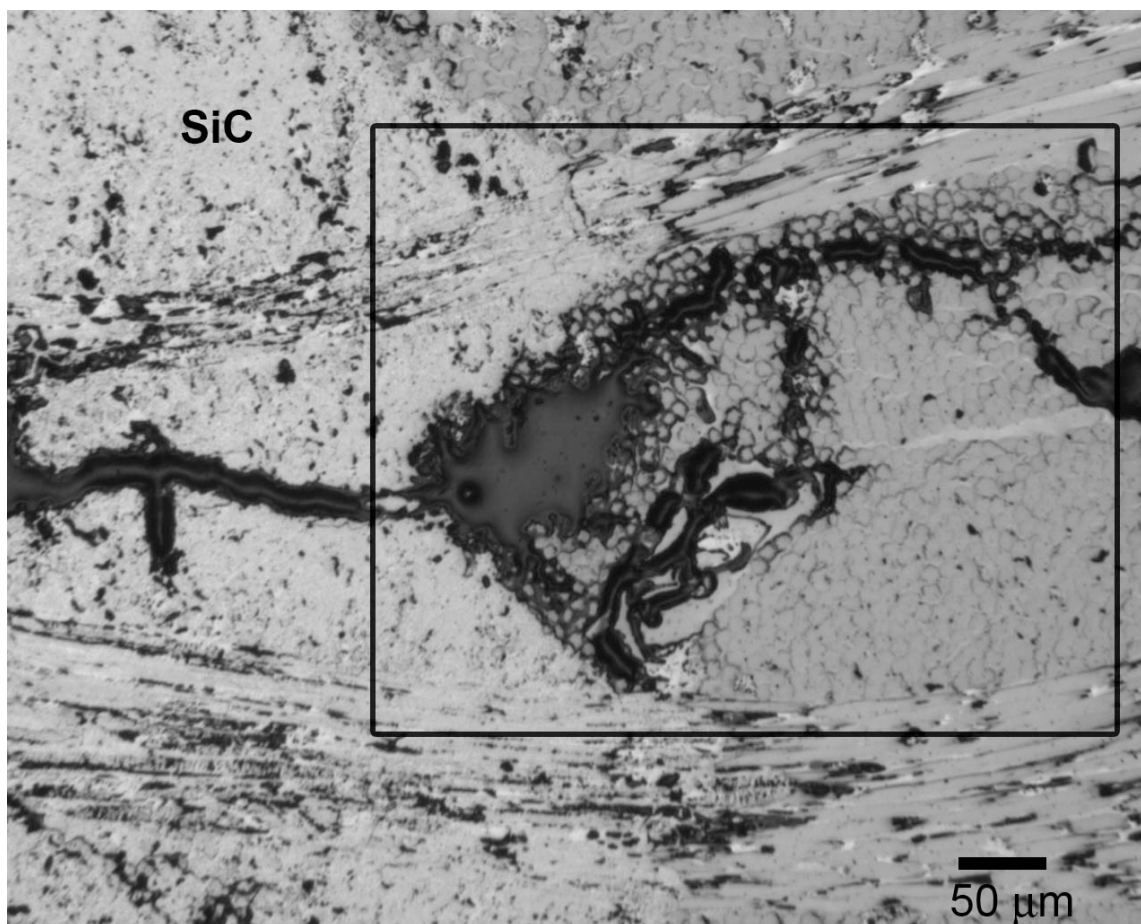
Figure 11. Cavity formed in RCC P-3/SiC after oxidation at 900°C for 1 h.

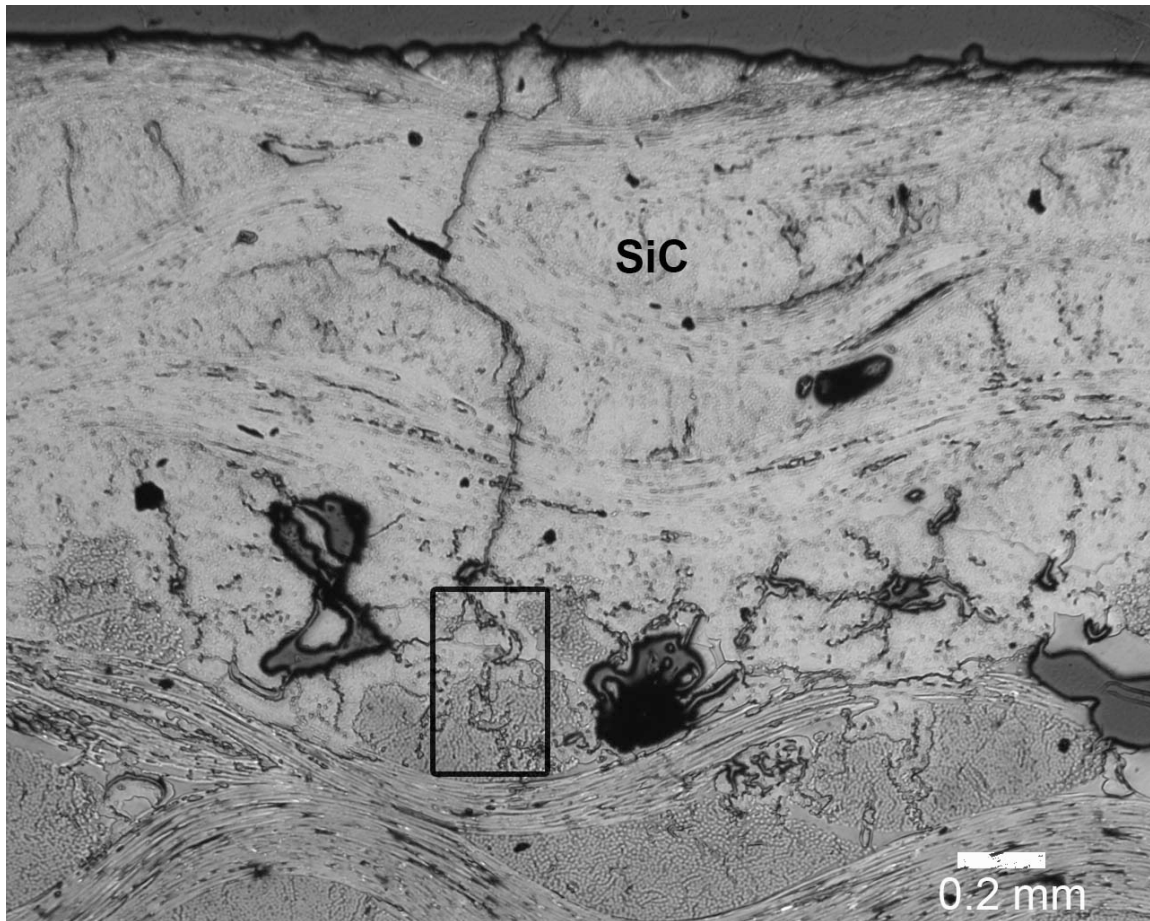
Figure 12. Through thickness crack on RCC-P3/SiC/TEOS/Sealant specimen after a total of 3.5 h in the arc-jet at  $1538^\circ\text{C}$ . Note there is no clear oxidation damage below the crack.

path to oxidation cavities, as shown in Fig. 12. It is important to note that this specimen had the full oxidation protection—a SiC conversion coating, TEOS-derived  $\text{SiO}_2$ , and two applications of the sodium silicate based glass. Nonetheless, the lack of oxidation damage at  $1538^\circ\text{C}$  is significant and consistent with the limited oxidation seen in furnace-treated specimens at  $1500^\circ\text{C}$ .

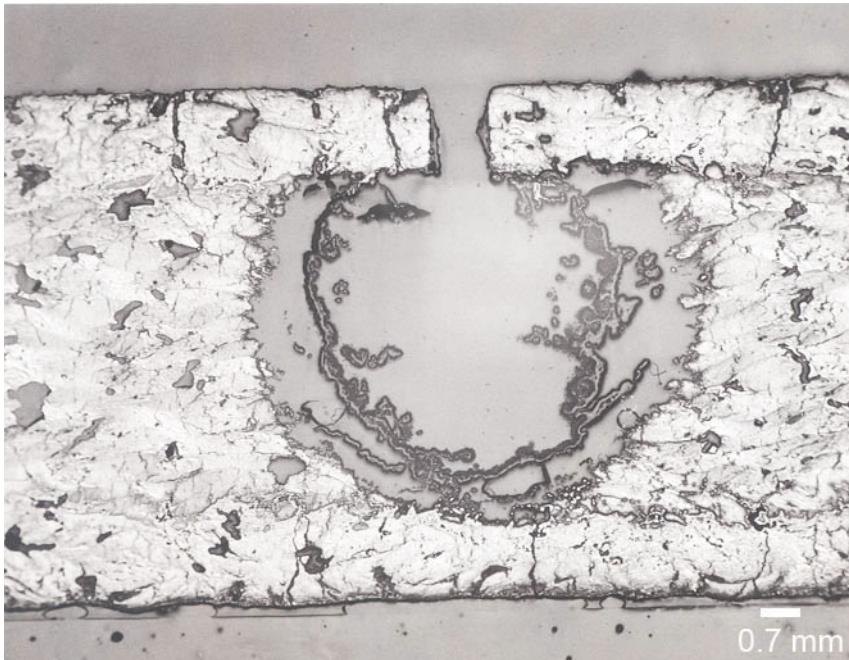
Figure 13(a). Oxidation through a pinhole intentionally drilled in RCC. This RCC-P3/SiC/TEOS/Sealant specimen was oxidized for a total of 3.5 h in the arc-jet at 1538°C.

The regions below a large drilled hole showed substantial oxidation, as would be expected (Fig. 13(a)). The cavity is roughly spherical on this macroscopic scale, which suggests uniform attack in all directions, as expected for a situation where diffusion

control dominates. However a closer examination of the cavity walls indicates consumption is not truly uniform and there is clear evidence of preferential attack (Figs. 13(a) and (b)). Thus even at high temperatures where gas phase diffusion control dominates, there is selective attack within the carbon/carbon, indicating that rates of chemical reaction must still be important in the overall mechanism. Fig. 13(b) shows a close-up of the edge of one of the oxidation cavities. Note first the presence of denuded fibers in both the longitudinal and transverse directions. This is due to preferential attack at the fiber/matrix interface. The arrow points to a bundle of transverse fibers with denuded fibers along the edges and also along cracks into the bundle. Oxidation occurs preferentially down cracks and at the fiber edges.
