# **Oxidation Microstructure Studies of Reinforced Carbon/Carbon**

*Keywords:* Carbon/carbon composites, Oxidation, Coating, Reactivity, Graphitic carbon

Laboratory oxidation studies of reinforced carbon/carbon (RCC) are discussed with particular emphasis on the resulting microstructures. This study involves laboratory furnace (500-1500°C) and arc-jet exposures (1538°C) on various forms of RCC. RCC without oxidation protection oxidized at 800 and 1100°C exhibits pointed and reduced diameter fibers, due to preferential attack along the fiber edges. RCC with a SiC conversion coating exhibits limited attack of the carbon substrate at 500, 700 and 1500°C. However samples oxidized at 900, 1100, and 1300°C show small oxidation cavities at the SiC/carbon interface below through-thickness cracks in the SiC coating. These cavities have rough edges with denuded fibers and can be easily distinguished from cavities created in processing. Arc-jet tests at 1538°C show limited oxidation attack when the SiC coating and glass sealants are intact. When the SiC/sealant protection system is damaged, attack is extensive and proceeds through matrix cracks, creating denuded fibers on the edges of the c

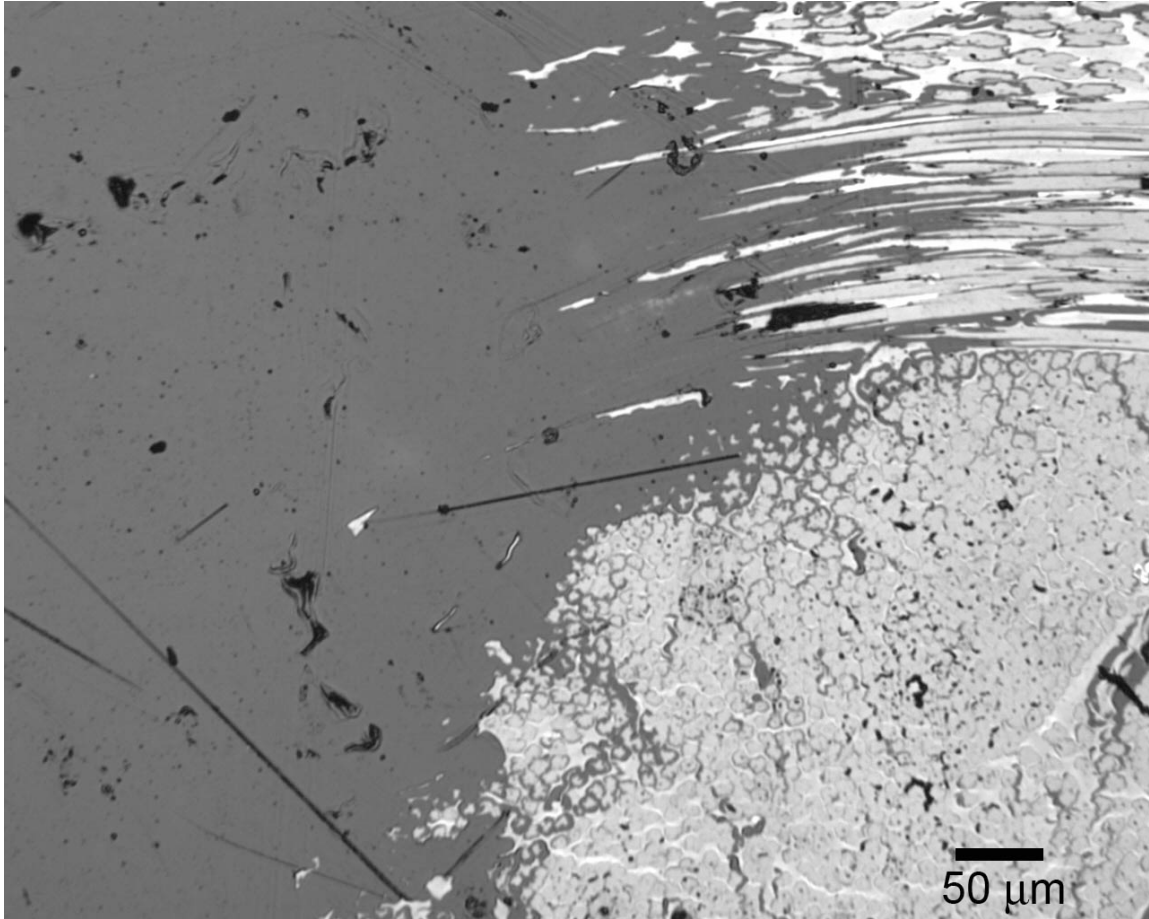
Figure 13(b) High-magnification photo of the edge of cavity in Fig. 13(b). The arrow points to a transverse fiber bundle with internal cracks, which are likely oxygen paths. This RCC-P3/SiC/TEOS/Sealant specimen was oxidized for a total of 3.5 h in the arc-jet at 1538°C

control dominates. However a closer examination of the cavity walls indicates consumption is not truly uniform and there is clear evidence of preferential attack (Figs. 13(a) and (b)). Thus even at high temperatures where gas phase diffusion control dominates, there is selective attack within the carbon/carbon, indicating that rates of chemical reaction must still be important in the overall mechanism. Fig. 13(b) shows a close-up of the edge of one of the oxidation cavities. Note first the presence of denuded fibers in both the longitudinal and transverse directions. This is due to preferential attack at the fiber/matrix interface. The arrow points to a bundle of transverse fibers with denuded fibers along the edges and also along cracks into the bundle. Oxidation occurs preferentially down cracks and at the fiber edges.

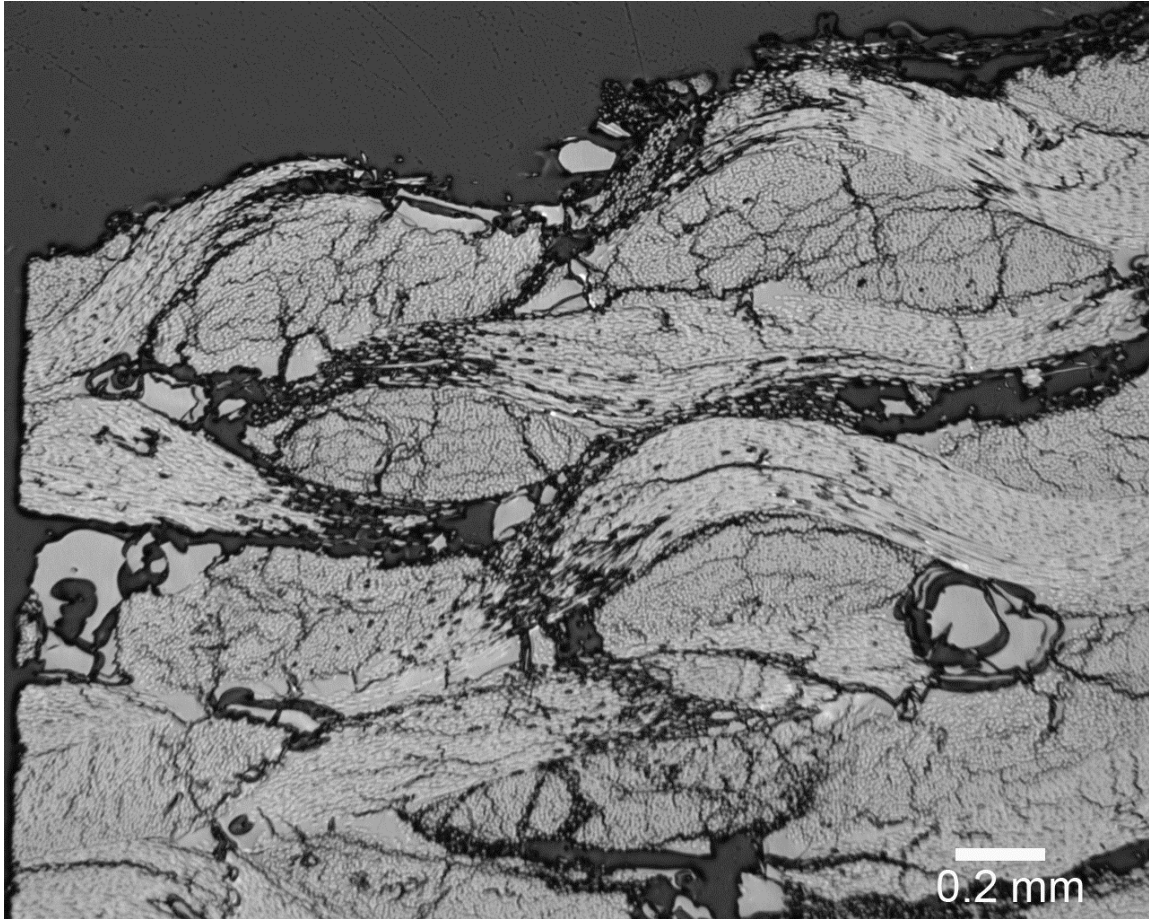
Figure 14(a). Cross-sectional view showing impact damaged RCC. This RCC-P3/SiC/TEOS/Sealant specimen was oxidized for three 900 s cycles in the arc-jet at 1538°C. Arc impinged on the top.

Figs. 14(a)-(c) shows an exposed region of carbon/carbon. Note the channels between fiber bundles with denuded fibers. Figure 14(b) shows a higher magnification view.. In Fig. 14(c) a large section of matrix which is intact after the oxidation treatment is noted. The matrix is graphitized during processing at a high temperature, so it should exhibit similar oxygen reactivity to the fibers. These micrographs suggest that oxidation occurs along oxygen paths created by cracks. Fibers are attacked at the fiber/matrix interface, denuded and are eventually consumed, enlarging the cracks further.

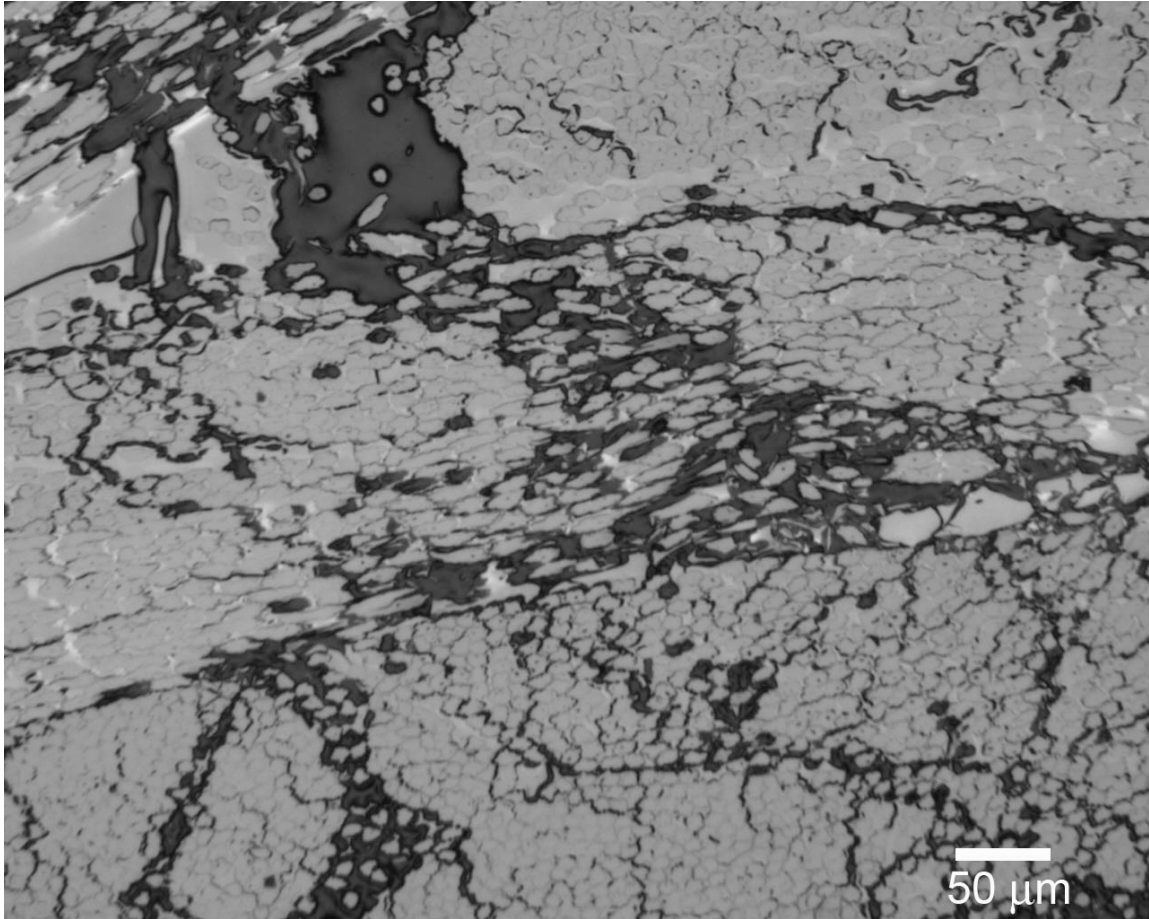
Figure 14(b). Cross-sectional view showing channels of oxidation and denuded fibers. This RCC-P3/SiC/TEOS/Sealant specimen was oxidized for three 900 s cycles in the arc-jet at 1538°C. Arc impinged on the top.

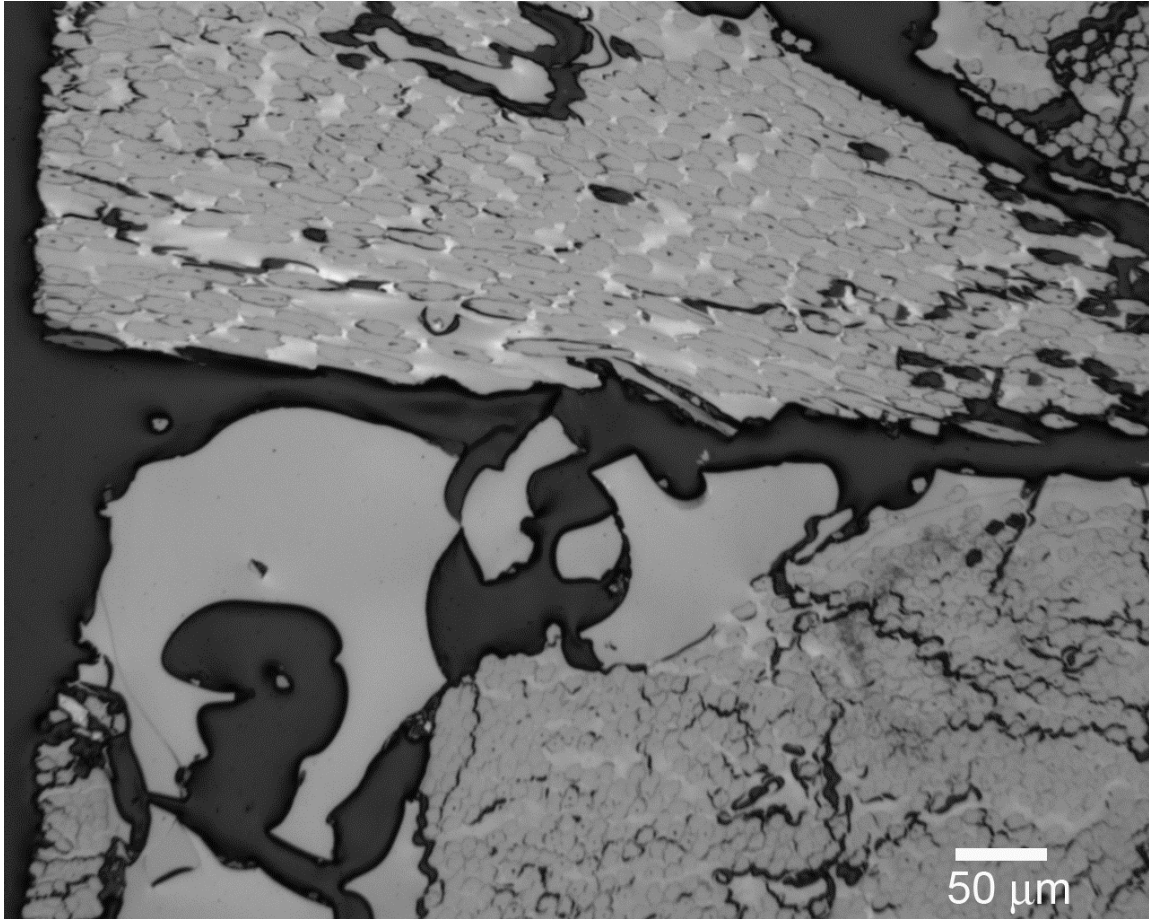
Figure 14(c). Cross-section view showing large regions of intact matrix. This RCC-P3/SiC/TEOS/Sealant specimen was oxidized for three 900 s cycles in the arc-jet at 1538°C. Arc impinged on the top.
