Development of an Extra-vehicular (EVA) Infrared (IR) Camera Inspection System

Michael Gazarik, Dave Johnson, Ed Kist, Frank Novak, Charles Antill, David Haakenson, Patricia Howell, John Pandolf, Rusty Jenkins, NASA Langley Research Center.
Rusty Yates, Ryan Stephan, NASA Johnson Space Center
Doug Hawk, Swales Aerospace Corporation, NASA Goddard Space Flight Center
Michael Amoroso, Jacobs-Sverdrup, NASA Johnson Space Center

This paper discusses the on-orbit RCC inspection measurement concept and requirements, and then presents a detailed description of the EVA IR Camera System design.

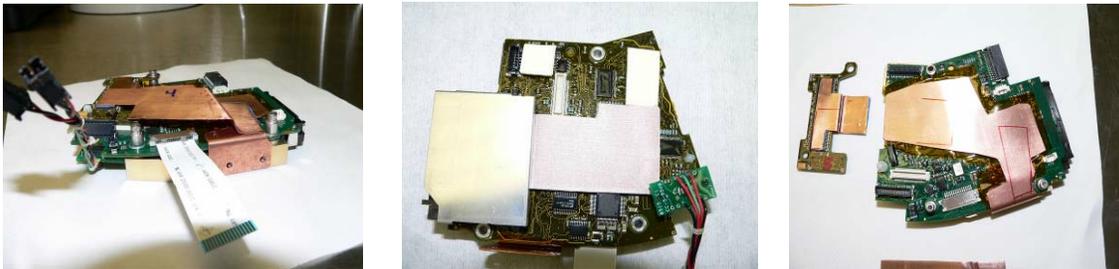
Figure 1 Copper thermal straps from Integrated Circuits to metal camera structure.

The first and second concerns, operating at on-orbit thermal conditions and in a vacuum, were answered by testing the cameras in a thermal vacuum chamber. We found that the camera operated normally in a vacuum, but some of the integrated circuits ran too hot. To fix this problem, we formed copper heat straps and thermally bonded them to the integrated circuits (figure 1). The other end was bolted to the metal frame of the camera. We used thermal pads (Sil Pads) to fill gaps and maintain thermal conductivity where necessary. Additionally, to guard against the possibility of the camera getting colder than storage limits, survival heaters and thermostats were installed.

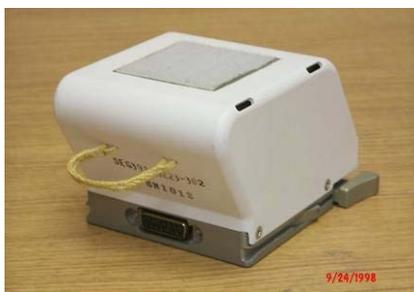
Figure 2. EHIP Battery

Space flight qualification for batteries is a complex and time consuming exercise. Therefore, we decided to look for a pre-qualified battery to use in the camera. We found that the EHIP battery (figure 2) was the right form factor and had the right amount of energy storage. This is the battery used to power the headlights on the space suit helmets. The camera housing was adapted to accept the EHIP battery. The DC-DC converters were designed to convert the batteries 6 volts to 12 volts for camera use. A battery voltage monitor was designed to alert the astronauts when approximately 75% of the battery charge is depleted.

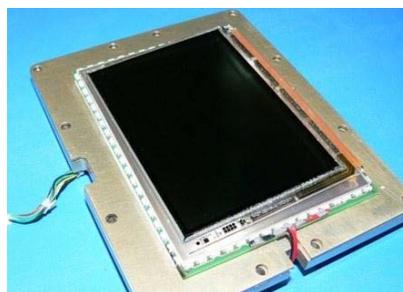
Figure 3. LED backlight replacing Fluorescent tube

During the vacuum testing it was discovered that the high voltage used for the cold cathode fluorescence (CCF) backlighting was generating a corona. It was decided that LCD displays CCF would be replaced with an array of white LEDs (figure 3). These LEDs were brighter than the CCF and would accommodate daylight viewing as well as eliminate the high voltage issue.
