NASA/CR-2007-214885/VOL2

Hypervelocity Impact (HVI)

*Volume 2: WLE Small-Scale Fiberglass Panel Flat
Multi-Layer Targets A-1, A-2, and B-1*

*Michael R. Gorman and Steven M. Ziola
Digital Wave Corporation, Englewood, Colorado*

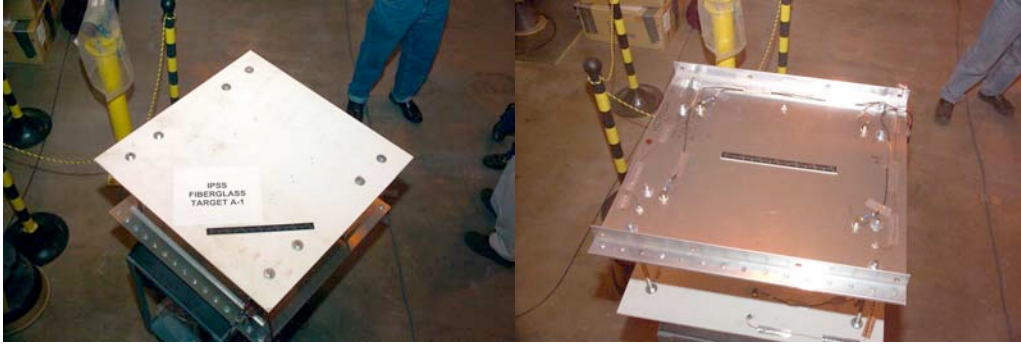
Figure 1: Target A-1. Left: Top View. Right: Bottom View.

Targets A-1 and A-2 consisted of a fiberglass front plate followed by an aluminum backplate. Target size was 30" x 30", with 0.25" thick fiberglass and 1/8" thick aluminum. Standoff between the fiberglass and aluminum was 12". The plates were connected using (8) 0.5" all-thread rods. L-shaped angles added to the back of the aluminum plate were used to attach the target to a target support stand, which was placed in the target chamber. The fiberglass panel was a 19 ply (0.90) woven material. Target A-1 contained grommets that isolated the fiberglass panel from the all-thread (see Figure 1 and Figure 2).

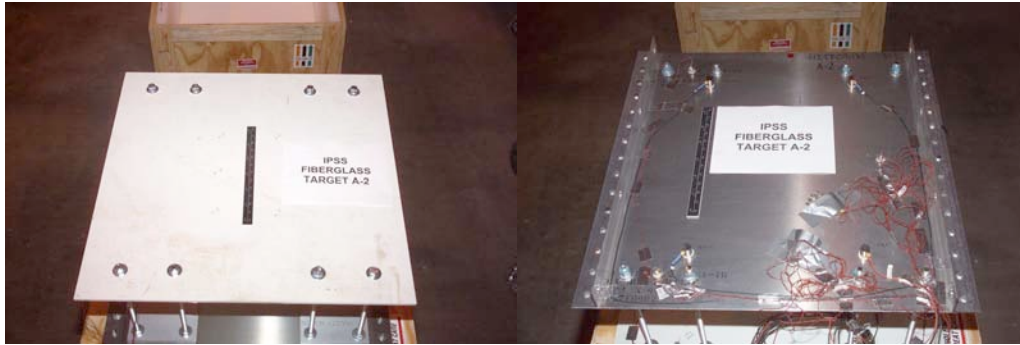
Figure 3: Target A-2 Left: Top View. Right: Bottom View.

Target A-2 (Figure 3 and Figure 4) was similar to Target A-1 but the fiberglass panel was not isolated from the all-thread (no grommets).

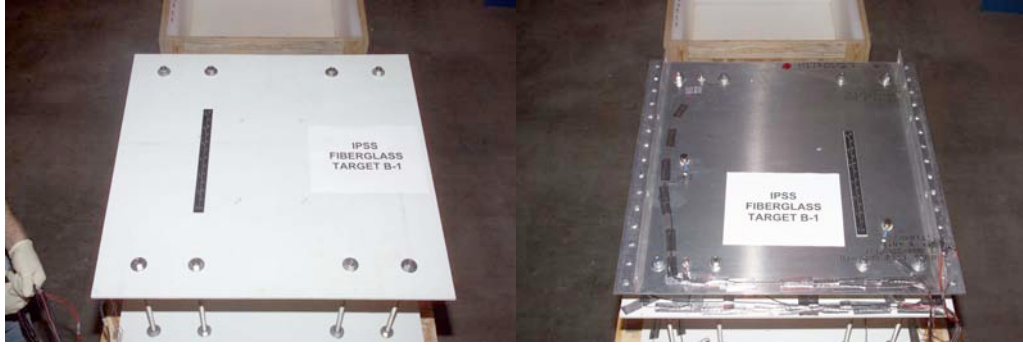
Figure 5: Target B-1. Left: Top View. Right: Bottom View.

Target B-1 (Figure 5 and Figure 6) used two fiberglass plates to model MMOD impacts with a trajectory that would go through the WLE panel and not intersect directly with the wing spar. Target B-1 consisted of a 30 x 30 19 ply fiberglass panel, a 12" gap, a second 19 ply fiberglass panel, a 3.8" gap, and a 0.125" thick aluminum plate. Target B-1 contained grommets that isolated the fiberglass panel from the 0.5" all-thread.

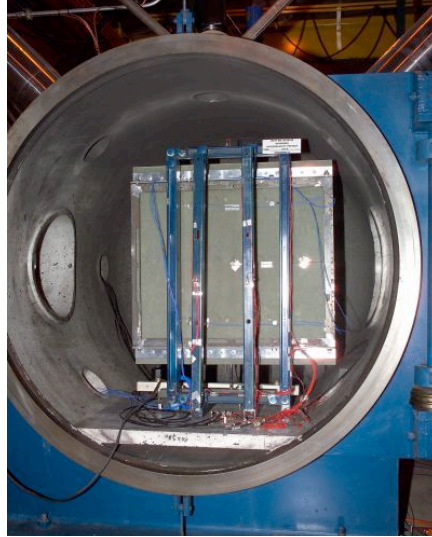
There were a total of 15 shots fired. All targets were oriented at 90 degrees (perpendicular to gun bore) for all shots (Figure 7).

Figure 7: Fiberglass Panel Target with 90 deg Impact Angle. Back Side View.

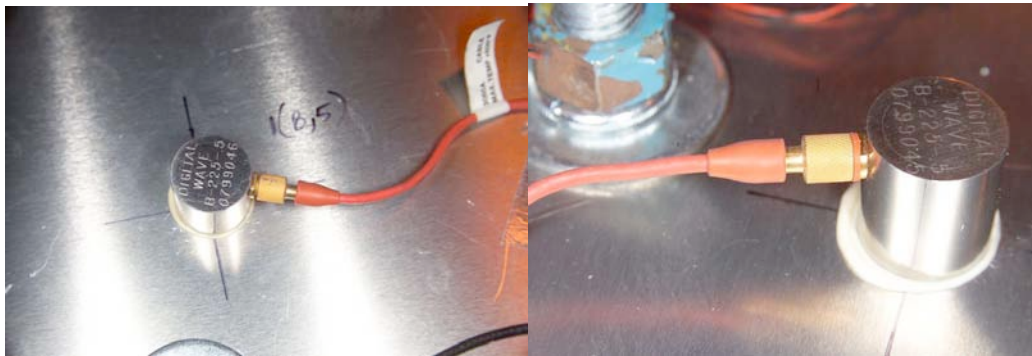
On Targets A-1 and A-2, four acoustic (ultrasonic) emission sensors were coupled to the aluminum backplate with Lord 202 acrylic adhesive (Figure 8). Two sensors were coupled to the surface of the fiberglass panel. Diagrams of the sensor layout are shown in Figure 9, Figure 10, Figure 11, and Figure 12.

Figure 8: Detail of Sensors on Targets A-1 (left) and A-2 (right).

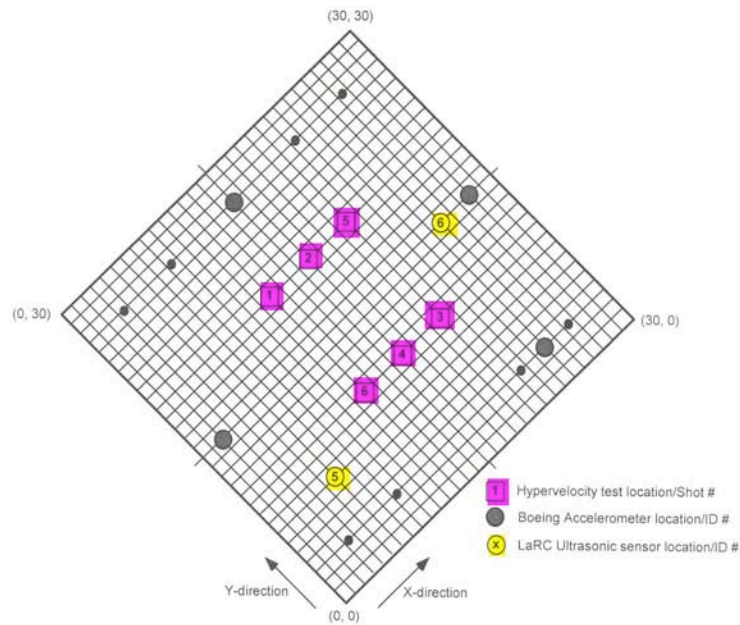
Figure 9: Diagram of Sensor Locations on Fiberglass Panel Target A-1. Front View. Acoustic emission sensors are highlighted in yellow with the following coordinates: #5(6, 7), #6 (25, 15) Dimensions are inches. Impact locations are highlighted in magenta with the following coordinates: #1 (12, 20), #2 (16, 20), #3 (20, 10), #4 (16, 10), #5 (20, 20), #6 (12, 10)

Sensors 5 and 6 were affixed to the fiberglass panel of Target A-1 (Figure 9). Sensors 1-4 were affixed to the aluminum backplate (Figure 10). Shots #1- 6 struck Target A-1. Shots #5 and #6 created holes rather than craters. There were a variety of data acquisition problems for shots #1, 3, 4, 5, and 6.

In the fiberglass panel, fibers are aligned in the x and y directions (see Figure 9). In addition to having slower speeds, waves that travel diagonally are attenuated more than waves that travel along the fiber direction. This is generally known as material anisotropy and is referred to here as diagonal attenuation. Compensation for this effect is described in detail for Targets C-1 and C-2.

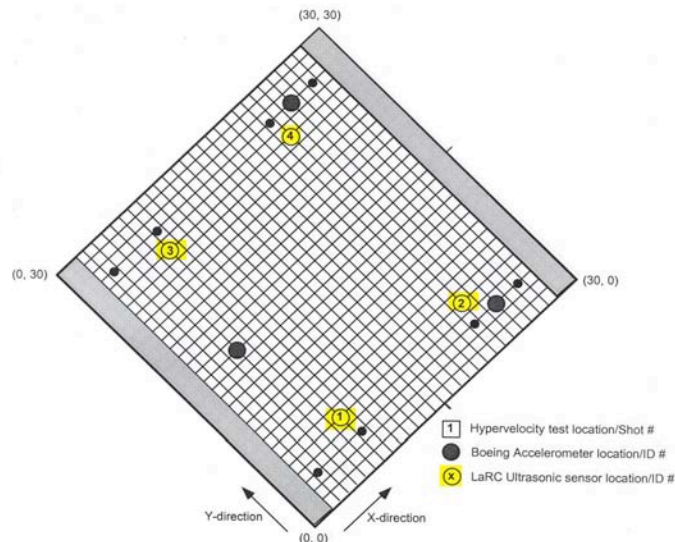
Figure 10: Diagram of Sensor Locations on Aluminum Back Plate Target A-1. Front View. Acoustic emission sensors are highlighted in yellow with the following coordinates: #1 (8, 5), #2 (22, 5), #3(8, 25), #4 (22, 25) Dimensions are inches.

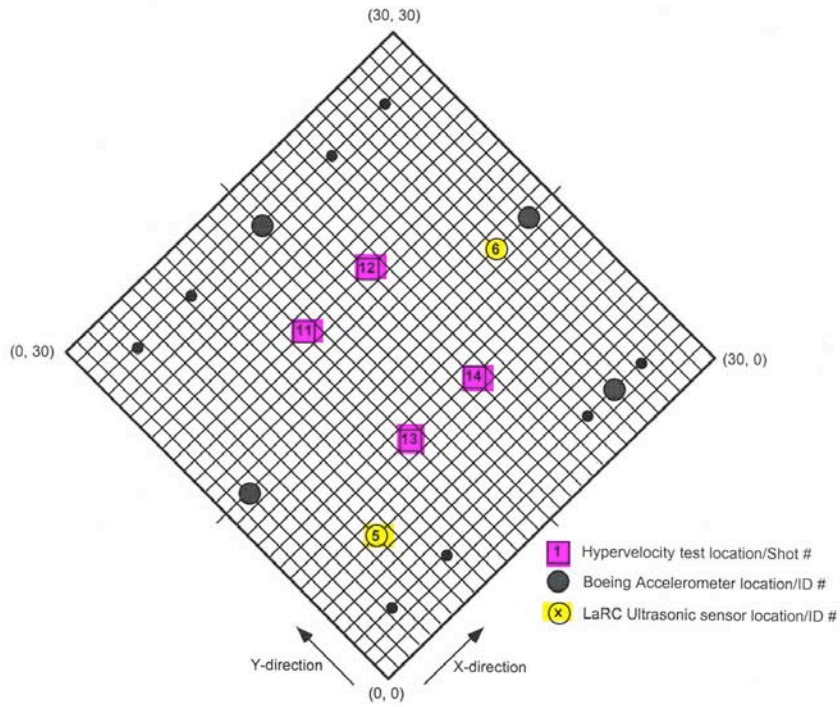
Figure 11: Diagram of Sensor Locations on Fiberglass Panel Target A-2. Front View.
 Acoustic emission sensors are highlighted in yellow with the following coordinates:
 #5(6, 7), #6 (25, 15) Dimensions are inches.
 Impact locations are highlighted in magenta with the following coordinates:
 #11 (12, 20), #12 (12, 10), #13 (18, 20), #14 (18, 10), #15 (20, 20)

Like A-1, sensors 5 and 6 were affixed to the fiberglass panel on Target A-2 (Figure 11). Sensors 1-4 were affixed to the aluminum backplate (Figure 12). Shots #11- 15 struck target A-2. Only shot #14 created a hole. There were data acquisition problems for shots #11, 12, and 15.

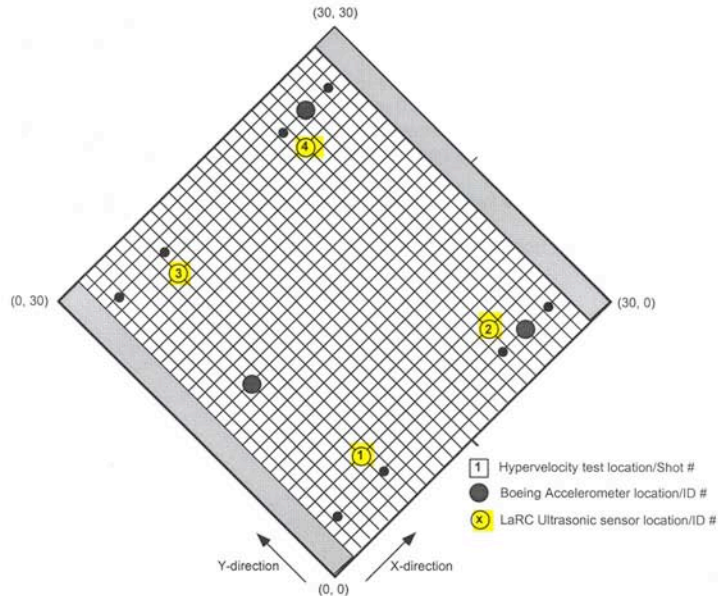
Figure 12: Diagram of Sensor Locations on Aluminum Back Plate Target A-2. Front View.
 Acoustic emission sensors are highlighted in yellow with the following coordinates:
 #1(8, 5), #2(22, 5), #3(8, 25), #4 (22, 25) Dimensions are inches.

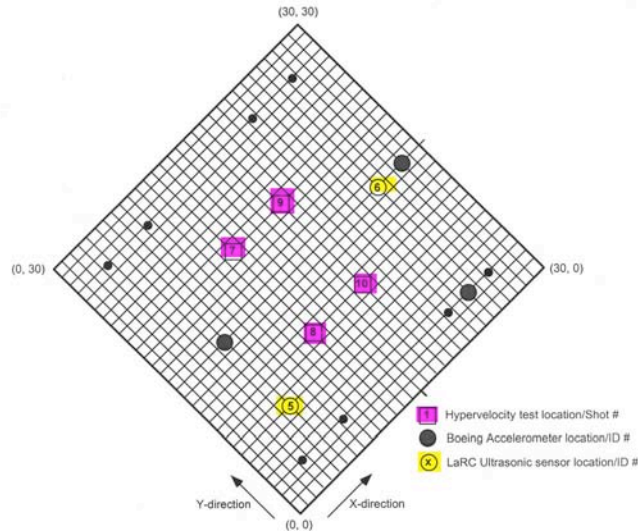
On Target B-1, sensors 1-4 were coupled to the second fiberglass plate with Lord 202 acrylic adhesive. Sensors 5 and 6 were coupled to the first fiberglass plate and sensors 7 and 8 were coupled to the aluminum backplate. Diagrams of the sensor layout are shown in Figure 13, Figure 14, and Figure 15.

Figure 13: Diagram of Sensor Locations on Fiberglass Plate 1 Target B-1. Front View.
 Acoustic emission sensors are highlighted in yellow with the following coordinates:
 #5(6, 7), #6 (25, 15) Dimensions are inches.
 Impact locations are highlighted in magenta with the following coordinates:
 #7 (12, 20), #8 (12, 10), #9 (18, 20), #10 (18, 10),

Sensors 5 and 6 were affixed to fiberglass plate 1 on Target B-1 (Figure 13). Sensors 1-4 were affixed to fiberglass panel 2 (Figure 14). Sensors 7 and 8 were affixed for the aluminum back plate (Figure 15). Shots #7-10 struck target B-1. Shots #9 and 10 created holes. There were data acquisition problems for shots #7, 9, and 10.

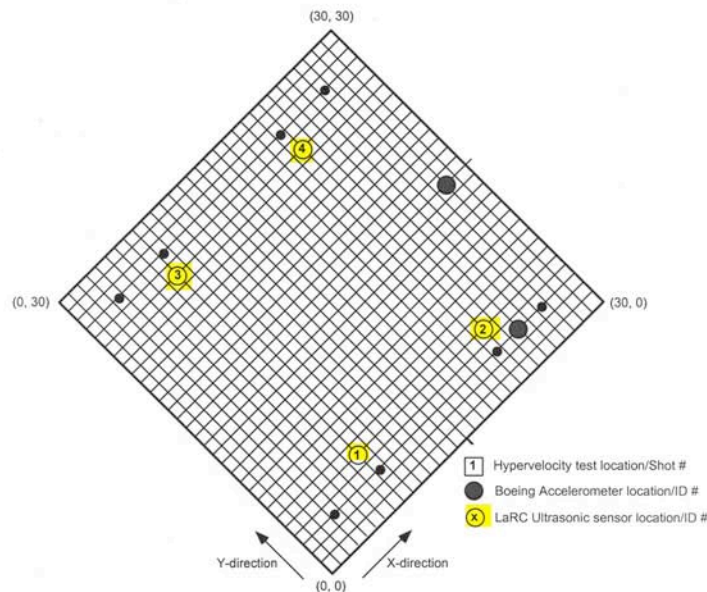
Figure 14: Diagram of Sensor Locations on Fiberglass Plate 2 Target B-1. Front View.
 Acoustic emission sensors are highlighted in yellow with the following coordinates:
 #1 (8, 5), #2 (22, 5), #3 (8, 25), #4 (25, 15) Dimensions are inches.

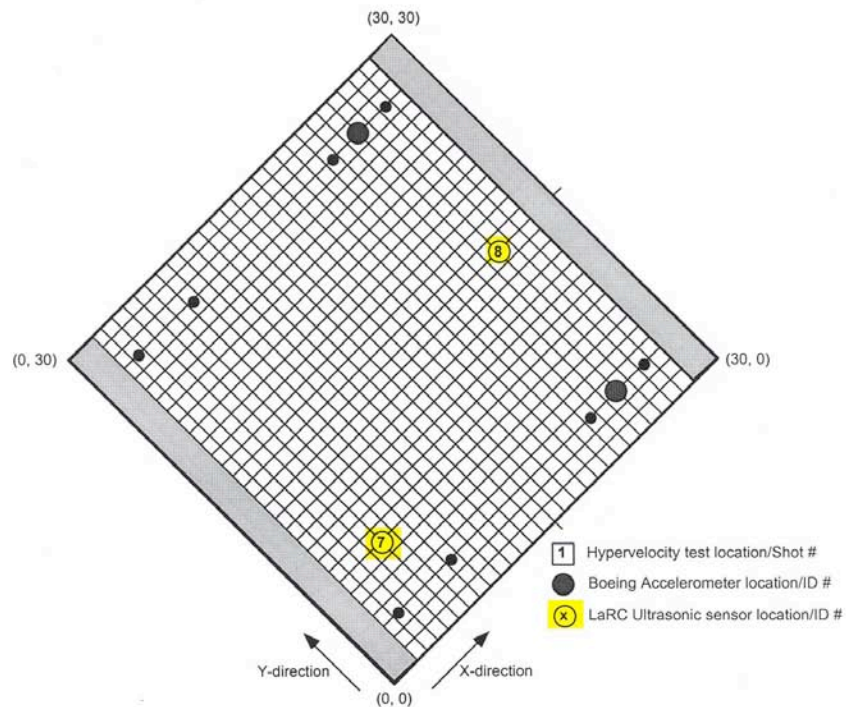
Figure 15: Diagram of Sensor Locations on Aluminum Back Plate Target B-1. Front View.
Acoustic emission sensors are highlighted in yellow with the following coordinates:
#7(6, 7), #8 (25, 15) Dimensions are inches.

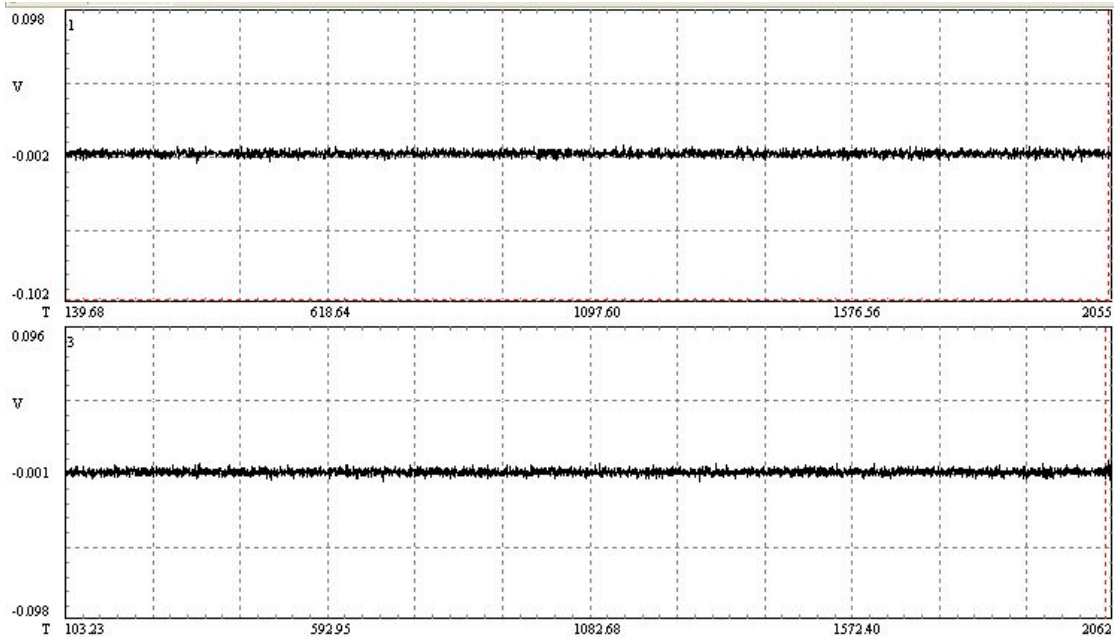
Figure 16: Example of DC Offset

Some recorder channels were found to have a slight DC offset (Figure 16). This added significantly to the wave energy when the integral of squared voltage versus time signal was computed. To eliminate the offset, the average wave signal voltage for the impact event was subtracted from each data point. This resulted in a zeroed raw wave signal (no DC offset). Correcting the offset was more important for small signals than large signals.

The top signal is centered at -0.002 V whereas the bottom signal is centered at -0.001V.

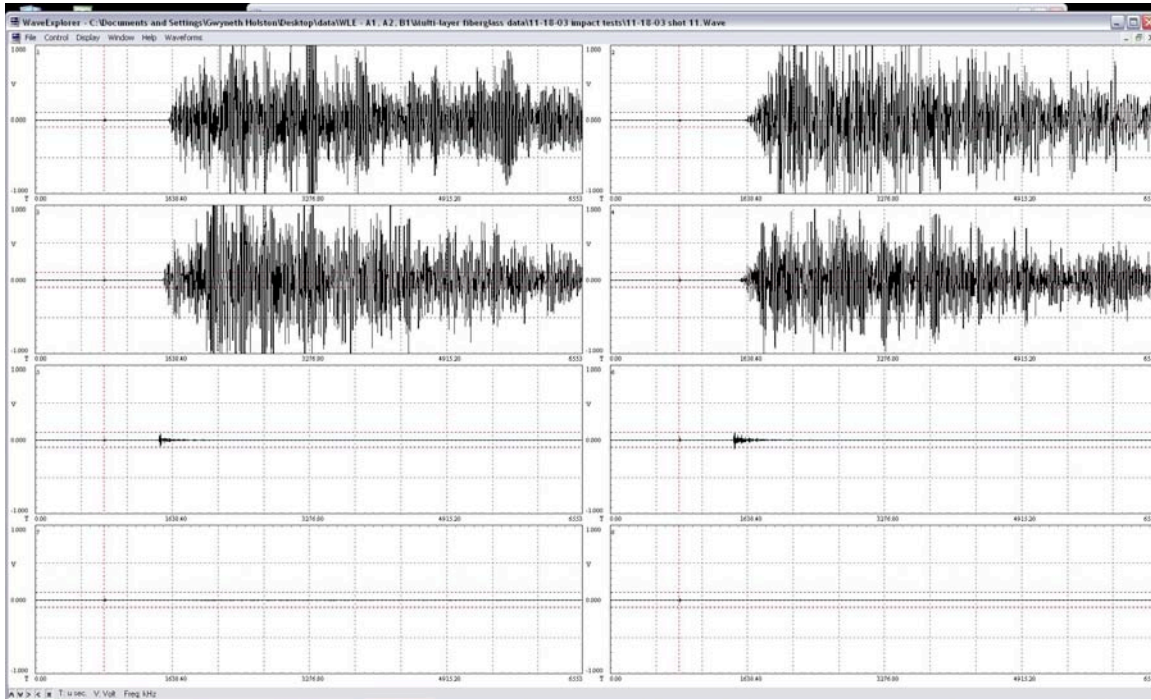
Figure 17: A-2 Impact Signal for Shot #11

A typical impact signal is shown in Figure 17. The impact signal has a distinct waveform and varies in both in arrival time and amplitude on each channel. The distinct modal characteristics can be seen in a time expanded view in Figure 18. The E mode is seen to arrive first with its lowest frequency in front followed by progressively higher frequencies. This is followed by the flexural (F) wave. The F wave characteristics are harder to discern because of the filtering of the attenuators and other effects that tended to damp out the low frequencies.

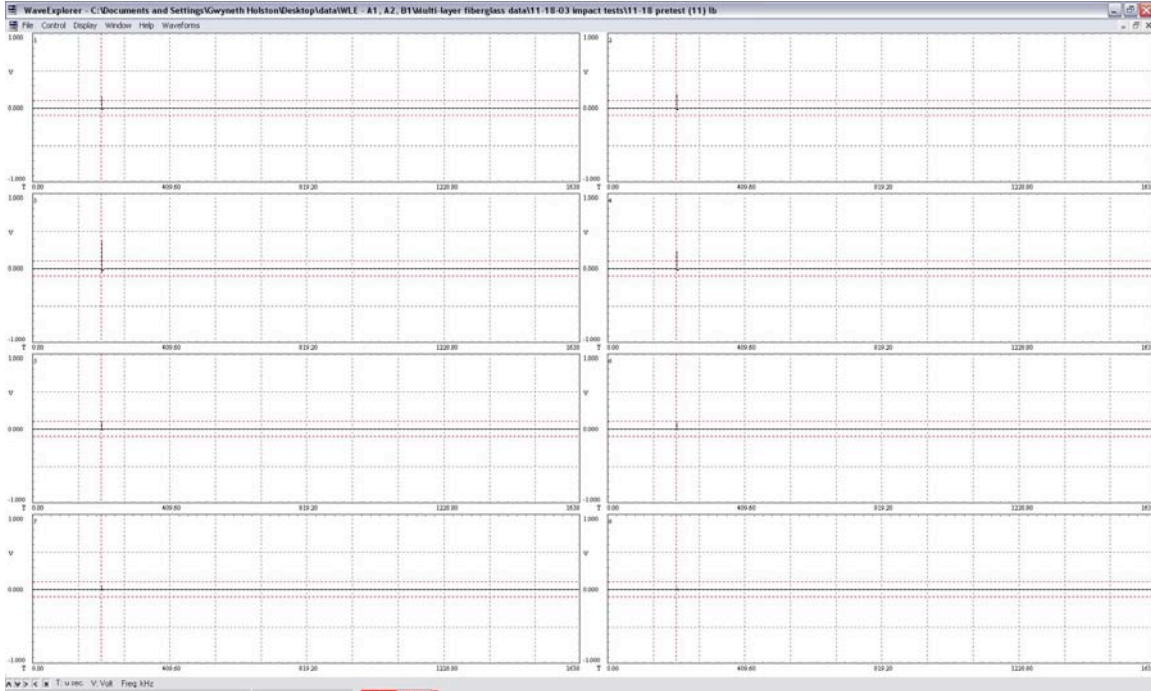
Figure 19: A-2 Electromagnetic Interference for Shot #11

The sound waves produced by each impact are shown complete in the Appendix to this section. There it can be seen that the impact waves have the plate mode characteristics, i.e., the extensional wave arrives first, with its low frequency components out front followed by higher frequency components, and the F wave with just the opposite frequency arrangement. This differs, for example, from noise caused by electromagnetic interference (EMI). In contrast, EMI noise typically looks the same on every channel and

arrives simultaneously (Figure 19). EMI exhibits no plate wave propagation characteristics.

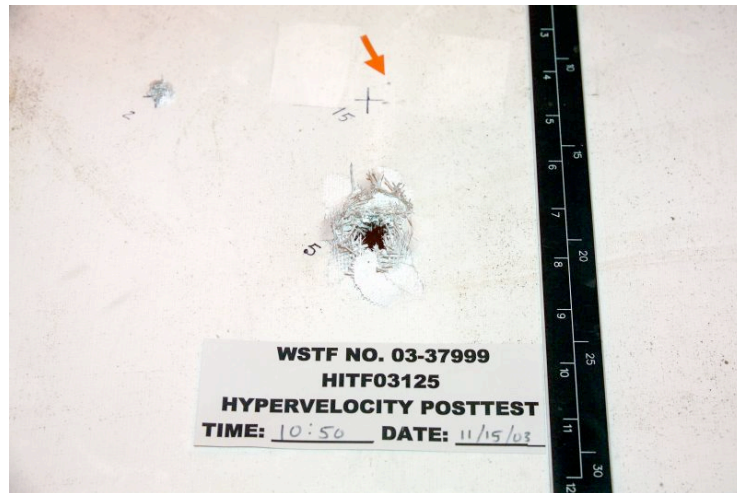
Figure 20: A-1 Shot #5 Impact Damage

The damage for each shot is given in Table 2. The crater volume damage is the product of the recorded length, width, and depth measurements on the front side of the panel for each impact. Damage area is the product of recorded length and width measurements on the front side of the panel. Examples of impact damage are Figure 20, Figure 21, and Figure 22.

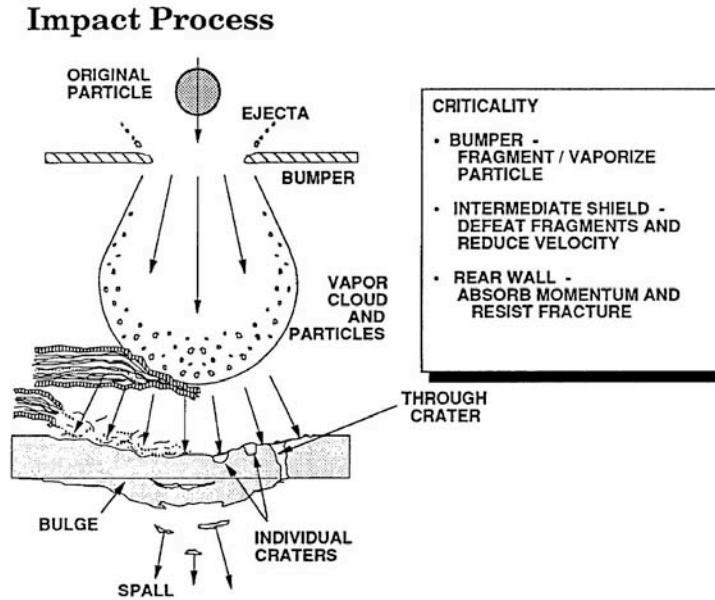
Figure 23: Multilayer Penetration Mechanisms¹

For these targets, after the impactor hit the first layer of fiberglass, small particles impacted the second layer of fiberglass (Figure 23). This is referred to as 'spalling damage'. The secondary impacts reflected back up the metal rods that joined the layers together resulting complex data recorded by sensors on the first layer. The time for collecting wave signal energy was approximately 1000 μ s after impact. This very short time may have only collected the energy due to the primary impact on the first layer of fiberglass, but it may have also measured some of the energy from the spall. This should be kept in mind as an additional source of possible error.

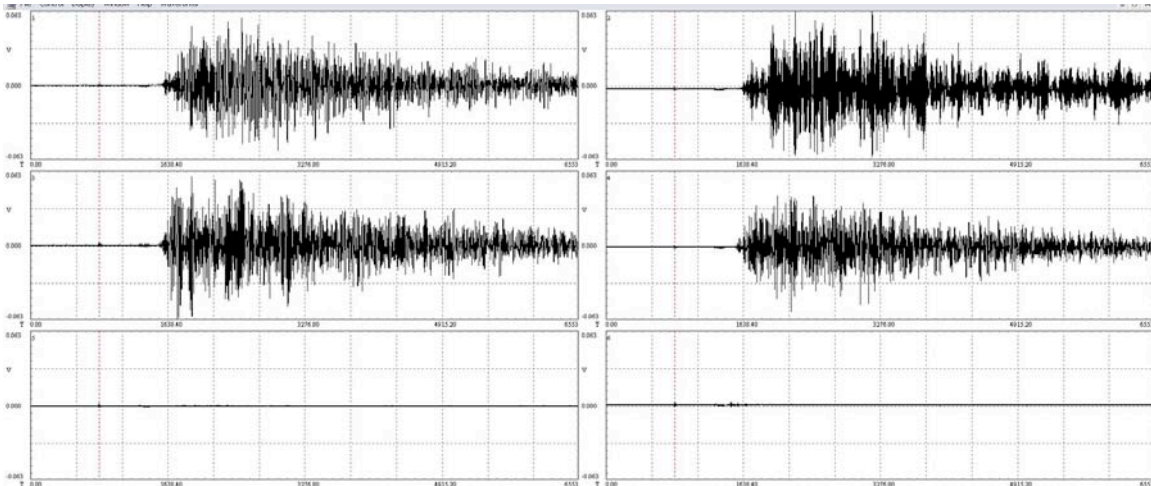
There was too much attenuation on shot #1, channels 5 and 6 (see Figure 24). Channel 5 showed a very small signal that was later traced to a bad preamp input connector.

Figure 24: Impact Waveform for Shot #1. Notice the missing signal for sensor 5 in the bottom left corner.

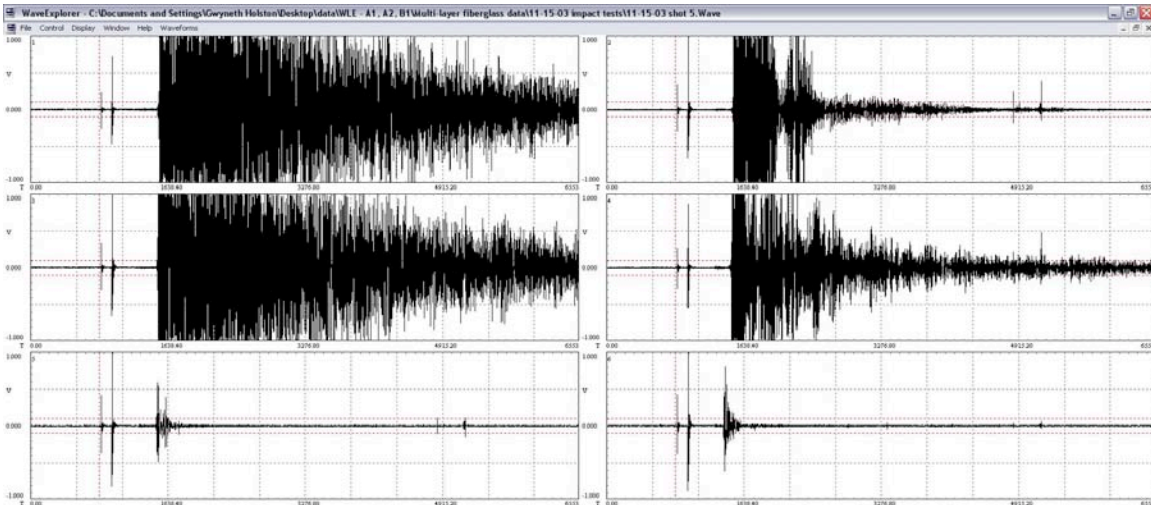
The gain was too high on channels 1-4 on shot #5 causing saturation (Figure 25). Large EMI signals were observed on all channels at and just after trigger. Sensors 2 and 6 were knocked off of the specimen and had to be rebonded before the next test.

Figure 25: Shot #5 Impact Waveform. Notice saturation on channels 1-4. Channels 2 and 6 have shortened signals due to sensors being knocked off during impact.

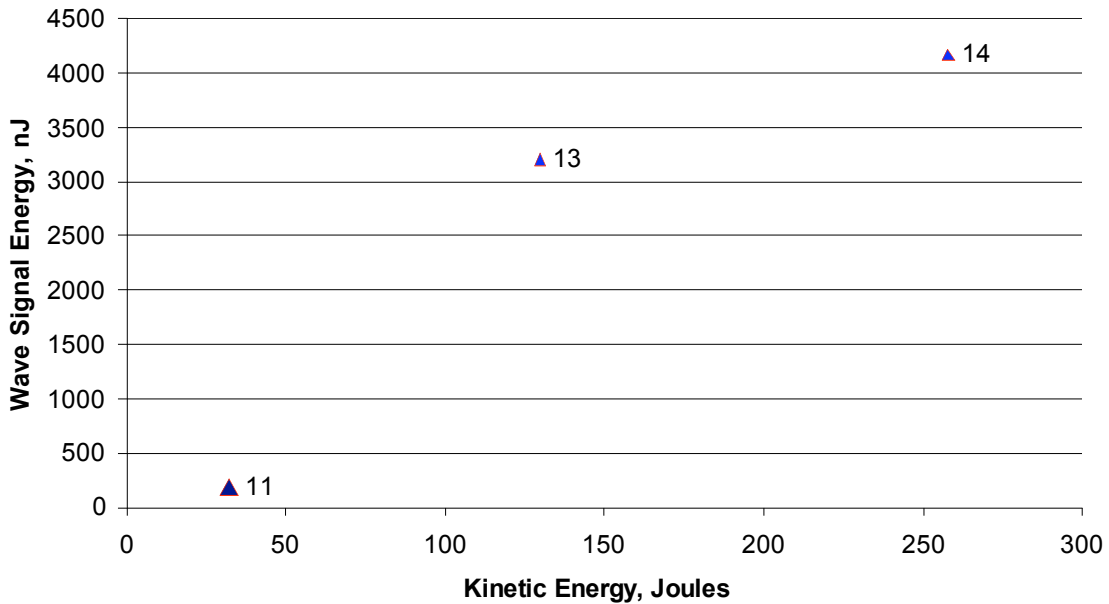
Figure 26: Wave Signal Energy vs. Kinetic Energy on A-2 Fiberglass Plate (Sensors 5 and 6)

Acceptable data was collected on Target A-2 fiberglass plate sensors 5 and 6 for shots #11, 13, and 14. The wave signal energy for these shots was plotted versus kinetic energy in Figure 26. There was a trend of increasing wave signal energy with increasing kinetic energy.

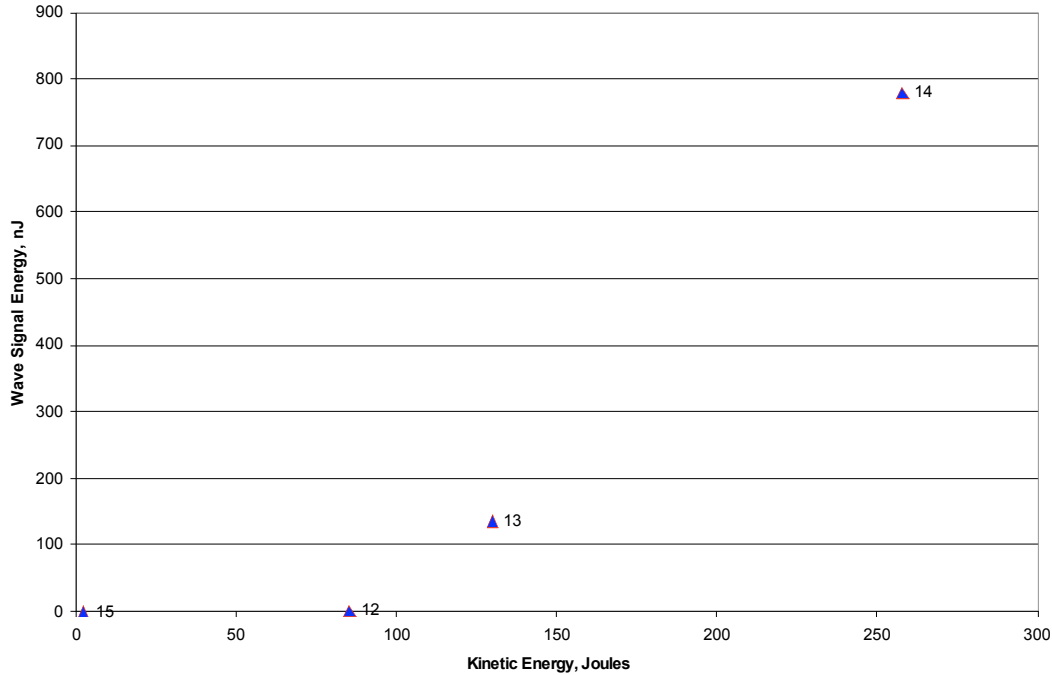
Figure 27: Wave Signal Energy vs. Kinetic Energy for A-2 Aluminum Back Plate (Sensors 1-4)

Good data was collected on Target A-2 aluminum back plate sensors 1-4 for shots #12- 15. The wave signal energy versus kinetic energy shows a linear trend in Figure 27. Shot #14 created a hole and had a high wave signal energy.

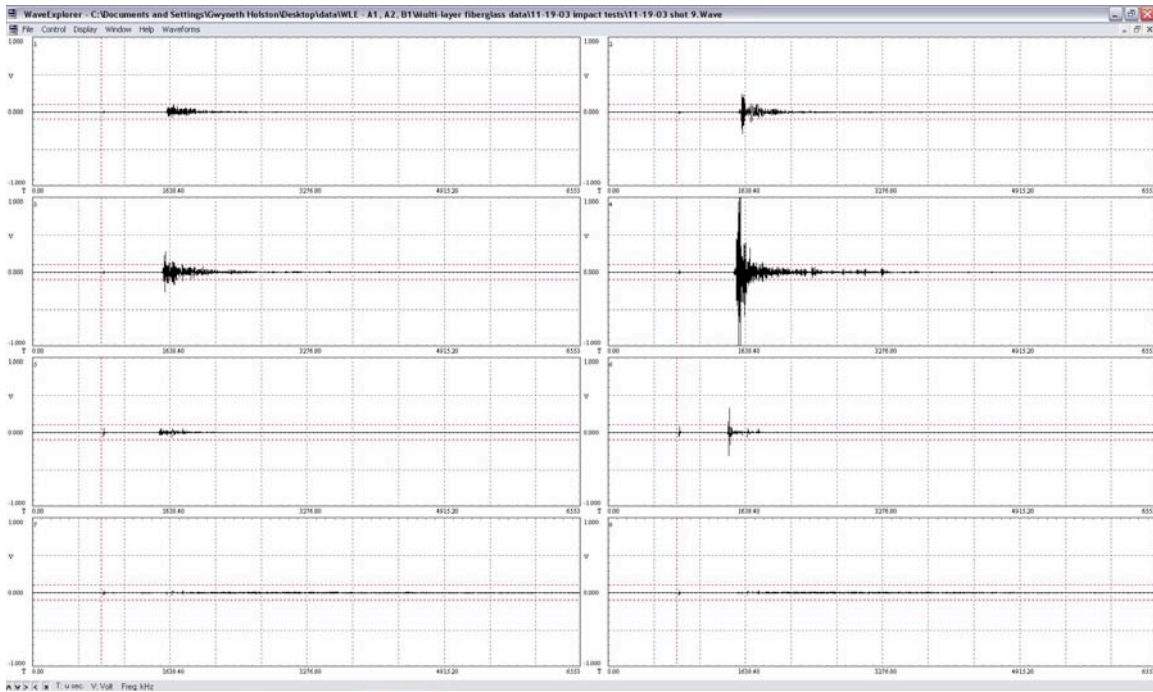
Figure 29: Shot #9 Impact Waveform

Shot #9 was barely saturated on channel 4. There was too much attenuation on channels 7 and 8. Sensor 6 became disbonded as was evident in signal (Figure 29). Sensor 6 was tested and replaced for the next shot.

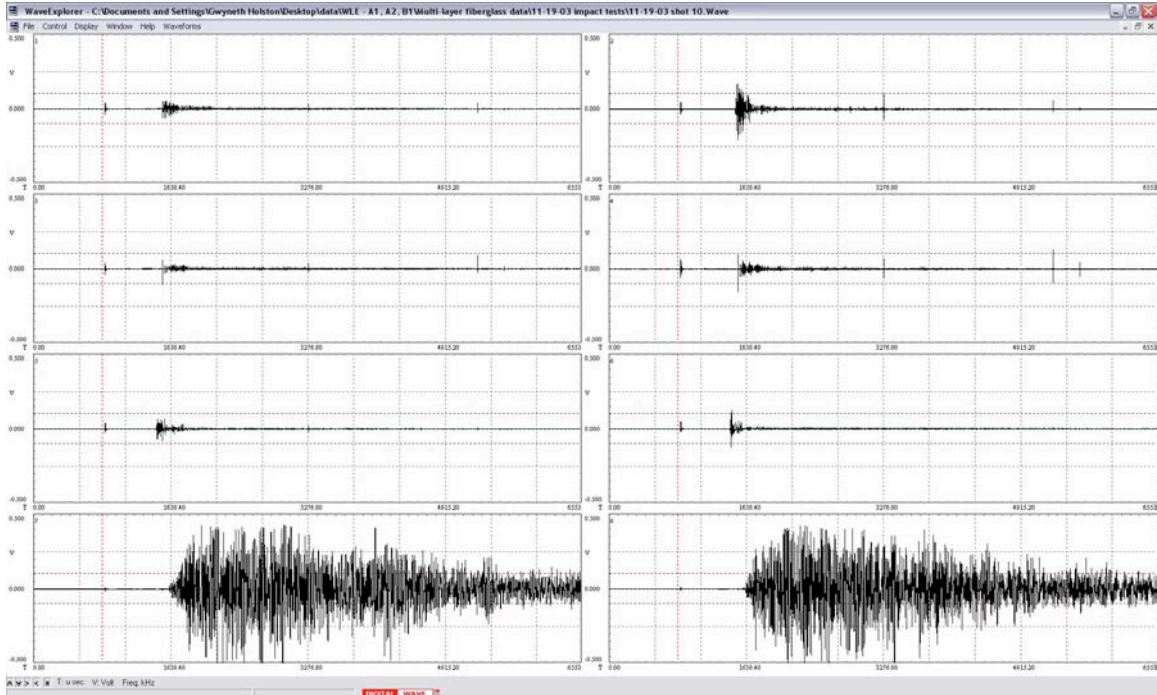
Figure 30: Shot #10 Impact Waveform

Shot #10 was slightly saturated on channels 7 and 8 (Figure 30).

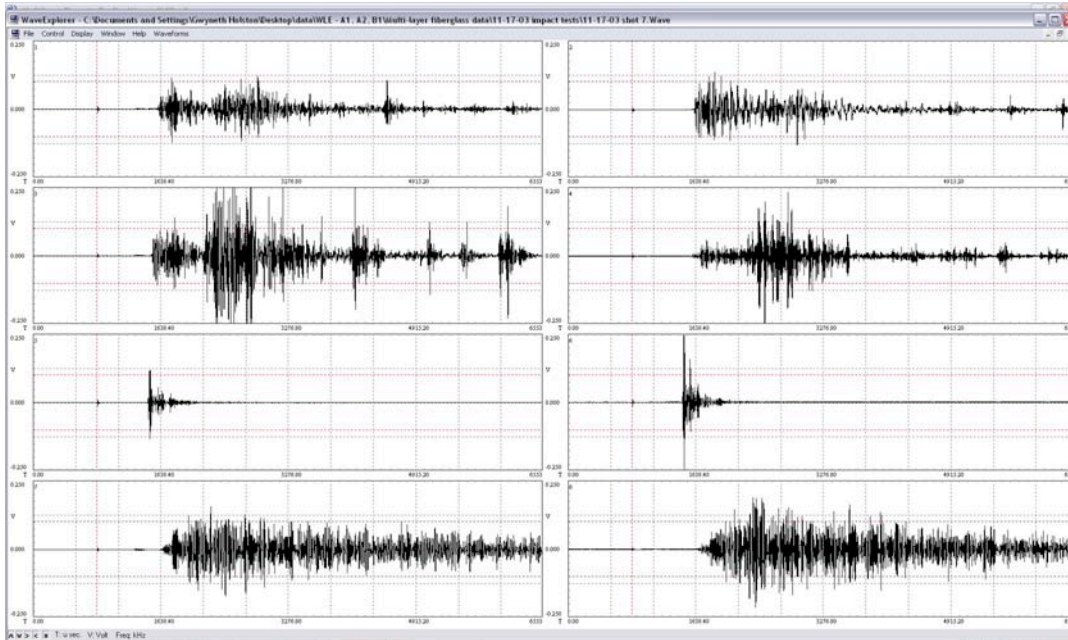
Figure 31: Shot #7 Impact Waveform, Sensors 1-8

Valid data was collected on Target B-1 aluminum back plate sensors 7 and 8 for shots #7 and 8. Consider the impact waveform for shot #7 (Figure 31). The wave signal first arrived on sensors 5 and 6 since they were located on the first layer of fiberglass. It arrived at sensor 5 slightly before sensor 6 because it impacted closer to sensor 5. These channels clearly showed a large amplitude at initial impact that decreases with time. The wave signal then proceeded to sensors 1-4 on the second layer of fiberglass. The wave signal appears distorted because it had to travel through the all-thread rods from the first fiberglass plate to the second. The wave reverberated inside the rods to create the types of signals observed on sensors 1-4 and, finally, 7 and 8.

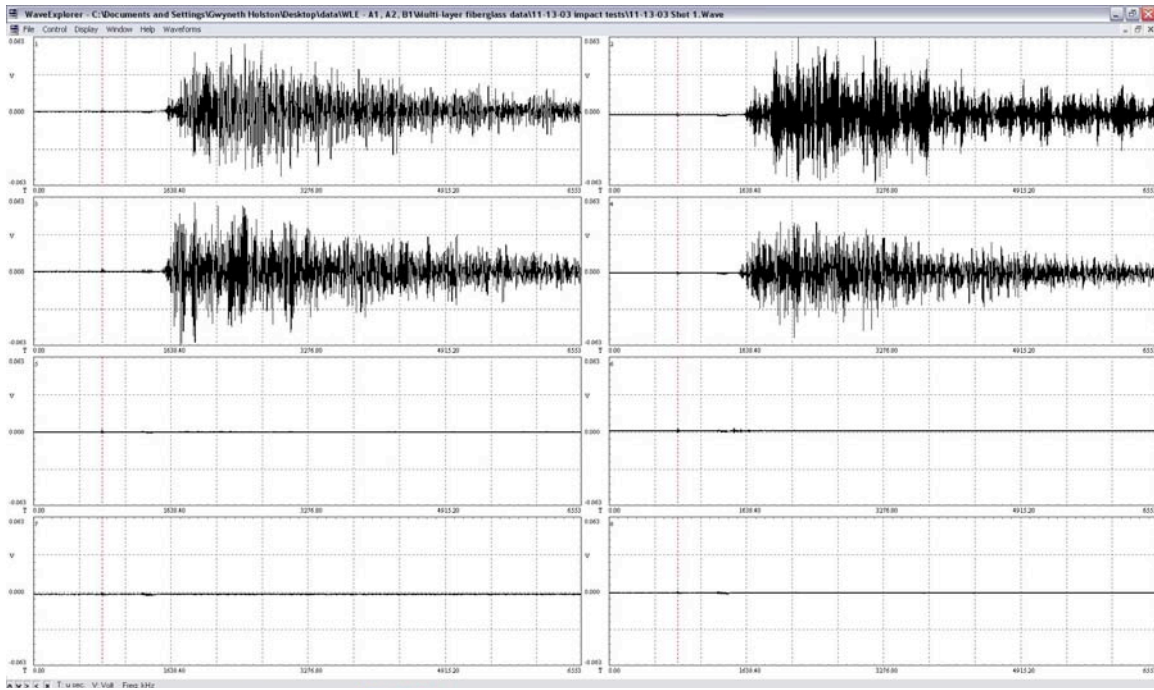
Comments: Too much attenuation, especially on Ch. 5-6. Channel 5 shows very small signal that is suspect. Problem later traced to bad preamp input connector. EMI type signals seen on all channels at trigger time (819 microseconds) and again later at 1296 microseconds

Figure 35: A-1 Shot #1 Impact Waveform

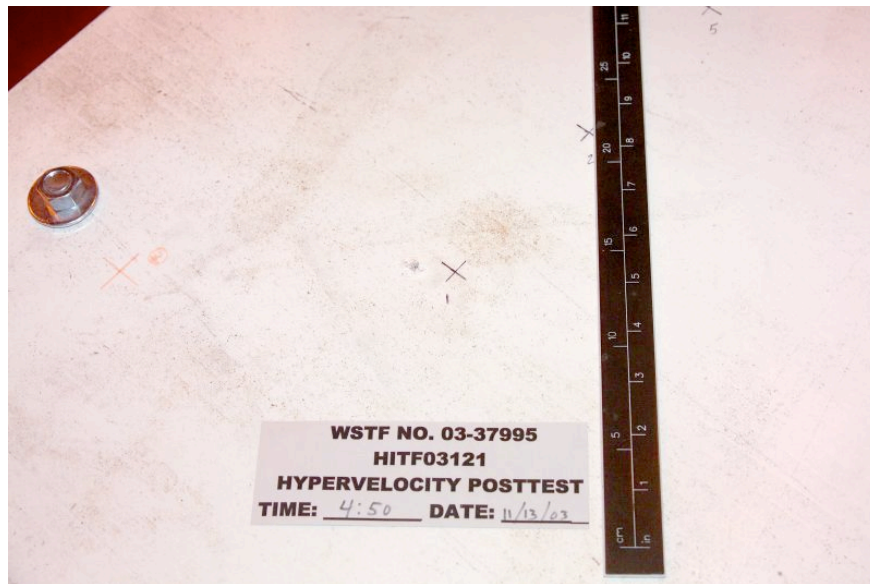
Figure 36: A-1 Shot #1 Impact Damage

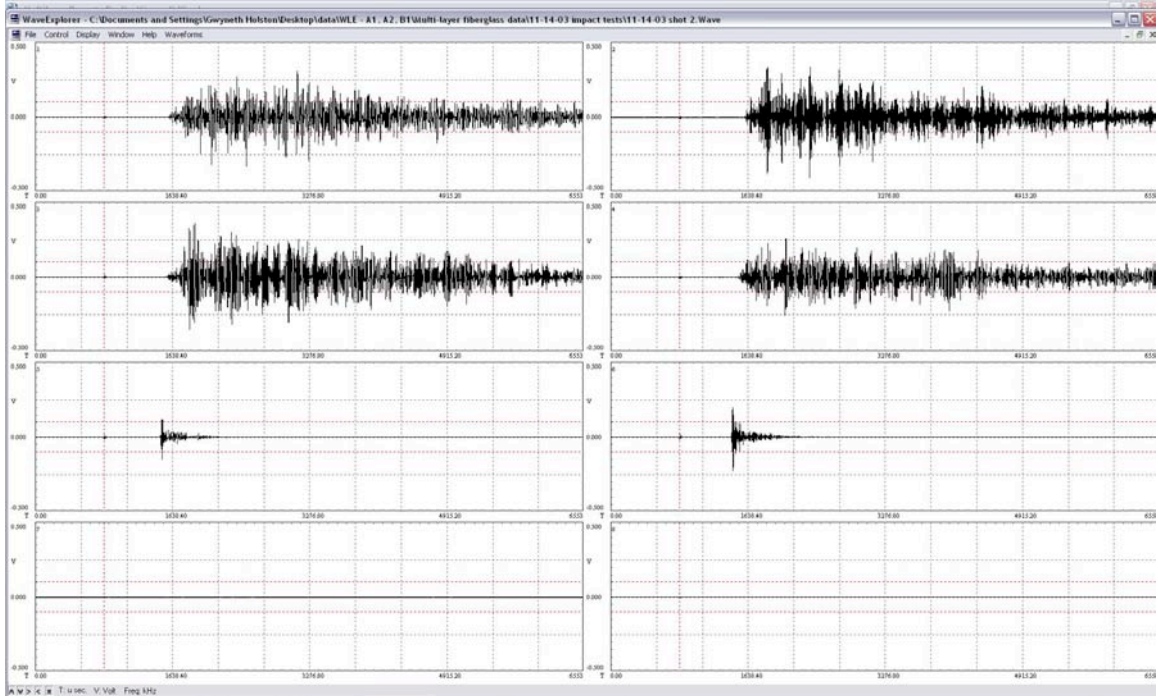
Comments: All signals in range. Channel 5 acquired on this shot.

Figure 37: A-1 Shot #2 Impact Waveform

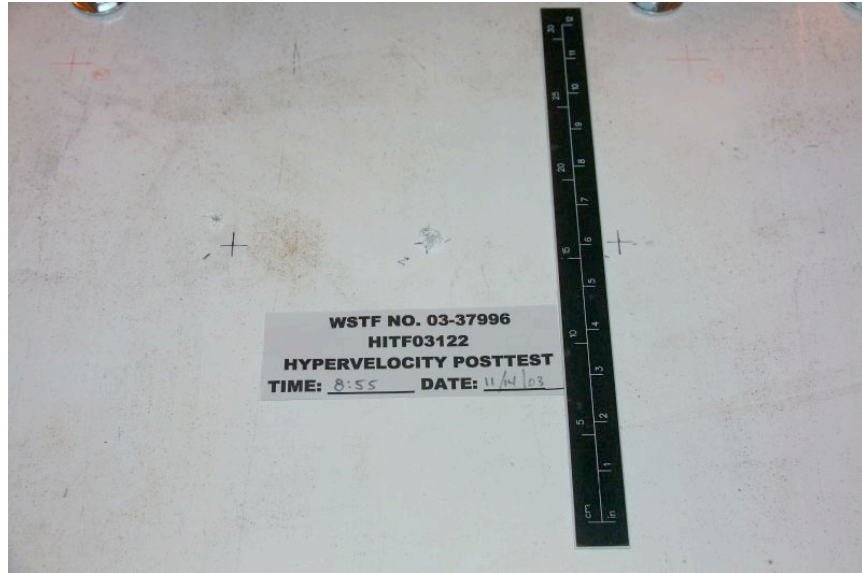
Figure 38: A-1 Shot #2 Impact Damage

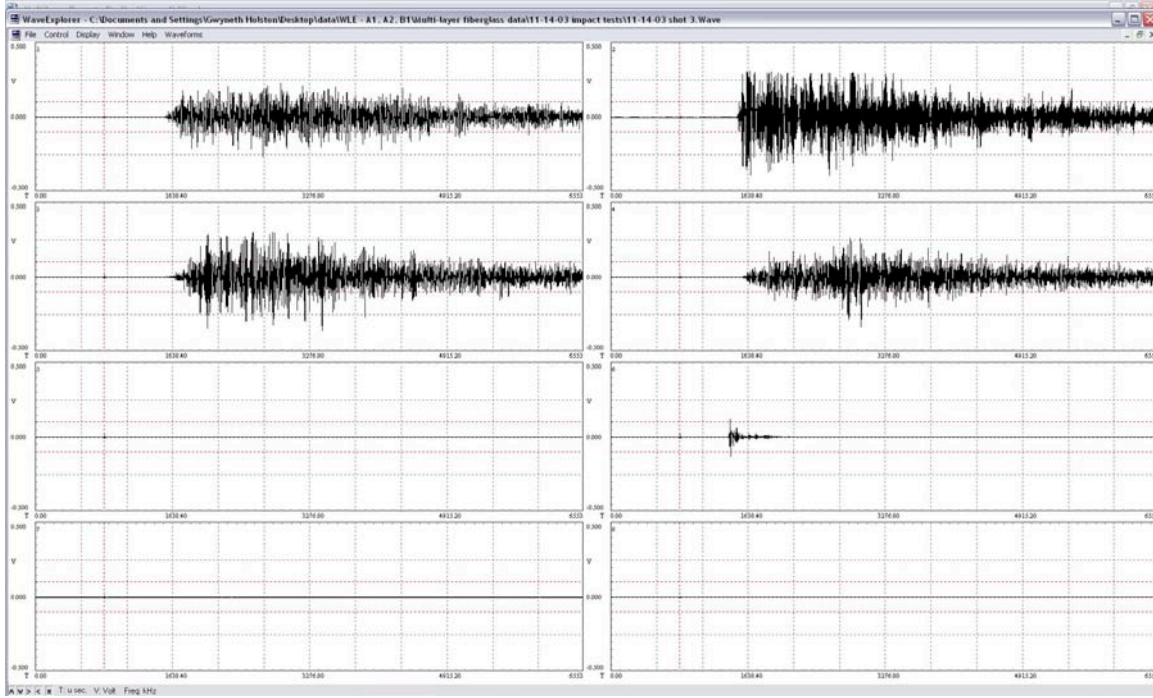
Comments: All signals in range except some saturation on channel 2. Channel 5 data not acquired because of problem later found to be bad input connector on preamp.

Figure 39: A-1 Shot #3 Impact Waveform

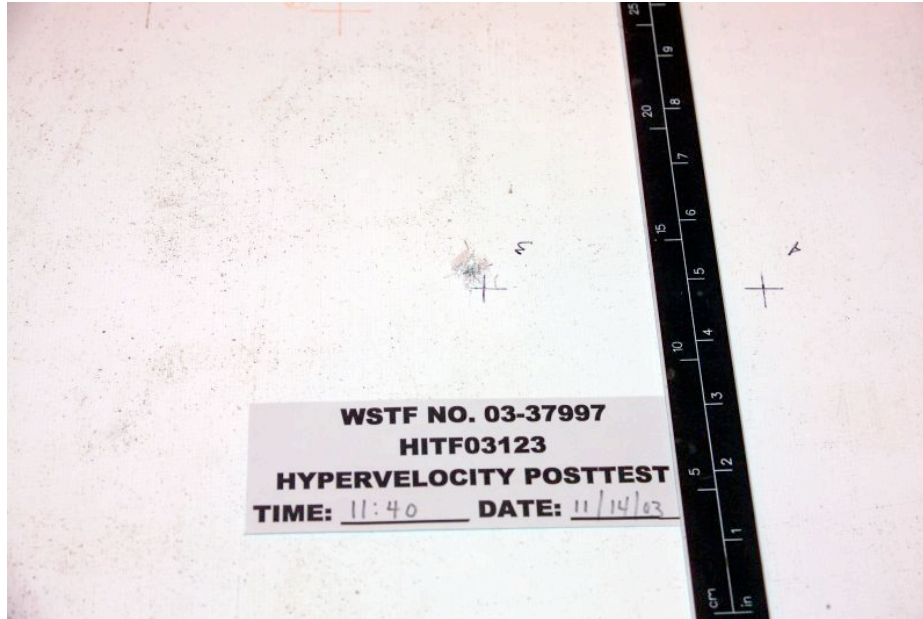
Figure 40: A-1 Shot #3 Impact Damage

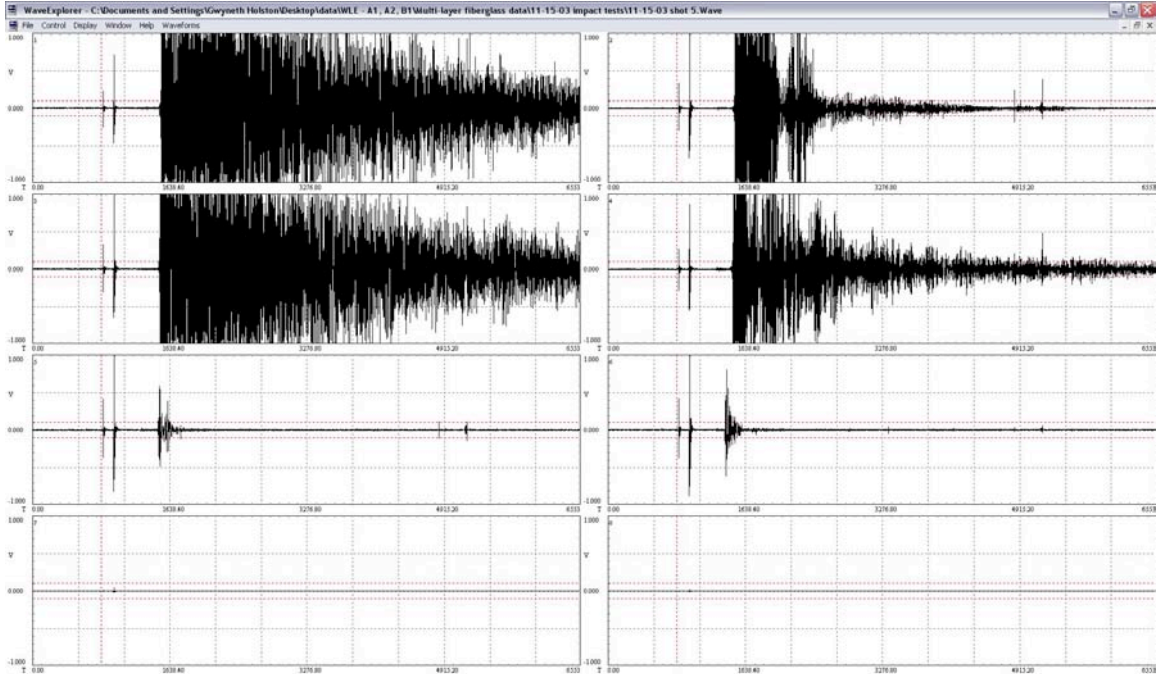
Comments: Gain improperly set much too high on Channels 1-4 causing much saturation. Signals obtained and in range on Ch. 5-6. Large EMI signals observed on all channels at and just after trigger. Sensors 2 and 6 were knocked off of the specimen and had to be rebounded before the next test.

Figure 41: A-1 Shot #5 Impact Waveform

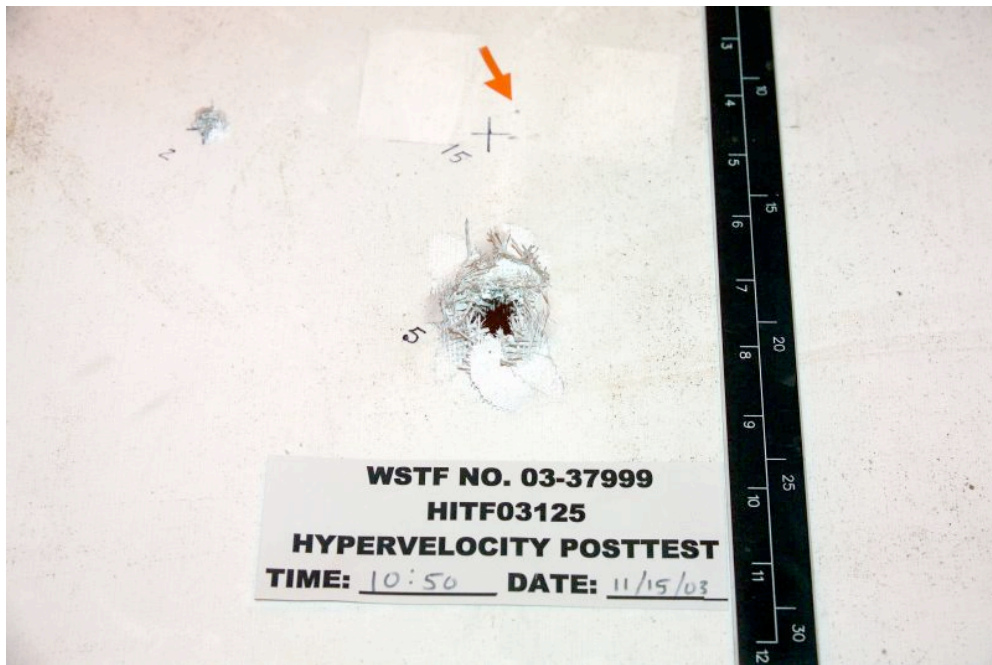
Figure 42: A-1 Shot #5 Impact Damage

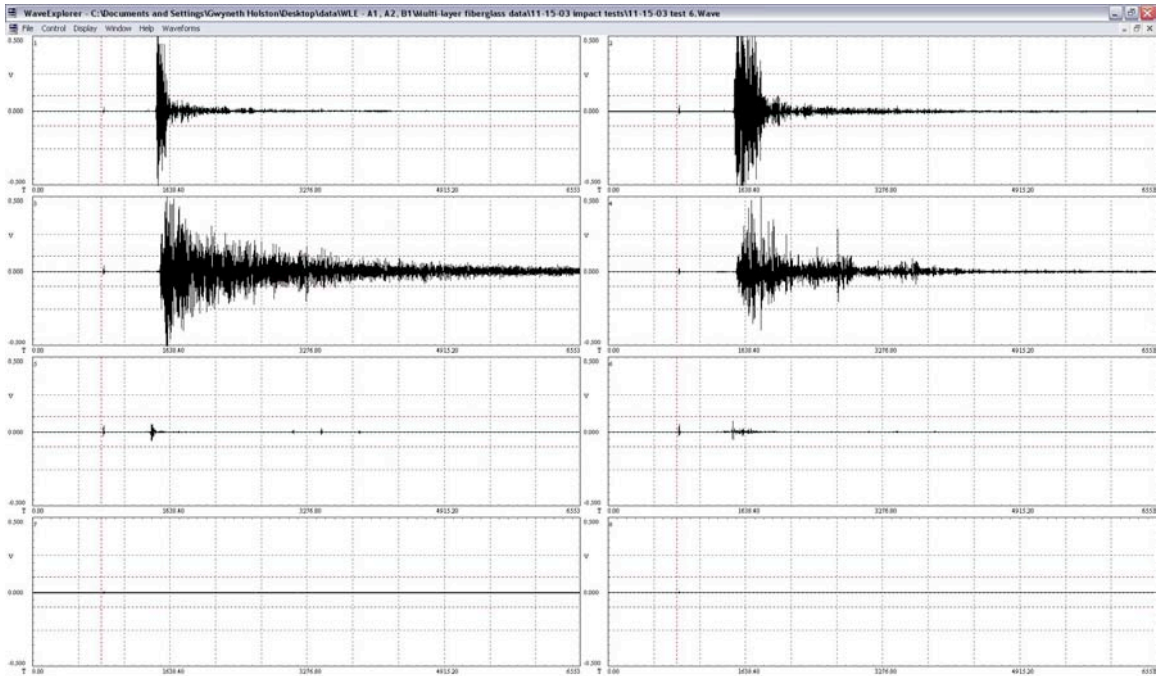
Comments: Signals in range although very small on Ch. 5-6. Sensor 1 was knocked off specimen during impact. A much shortened time signal is usually observed when the sensor comes off the target.

Figure 43: A-1 Shot #6 Impact Waveform

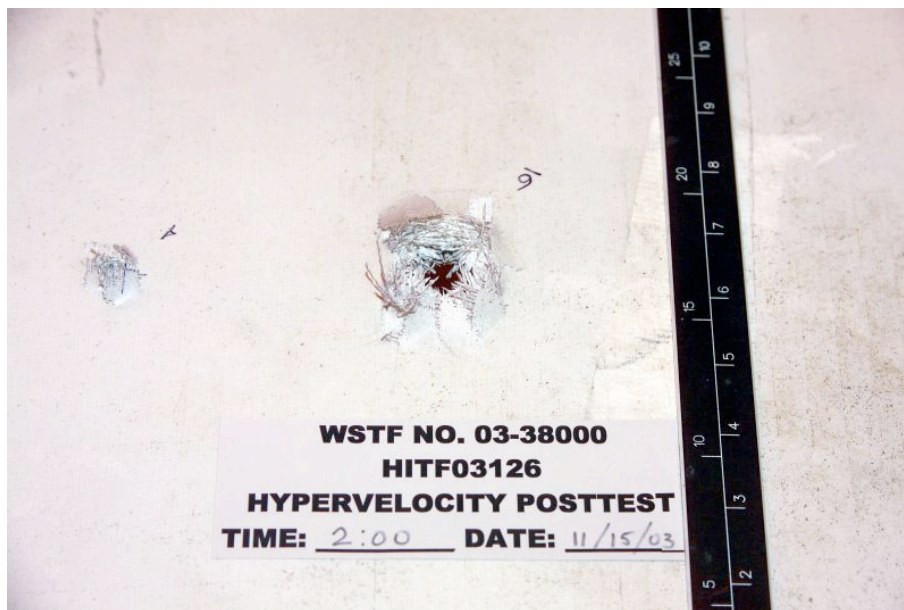
Figure 44: A-1 Shot #6 Impact Damage
