NASA/CR-2007-214885/VOL2

Hypervelocity Impact (HVI)

*Volume 2: WLE Small-Scale Fiberglass Panel Flat
Multi-Layer Targets A-1, A-2, and B-1*

*Michael R. Gorman and Steven M. Ziola
Digital Wave Corporation, Englewood, Colorado*

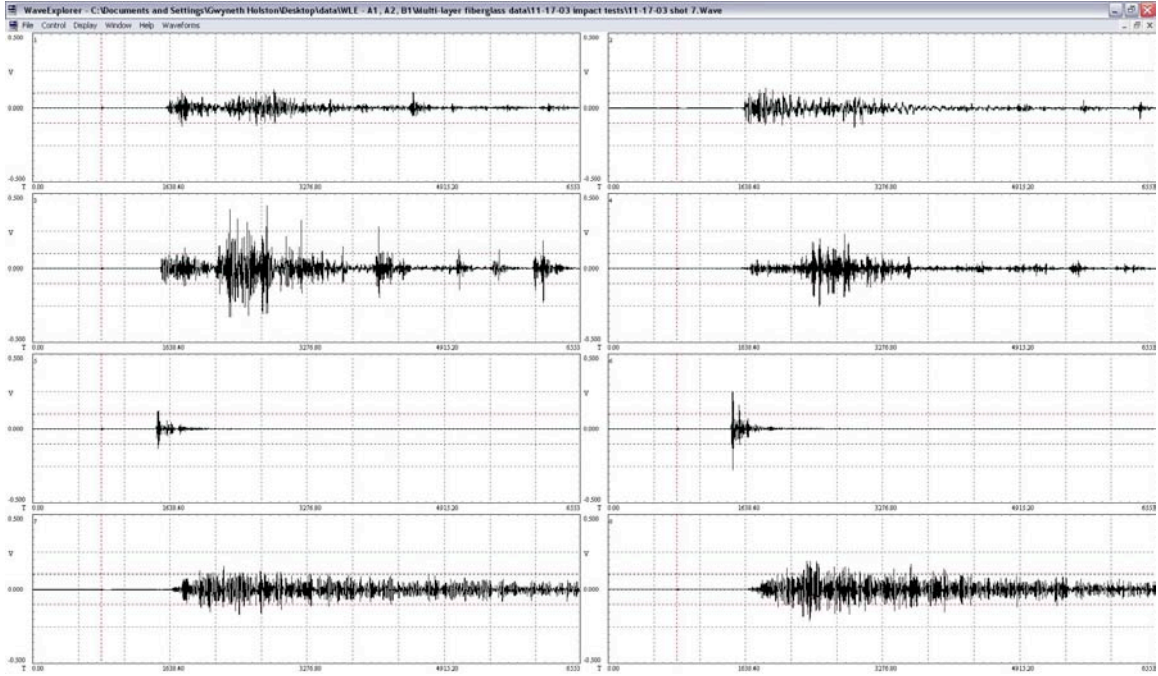
Comments: Signals in range on all channels and channel 5 signal acquired. EMI near trigger much smaller.

Figure 45: B-1 Shot #7 Impact Waveform

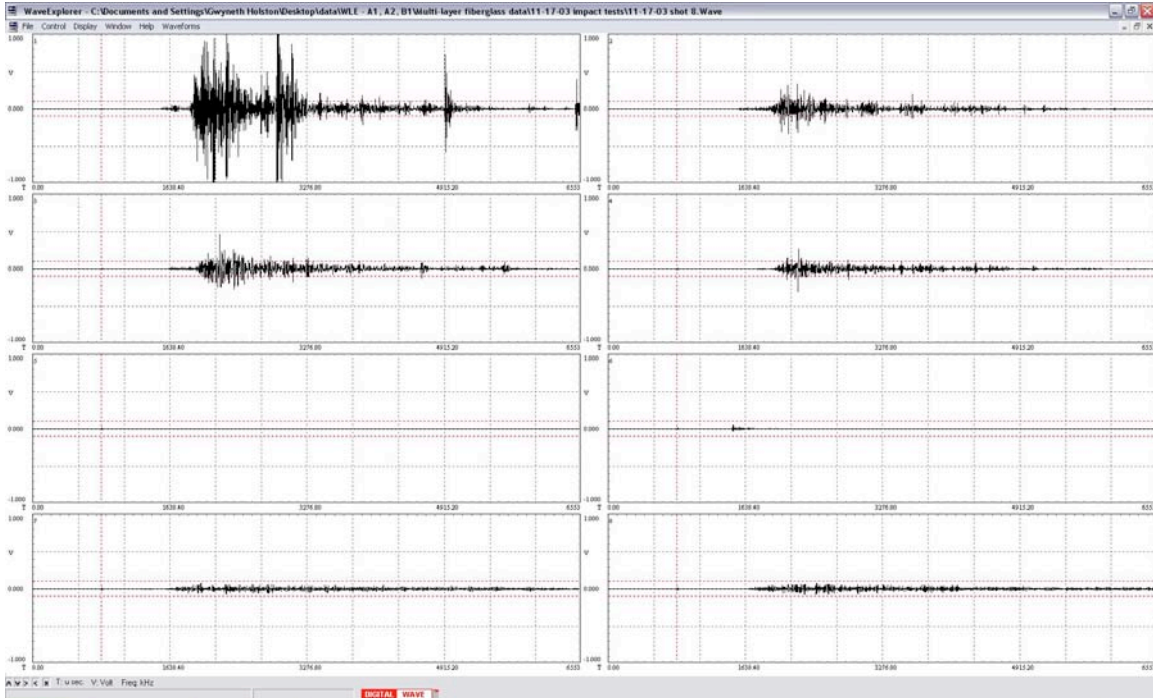
Comments: Signals in range on all channels although small on channel 6-8. Channel 5 signal not acquired because of problem later found to be bad input connector on preamp.

Figure 47: B-1 Shot #8 Impact Waveform

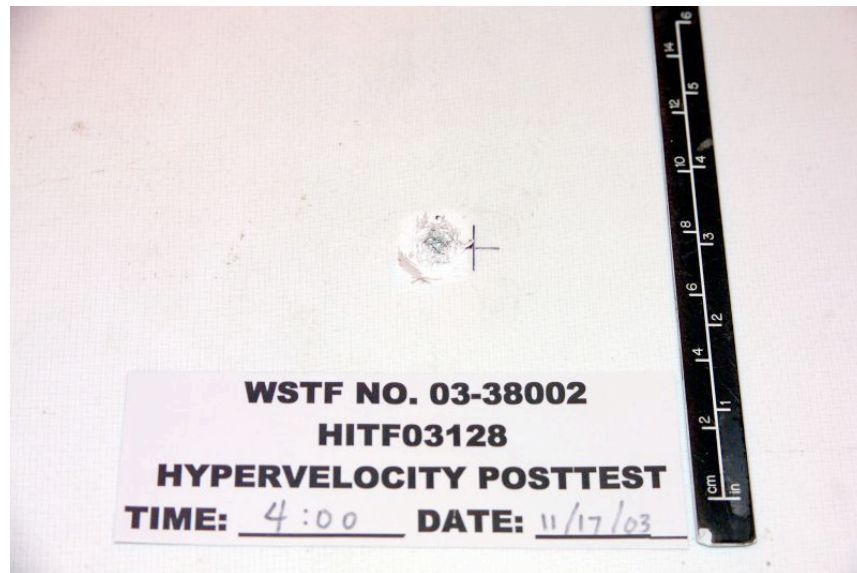
Figure 48: B-1 Shot #8 Impact Damage

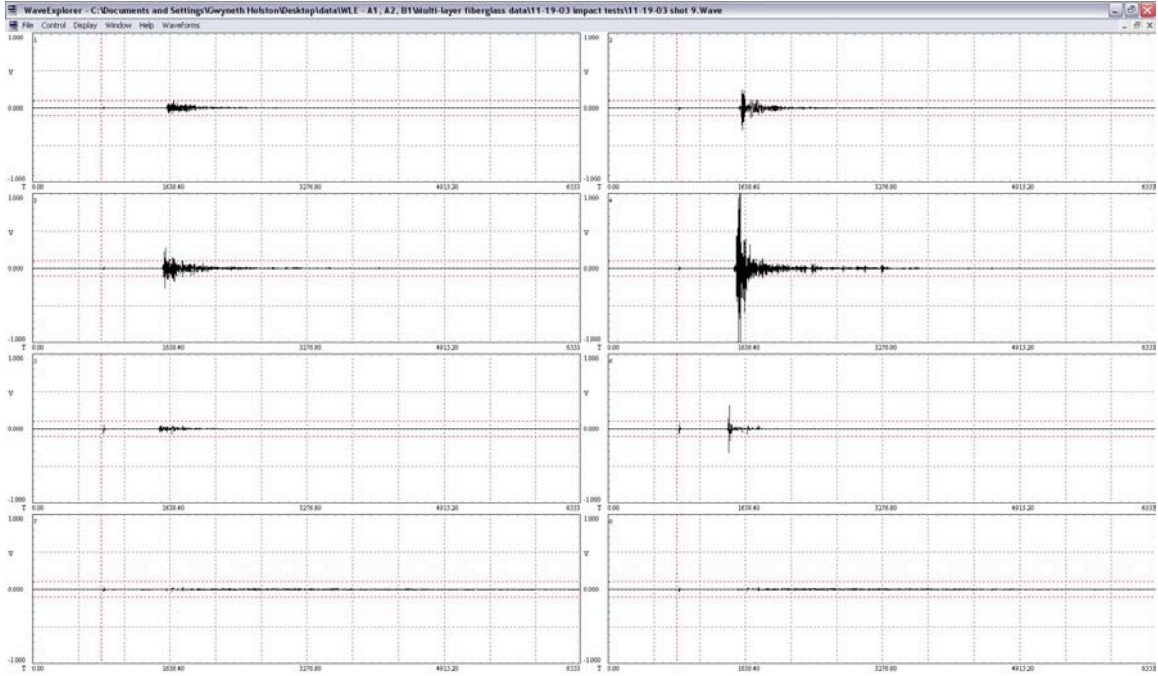
Comments: Saturation on Channel 4 only. Too much attenuation on channels 7-8. EMI signals observed at trigger time. Sensor 6 became disbonded as was evident in signal. Another EMI signal generated when sensor 6 stops functioning. Sensor 6 was tested and replace for next shot.

Figure 49: B-1 Shot # 9 Impact Waveform

Shot #9 was barely saturated on channel 4. There was too much attenuation on channels 7 and 8. Sensor 6 became disbonded as was evident in signal (Figure 29). Sensor 6 was tested and replaced for the next shot.

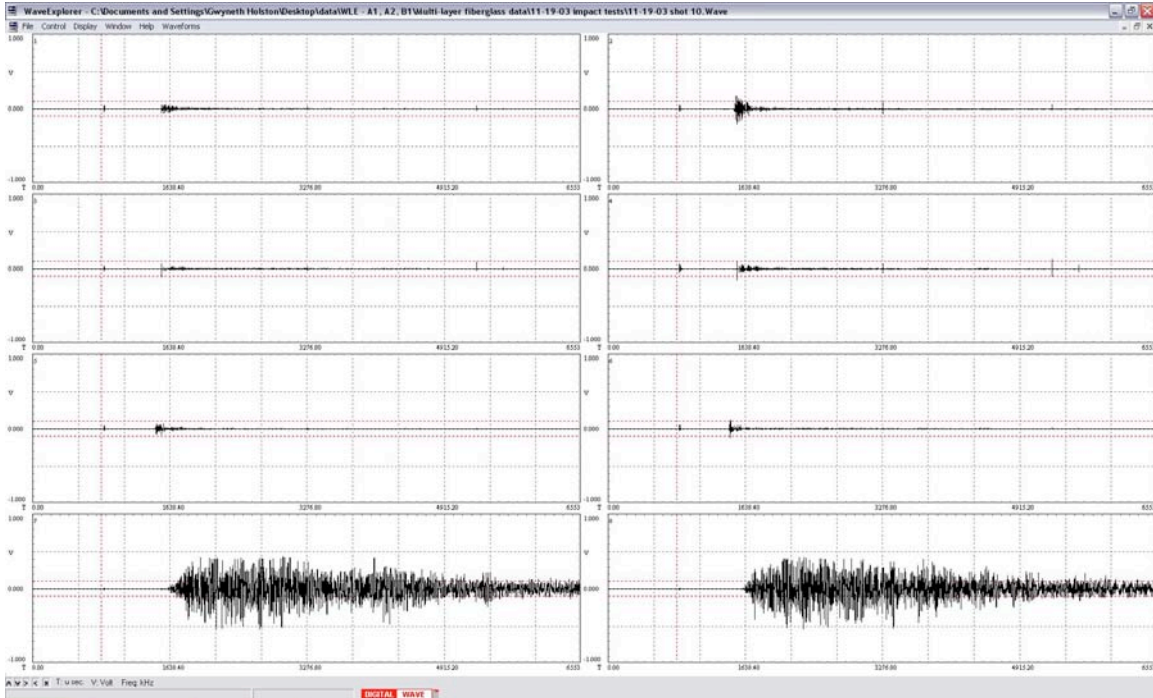
Comments: Saturation on Channel 7-8. EMI pulses seen at trigger time and also later in signals. No sensors debonded during test.

Figure 51: B-1 Shot #10 Impact Waveform

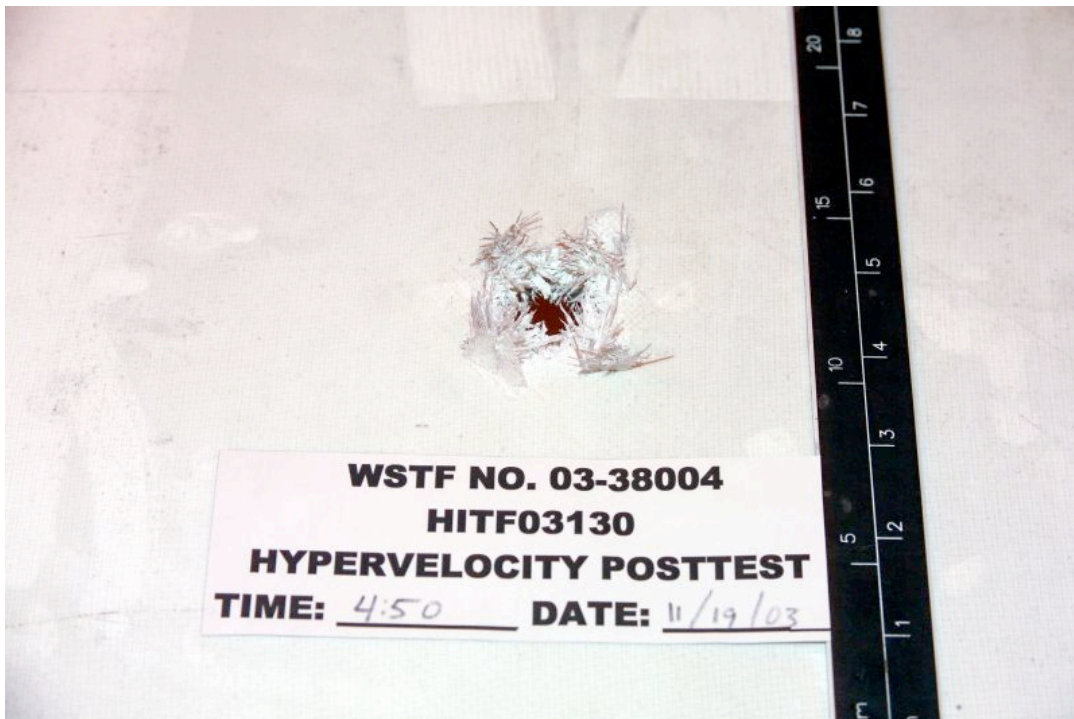
Figure 52: B-1 Shot #10 Impact Damage

Figure 21: B-1 Shot #10 Impact Damage

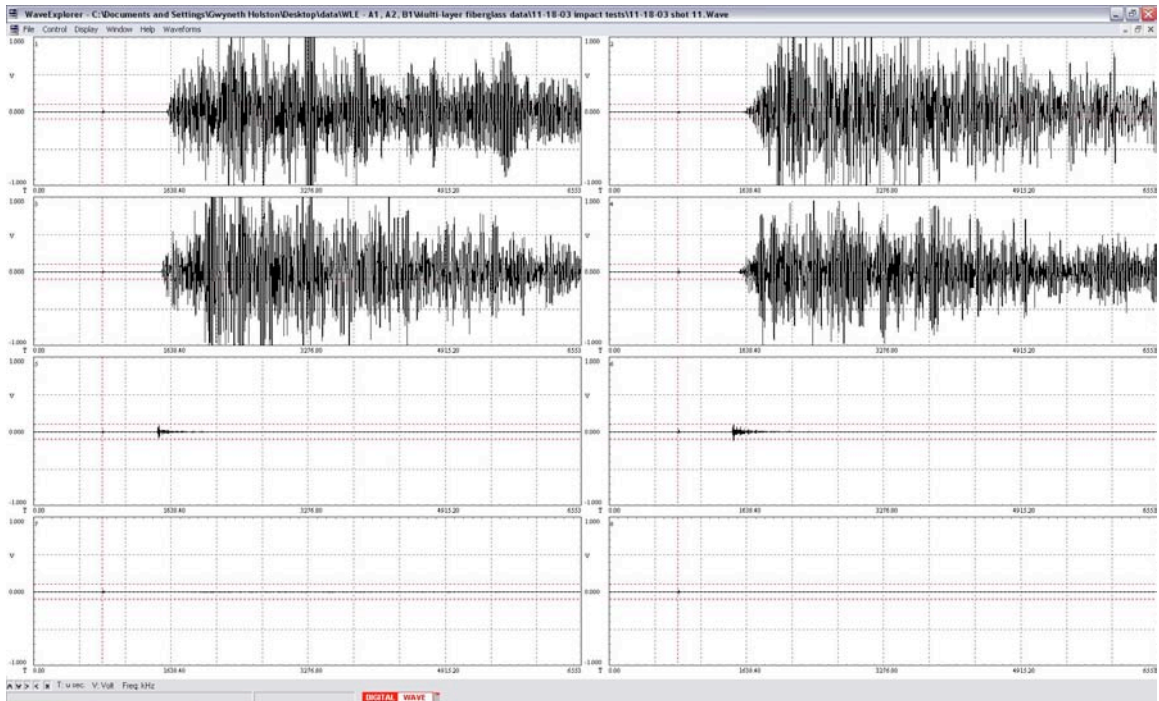
Comments: Signals saturated on channels 1-3 later in signal, not in direct arrivals. Signal acquired for this impact on channel 5. Channels 1-4 compared to Shot 1 on panel A-1 (with grommets) and showed ~14 dB higher amplitude without grommets. Channel 6 was similar in amplitude to the Shot 1 Channel 6.

Figure 53: A-2 Shot #11 Impact Waveform

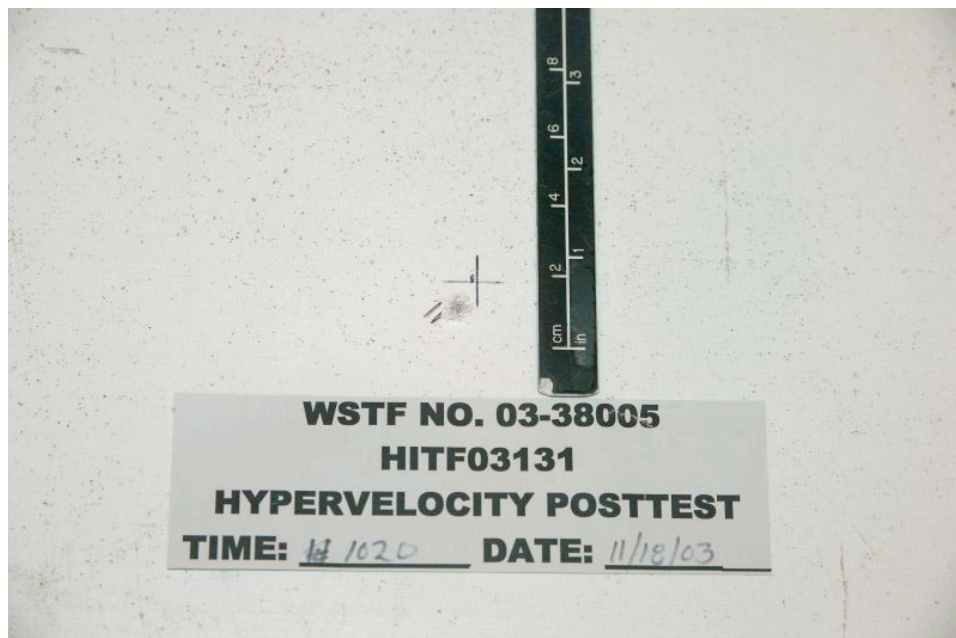
Figure 54: A-2 Shot #11 Impact Damage

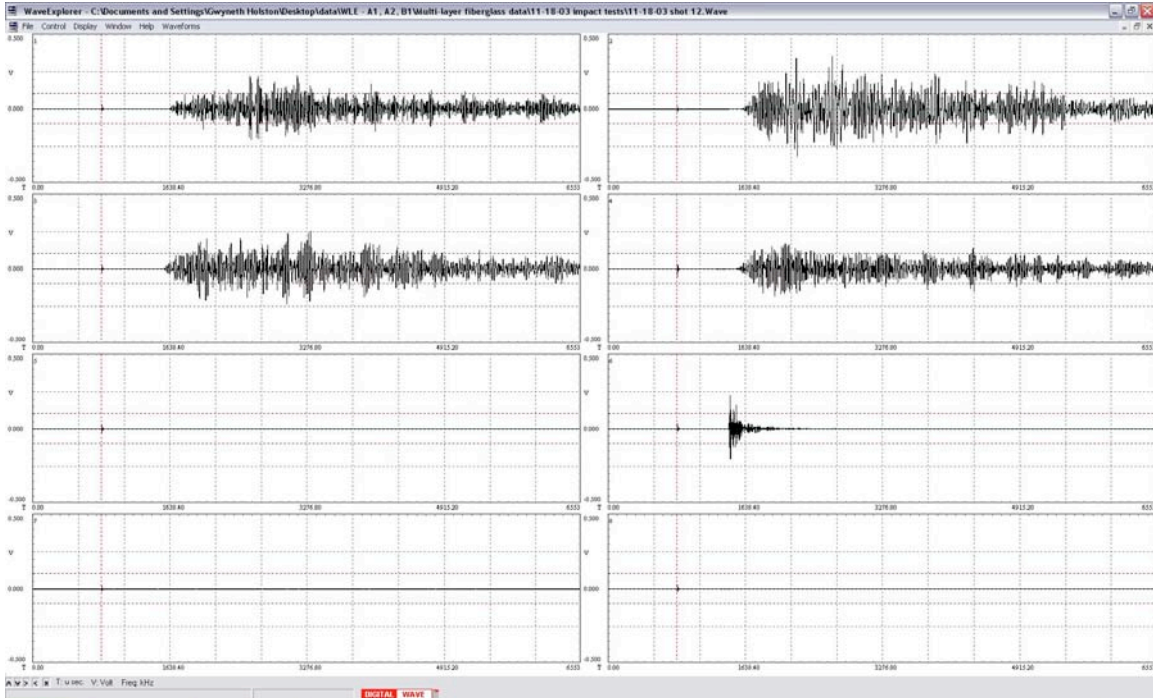
Comments: All signals in range. Channel 5 not recorded because of problem later identified as bad input connector on preamp. Channels 1-4 compared to Shot 2 on panel A-1 (with grommets) and showed ~14 dB higher amplitude without grommets. Channel 6 was similar in amplitude to the Shot 1 Channel 6.

Figure 55: A-2 Shot #12 Impact Waveform

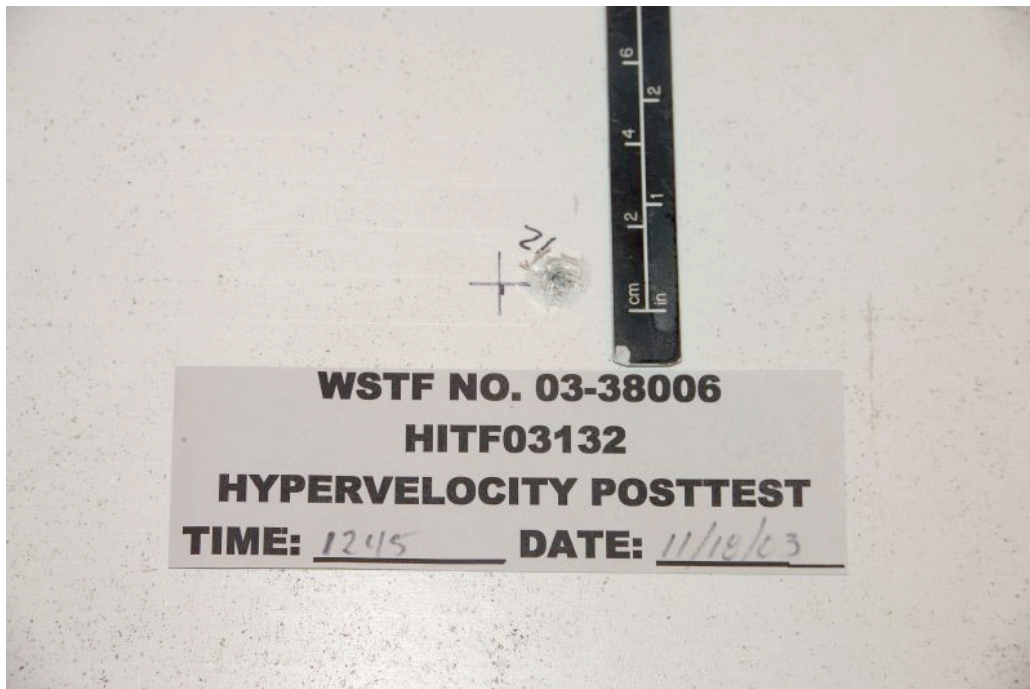
Figure 56: A-2 Shot #12 Impact Damage

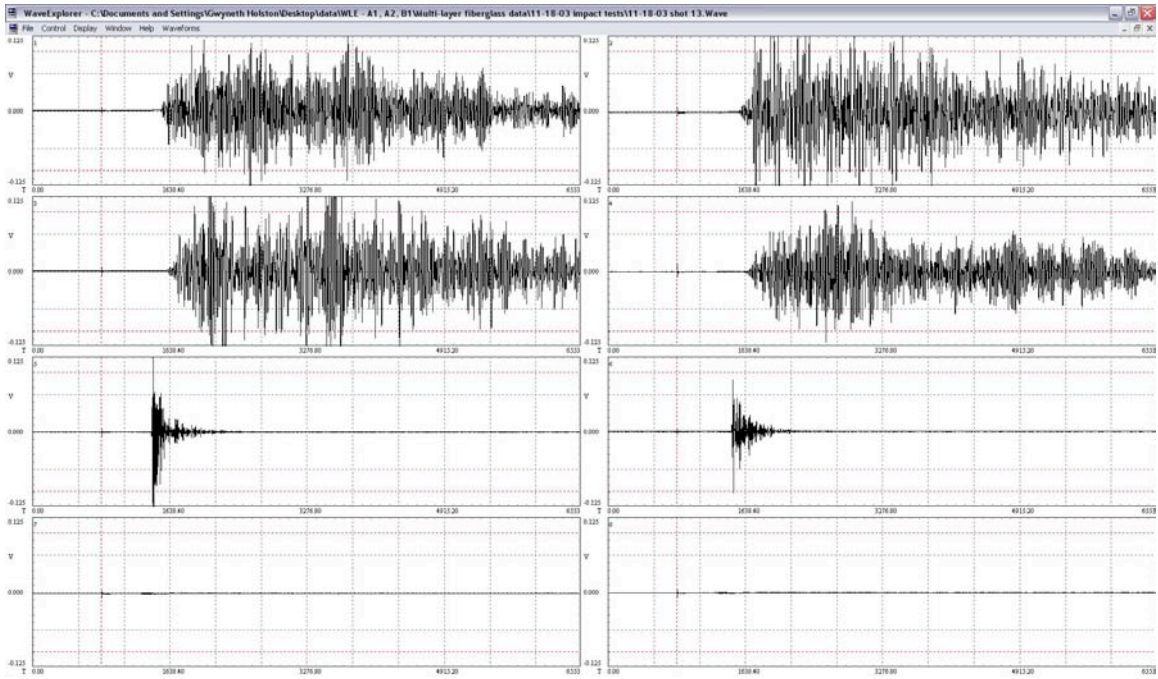
Comments: All signals in range. Preamp was replace on ch. 5 eliminating problem that caused previous loss of data on this channel. Again, signals on ch 1-4 compared to shot 3 on panel A-1 (w/grommets) and similar ~14 dB signal change observed.

Figure 57: A-2 Shot #13 Impact Waveform

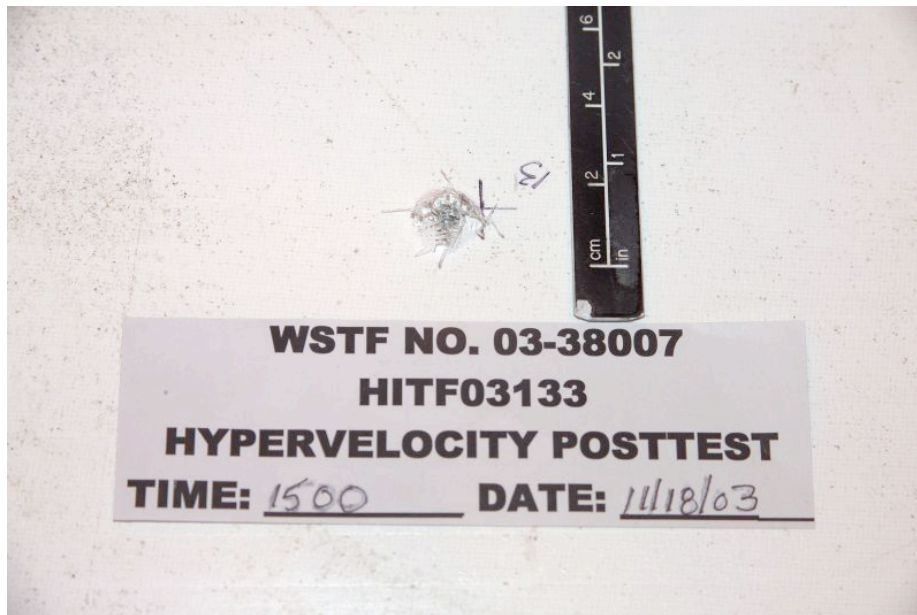
Figure 58: A-2 Shot #13 Impact Damage

Figure 22: A-2 Shot #13 Impact Damage

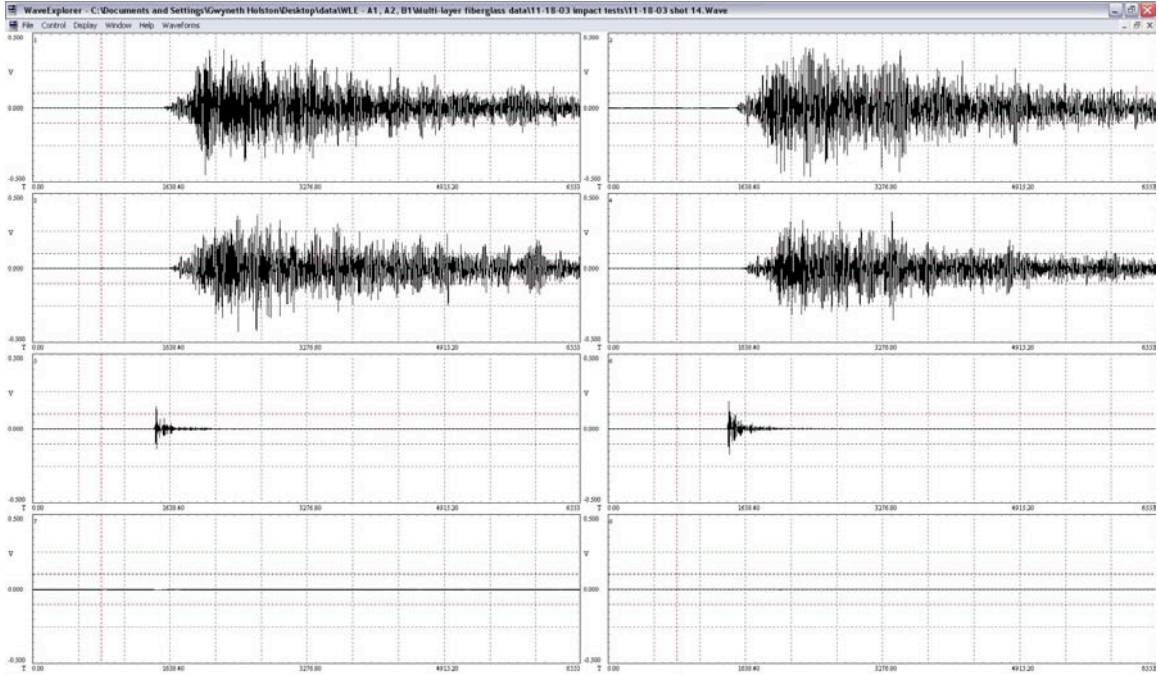
Comments: Again all signals in range. No comparison with signal from shot 4 possible as shot 4 data was lost because of a computer error.

Figure 59: A-2 Shot #14 Impact Waveform

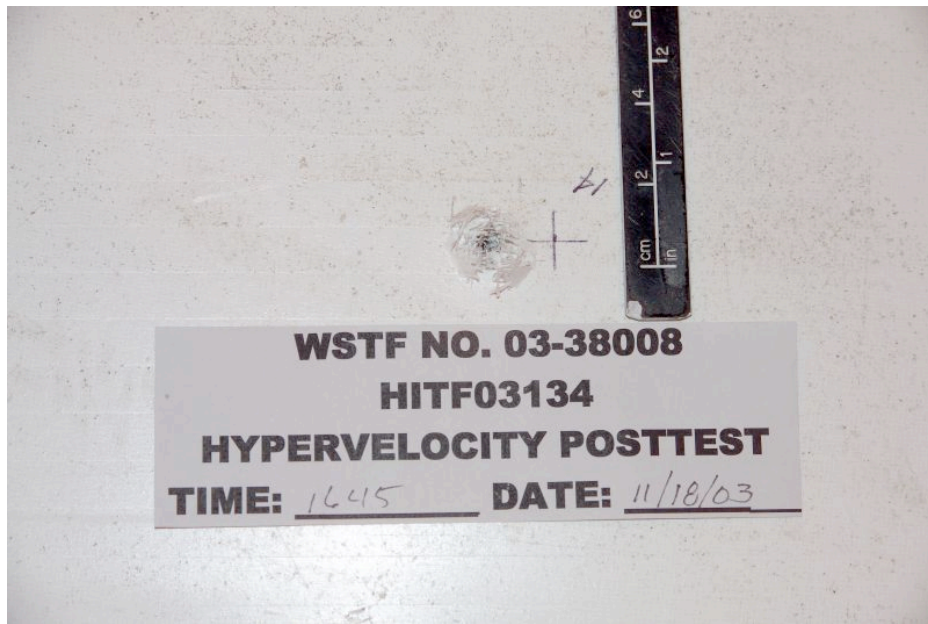
Figure 60: A-2 Shot #14 Impact Damage

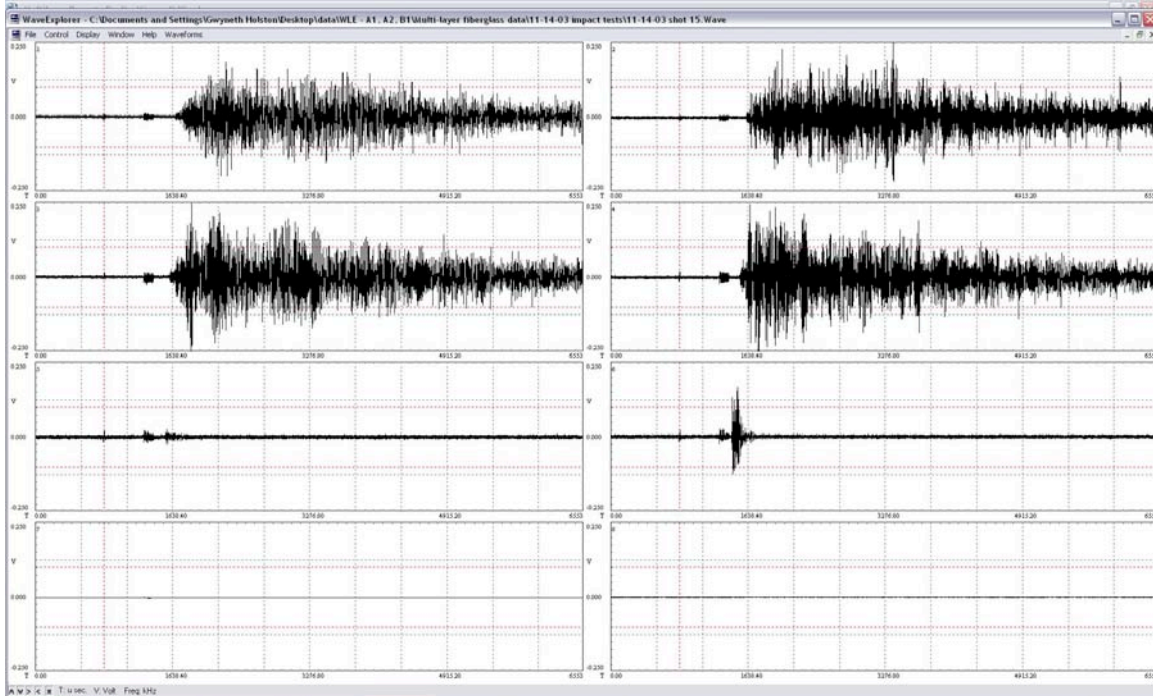
Comments: All signals in range except. Very small signal on Channel 5 that is suspect because of problem later found to be bad input connector on preamp.

Figure 61: A-2 Shot #15 Impact Waveform

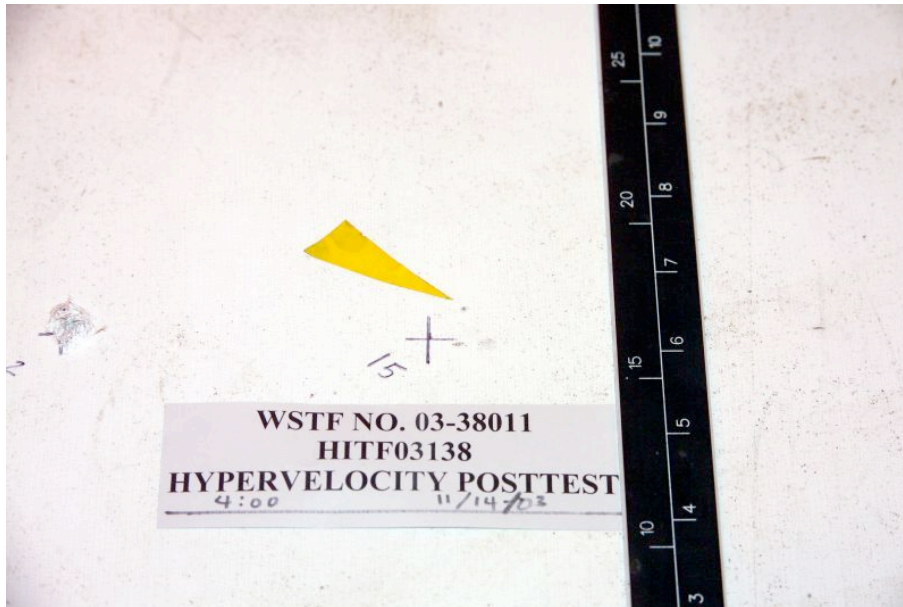
Figure 62: A-2 Shot #15 Impact Damage
