# Impact Resistance of EBC Coated SiC/SiC Composites

Impact performance of 2-D woven SiC/SiC composites coated with 225 and 525  $\mu\text{m}$  thick environmental barrier coating (EBC) was investigated. The composites were fabricated by melt infiltration and the EBC was deposited by plasma spray. Impact tests were conducted at room temperature and at 1316  $^{\circ}\text{C}$  in air using 1.59-mm diameter steel-balls at projectile velocities ranging from 110 to 375 m/s. Both microscopy and nondestructive evaluation (NDE) methods were used to determine the extent of damage in the substrate and coating with increasing projectile velocity. The impacted specimens were tensile tested at room temperature to determine their residual mechanical properties. At projectile velocities less than 125 m/s, no detectable damage was noticed in the MI SiC/SiC composites coated with 525  $\mu\text{m}$  EBC. With increase in projectile velocity beyond this value, spallation of EBC layers, delamination of fiber plies, and fiber fracture were detected. At a fixed projectile velocity, the composites coated with 525  $\mu\text{m}$  EBC showed less damage than the composite coated with 225  $\mu\text{m}$

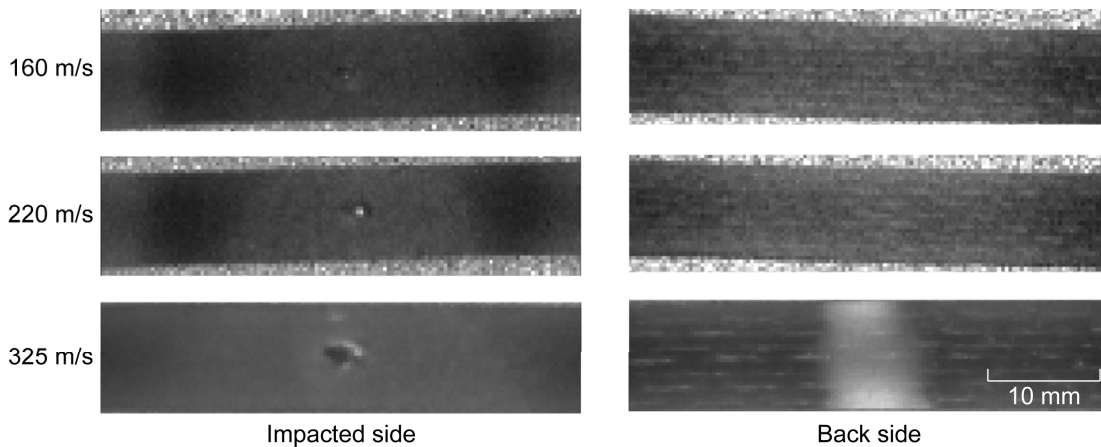
Figure 3.—Pulsed thermography images showing evolution of subsurface damage with projectile velocity for 525  $\mu\text{m}$  EBC coated MI SiC/SiC composites impact tested at room temperature.

The weave pattern of the 2-D SiC cloth observed in figures 2(d), (e), and (f) also can be recognized in the thermal images shown in figure 3. At projectile velocities less than 220 m/s, little damage occurred to the EBC coating. With an increase in projectile velocity greater amounts of damage to EBC coating was noticed, but perforation or backside damage was not observed at projectile velocities as high as 375 m/s. In contrast, composite coated with 225  $\mu\text{m}$  EBC showed increasing amount of backside damage at projectile velocities greater than 220 m/s and perforation at projectile velocities greater than 300 m/s.

Figures 3 and 4 show the thermal and CT images of the specimens shown in figure 2. These figures show both the surface and subsurface damages. The white spot at the center of the specimen in figure 3(c) is an indication of delamination area as detected from the backside of the sample with thermography. In the CT images shown in figure 4, defect identification in the substrate becomes more difficult because of

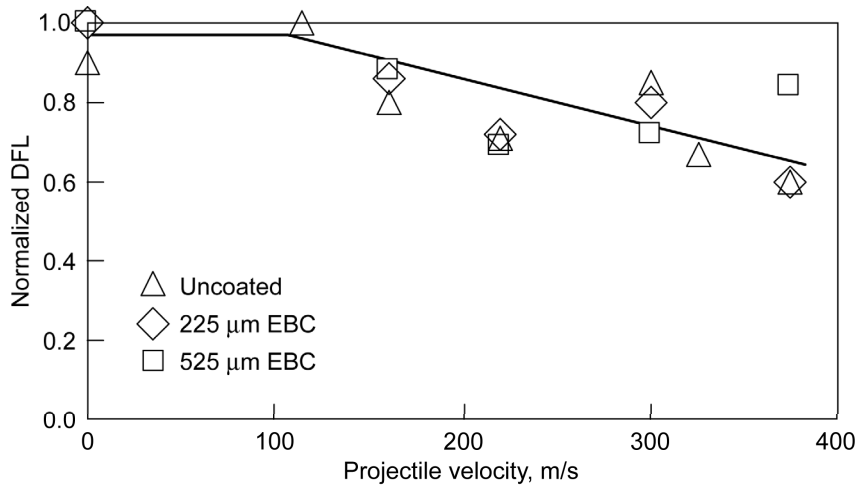
Figure 12.—Influence of projectile velocity on stress corresponding to DFL for uncoated and EBC coated MI SiC/SiC composites impact tested at room temperature. Normalized DFL reflects ratio of the DFL stress of impacted to un-impacted specimens. Uncoated data is from reference 20.

To determine the effect of impact damage on tensile properties of the EBC coated composites accounting for batch to batch to variations in mechanical properties, it is necessary to normalize the data. Figures 11, 12, and 13 show influence of projectile velocity on normalized E, DFL stress, and UTS. For normalization, the tensile properties of the impact tested composites are divided by those of as-produced condition. For example, normalized E indicates ratio of E of the impact tested EBC coated specimens to the E of EBC coated specimens. In these figures the normalized data of impact tested MI SiC/SiC composites without EBC coating from reference 20 are also included. The following general statements can be deduced from these figures. First, the composites tested at projectile velocities up to 110 m/s show no significant loss in tensile properties compared to baseline tensile data for the as-produced EBC coated composites. Second, beyond 110 m/s, E, DFL, and UTS decrease linearly with increase in projectile velocity. Third, the E and DFL stress loss behaviors with increasing projectile velocity for the uncoated and EBC coated composites are similar. Fourth, the loss of UTS with increasing projectile velocity for the composite coated with 525  $\mu\text{m}$  EBC is much lower than that observed for uncoated and 225  $\mu\text{m}$  EBC coated composites. The loss of modulus and DFL stress indicates delamination of the fiber plies from the matrix and cracking of the matrix, where as loss of UTS indicates loss of load carrying capability of the composite due to loss of fiber as the projectile penetrates through the thickness. These plots also suggest that SiC/SiC composites coated with thicker EBC retain a greater percentage of the as-fabricated tensile properties after impact testing at velocities as high as 375 m/s compared to the uncoated SiC/SiC composites or similar composites coated with thinner EBC.
