Saturn V - Design Considerations & Launch Issues

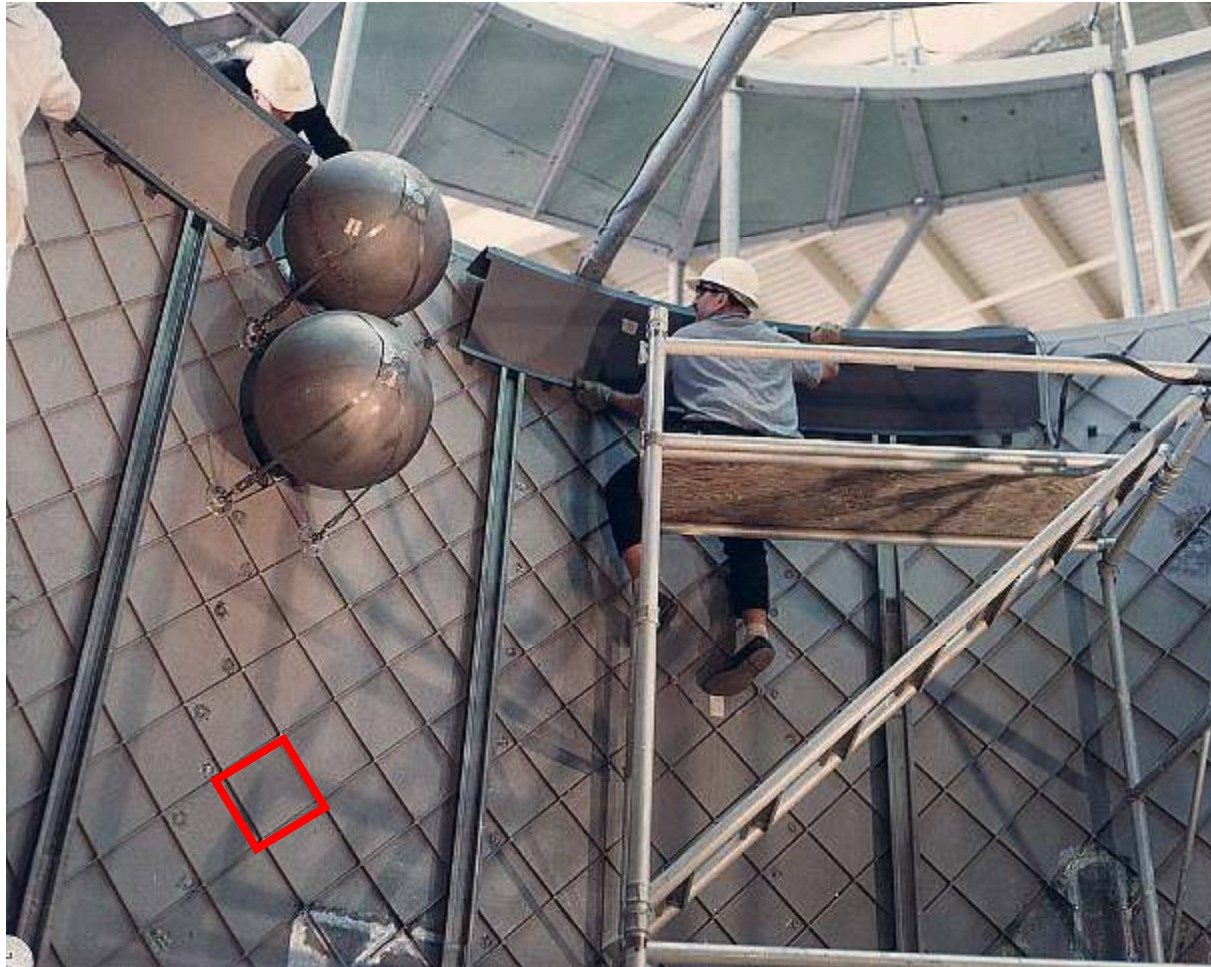
Tank Structures

- Waffle pattern was etched into the S-II and S-IVB

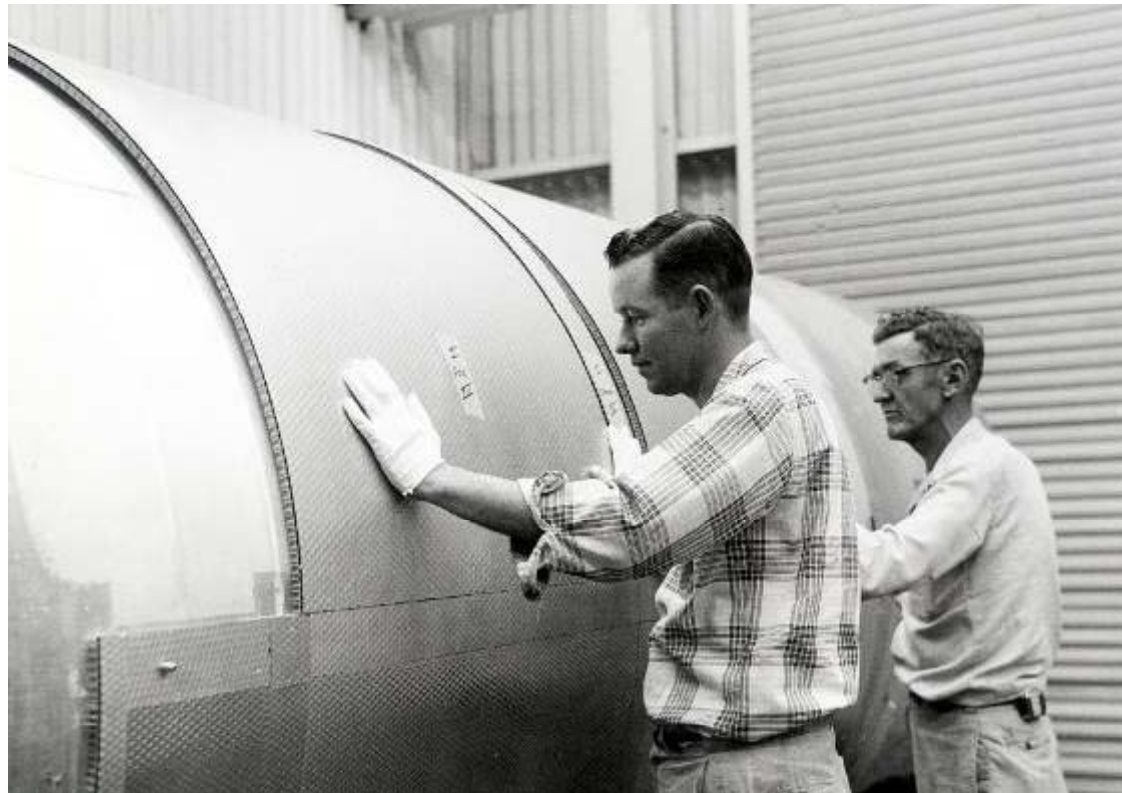
S-II (External Insulation)

- ❑ First method of application: Glue large panels of insulation
 - Trapped air posed problems
 - Tried helium purge to remove trapped air

- ❑ Sprayed insulation on, trimmed excess

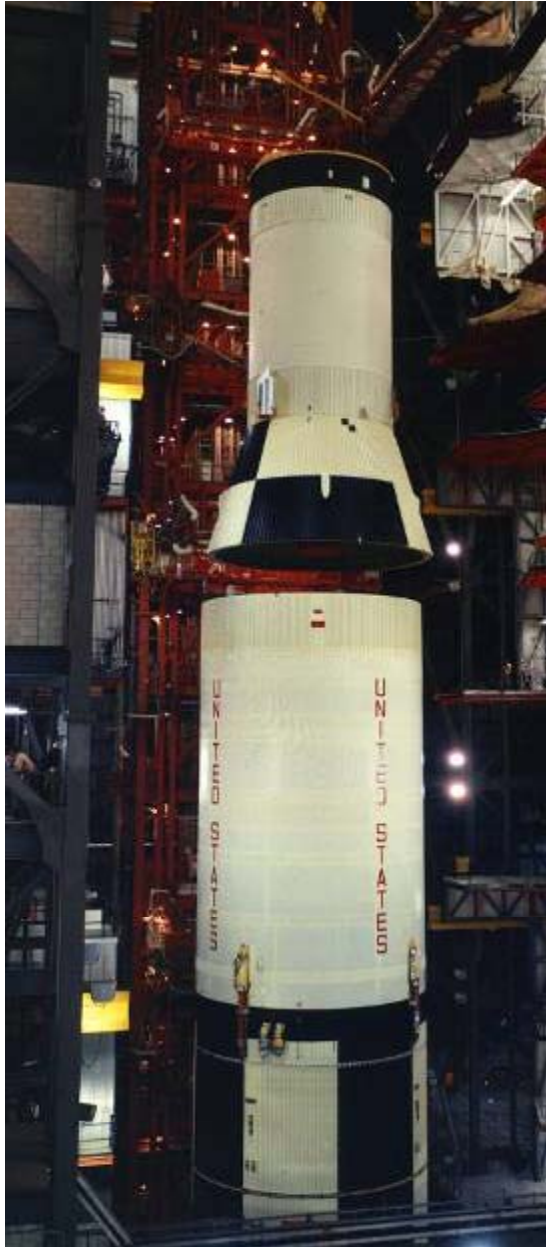
S-IVB (Internal Insulation)

- ❑ 4,300 individually shaped foam bricks glued to the interior

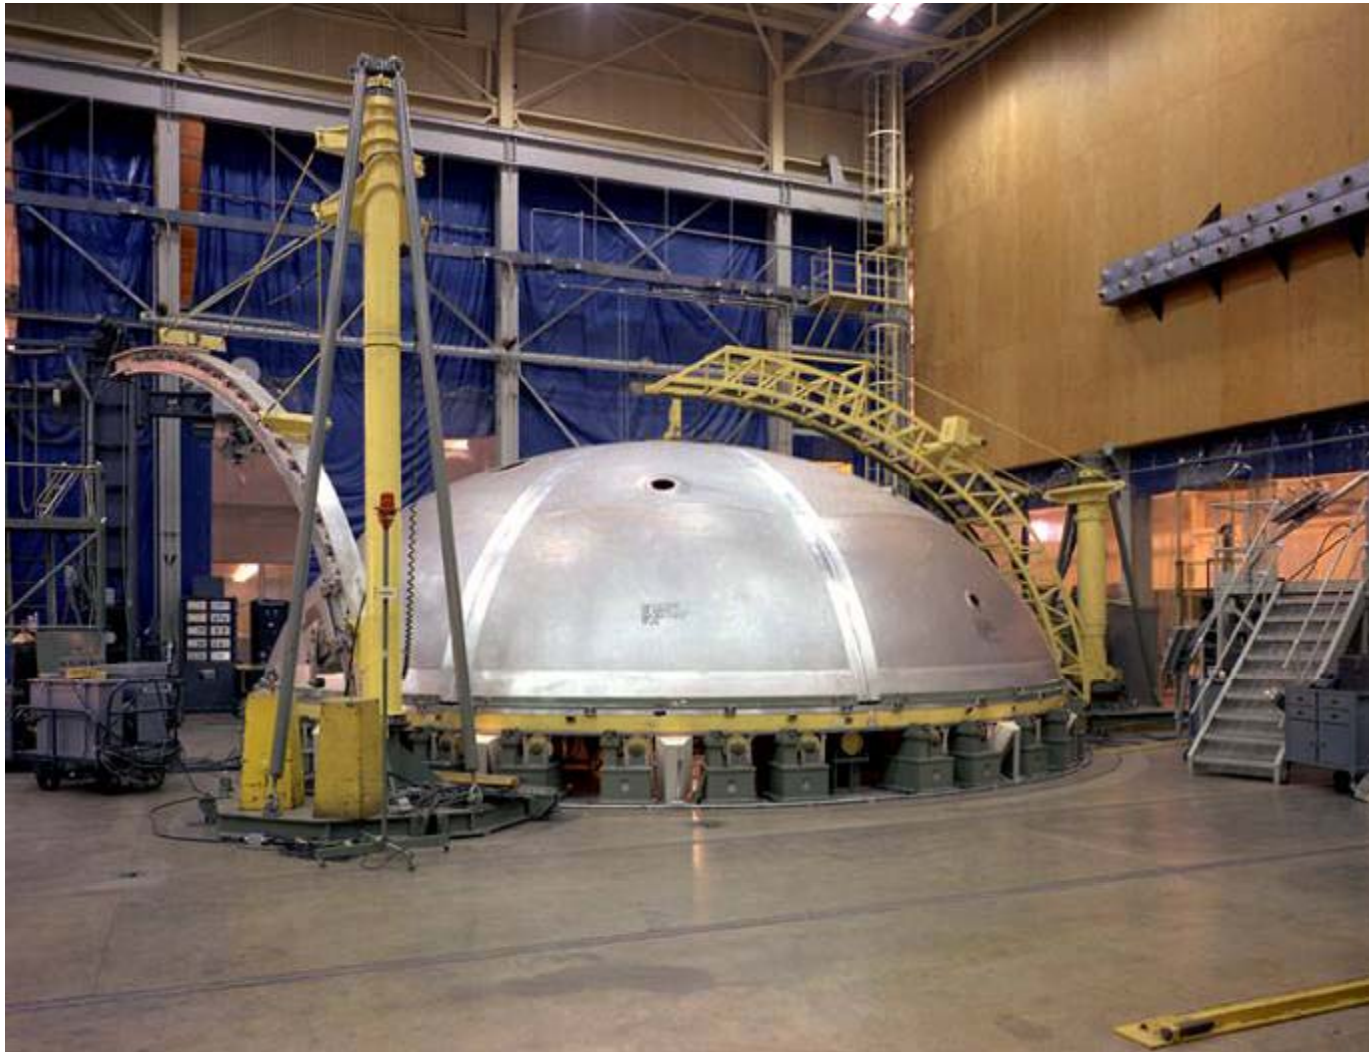
Welding

- ❑ Large pieces that can deform under their own weight
- ❑ Extremely long welds required with tight tolerances

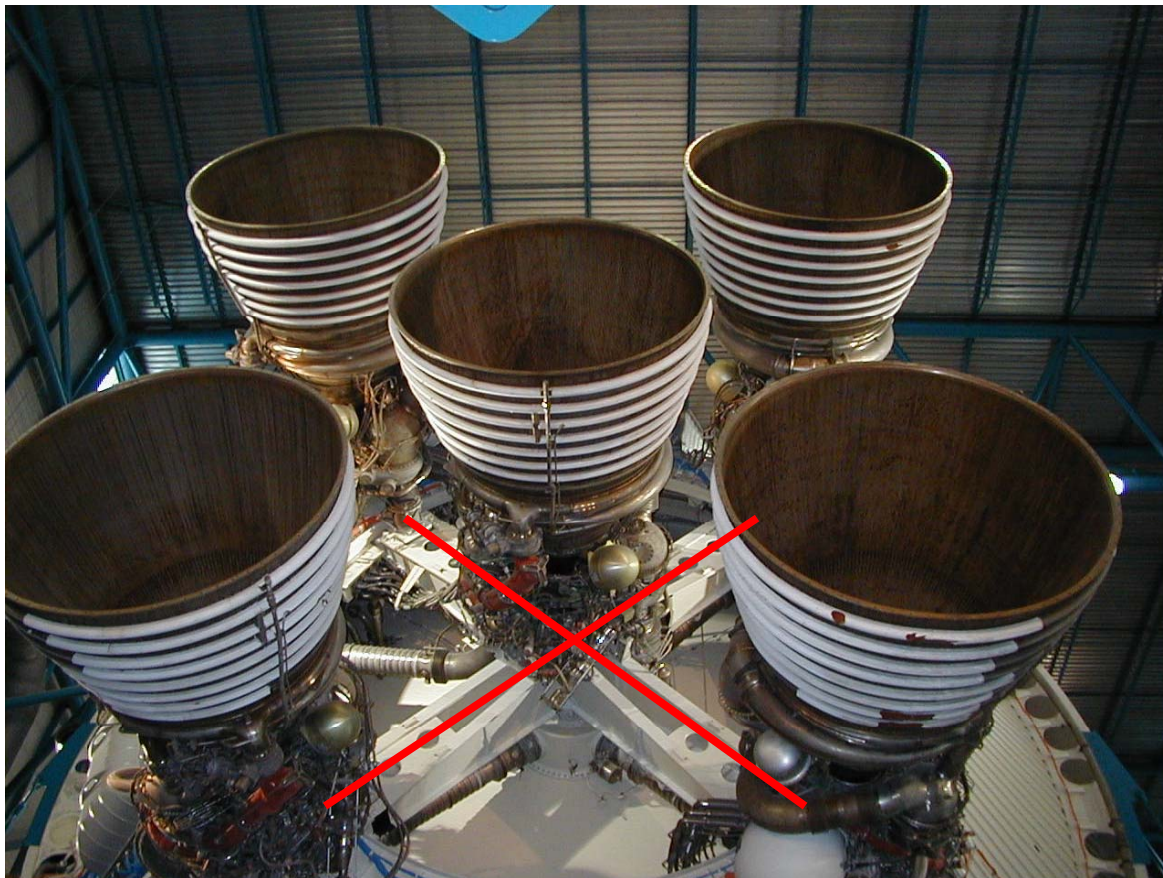
Pogo – Stage 2

- ❑ Center Engine (#5) on S-II supported only via cross beams
 - Allowed engine to move, which contributed to the Pogo effect
