ANSI/AIAA s-081A Pressure Vessel Standards Implementation Guidelines August 6-7, 2009

Composite Pressurized Structures Group
NASA White Sands Test Facility
Nathanael Greene 575.525.7601
Regor Saulsberry 575.524.5518

Composite Overwrapped Pressure Vessel NDE

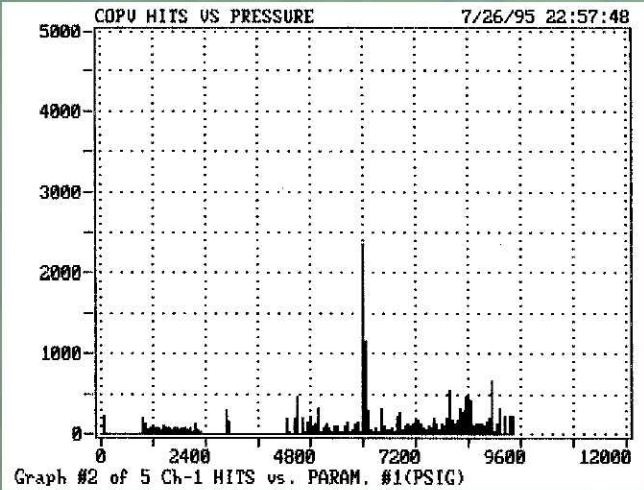
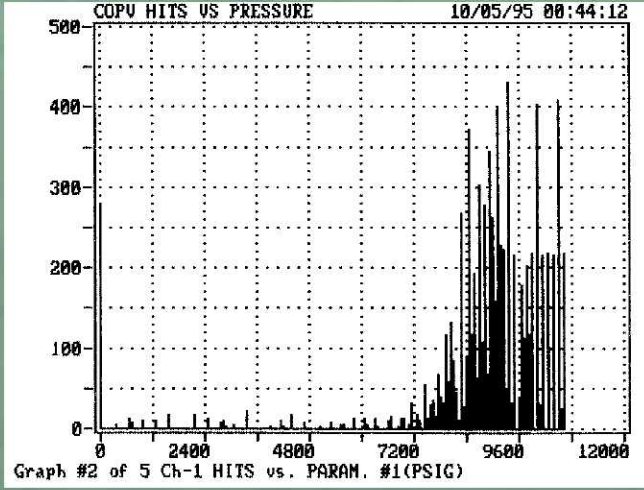
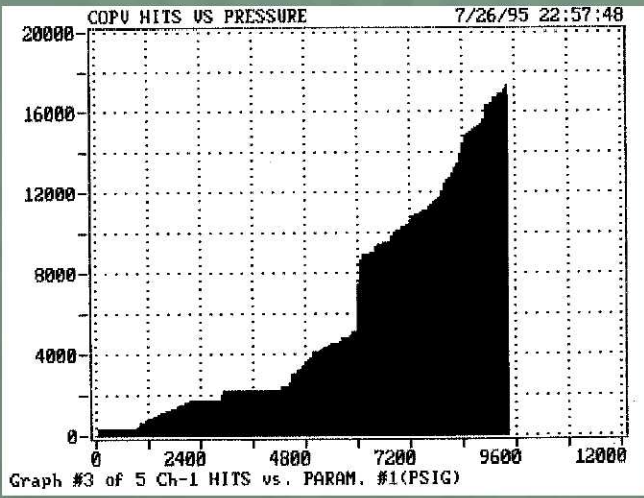
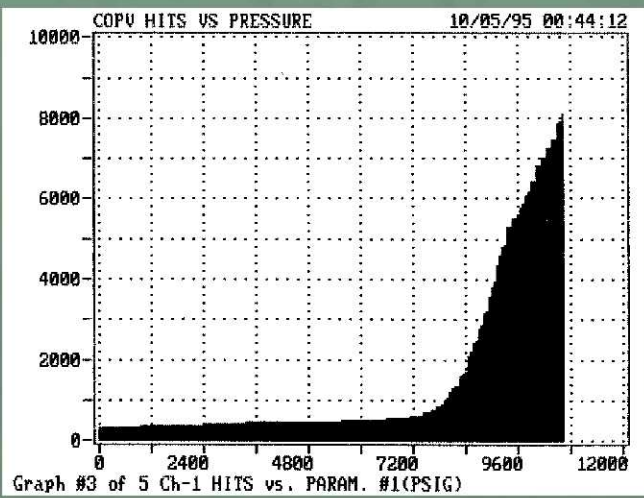
AE Spectra

Impact-damaged COPV

Undamaged COPV

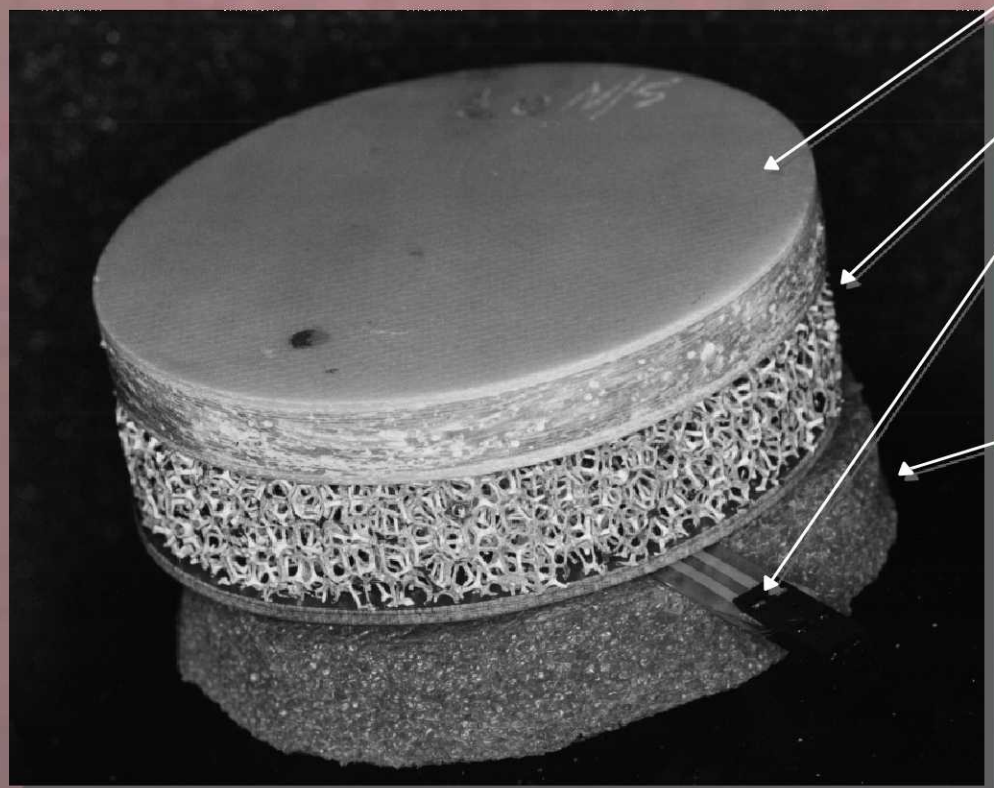
Hard-shell laminate cover shield

Fiberglass/epoxy composite
hardshell

Aluminum mesh foam

Resistive force sensor
mounted on thin
fiberglass board

Ensolite[®] high-density foam

Impact indicator/protector cross section

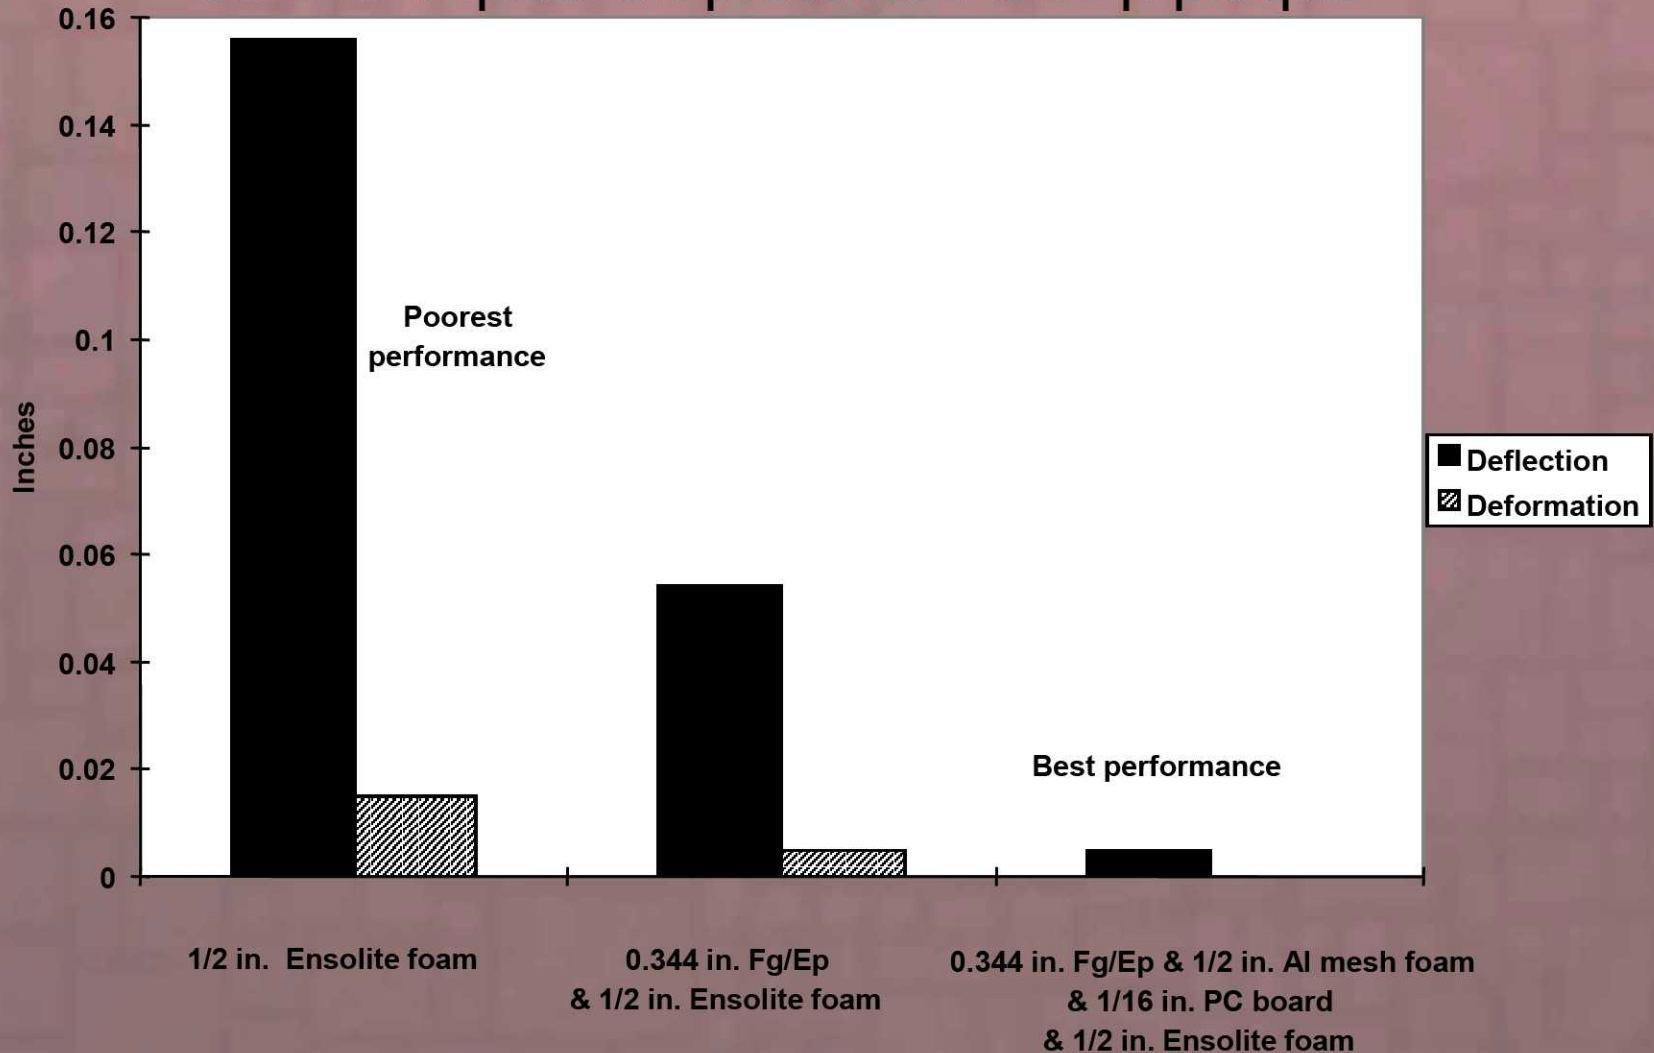
Protector Mechanical Performance

35 ft-lb impact on protected Gr/Ep plaque

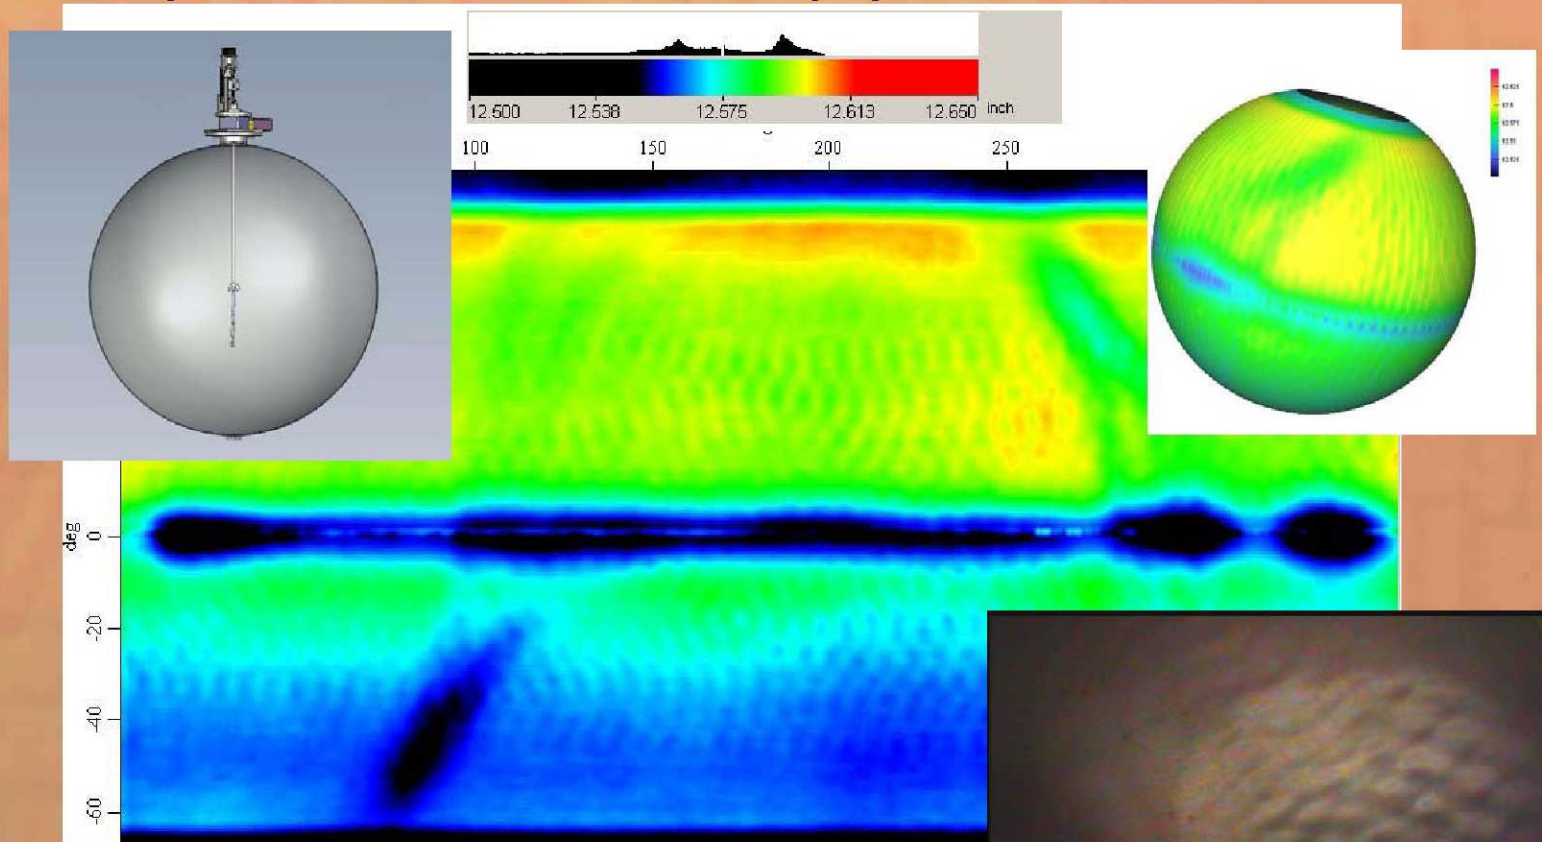
Laser Profilometry of COPV's interior surface quantifies liner buckling not inspectable by other methods and mirrors physical observation

Calibration traceable to National Standard and demonstrated better than 0.001 accuracy/repeatability on 26-in. and better than 0.002 accuracy/ repeatability on 40-in.

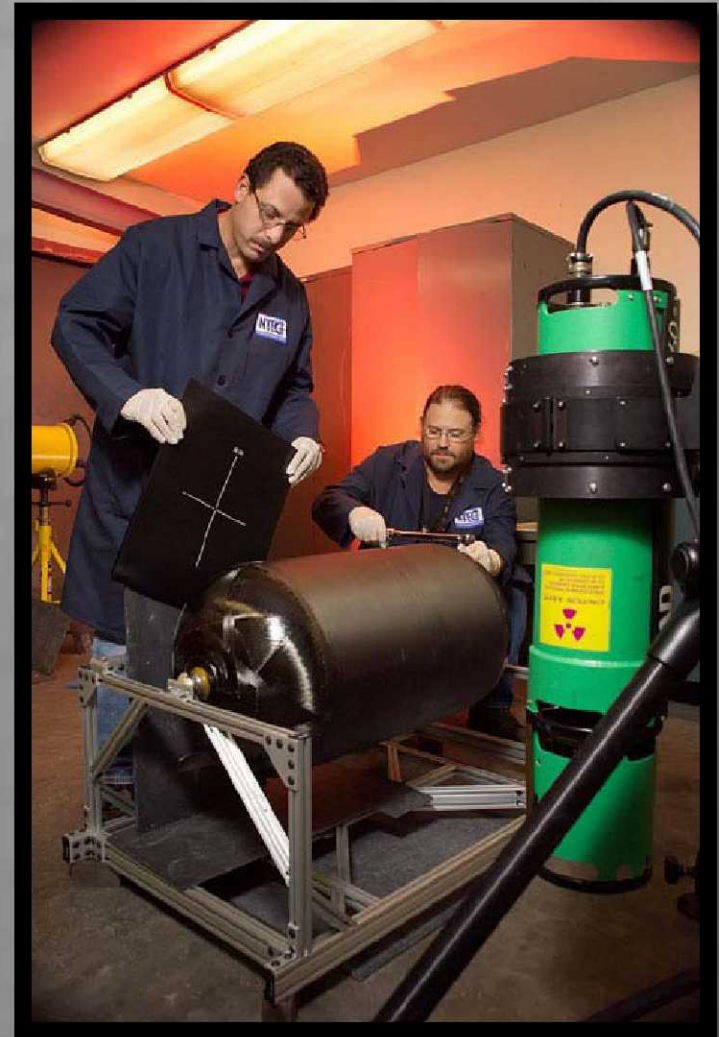
Radiography

- Radiographic examination
 - Identify cracks in liner
 - Image discontinuities in the weldments
 - Thickness of the weldment heat-affected zones
- Identify Liner buckles or ripples

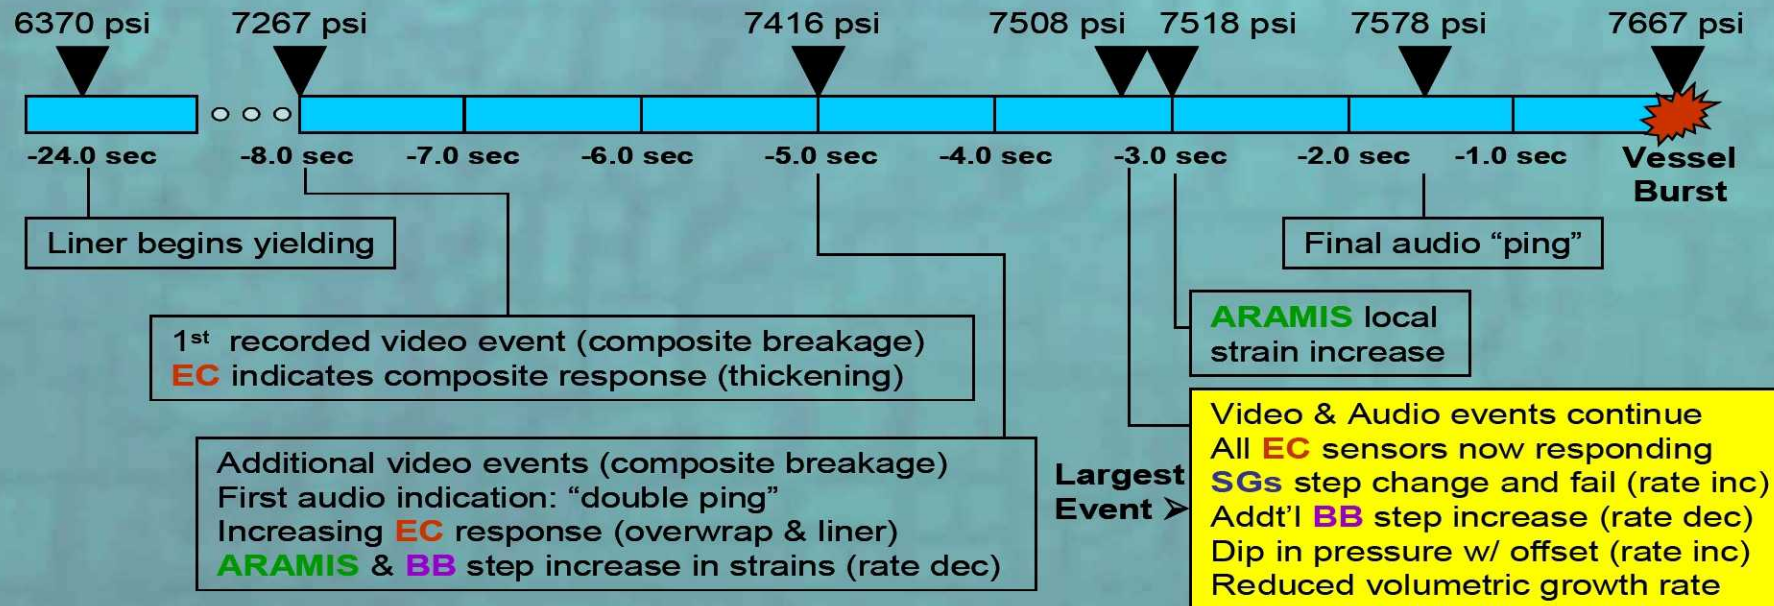
Chronological Mapping of Tank Failure

Team mapped all the instrumentation data to the video record to determine the chronological sequence of the burst events

- Found that all data were consistent
- Acoustic emission system became saturated and was not usable late in the burst
- At T-8 sec, visual evidence of fiber failure at the outer surface with minimal response from other onboard instrumentation
- The timeline from T-5 onward was a flurry of activity from most of the onboard instrumentation

EC = Eddy Current
ARAMIS = Digital Image
SG = Strain Gauge
BB = Belly Bands

t-5 thru t-3.2 sec
NOTE: Steady tow breakage on video towards burst point.

Final 3 seconds
NOTE: EC shows steady composite thinning. Liner sensors show similar trends.

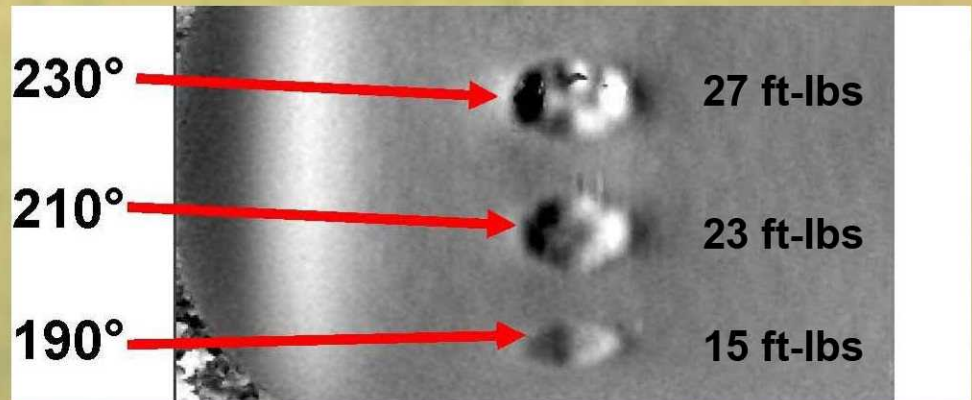
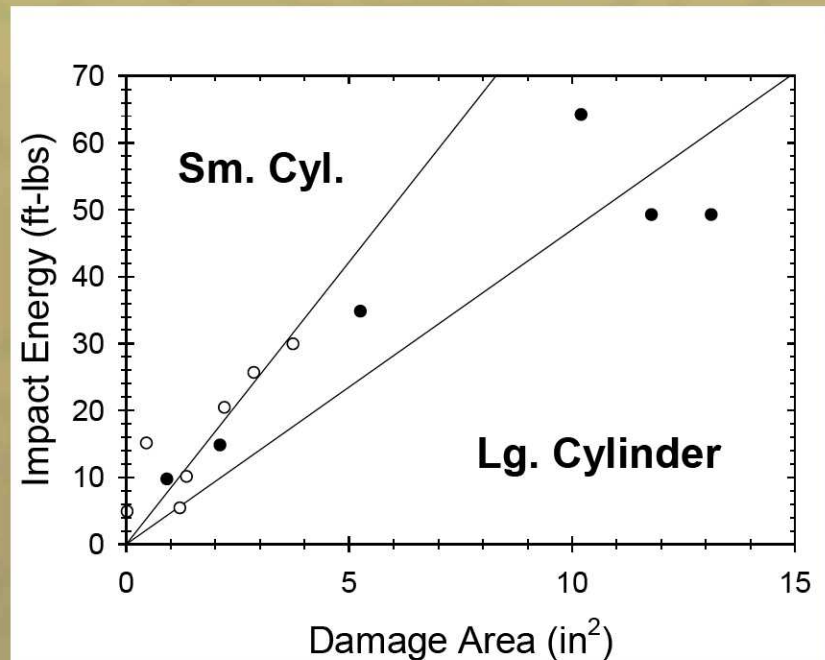
Shearography Inspection

1. Shearography detected small damage sites below the visual detection threshold
2. Shearography indicated damage much more extensive than visually evident
3. Damage area increases with impact energy for all COPVs

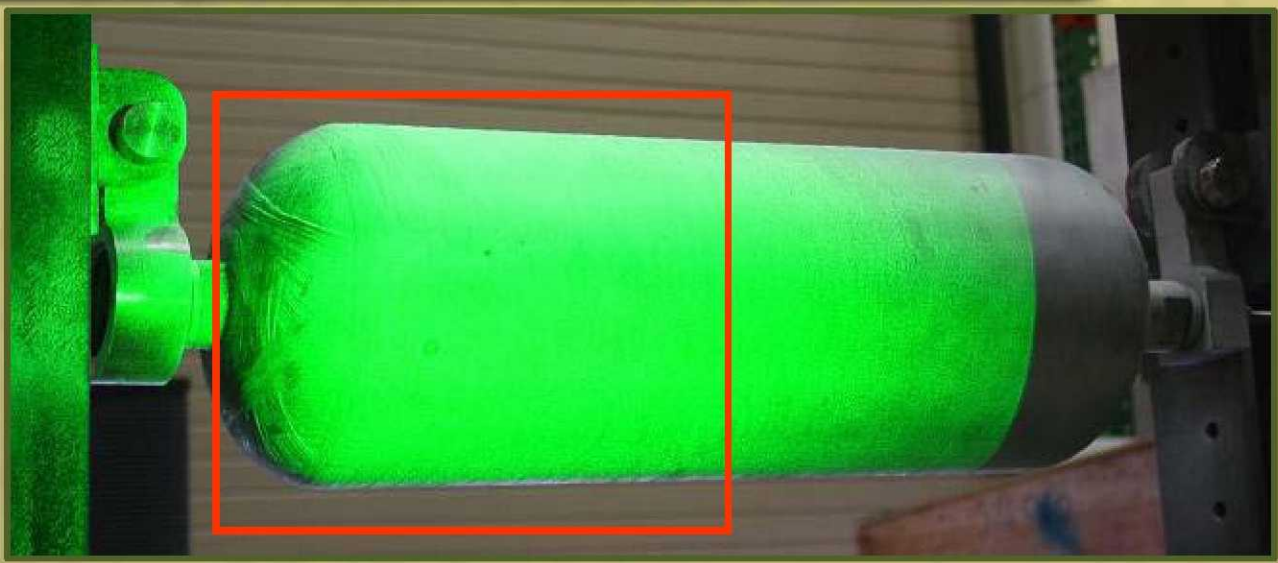
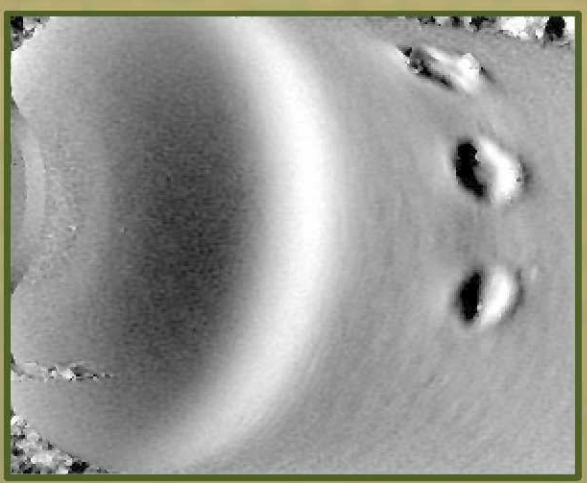
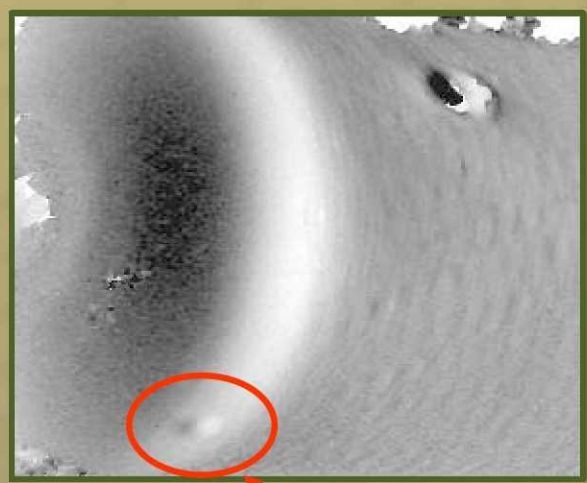
6 x 22-in. Graphite COPV Shearography Inspected with 10 psid

Centered
at 30

Centered
at 60

Unprogrammed Damage

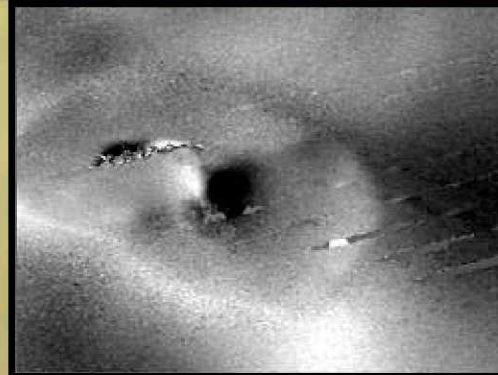
Carbon Fiber COPV: Impact Damage

1- 5 psi. Shows broken fibers at center with a large delamination.

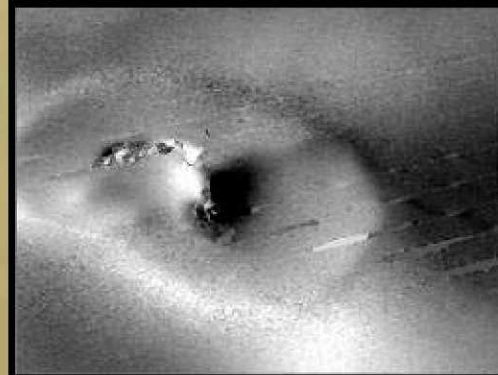
20-24 psi. Shows more detail.

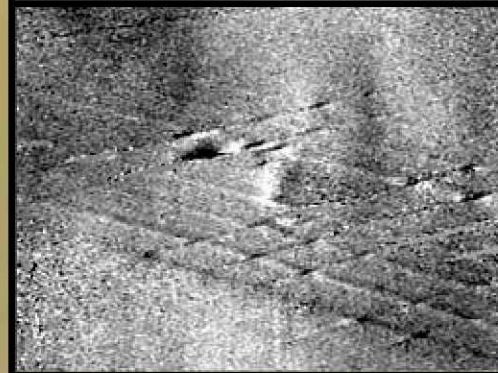
150-154 psi. Image of delamination not detected, broken fibers in center.

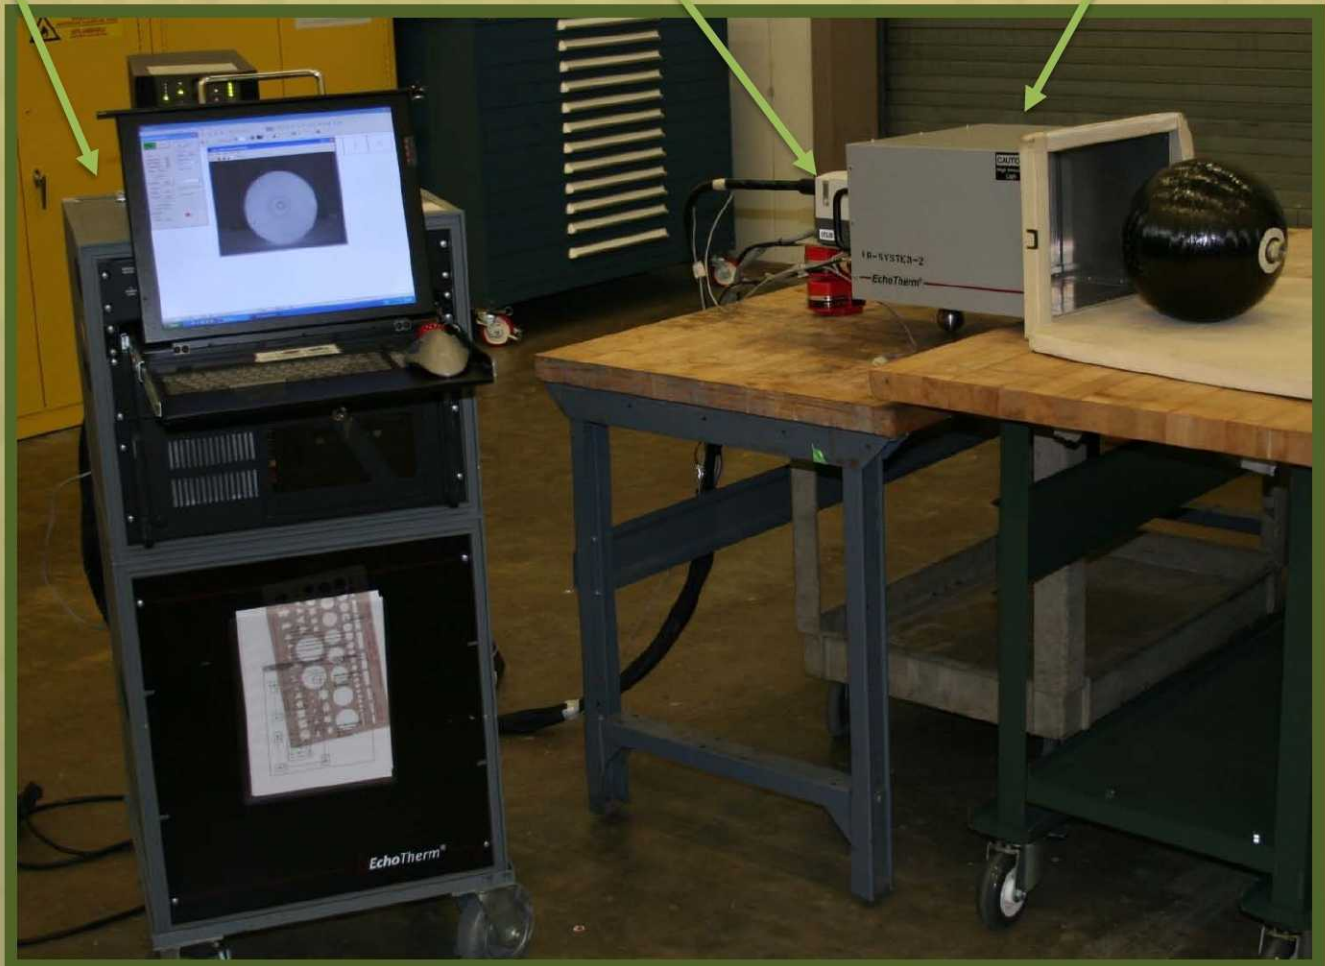
Flash Thermography Setup

Data Acquisition Station

Camera

Hood containing 2 high intensity flash bulbs

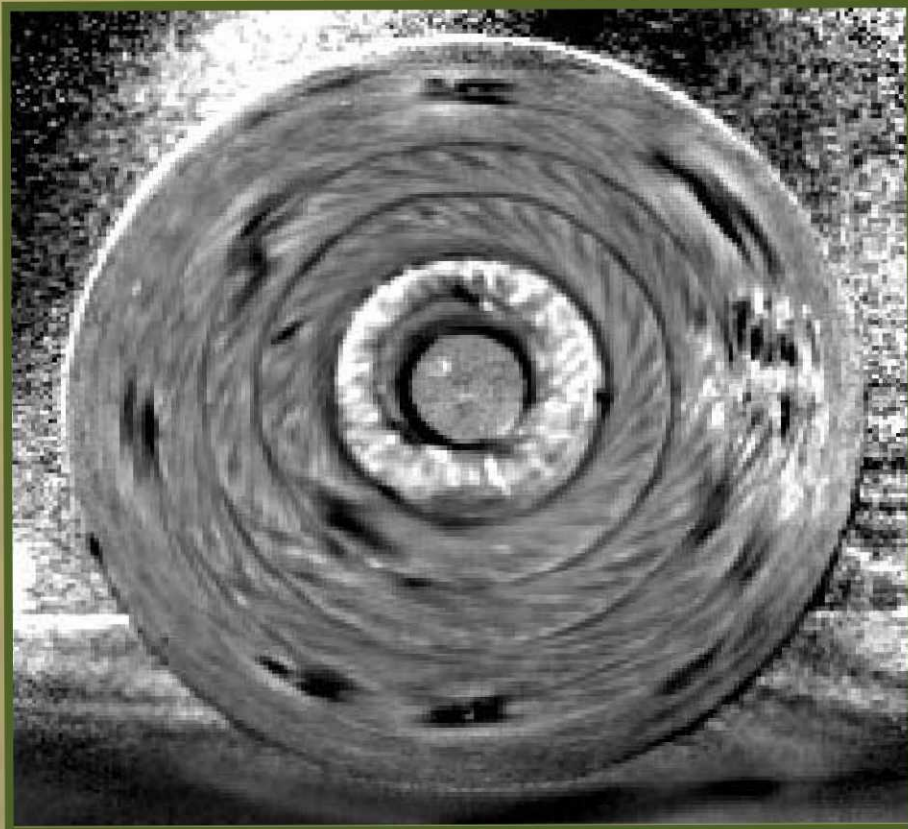
Bottom Boss 0 deg TDC

2nd Derivative

2.5 Sec.

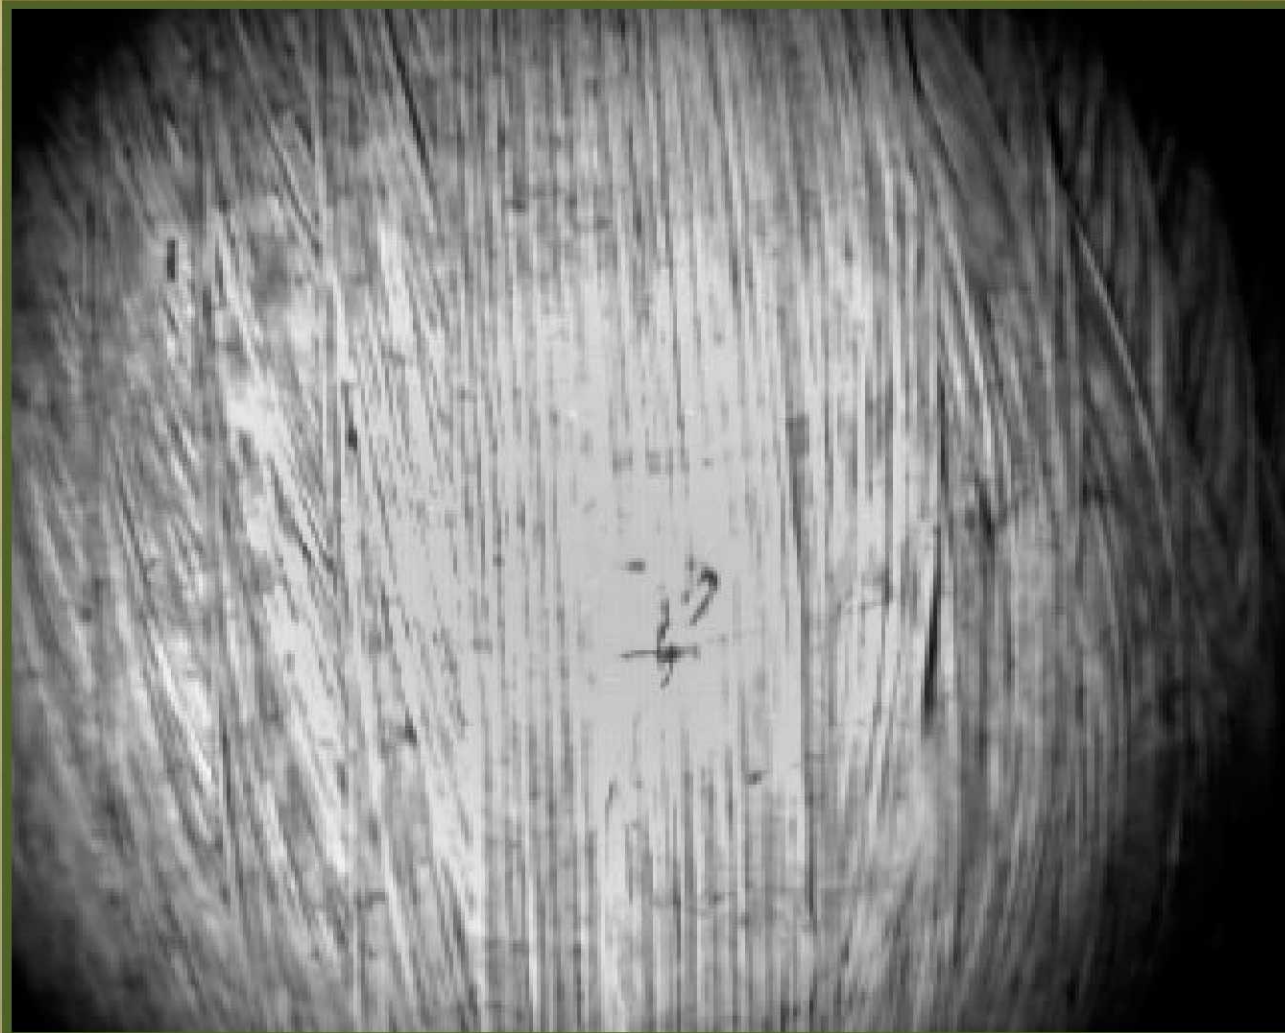
COPV 47 at 135 , 2.5 sec, Raw, 25 mm
