Inspection for Damage to Carbon/Epoxy Composite Overwrapped Pressure Vessels

NASA White Sands Test Facility
August 2010

Objective: To train aerospace flight hardware visual inspectors detect visible damage to the composite shell of Graphite/Epoxy COPVs. This course satisfies requirements of KHB 8715.3 (latest revision), AIAA S-081, AIAA S-081A, and AFSPCMAN 91-710 for trained visual inspectors of flight-weight COPVs.

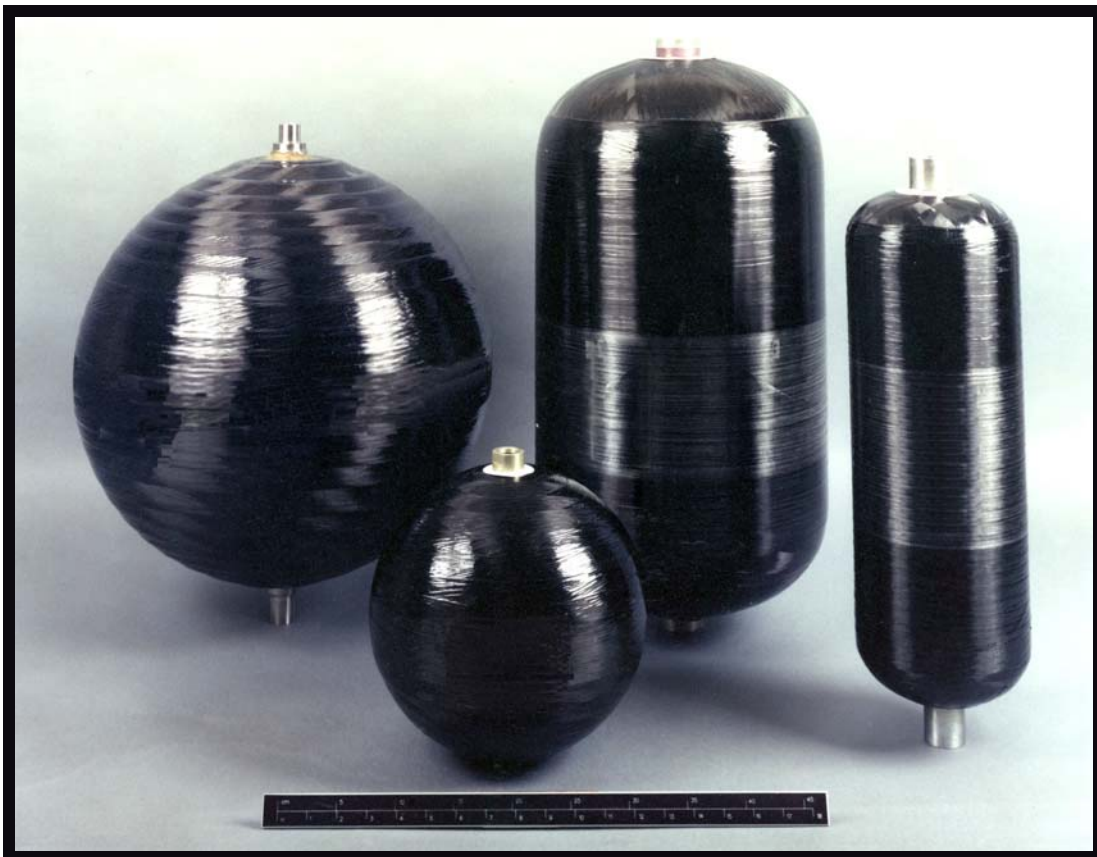
COPV Program Test Articles

- Establish baseline strength
- Determine
 - Failure mode/safe life
 - Effects of impact damage and the consequences of long-term pressurized storage (1/2 year and >12 years)
- Evaluate
 - Materials compatibility with Aerospace fluids
 - Hypergols
 - Cryogens
 - Other (e.g. alcohol)
 - NDE techniques

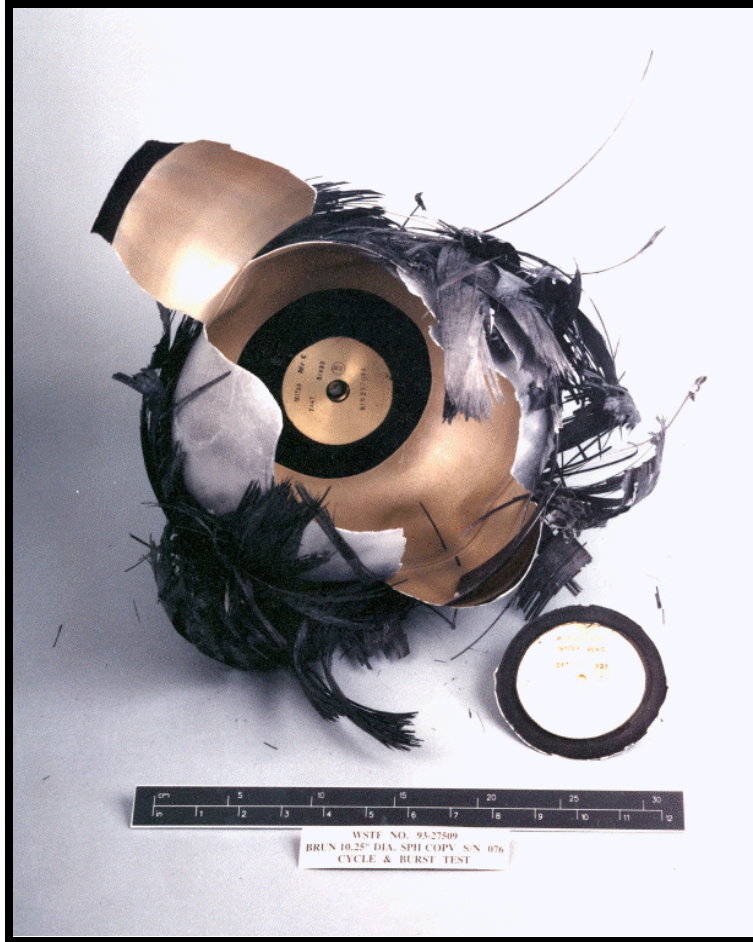
Small Sphere Undamaged Burst

- Determine baseline burst strength and failure mode
 - Manufacturers' system/procedures vary
 - Baseline WSTF system/procedures
- Use DI water pressurization media
 - May cycle before burst

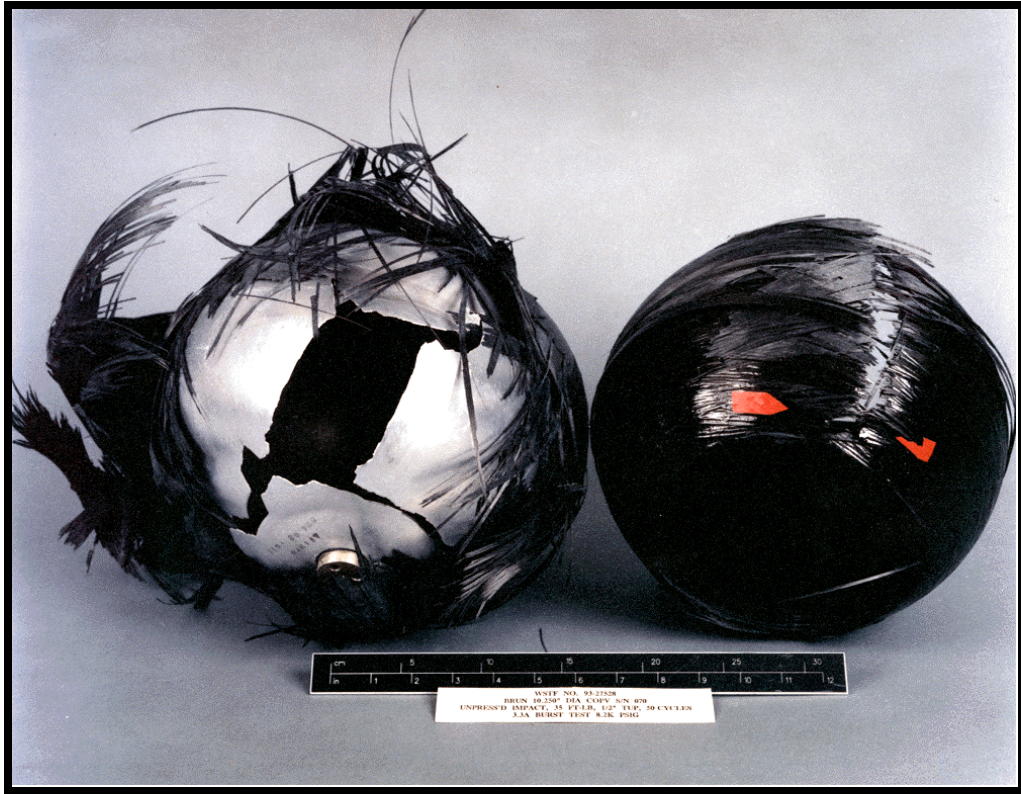
10.25 in. dia spherical COPVs

CIE: 35 ft-lbf
 MEOP: 6000 psig
 Undamaged $P_b V / W = 9.68 \cdot 10^5$ in.

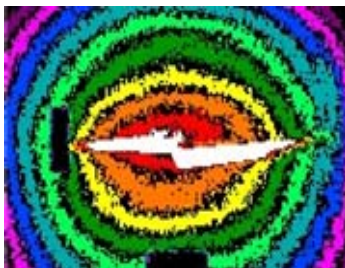
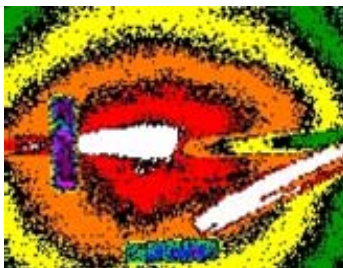
IR Thermography

Before sustained loading

After sustained loading

13 x 25 in. cylinders
4500 psi hydrostatic impact
0.5 in. dia hemispherical tup
35 ft-lbf

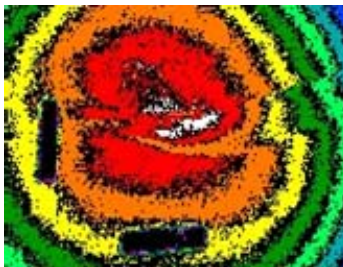
Damage Growth During Six-month Test

19 in. dia spheres
4725 psi pneumatic impact
0.5 in. dia hemispherical tup
100 ft-lbf

- Damage growth observed during longer term pressurized storage
- Damage growth appears superficial
- No pressurization effect on BAI observed (6 month test duration)
- Multiyear tests in progress
 - > 12 years in testing

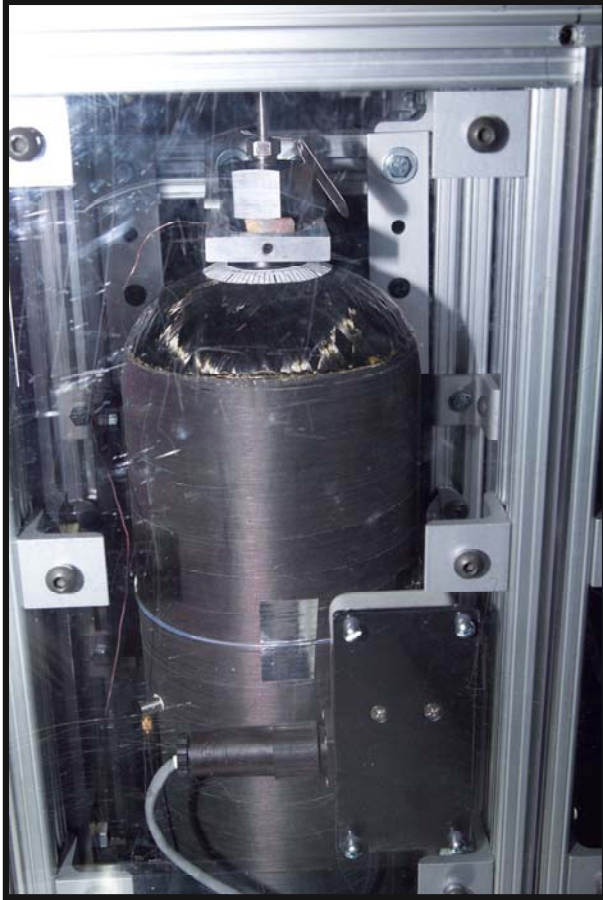
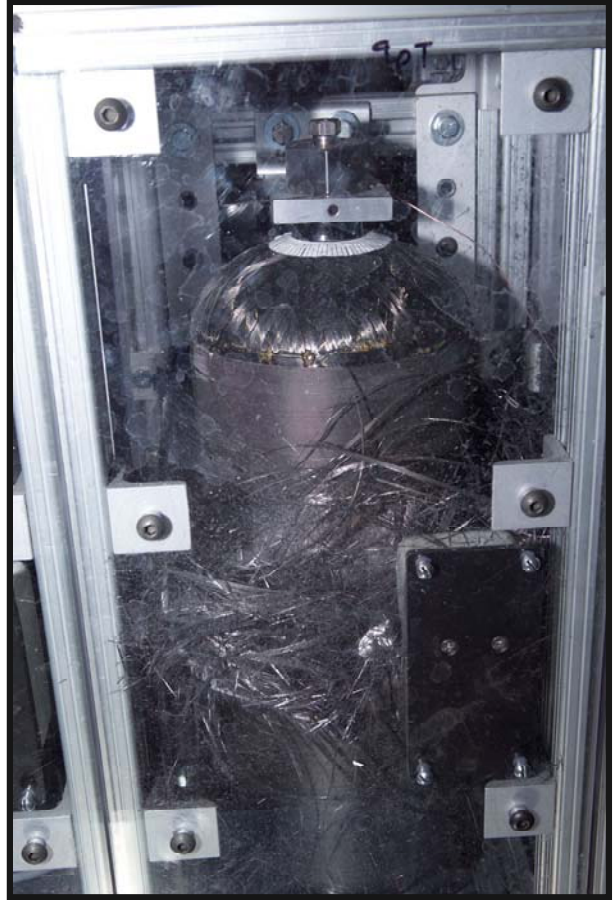
Stress Rupture Facility

- Examine affects of sustained load on a composite structure
 - NNWG program to track progressive stress rupture and monitor with various NDE
 - Various fiber types
 - Multiple stress ratios
 - On-going program with multiple campaigns

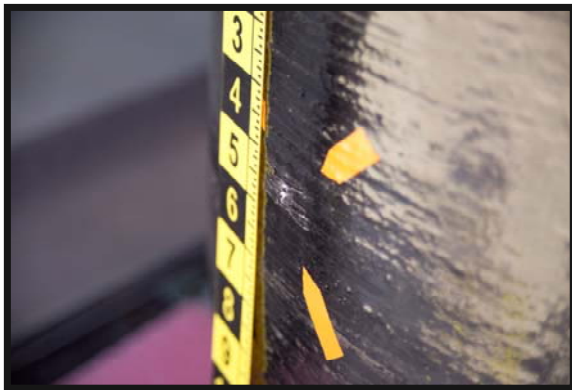
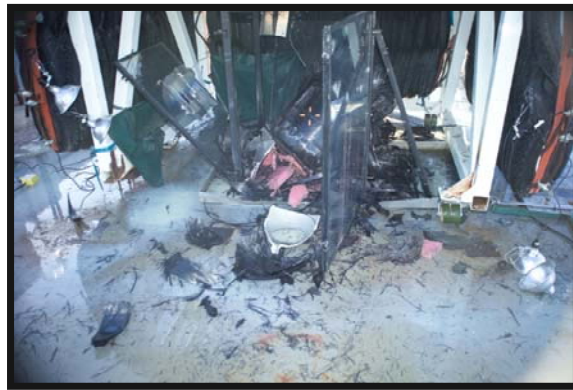
Impact/Burst Photos

- Nominal burst: 14,300 psia
 - Approach C: 15,565 psi
 - 1/8 in. radius guillotine 15 ft-lb
 - 1/2 in. Hemi tup 10 ft-lb
 - Approach D: 14,600 psi
 - 1/2 in. Hemi tup 44 Ft-lb impact

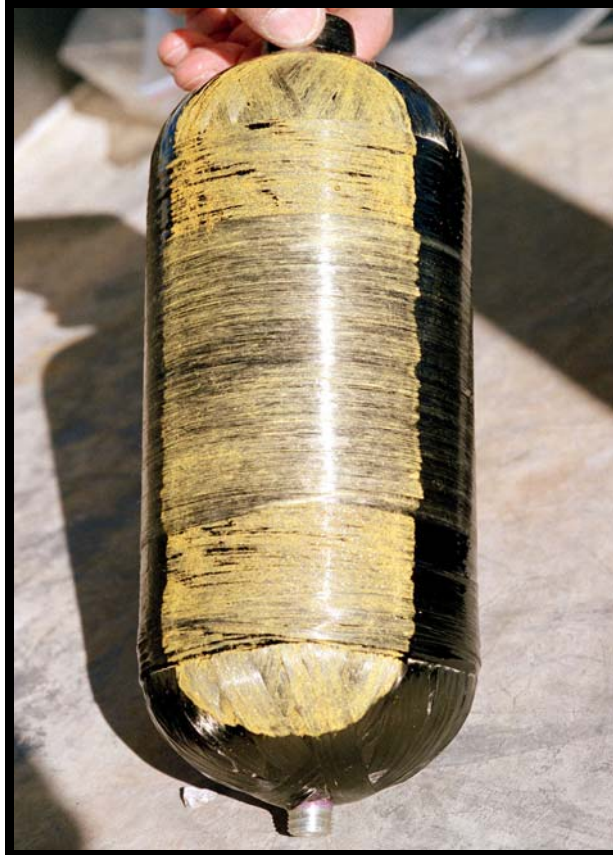
SCI Subscale Vessel after N₂O₄ Exposure

Exposure Condition	Burst Strength (psi)
Baseline	10,600
Hydrazine, 2 h	11,500
N ₂ O ₄	10,500
Liquid oxygen	10,600

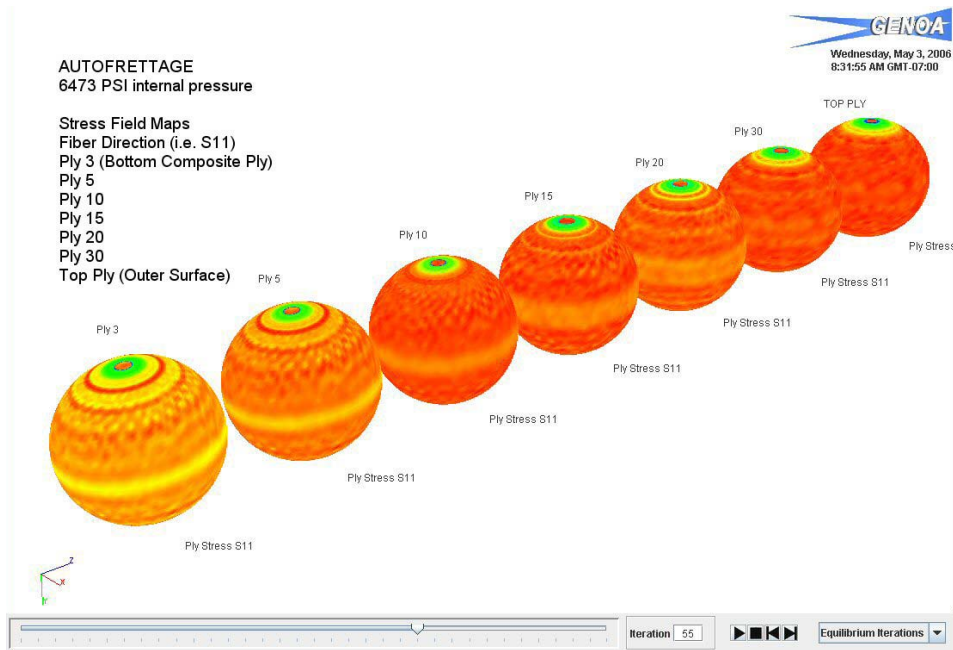
“Proof” Pressure Stress at Various Depths in Composite

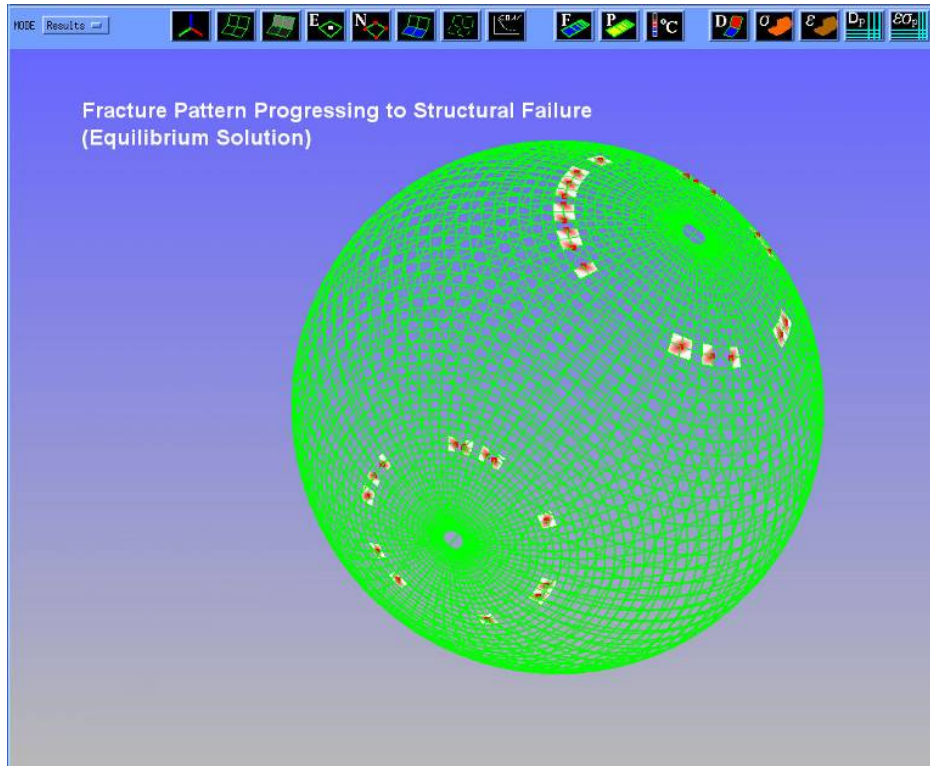
Fracture Patterns

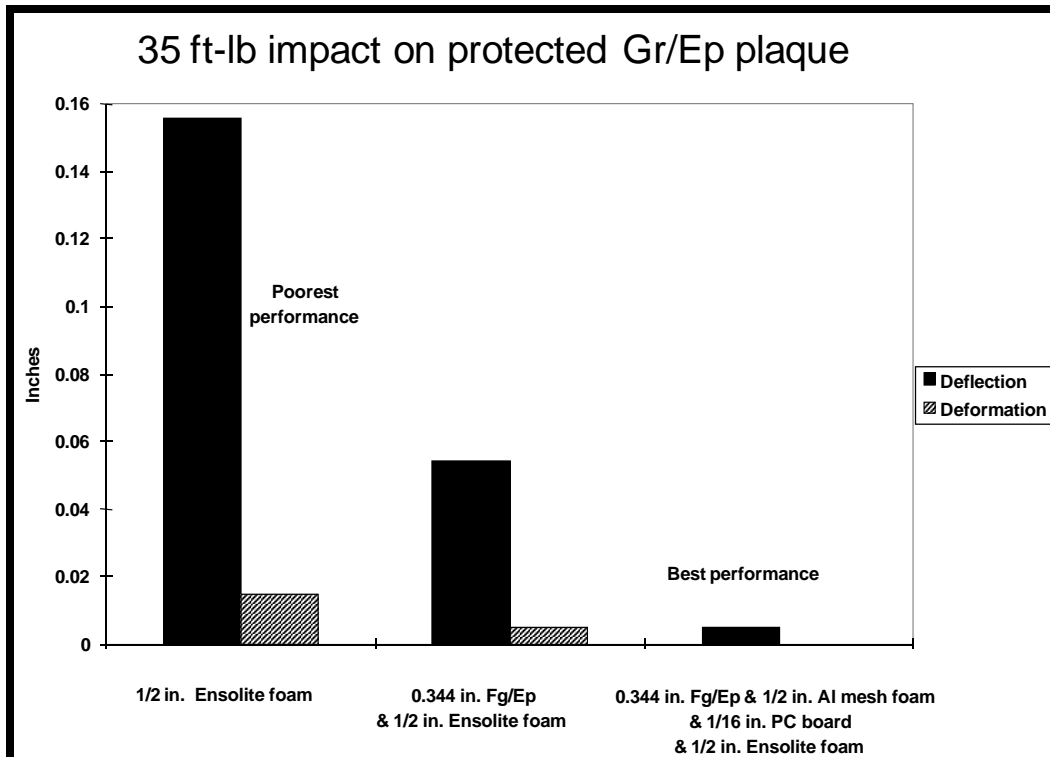
Protector Mechanical Performance

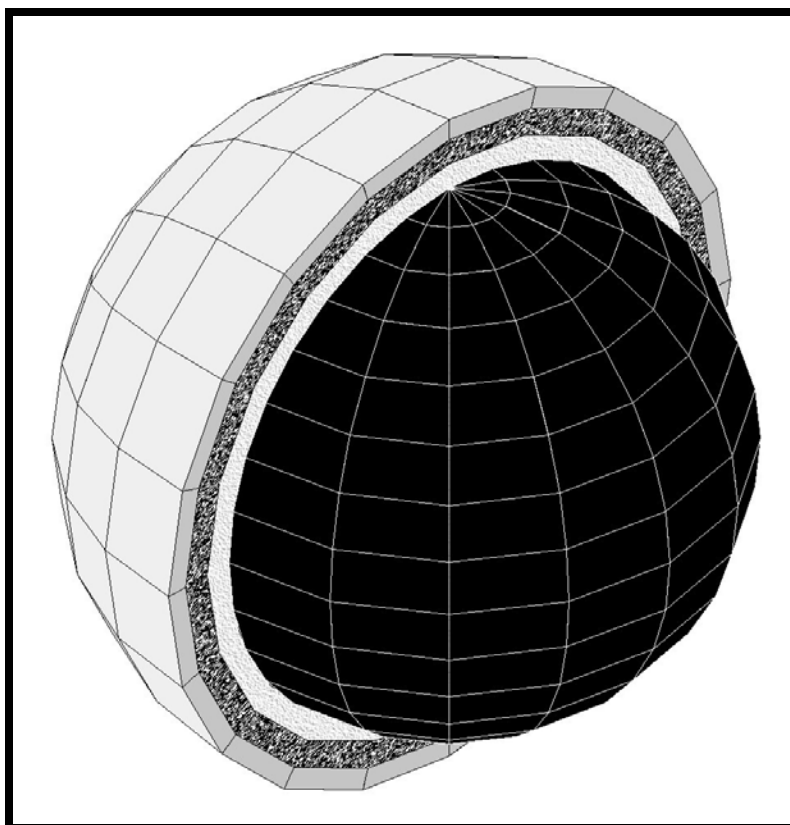
Spherical Protective Cover

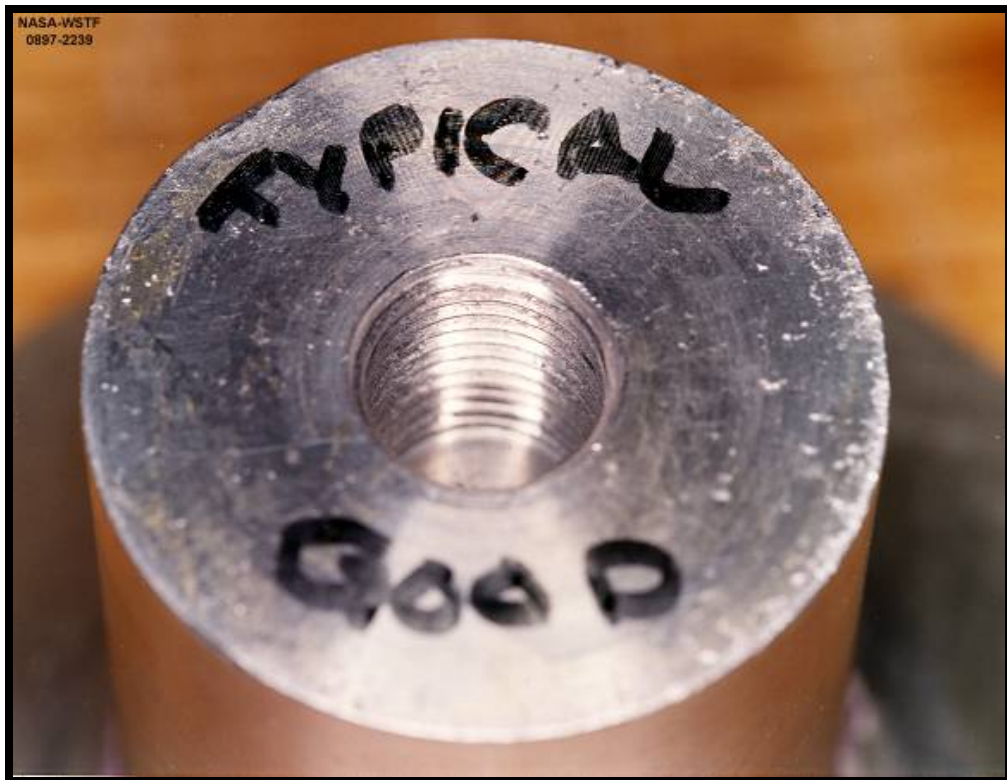
Typical Inlet Thread

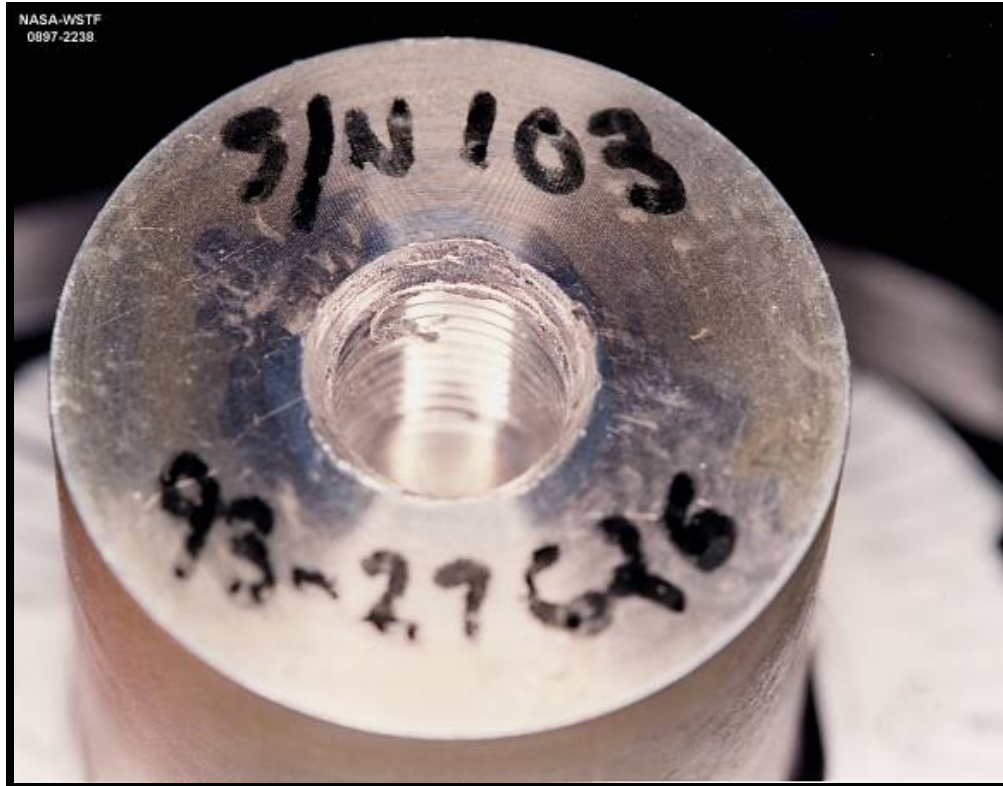
Inlet Thread Damage

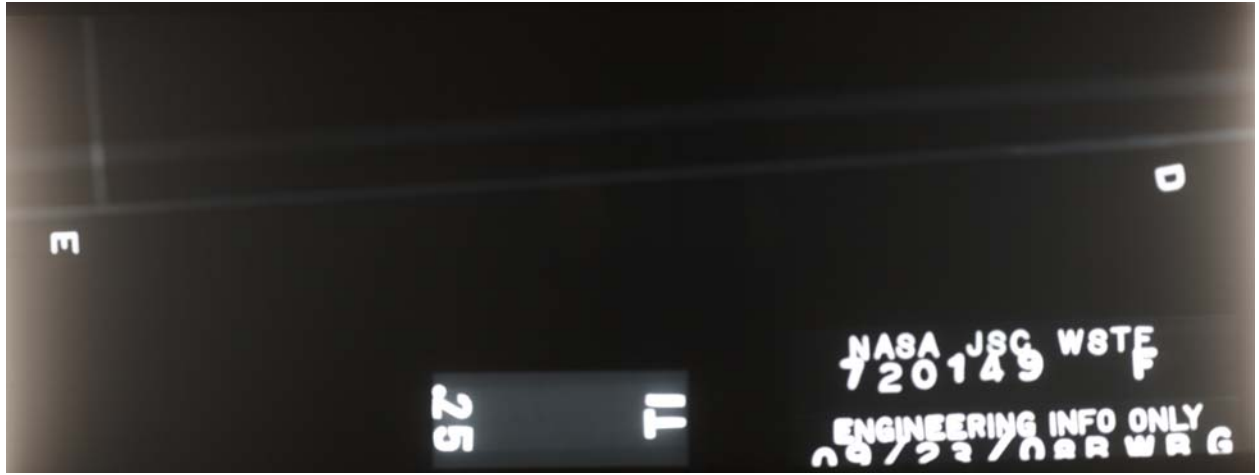
Typical X-ray Image

- MIL-STD-453
 - Only identifies defects in metallic components
 - Typically requires five 72° angle views for large sphere
 - Overwrap tends to reduce sensitivity to metallic liner defects
 - Needs more development and standardization

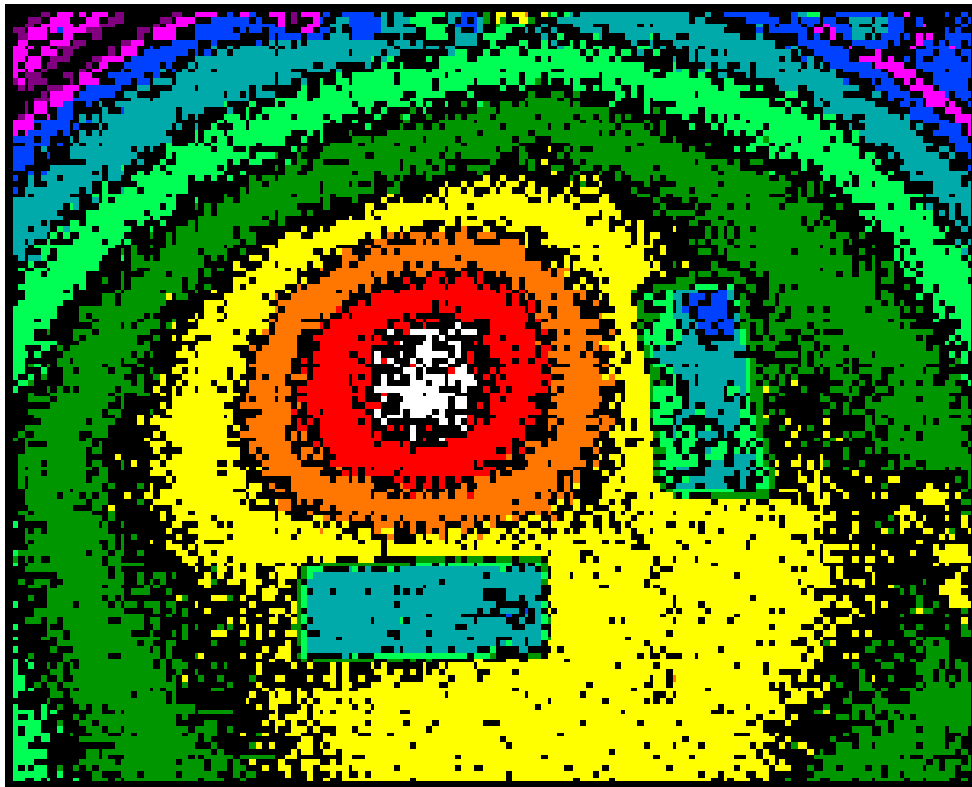
IR Thermographic Image - 35 ft-lbf impact on 10.25 in. dia spherical COPV

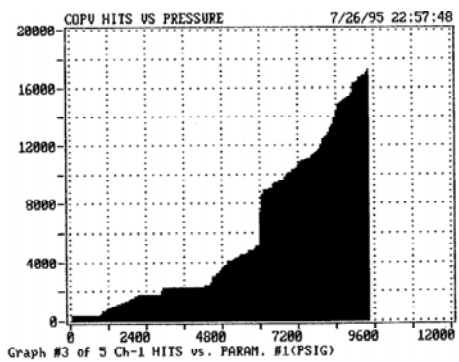
Impact damaged COPV

Undamaged COPV

Acoustic Emission Spectra

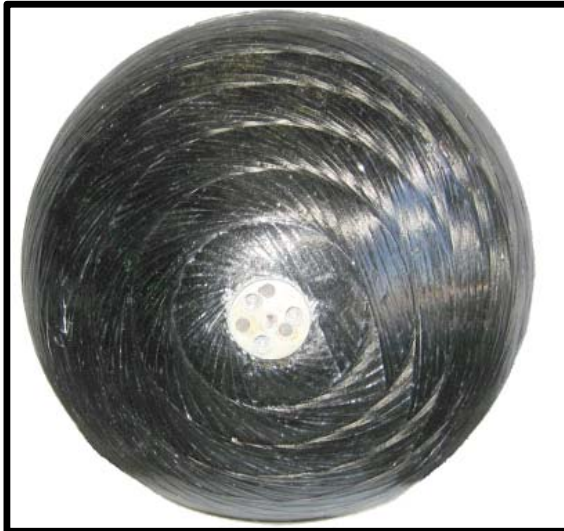
10-in. dia Carbon Fiber COPV

Shearography Test with 1.2 psid

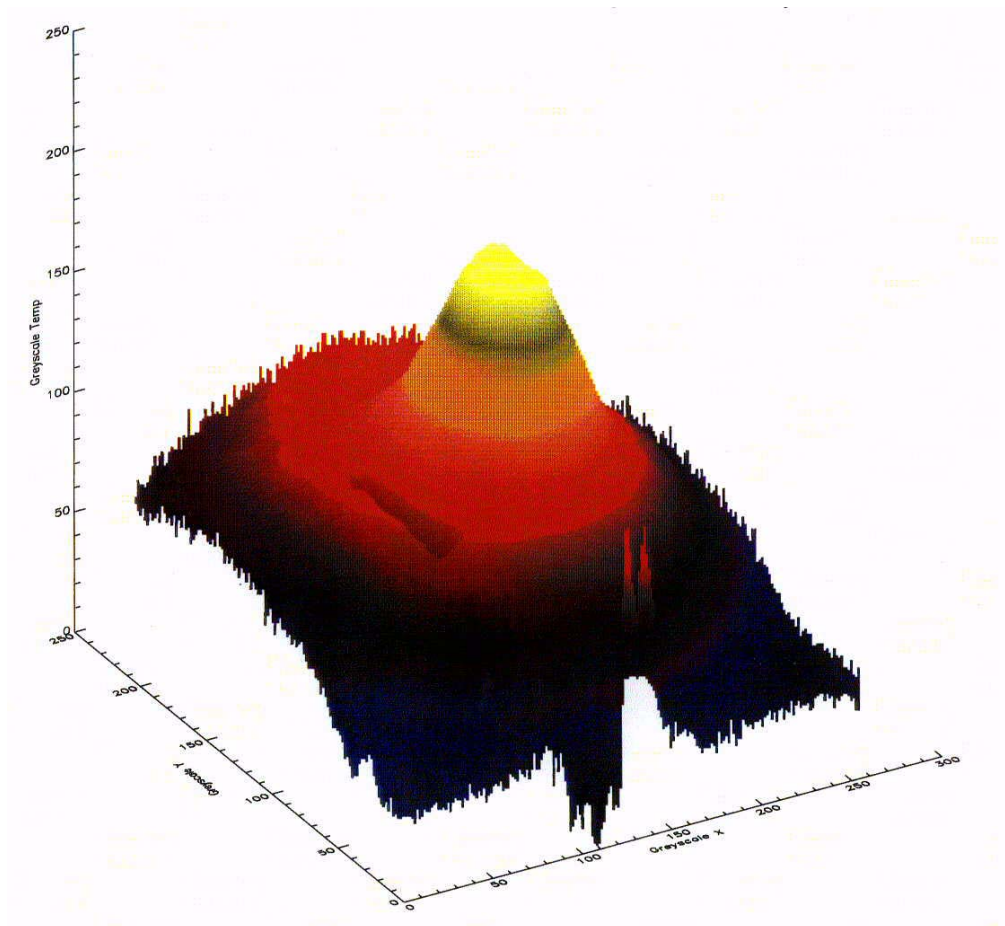
Video of IR Thermographic Image (35 ft-lbf impact on small sphere)

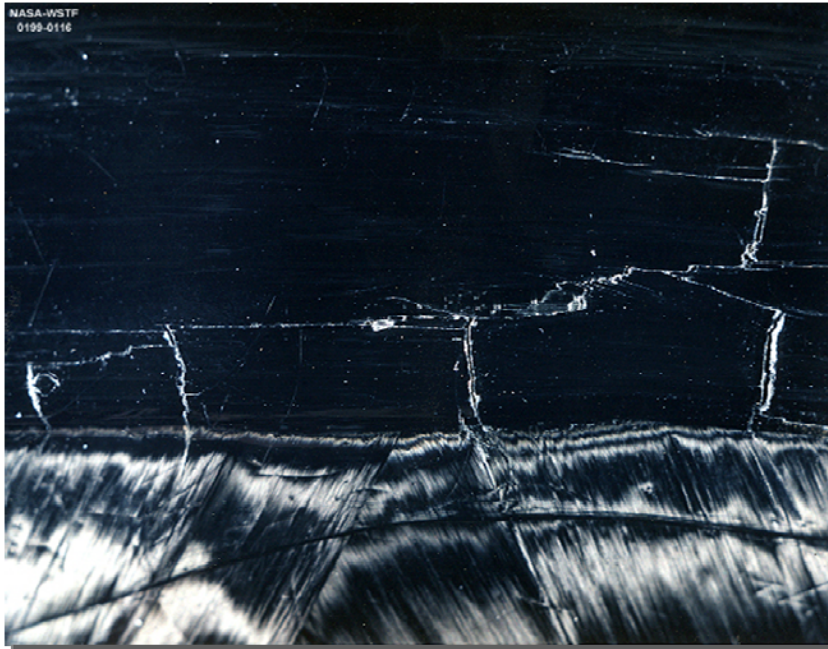
Small cylinder, manufacturing defect, nonelastic end crack

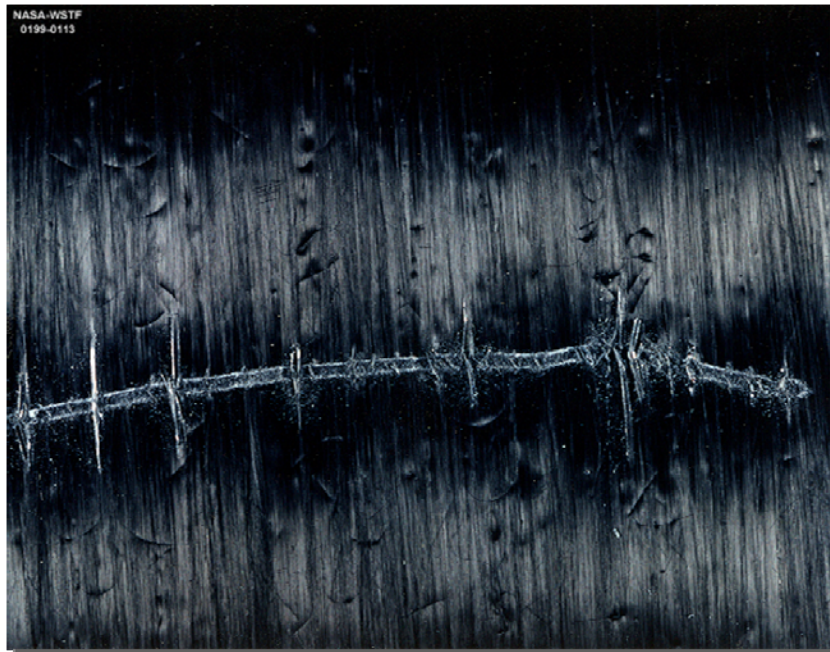
Small cylinder, significant scratch, transverse to winding direction

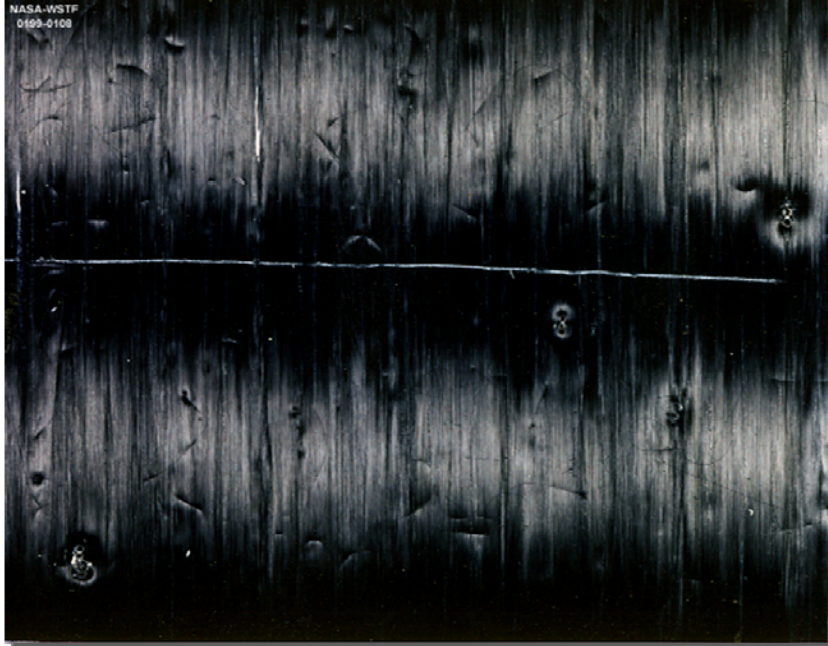
Small cylinder, cut, transverse to winding direction

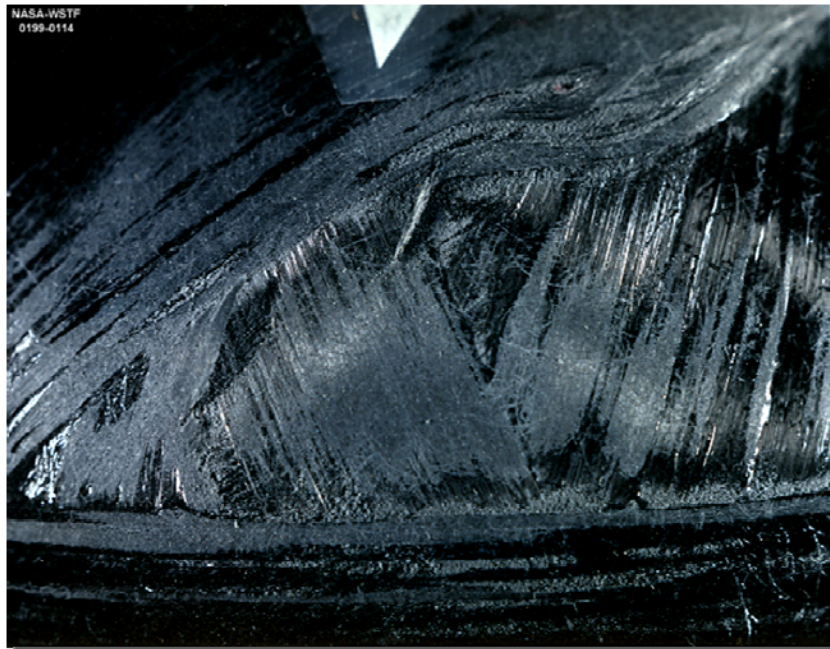
4.6 x 10 in. cylinder, abrasion

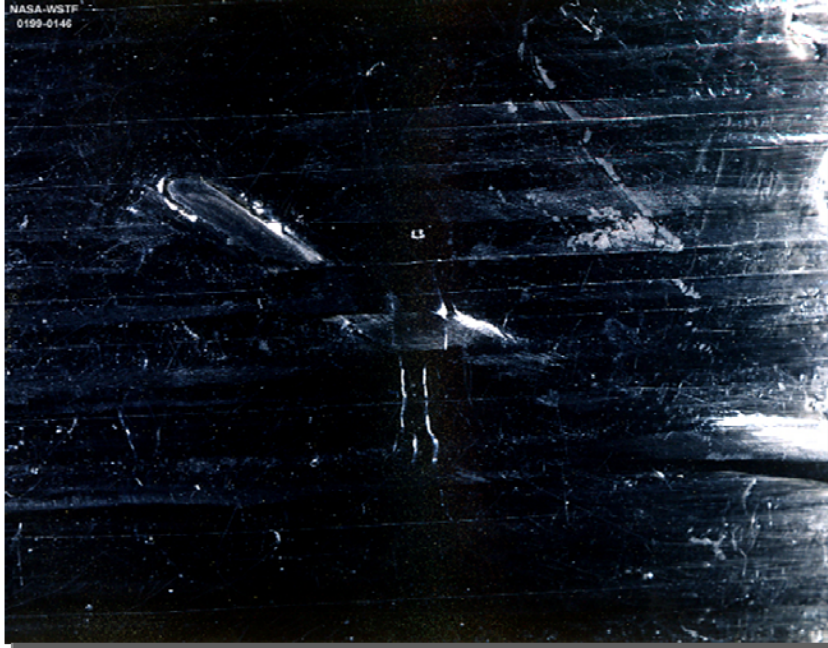
4.6 x 10 in. cylinder, significant abrasion

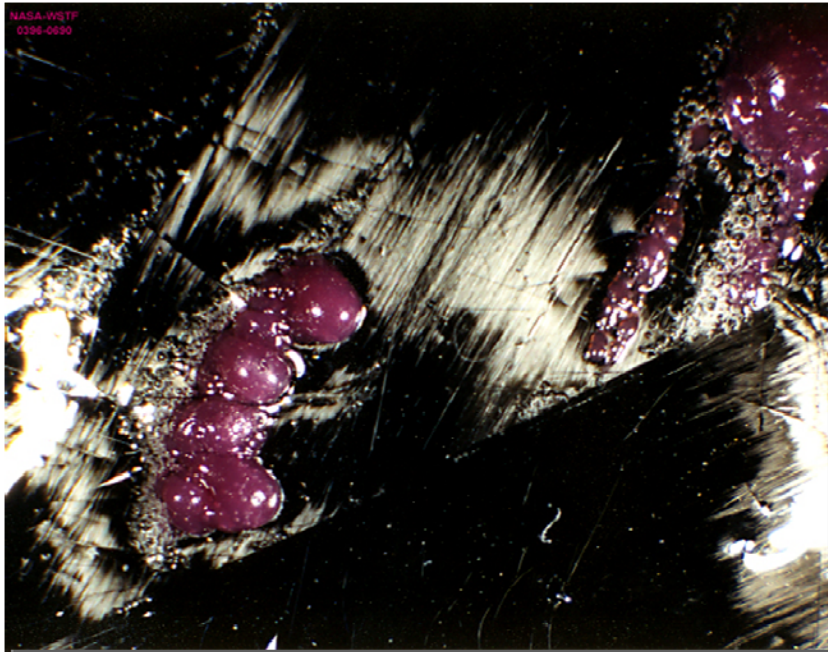
4 x 9 in. cylinder, excess bonding agent

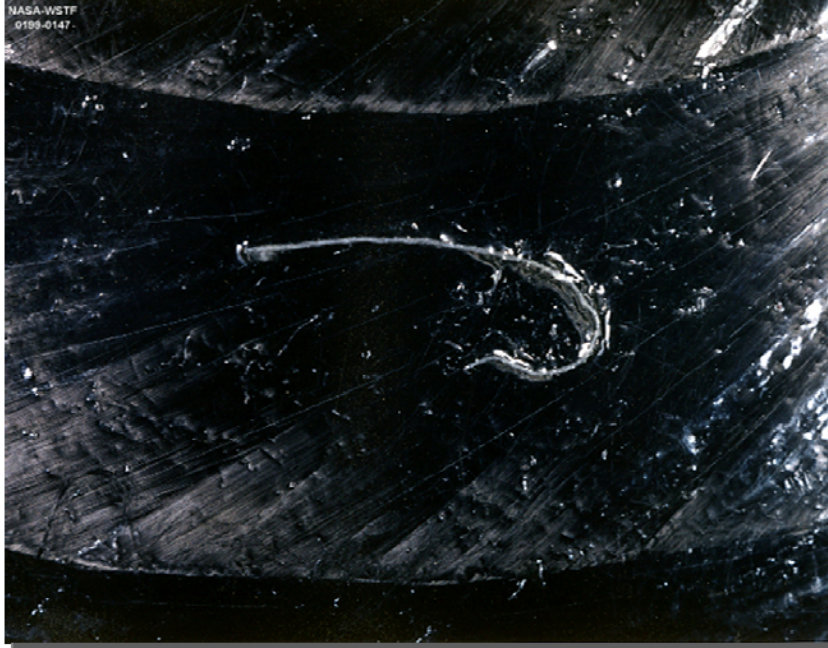
4 x 9 in. cylinder, surface resin porosity

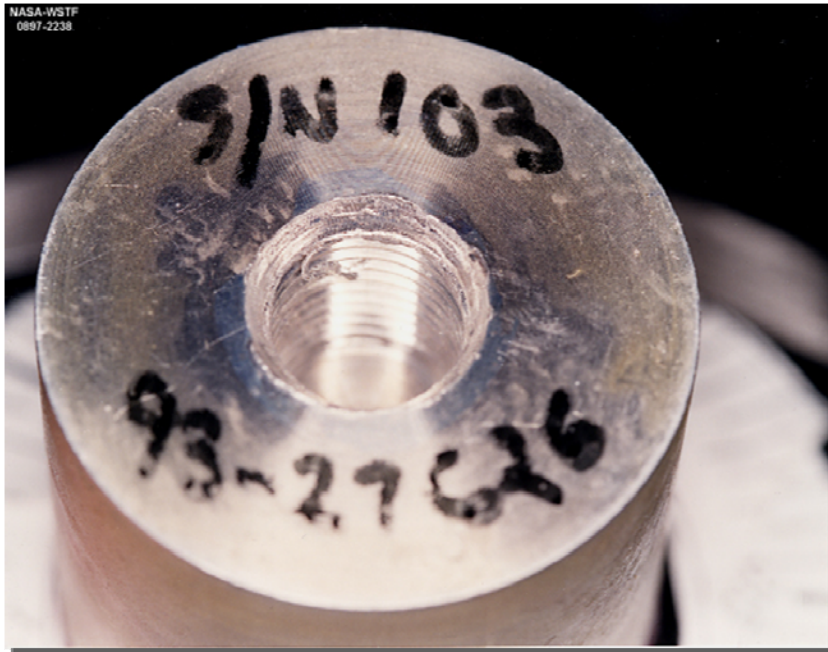
Typical inlet thread
