Experimental Study of the Compression Response of Fluted-Core Composite Panels with Joints

Marc R. Schultz¹ and Cheryl A. Rose²

NASA Langley Research Center, Hampton, VA 23681-2199, USA

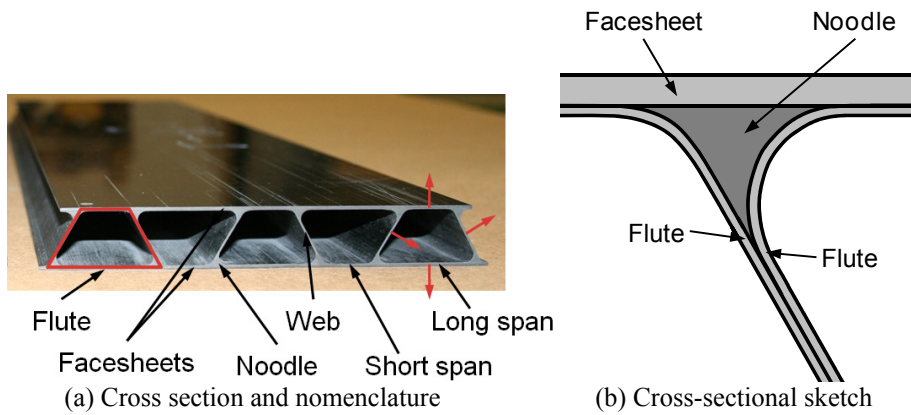
Figure 1. Cross section of an unjointed fluted-core composite panel.

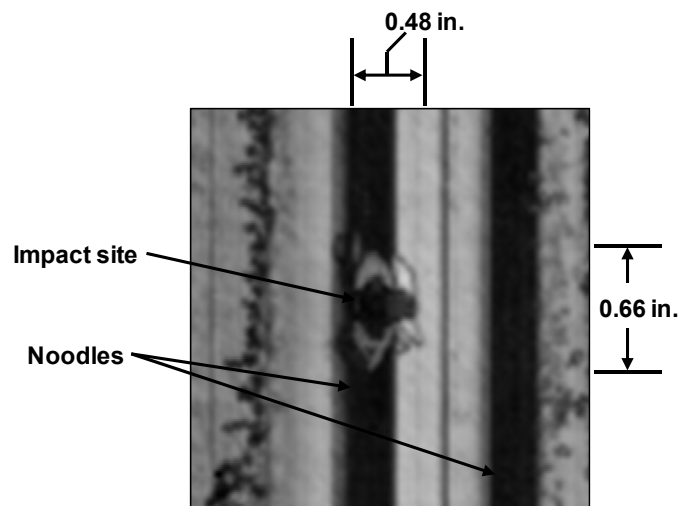
Figure 6. Ultrasonic scan of CJA-3A, the basic-joint test article with the over-noodle impact.

The impacted basic-joint test article was designated CJA-3A. This test article was impacted with a ½-in. spherical tup with a 6 ft-lb impact energy. The impact location was over the splice plate and over a noodle on the back face (Table 1). Impact damage included a residual dent with a depth of 0.007-in., but no visible cracks, tears, or ruptures. An ultrasonic scan of the impact damage showed a damage zone that extended along the noodle (see Fig. 6). The impact damage in this basic-joint test article was less extensive than the impact damage in the baseline unjointed test article that was impacted in the same location.

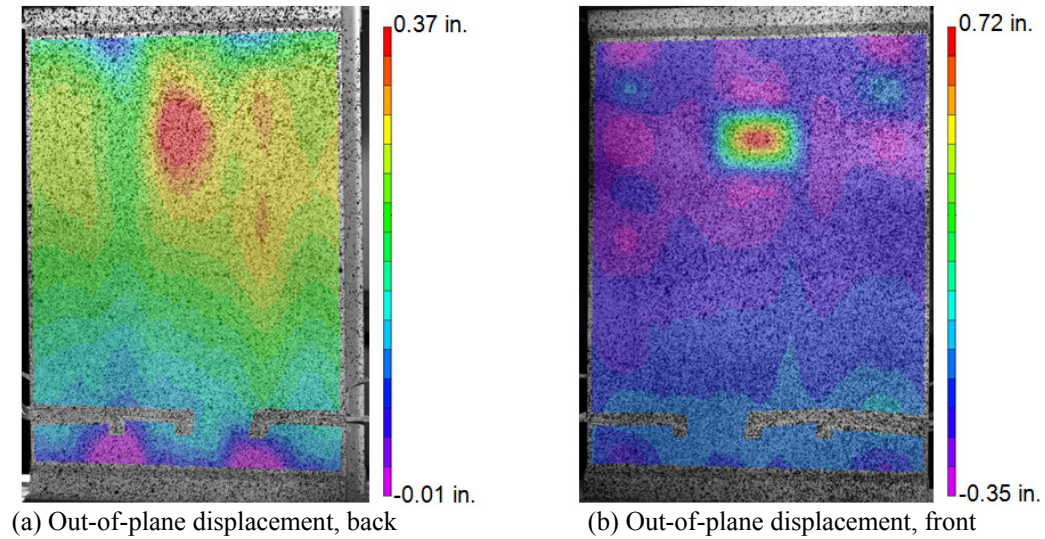
Figure 9. Test article CWA-1B (I-beam joint, pristine): 47,400 lb. Positive displacements are outward.

Slight global panel bending toward the back face occurred as CWA-1B was loaded. During initial loading, inward facing half waves developed near the tabs in all of the long spans on both the front and back faces (two flutes on each face). With continued loading, distributed buckling with 9 half waves developed along the length of the two long front spans. No distributed buckling was seen on the back of the test article. As the loading continued, at 47,400 lb, a single large bulge developed suddenly directly over the I-beam about 1.9 in. below the upper tab on both the front and back faces, i.e., both faces bulged outward at essentially the same location. The bulge on the front surface had a maximum outward displacement of about 0.1 in. relative to the displacement of the surrounding face, and the bulge on the back face had a much smaller maximum outward displacement of about 0.02 in. relative to the displacement of the surrounding face. Additionally, the bulge on the front surface was much more localized and had smaller in-plane dimensions than the back-surface bulge (Fig. 9). It is speculated that these bulges were caused by a separation of the scarf plank on the front face from the underlying joint structure, and that this failure also allowed the back face, and web, to bulge out in the opposite direction. After the bulges appeared, the load continued to increase to a peak load of 47,600 lb, at which point there was a 600-lb drop in load. After the load drop, the load again increased until there was a sudden transverse failure through the bulges at a load of 47,400 lb. On the front face, the scarf plank did not rupture, but bowed out over its entire width, and the material failed in the structure beneath the scarf plank. On the back face, the entire face, including the scarf plank, failed. The out-of-plane deformations just prior to failure are shown in Fig. 9.

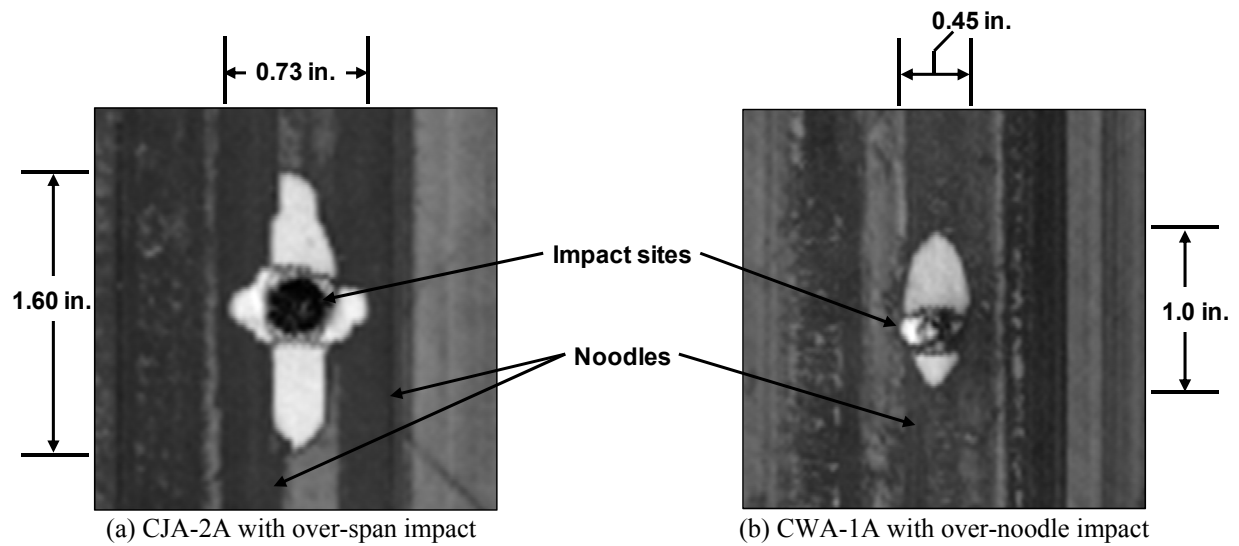
Figure 10. Ultrasonic scans of the impact regions of the impacted I-beam-joint test articles.

The two impacted I-beam-joint test articles were designated CJA-2A and CWA-1A. As shown in Table 2, test article CJA-2A was impacted on the back face in the span separating the I-beam from an adjacent noodle, and test article CWA-1A was impacted in the middle of the back face directly over the I-beam. Impact damage on CJA-2A included a residual dent with a 0.015-in. dent depth and a semi-circular tear in the facesheet at the impact site. In addition, as seen in the ultrasonic scan of Fig. 10a, the over-span impact resulted in a damage zone that extended along the length of the test article, parallel to the noodles. The majority of the damage was limited to the area between the adjacent noodles, but there was some delamination damage in the facesheets over the noodles. The extent of damage in this case was slightly larger than in the corresponding unjointed test article that was impacted over the central short span in the back face. The impact damage in CWA-1A included a residual dent with a dent depth of 0.010 in., but no visible cracks, tears, or ruptures in the facesheet and a damage zone that extended along

the noodle (see Fig. 10b). The damage zone in this case was larger than for the basic-joint test article that was impacted over the noodle.
