Test and Analysis of Sub-Components of Aluminum-Lithium Alloy Cylinders

Integrally machined blade-stiffened panels subjected to an axial compressive load were tested and analyzed to observe the buckling, crippling, and postcrippling response of the panels. The panels were fabricated from aluminum-lithium alloys 2195 and 2050, and both alloys have reduced material properties in the short transverse material direction. The tests were designed to capture a failure mode characterized by the stiffener separating from the panel in the postbuckling range. This failure mode is attributed to the reduced properties in the short transverse direction. Full-field measurements of displacements and strains using three-dimensional digital image correlation systems and local measurements using strain gages were used to capture the deformation of the panel leading up to the failure of the panel for specimens fabricated from 2195. High-speed cameras were used to capture the initiation of the failure. Finite element models were developed using an isotropic strain-hardening material model. Good agreement was observed between the measured and predicted responses for both alloys.

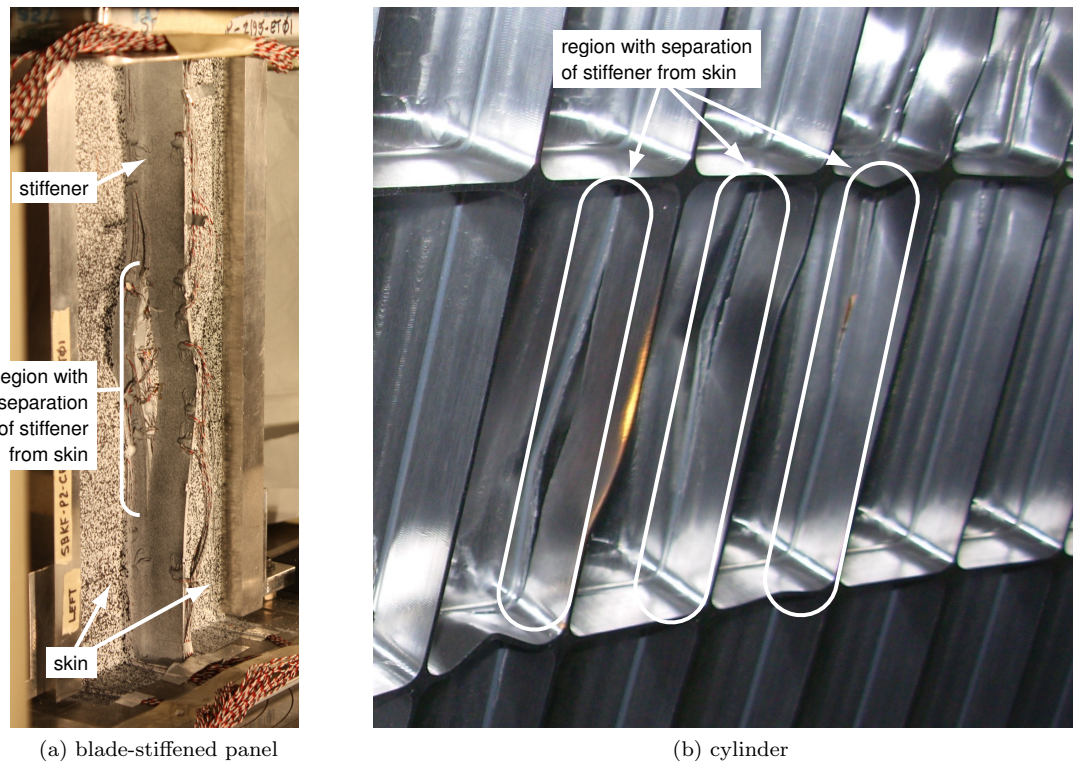
Figure 1. Examples of separation failures in structural testing

postbuckling range, failures have been observed that are characterized by the separation of the stiffener from the skin, referred to herein as a separation failure. Two examples of the separation failure in Al-Li alloy 2195 structures are shown in Figure 1, for a blade-stiffened panel of the same geometry as discussed in this paper, in Figure 1a, and for an orthogrid stiffened cylinder, in Figure 1b. In the panel and the cylinder, the separation failure occurred near the base of the stiffener, and is attributed to the reduced ST properties. Also in both cases, the separation failure occurred after buckling, and crippling (maximum load) in the case of the blade-stiffened panel; therefore, this type of failure may not typically be significant when designing structures manufactured from Al-Li alloys, as most designs do not allow buckling to occur. However, it is important to understand the physical mechanisms that initiate this type of failure so that if it is encountered either in future testing or in flight hardware, there will be knowledge of the behavior that precipitated the separation failure.

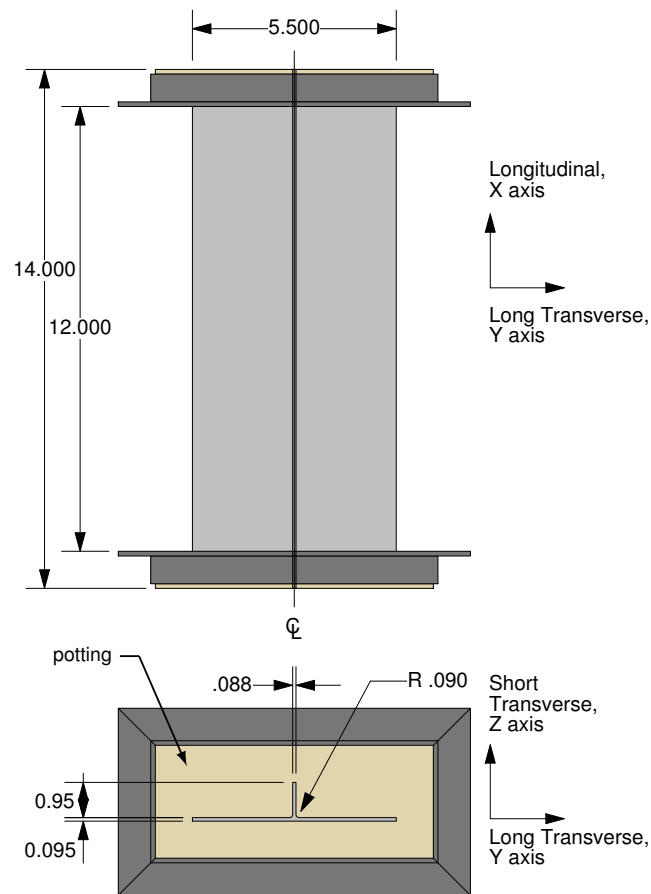
Figure 2. Specimen geometry (all units in in.)

The geometry of the test specimens is shown in Figure 2. Each specimen was fabricated so that the stiffener is aligned with the longitudinal material direction, as it would be if it were part of a larger orthogrid

panel in a cylinder. The skin lies in the plane comprised by the longitudinal and long transverse material directions, and the stiffener extends from the skin in the short transverse material direction. The specimens have an overall length of 14 in. On both ends, one inch of the length of the specimen is potted in an epoxy grout, which is held in place by an aluminum frame. The area of the potted region is shown in Figure 2, and is used to enforce a clamped boundary condition. Considering the potting, the length of the test section is 12 in. The width of the panel is 5.5 in., with the integrally machined stiffener at the center of the skin section. The skin has a thickness of 0.095 in. The stiffener height is 0.95 in., and its thickness is 0.088 in. The fillet radius at the junction of the stiffener and the skin is 0.125 in. Stiffener geometry was taken from a typical design of an ET cylinder. Width of the panel was determined from a previous set of specimens in which the effects of panel width were studied. The current width was chosen because it was expected to minimize the variability of the location at which the initiation of the separation failure could occur. As will be described below, reducing this variability, allowed for some of the image systems to be focused on a smaller area of the specimen as a means of increasing the resolution of the systems. To ensure uniform loading, the ends of the specimen were machined flat and parallel.

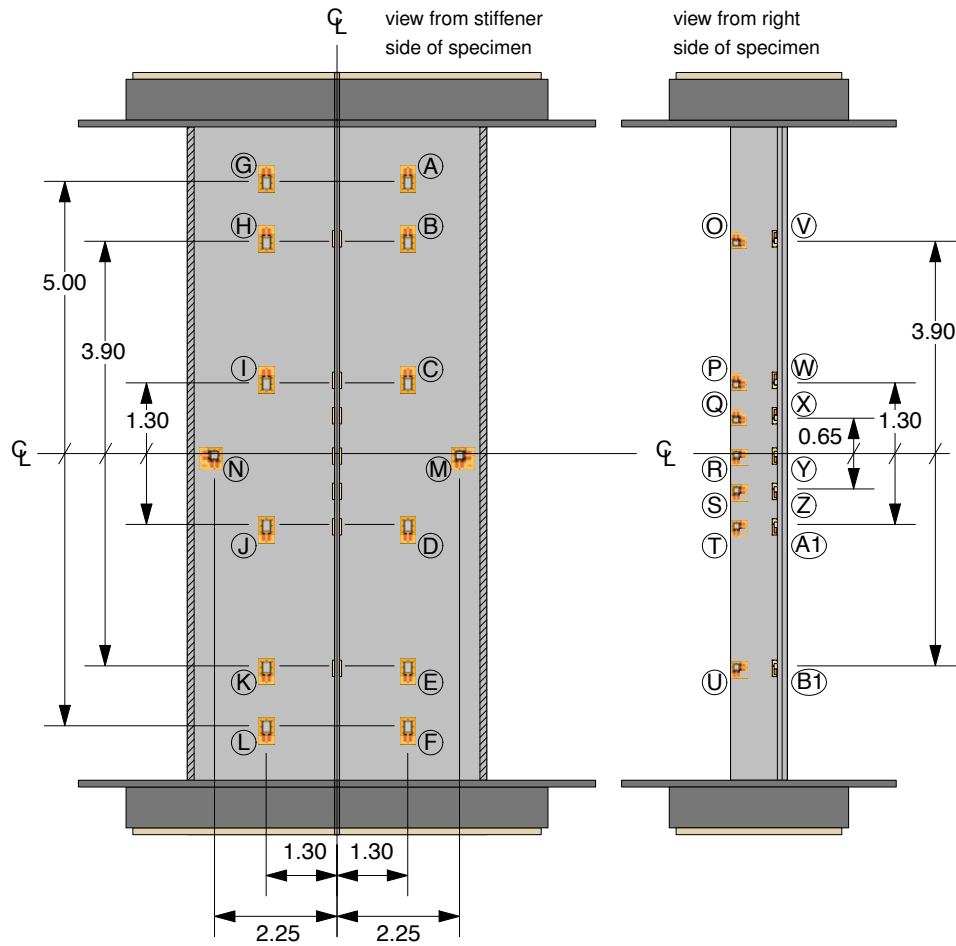
Figure 3. Strain gage pattern (all units in in.)

In preparation for testing, electrical-resistance strain gages were installed at the locations indicated in Figure 3. Each location is identified by a letter, and at all locations the strain gage shown is one of a back-to-back pair, e.g., for gage A shown on the stiffener side of the panel there is another gage A on the opposite side of the skin, or skin side of the panel. Similarly for gage O shown on the right side of the stiffener there is another gage O on the left side of the stiffener. Except for gages M and N, the strain gages on the skin are uniaxial strain gages measuring strain in the longitudinal material direction. Gages M and N are biaxial gages measuring the strain in the longitudinal and long transverse directions. All strain gages on the stiffener are biaxial gages measuring strains in the longitudinal and short transverse directions.

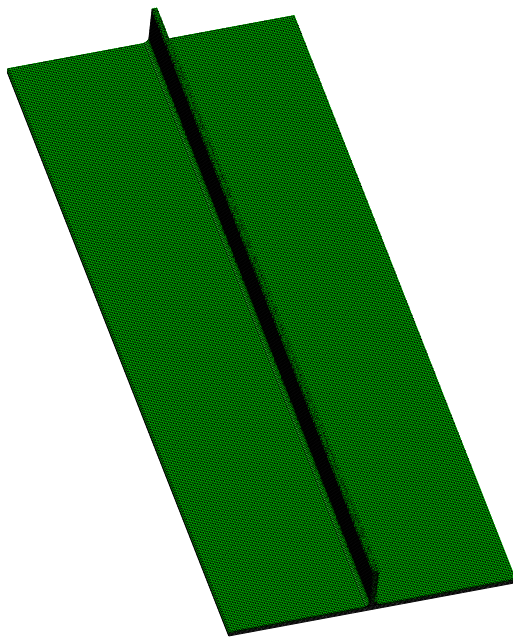
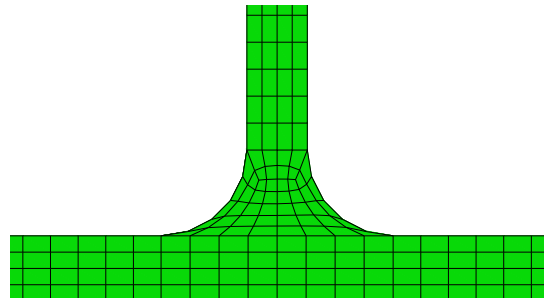
(a) full mesh

(b) cross section near base of stiffener

Figure 4. Finite element representation

The finite element models of the blade stiffened panels in this study were built using MSC Patran 2011,² and the analyses were performed with Abaqus/Standard 6.11.³ A representative finite element mesh and a detailed view of the cross section of the mesh near the base of the stiffener are shown in Figure 4. The geometry of the model is the same as is given in Figure 2. The model is comprised of 236,600 C3D8R three-dimensional solid elements. The approximate element size is 0.04 in. \times 0.04 in. \times 0.025 in. for elements in the skin and stiffener that are not in the fillet region. The element size varies in the fillet region at the base of the stiffener, as can be seen in Figure 4b, to accommodate for the fillet geometry and the change in the cross sectional aspect ratio from the elements in the skin to the elements in the stiffener.

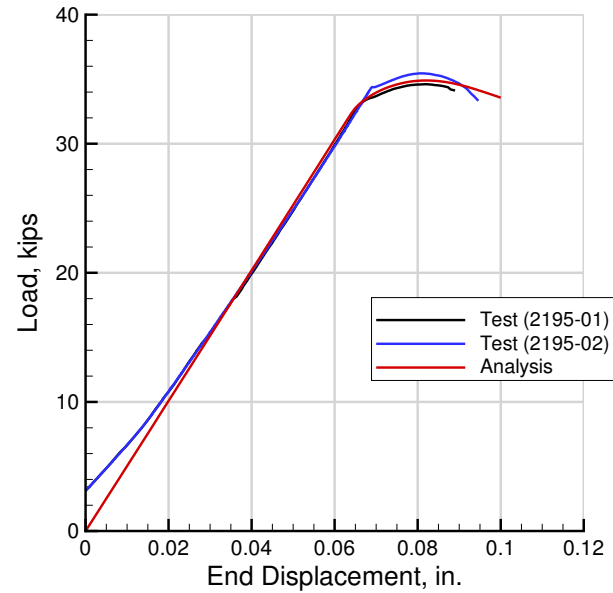
Figure 5. Load vs. end displacement response for 2195 specimens

The two Al-Li 2195 specimens were subjected to an axial compressive load until the separation failure occurred in both specimens. These specimens are denoted herein as 2195-01 and 2195-02. The load-end displacement responses for the two specimens and the corresponding finite element analysis are shown in Figure 5. The end displacements for the specimens were adjusted so the slope of the linear portion of the load-end displacement response aligned with the slope from the analysis. Adjusting the end displacement by a constant value accounts for the nonlinearity in the load-end displacement response due to the settling of the test article in the test frame. The specimens buckle, cripple, and ultimately fail when the stiffener separates from the skin, and the loads at which these occur are summarized in Table 4. Here the crippling load was the maximum load incurred during the test. An approximate buckling load was determined using the stiffener out-of-plane displacements measured with the DIC system by tracking the displacement of the bow tie markers on the stiffener. Linear curve fits of the prebuckling and initial postbuckling portions of the response were extrapolated to find an intersecting point, which was considered the buckling load. Also included in Table 4 are the end displacements at which the separation failure occurs in the test specimens. A failure criterion was not included in the analysis, so the values included for the end of the tests are for when the analysis was stopped. The analysis was stopped at an end displacement of 0.1 in., because that end displacement was greater than the end displacement at failure for either of the test specimens.

There is good agreement between the tests and analysis when comparing the values summarized in Table 4. The buckling, crippling, and failure loads for specimens 2195-01 and 2195-02 were within 5% of each other. The buckling load for the analysis was within 1% and 6% of the buckling loads for 2195-01 and 2195-02, respectively. Also, the crippling load for the analysis was within 1% and 2% of the crippling loads for 2195-01 and 2195-02, respectively. To compare the failure load from the tests to the analysis, the load from the analysis at the end displacements at which failure occurred in the tests was used. In the analysis the

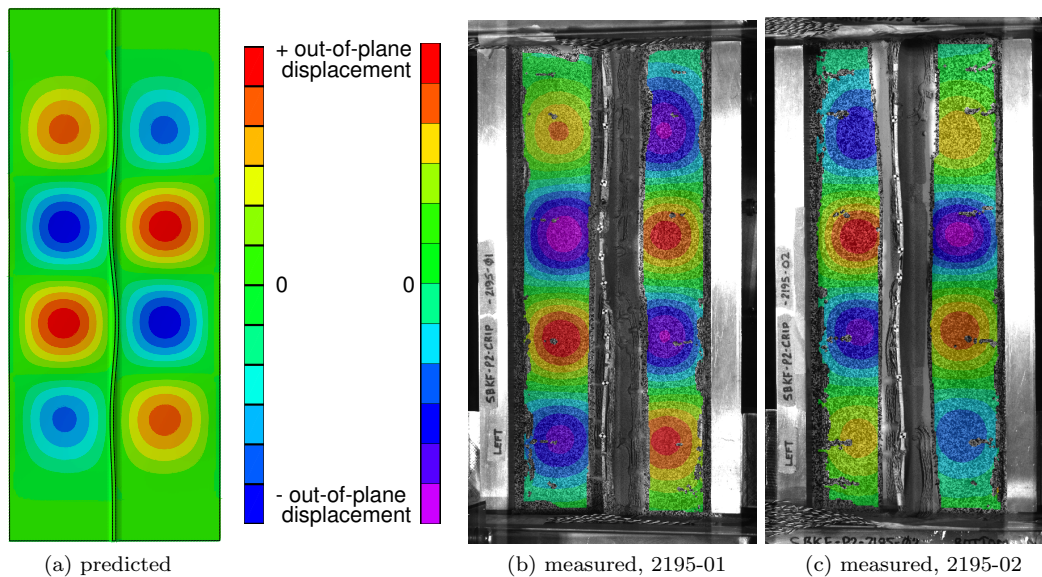
Figure 6. Buckling shapes for 2195 specimens

Full-field out-of-plane displacements of the skin are shown using color contours to represent the buckling mode in Figure 6 and the deformed shape at the end of the test from the stiffener side and skin side in Figures 7 and 8, respectively. In these figures positive displacements are in the direction of the stiffener, with the largest positive displacements represented by red; and negative displacements are in the direction away from the stiffener, with the largest negative displacements represented by the dark blue (predicted results) or purple (DIC measurements). In the tests and analyses, the skin and stiffener buckling modes had four half waves along the length. The half waves closer to the midlength had larger amplitudes than the half waves nearer the ends of the test section, and this is indicated by larger areas of red and blue/purple contours near the midlength. Specimen 2195-02 buckled into a shape with a negative amplitude compared to 2195-01 and the analysis. At the end of the tests and analysis, the deformation shape had developed to where the half waves near the midlength that buckled in the direction away from the stiffener had significantly larger amplitudes than the other half waves, as indicated by the blue and purple contours in Figures 7 and 8. Also, at the nodes between half waves, the skin behind the stiffener had deflected out of plane, as shown in Figure 8, where blue contours from a half wave on one side of the stiffener extend diagonally across the skin behind the stiffener to a half wave on the other side of the stiffener. This type of deflection, seen earlier in the postbuckling range, was an indication of crippling of the specimen. Prior to crippling the stiffener was effectively a boundary between the two sections of skin.

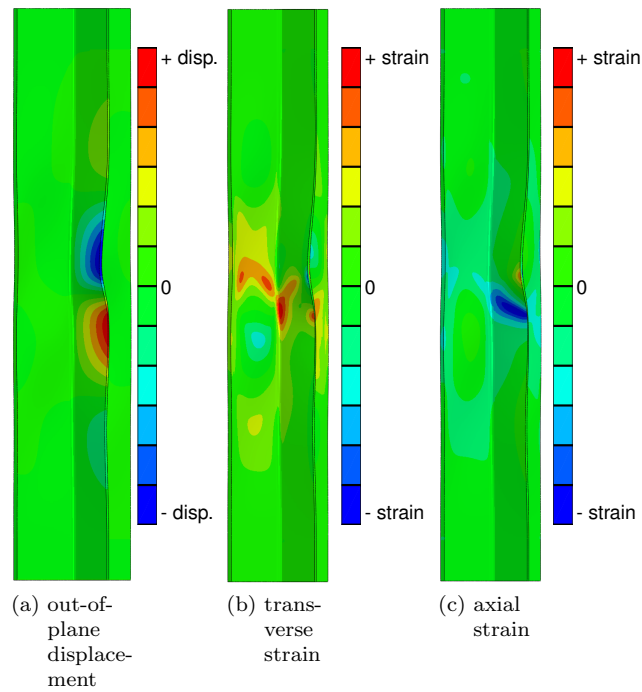
Figure 10. Out-of-plane displacements and strains from 2195 analysis

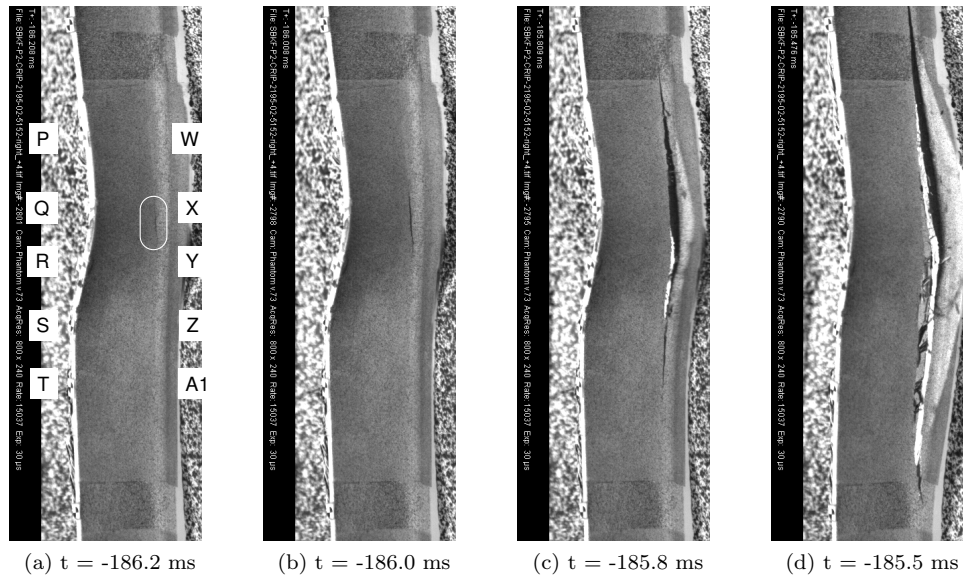
Figure 11. Progression of separation failure in 2195-02

Examining images from the high speed cameras for 2195-02 show the separation failure initiated from the area of high tensile transverse strain between gage locations X and Y. Images after the initiation of the separation failure in 2195-02 are shown for the high speed cameras on the right side of the stiffener in Figure 11. Only images from the right side of the stiffener are shown because it was much easier to see the crack in still images, however, the crack initiation and growth appeared simultaneously on the left side of the stiffener. A small crack, indicating the location of the onset of the separation failure, is encircled in Figure 11a. Note the location of the crack is near the base of the stiffener where the area of high tensile strain was seen in Figure 9 (although in this case it is on the opposite side of the stiffener). After approximately 1.5 ms, the separation had progressed along slightly less than half of the length of the test section, as shown in Figure 11d. The separation also started to tunnel through the fillet toward the skin as the propagation of the separation stopped. The initiation of the separation failure occurred between gage locations Y and Z for 2195-01.

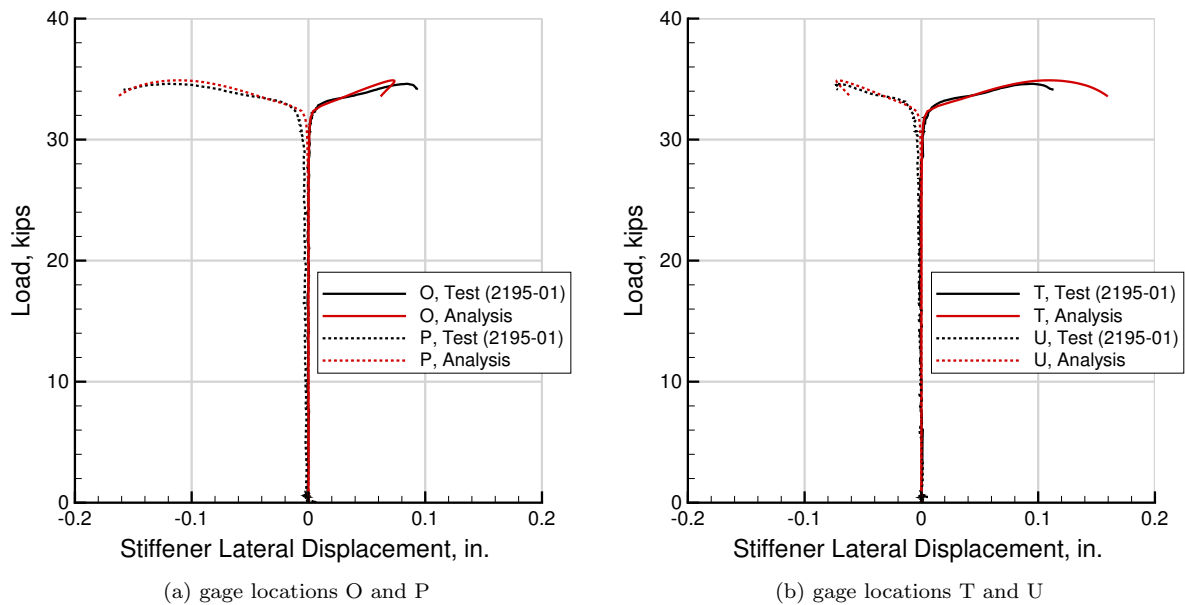
Figure 12. Stiffener lateral displacements for 2195

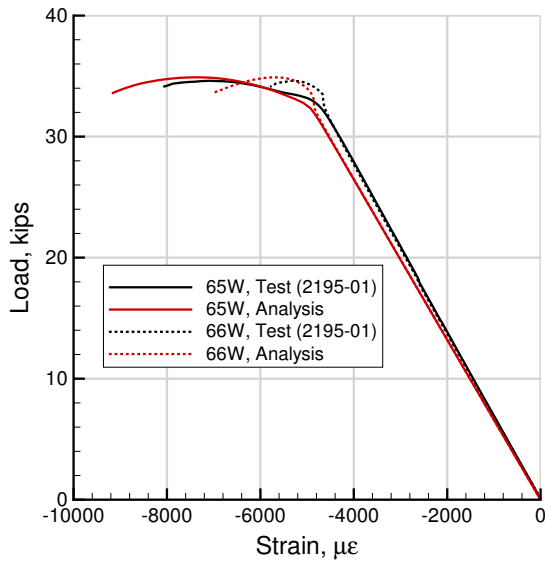
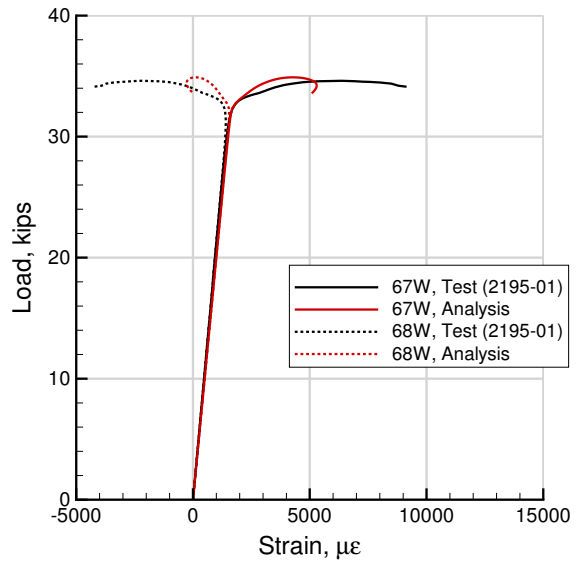
(a) longitudinal strain

(b) short transverse strain

Figure 13. Strains in the longitudinal and short transverse directions at gage location W

where the separation failure was initiated are considered. Specifically, when comparing the strains in the longitudinal and short transverse directions at the base of the stiffener and at strain gage locations W, X, Y, Z, and A1, there was good agreement between the test and analysis results. Load-strain responses for these gage locations are shown in Figures 13–17. In the prebuckling range for the strains in the short transverse direction, herein referred to as transverse strains, the positive strains were a result of Poisson expansion since the loading was in the longitudinal direction. Once buckling occurred and the stiffener began to deflect, transverse strains on one side of the stiffener continued increasing and on the other side started decreasing. At both gage locations W and A1, transverse strains from the analysis reverse near the end of the analysis, which was consistent with the decreasing magnitude of stiffener lateral displacements at locations P and T shown in Figures 12a and 12b. This strain reversal is not seen in the strains for the specimen, and could be an indication that plasticity has been induced in the specimen but not in the analysis.

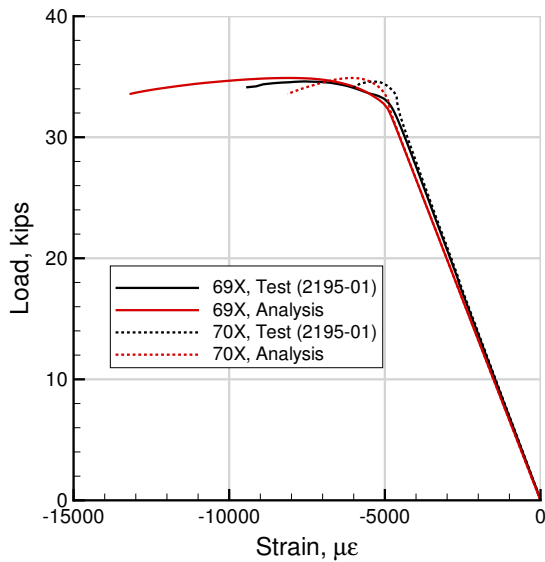
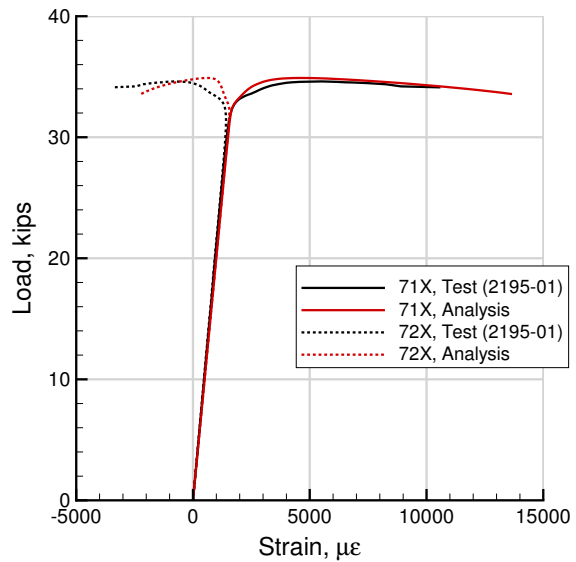
(a) longitudinal strain

(b) short transverse strain

Figure 14. Strains in the longitudinal and short transverse directions at gage location X

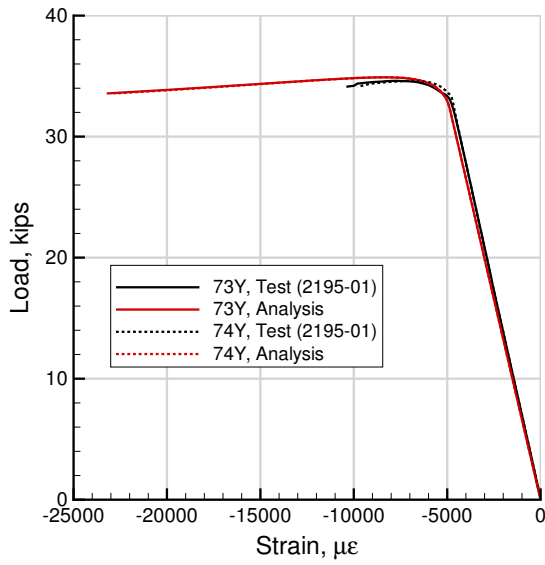
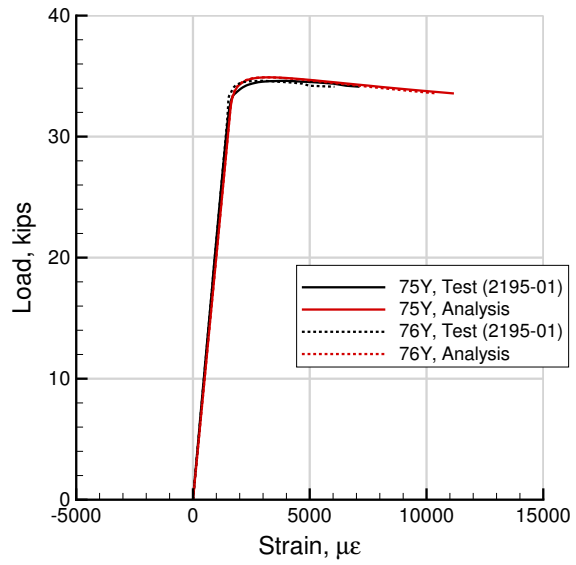
(a) longitudinal strain

(b) short transverse strain

Figure 15. Strains in the longitudinal and short transverse directions at gage location Y

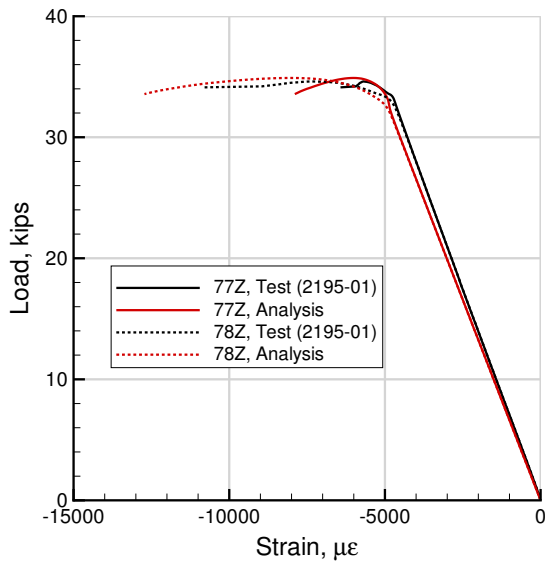
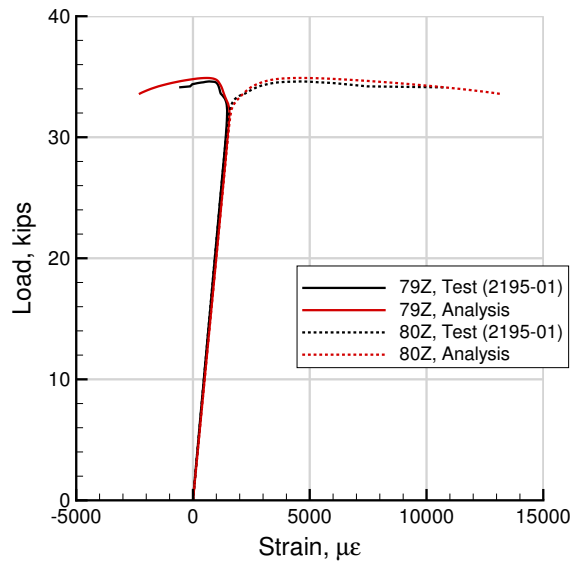
(a) longitudinal strain

(b) short transverse strain

Figure 16. Strains in the longitudinal and short transverse directions at gage location Z

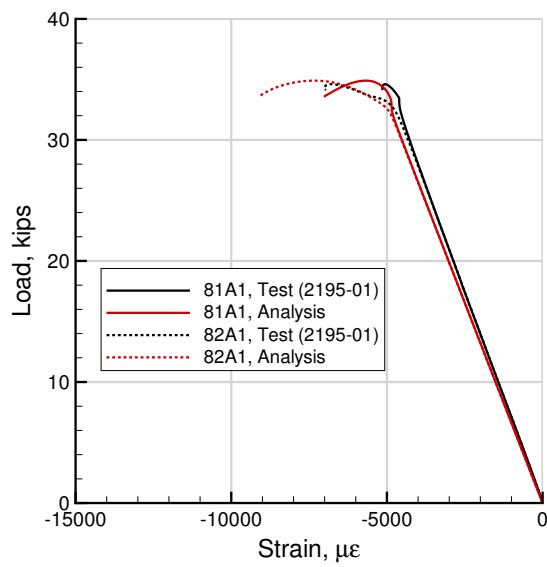
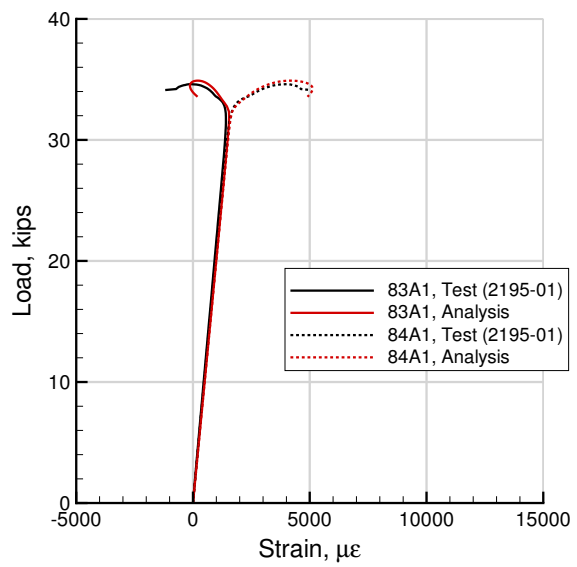
(a) longitudinal strain

(b) short transverse strain

Figure 17. Strains in the longitudinal and short transverse directions at gage location A1

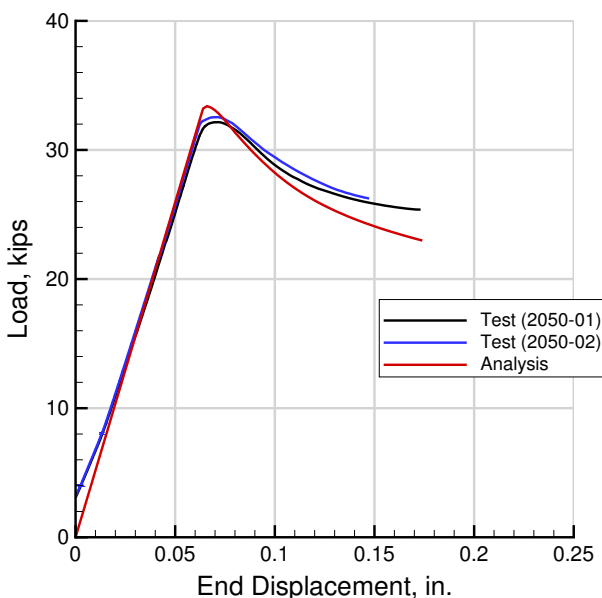
Figure 18. Load vs. end displacement response for 2050 specimens

The load-end displacement responses for the two specimens and the corresponding predicted response are shown in Figure 18. As with the 2195 specimens, the end displacements were adjusted so the slope of the linear portion of the load-end displacement response aligned with the slope from the analysis. The buckling and crippling loads, and load and end displacement at the end of the test are summarized in Table 5. For the specimens, the measured buckling and crippling loads were within 3% of each other. The measured buckling loads were within 7% of the predicted buckling load, and the measured crippling loads were within 4% of the predicted crippling load. The predicted load at an end displacement of 0.174 in. was 23.0 kips, and for an end displacement of 0.147 in. was 24.2 kips. These predicted loads were within 10% and 8% of the the loads for 2050-01 and 2050-02, respectively. While the difference between specimen load at the end of the test and the predicted loads at the corresponding end displacements was not significant, the predicted slope of the load-end displacement response in the postcrippling range indicates the panel was softening at a faster rate in the analysis than was seen in the specimens. Further analyses are necessary to determine the reason for this behavior, and whether it could lead to a premature prediction of material failure (once a failure criterion is added to the model), and whether it would affect the crippling load.

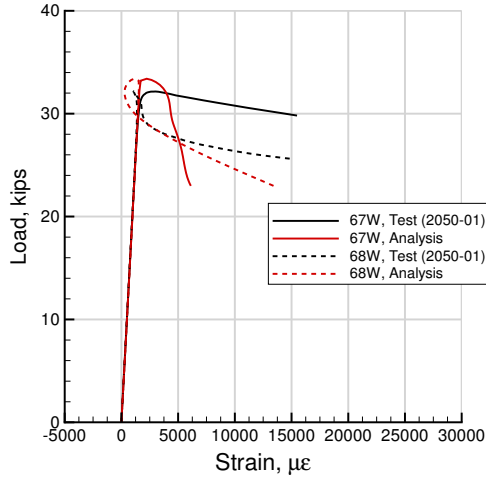
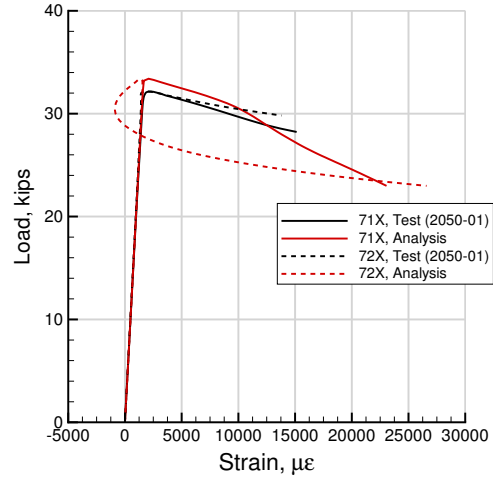
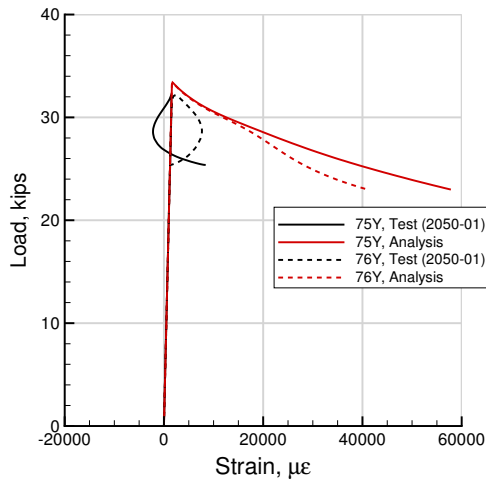
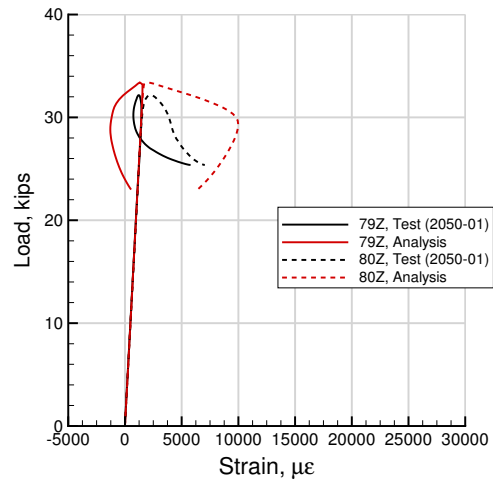
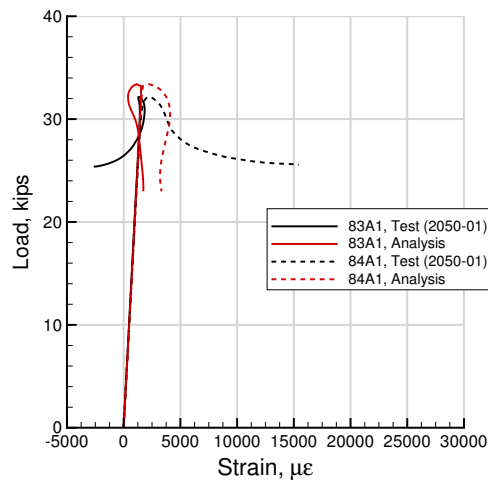
(a) gage location W

(b) gage location X

(c) gage location Y

(d) gage location Z

(e) gage location A1

Figure 23. Stiffener transverse strains for 2050-01 and analysis (odd-numbered gages on right side of stiffener, even-numbered gages on left side of stiffener)

Load-transverse strain responses at gage locations W, X, Y, Z and A1 are shown in Figure 23 for specimen 2050-01 and the analysis. Strain gages at locations W and X went off-scale in the postbuckling range, and those responses end at the last value before the gages went off-scale in Figures 23a and 23b. There were similarities in the characteristics of the strain responses; however, since the locations of the areas of highest strains developed at different locations in the test and the analysis, the comparisons had to consider the responses at different locations. In general, best agreement was seen when comparing the response of 2050-01 at one gage location to the analysis prediction at the adjacent gage location below. For example, the transverse strains on both sides of the stiffener continue to increase in the postbuckling range for the measurements at location X for 2050-01 (Figure 23b) and the predictions at location Y for the analysis (Figure 23c). For all other strain gage pairs shown in Figure 23, the strains on the left and right sides of the stiffener initially diverge in the postbuckling range. Another example of the agreement between the measured and predicted strains at adjacent locations would be the response at location Y for specimen 2050-01 (Figure 23c) was similar to the response at location Z in the analysis (Figure 23d). At these respective locations, in the initial postbuckling range, strains on opposite sides of the stiffener diverged and then after crippling a reversal of strain occurred on both sides of the stiffener.
