# Repair Concepts as Design Constraints of a Stiffened Composite PRSEUS Panel

A design and analysis of a repair concept applicable to a stiffened thin-skin composite panel based on the Pultruded Rod Stitched Efficient Unitized Structure is presented. The concept is a bolted repair using metal components, so that it can easily be applied in the operational environment. The damage scenario considered is a midbay-to-midbay saw-cut with a severed stiffener, flange and skin. In a previous study several repair configurations were explored and their feasibility confirmed but refinement was needed. The present study revisits the problem under recently revised design requirements and broadens the suite of loading conditions considered. The repair assembly design is based on the critical tension loading condition and subsequently its robustness is verified for a pressure loading case. High fidelity modeling techniques such as mesh-independent definition of compliant fasteners, elastic-plastic material properties for metal parts and geometrically nonlinear solutions are utilized in the finite element analysis. The best repair design is introduced, its analysis results are presented and facto

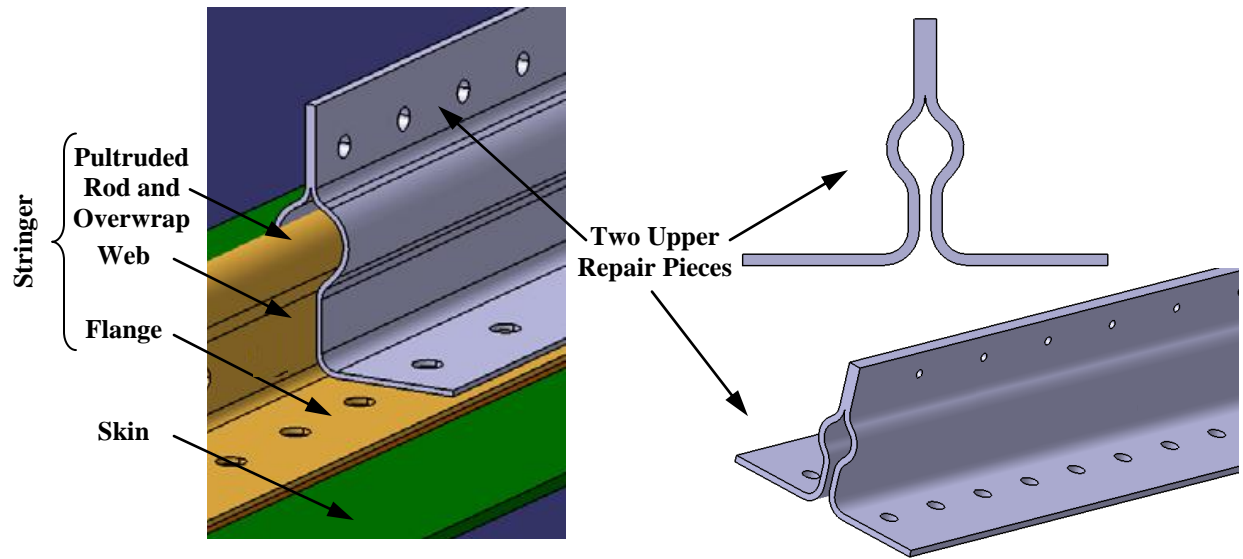
Figure 2. General Mohawk repair concept.

The general Mohawk repair concept was first proposed by The Boeing Company and initial exploration was conducted in a proprietary study. The Mohawk concept incorporates previously outlined desired features and one of its early variations is presented in Figure 2. The repair consists of two aluminum alloy upper repair pieces whose bottom ends rest on the panel's top flange surface and the vertical portions are designed to accommodate the web with the pultruded rod. The two upper pieces are bolted directly together above the rod, and if advantageous, may also be bolted together through the stiffener web below the rod. The clearance between the two upper repair pieces and the pultruded rod ensures that the repair is not clamped on the rod. The lower ends of the repair components are bolted through the flanges to an aluminum alloy strap (not visible in Figure 2). The width of this lower strap is equal to or greater than the combined widths of the two upper repair pieces, as dictated by the extent of the damage being repaired. Note, that by incorporating a stiff pultruded rod offset from the panel surface, the pristine PRSEUS panels are designed to efficiently carry not only in-plane but also bending loads. Consequently, the Mohawk repair concept is designed such that the neutral bending axis of the three assembled repair pieces (the two upper pieces and the lower strap) coincides with the neutral bending axis of the pristine panel. This way Mohawk can transfer combined in-plane and bending loads in a similar fashion as the pristine panel.

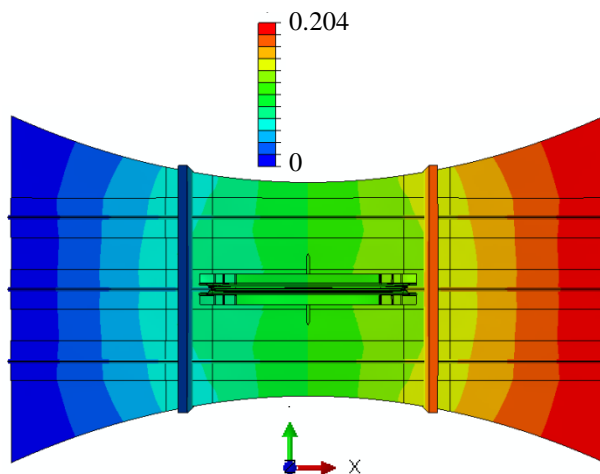
Figure 6. In-plane (X-axis) displacement (in.) at limit loading of 119.1 kip.

Results obtained at the limit loading level of 119.1 kip are illustrated in Figure 6 through Figure 9. In-plane displacement field in the direction of the loading (i.e., the X-axis direction) for the entire repaired panel is presented in Figure 6. It is seen that a smooth and uniform displacement across-the-width of the panel (i.e., in the Y-axis direction) was obtained in the section between the frames and no excessive disruption of the displacement field occurs due to the presence of the repair assembly. Maximum axial strain in the panel is presented in Figure 7 where the repair assembly is not plotted. The color bar legend in this plot is terminated at the stack 0-degree tension limit allowable strain of  $7000 \mu\epsilon$ ,<sup>8</sup> therefore all the locations exceeding this value are plotted in grey. It is seen that only small areas in the vicinity of the frame cap edges and at the tips of the saw-cut (as indicated) exceed the allowable strain value. However, in both cases the global FE model lacks enough fidelity to accurately compute local strain levels and tends to overestimate them. In the actual panel a more gradual cross section change exists where, e.g., a single-stack skin (0.052 in. thickness) transitions into a four-stack frame cap (0.208 in. thickness) while in a FE model a step change of the cross section is effectively introduced. The skin-to-frame cap transition area was the subject of a separate proprietary study using refined local analysis utilizing StressCheck software<sup>15</sup> and concluded that this area should not yield critical strain values. Also an array of testing conducted thus far<sup>6-8</sup> supports this conclusion. Similarly, a typical 0.2-in. element size used in the global FE model is insufficient to accurately represent a 0.125-in. radius at the saw-cut tip. Furthermore, while stop-drills may be introduced to mitigate strain concentration at the saw-cut tips,<sup>10</sup> this step is likely not required, as some design manuals, e.g., ref. [11], recommend verifying allowable values at certain distances (called characteristic lengths) away from the cut-out edges due to the presence of the stress relief in composites. Due to proprietary nature of ref. [11] the specific characteristic length value is not cited here.

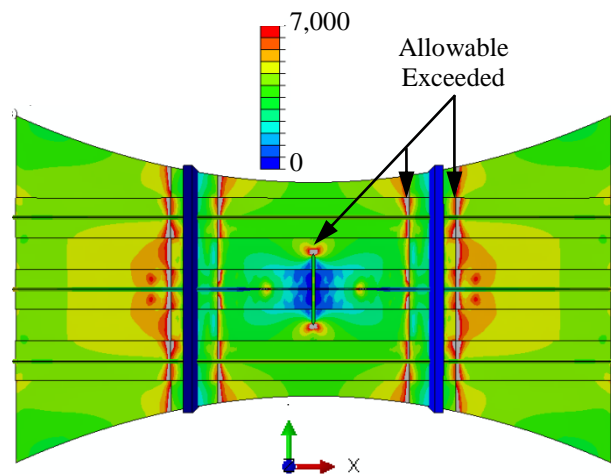
Figure 7. Maximum axial strain ( $\mu\epsilon$ ) at limit loading of 119.1 kip.

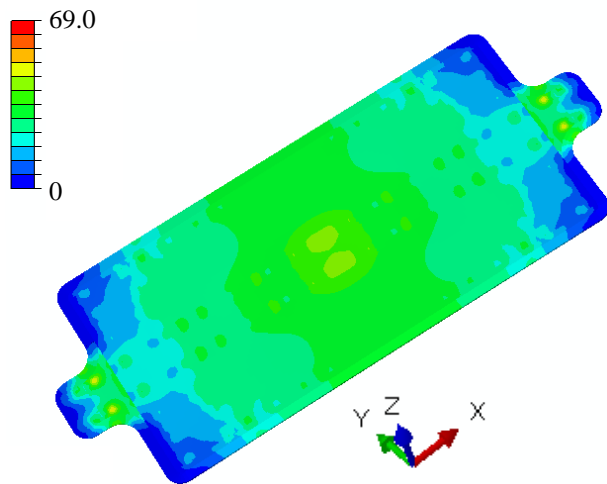
**Figure 8. OML strap maximum principal stress (ksi) at limit loading of 119.1 kip.**

Maximum principal stress fields in the OML repair strap and the IML assembly are presented in Figure 8 and Figure 9, respectively. It is seen that the repair assembly does not exceed the allowable yielding stress level of 69 ksi. The maximum stress levels in the OML strap are found to be 50.5 ksi and are located in the ‘tongue’ areas of the strap near the fastener joints. The maximum stress levels in the IML assembly are higher, reaching 63.3 ksi, and occur at the ends of the IML repair pieces in the fillets between the flange and web sections of the repair. Note, that the design of this section of the IML assembly exemplifies a compromise between the two conflicting factors inherent to this repair design. On one hand, increased thickness of the end sections of the IML repair piece allows distribution of a load over an increased cross section area, and therefore may reduce stress levels. At the same time, increased thickness means increased stiffness and results in higher loads being transferred into the IML assembly from the damaged panel. Consequently, passed certain thickness value, stress level reduction may be diminished or even not achievable. This in turn, not only adversely affects the repair assembly itself, but also may lead to undesirably high fastener loads and/or fastener-generated bearing stress levels in the composite holes accommodating these fasteners. Furthermore, over-stiff repair assembly alters the overall load paths in the repaired panel, potentially making them very different from those of the pristine panel.

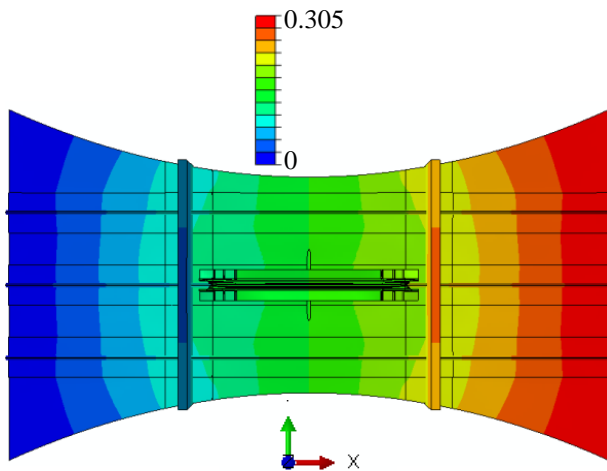
**Figure 10. In-plane (X-axis) displacement (in.) at ultimate loading of 178.7 kip.**

Results obtained at the ultimate loading level (178.7 kip) for the panel and the ultimate loading +10% level (196.5 kip) for the repair assembly are illustrated in Figure 10 through Figure 15. The in-plane displacement field for the entire repaired panel is presented in Figure 10. Similar to in-plane displacement field obtained for the limit load level presented in Figure 6, a smooth and uniform panel displacement field across-the-width was obtained in the section between the frames. Maximum axial strain in the panel is presented in Figure 11 where again, the repair assembly is not plotted. The color bar legend in this plot is terminated at the stack 0-degree tension ultimate allowable strain of 10,500  $\mu\epsilon$ , therefore all the locations exceeding this value are plotted in grey. Again, similar to the results presented before in Figure 7, it is seen that only small areas in the vicinity of the frame cap edges and at the tips of the saw-cut are exceeding allowable values. Per argument presented before when discussing Figure 7, strain levels in these areas are judged to be likely overestimated, and should not cause a premature failure of the panel.

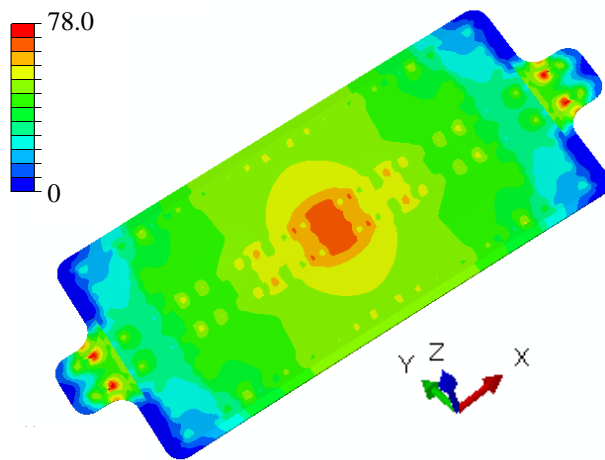
**Figure 12. OML strap maximum principal stress (ksi) at ultimate loading +10% of 196.5 kip.**

Maximum principal stress fields in the OML repair strap and the IML assembly are presented in Figure 12 and Figure 13, respectively. It is seen that the repair assembly does not exceed the allowable tensile strength level of 78 ksi. Maximum stress levels in the OML strap are found to be 74.7 ksi and are located in the ‘tongue’ areas of the strap in the vicinity of the second row of fasteners. The maximum stress levels in the IML assembly are higher, reaching 77.3 ksi, and occur at the ends of the IML repair pieces in the fillets between the flange and web sections of the repair. For both OML and IML repair pieces, the maximum stress levels at the ultimate loading +10% coincide

with the corresponding locations identified for the limit loading condition. Note, that the red areas are indicative of a plastic response regime, i.e., when stress level exceeds the yielding stress of 69 ksi. It is seen that apart from the locations discussed before when identifying the highest stress level locations, plastic response regime is also present in both OML and IML repair pieces in the vicinity of the saw-cut damage, i.e., at the mid-span of the OML strap and the mid-span of the IML repair assembly. Overall, the plastic response regime is an important factor when localized highly-stress sections of the repair assembly are of interest. Specifically, a plastic response results in stress relaxation, absence of which would otherwise result in significantly overestimated stress levels in the localized areas where the yielding stress is exceeded. Since these areas, however, are limited to relatively small sections of the overall repair assembly, their impact on the global response is minimal. When the in-plane force versus in-plane displacement plot was produced, the relationship (not shown here for brevity) exhibited virtually linear dependency. The above observation also points to the fact that no significant geometric nonlinearity was present in the analysis. Considering application of the inplane loading only and the fact that the neutral bending axis of the repair assembly coincided with the neutral bending axis of the pristine panel, this result comes as no surprise.

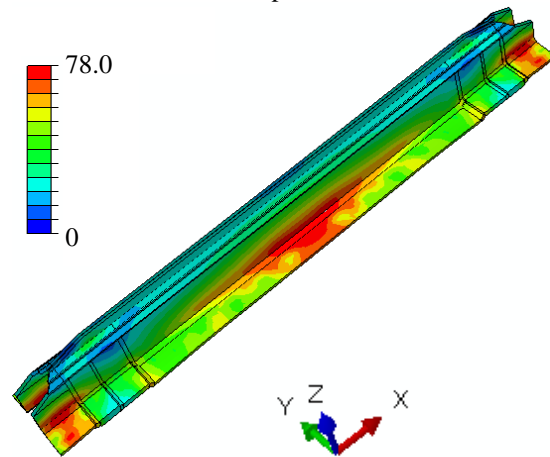
**Figure 13. IML repair assembly maximum principal stress (ksi) at ultimate loading +10% of 196.5 kip.**

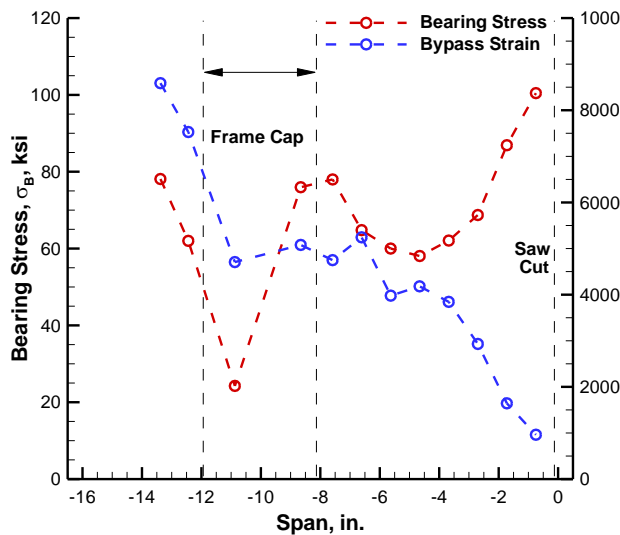
**Figure 14. Center flange spanwise bearing stress and bypass strain distributions at ultimate loading +10% of 196.5 kip.**

The center flange was found to be the critical location when the bearing stress and bypass strain levels were considered. Bearing stress and bypass strain distributions along the length of the panel's center flange at the ultimate loading level +10% (196.5 kip) are presented in Figure 14. Note, that due to symmetry about the axial and lateral direction (as depicted with dash-dotted lines in Figure 4), distributions on both sides of the center stringer and both sides of the saw-cut are also symmetric. In Figure 14 span station of -10 in. corresponds to the location of the center of the left frame, and 0 in. span station to the center of the saw-cut. Vertical black dashed lines highlight the width of the frame cap and the edge of the saw-cut damage, as annotated. Bearing stresses are computed per Eq. (1) from the fastener force output, while the bypass strains are directly available from the FE analysis, e.g., as presented in Figure 11. Note however, that Figure 11 was obtained at the ultimate load level, and consequently as mentioned before, it is intended for evaluation of the panel away from the fastener attachments. The strain results used in Figure 14 are obtained at the ultimate level +10% as they are intended for the repair assembly evaluation.

The highest value of the bearing stress is reached at the row of fasteners closest to the saw-cut, as seen in Figure 14, even though the diameter of these fasteners was reduced from 3/16-in. used elsewhere to 5/32-in. to reduce their stiffness. Other locations where the bearing stress levels are also high include the first row of fasteners at the end of the OML 'tongue,' which is a typical peaking effect associated with a doubler termination. Similar effect is also seen in the fourth and fifth rows of fasteners from the left, which are the first two rows of fasteners that attach the IML assembly (the first three fasteners from the left attach the OML strap only). The effect is stretched over the two consecutive fastener rows because the IML repair pieces have variable thickness in this region and, therefore, resemble a staggered two-step termination. Note, that when the third row of fasteners is excluded from the discussion, the overall variation of the bearing stress ranges from approximately 60 to 100 ksi. While the ideal distribution would be constant, such a design is not practical to be defined and manufactured. The presented design is a compromise between simplicity and a desired bearing stress distribution. It needs to be underscored, that the

The bypass strain distribution presented in Figure 14 displays a gradual, almost monotonic decay from its peak value at the beginning of the OML strap ‘tongue’ to its lowest value in the vicinity of the saw-cut. Such a distribution is expected, since away from the saw-cut, all three stringers are expected to carry approximately the same loading. As the saw-cut is approached, the loads from the center stringer are gradually transferred through the fasteners into the repair assembly. In the limit, i.e., on the edge of the saw-cut, bypass strain should asymptote to zero, as the center flange is unable to support any X-axis load component at this location.

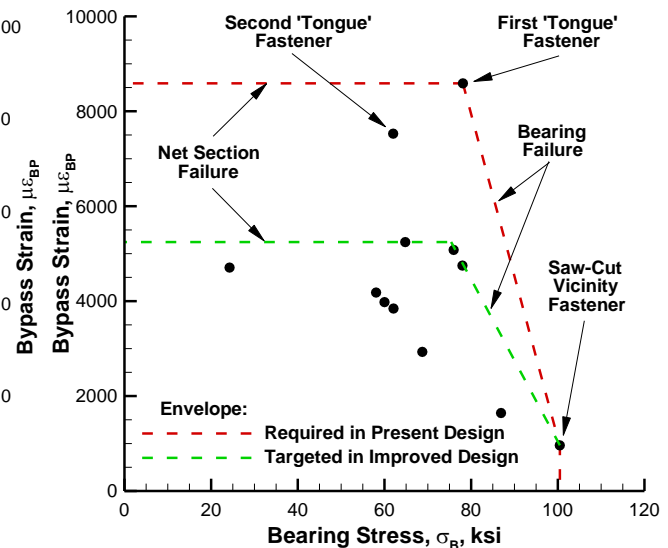
**Figure 15. Center flange bearing stress versus bypass strain envelope at ultimate loading +10% of 196.5 kip.**

The bearing stress versus bypass strain envelope is presented in Figure 15. While it presents the same data as Figure 14, and the spatial distribution information is lost, it is an important format for a bolted joint result representation as the allowable values of bearing stress and bypass strain are not independent. While the allowable envelope cannot be plotted in Figure 15 due to its proprietary nature,<sup>11</sup> a minimum required envelope encompassing the results of the FE analysis is plotted with a red dashed line. Annotated in Figure 15 are points that are critical in the current design or may become critical in a further effort to tune the design. As indicated before, the point labeled as ‘saw-cut vicinity fastener’ was already subject to refinement of the fastener diameter to reduce its bearing stress value. Therefore, any further reduction in the bearing stress level there is judged difficult. On the other hand, the other two highlighted points are associated with the OML strap ‘tongue’ and improvement in this section of the repair assembly is deemed more plausible. Specifically, elimination of the ‘tongues’ can be considered leaving the OML strap as a rectangular contour with rounded corners. In the most desirable scenario it may yield a reduction in the envelope that approaches the green dashed line in Figure 15. Certainly, the bearing stress and bypass strain levels are not independent of each other along the flange span. Examination of Figure 14 and Figure 15, however, seem to hint that the most substantial bearing stress increase when the ‘tongues’ are eliminated should result at the third fastener from the left. This fastener, however, is none of those that span the green dashed-line envelope, so even a significant movement of this data point in Figure 15 can still be accommodated within the boundaries of the desired shrunk envelope.

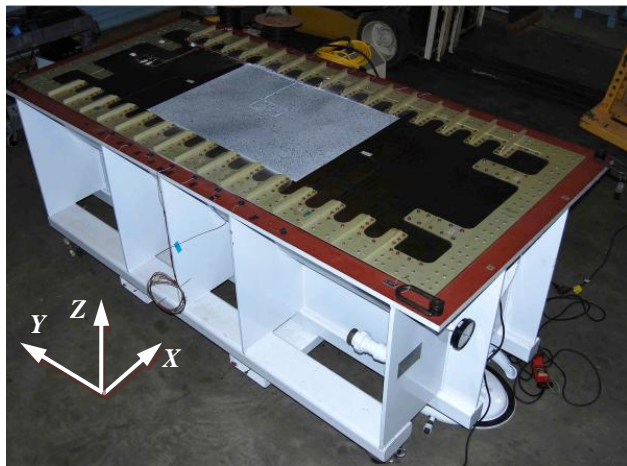
**Figure 16. Test set up of the pristine pressure panel.<sup>7</sup>**

Similar to the tension panel effort, an existing pressure panel test article configuration<sup>7</sup> was adopted in the studies. The overall test set up of a recent pristine pressure panel test<sup>7</sup> is presented in Figure 16. The coordinate system presented in Figure 16 is consistent with the one presented in Figure 1a and throughout the tension panel discussion in that sense that stringers are oriented along the X-axis and frames along the Y-axis. Since the pressure panel is mounted on the pressure vessel such that the panel substructure faces to the inside of the pressure vessel, the Z-axis is oriented to the outside of the pressure vessel, i.e., an elevated pressure inside the vessel causes a positive out-of-plane panel deformation. The dimensions of the opening at the top of the pressure vessel to which the panel was mounted were 100 in. by 40 in. and can be regarded as equal to the test section dimensions of the pressure panel. The substructure of the panel comprised of 15 stringers spaced 6 in. apart and two frames spaced 20 in. apart, i.e., the same substructure spacing as for the tension panel was maintained. Also unchanged, when compared with the tension panel, were the lamination stacking sequences and material properties, as introduced before in Table 1 and Table 2, respectively. Note that unlike the tension panel, the pressure panel longer direction is aligned with frames rather than stringers.

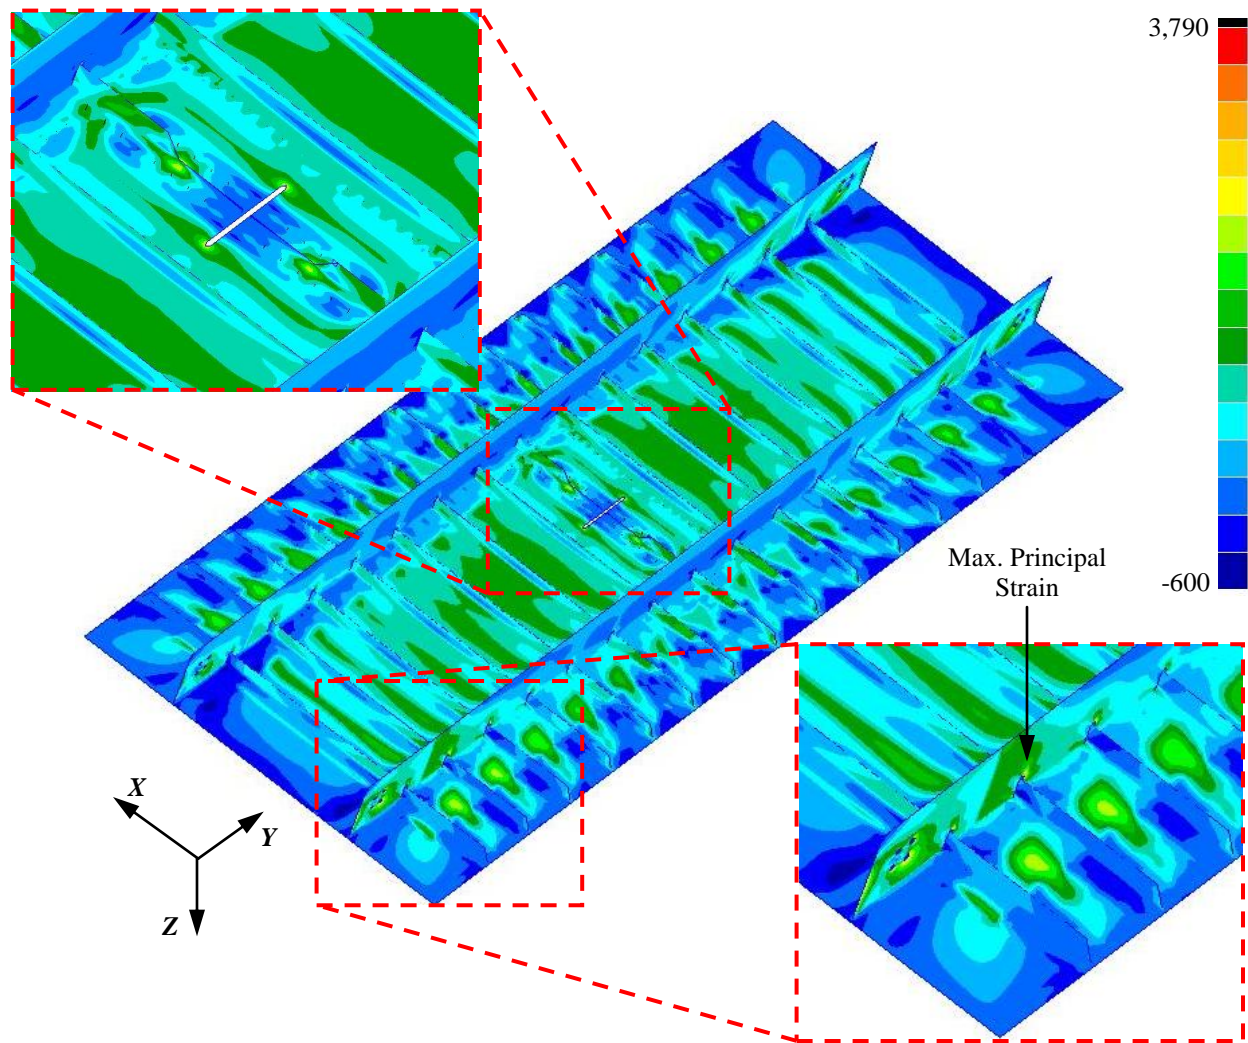
Figure 18. Maximum principal strain ( $\mu\epsilon$ ) under ultimate loading of 18.4 psi.

Maximum and minimum principal strain fields of the panel obtained at the ultimate loading level of 18.4 psi are presented in Figure 18 and Figure 19, respectively (repair assembly not shown). For a pressure loading scenario both maximum and minimum principal strain fields are presented because the two are yielding comparable strain levels, while in the previously considered tension loading case, the tension axial strain was clearly dominant. A close-up of a corner section of the panel away from the saw-cut is shown in Figure 18 because the maximum principal strain occurs in this region at the intersection of a stringer and a frame. Both figures also include a close-up section of the panel over which the repair assembly is installed. It is seen in the close-up of Figure 19 that the minimum principal strain occurs where the tapered section of the damaged stringer terminates at the flange. Overall, it is seen in Figure 18 that the maximum principal strain level is  $3790 \mu\epsilon$  and the minimum principal strain in Figure 19 is  $-5270 \mu\epsilon$ , both well within allowable values per Table 1.

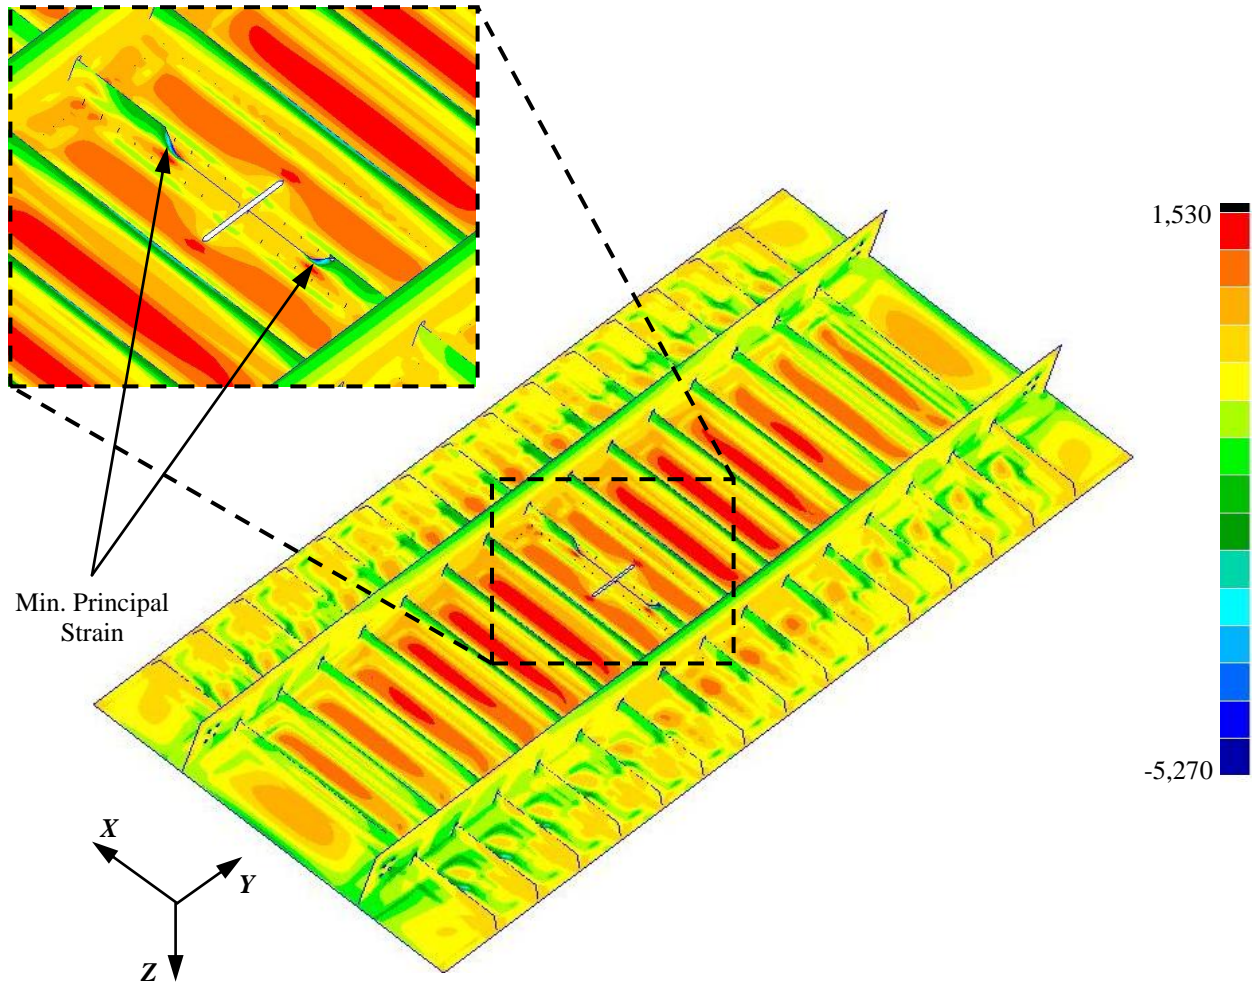
Figure 19. Minimum principal strain ( $\mu\epsilon$ ) under ultimate loading of 18.4 psi.

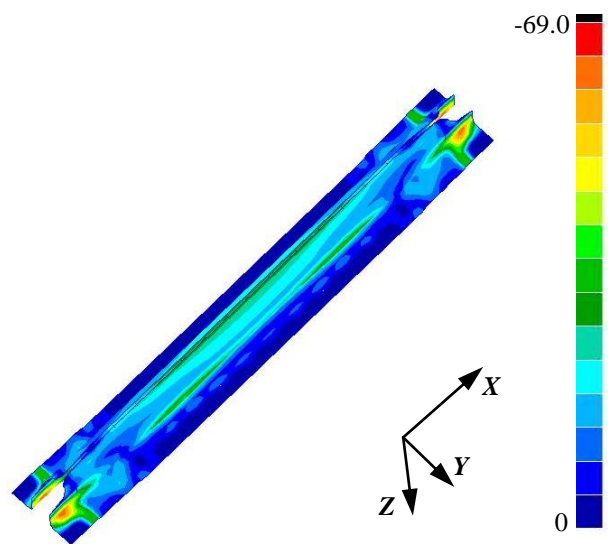
Figure 21. IML repair assembly minimum principal stress (ksi) at ultimate + 10% loading of 20.24 psi.

Maximum and minimum principal stress fields in the IML repair assembly at the ultimate loading +10% level of 20.24 psi are presented in Figure 20 and Figure 21, respectively. It is seen that the repair assembly does not exceed the yielding stress level of 69 ksi, therefore remains in the elastic regime. The maximum principal stress levels in the IML pieces are found to be 61.9 ksi and are located in the vicinity of the end fasteners, as seen in Figure 20. The minimum principal stress levels are found to be -63.6 ksi and are located close the ends of the IML pieces in fillet areas between the flange and web sections of the repair pieces, as seen in Figure 21. The maximum principal stress levels in the OML strap at the ultimate loading +10% level of 20.24 psi are presented in Figure 22.

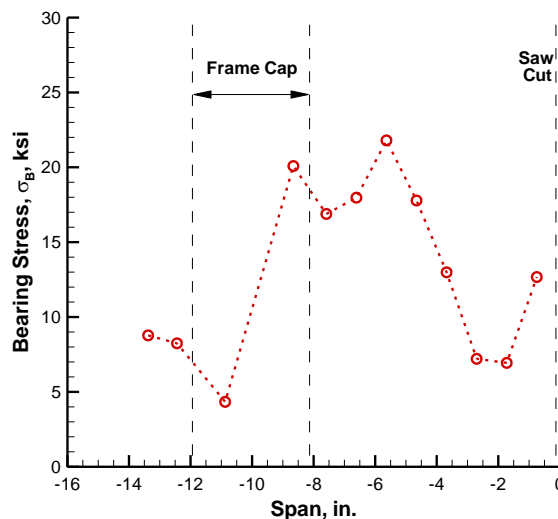
Figure 23. Center flange bearing stress distribution at ultimate + 10% loading of 20.24 psi.

Finally, the bearing stress distribution due to the fasteners installed in the center panel flange is presented in Figure 23 at the ultimate loading +10% level of 20.24 psi. As expected, the center flange again produced the highest bearing stress levels as was the case for the repaired tension panel. The maximum bearing stress of 21.7 ksi is identified at the sixth row of fasteners when counting from the saw-cut location. This value represents less than 22% of the maximum bearing stress identified for the tension panel. While the bypass strain level distribution at the ultimate load level +10% is not explicitly presented for brevity, the overall strain levels in the center flange are also significantly lower when compared to the repaired tension panel. The principal strain levels at a slightly lower loading of 18.4 psi shown in Figures 18 and 19 can be regarded as an indirect but corroborating evidence for the above statement. Therefore, a plot of bearing stress versus bypass strain is also omitted for brevity, as it is certain that its envelope would be contained within the envelope produced based on the tension panel analysis.
