Investigation of a Moiré Based Crack Detection Technique for Propulsion Health Monitoring

*Mark R. Woike, Ali Abdul-Aziz, Gustave C. Fralick, and John D. Wrbanek
Glenn Research Center, Cleveland, Ohio*

The development of techniques for the health monitoring of the rotating components in gas turbine engines is of major interest to NASA's Aviation Safety Program. As part of this on-going effort several experiments utilizing a novel optical Moiré based concept along with external blade tip clearance and shaft displacement instrumentation were conducted on a simulated turbine engine disk as a means of demonstrating a potential optical crack detection technique. A Moiré pattern results from the overlap of two repetitive patterns with slightly different periods. With this technique, it is possible to detect very small differences in spacing and hence radial growth in a rotating disk due to a flaw such as a crack. The experiment involved etching a circular reference pattern on a subscale engine disk that had a 50.8 mm (2 in.) long notch machined into it to simulate a crack. The disk was operated at speeds up to 12 000 rpm and the Moiré pattern due to the shift with respect to the refere

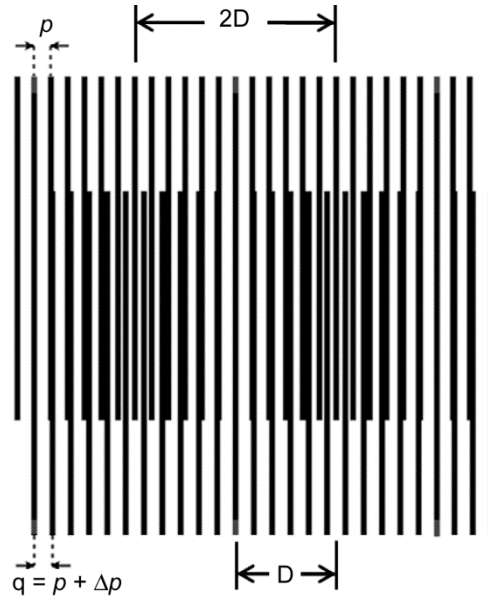
Figure 1.—Example of a Moiré pattern.

Figure 1 shows the overlap of two vertical patterns. The first pattern has a vertical line spacing of p , while the second pattern has been “stretched” and has a vertical line spacing of q , which is related to p by the following equation:

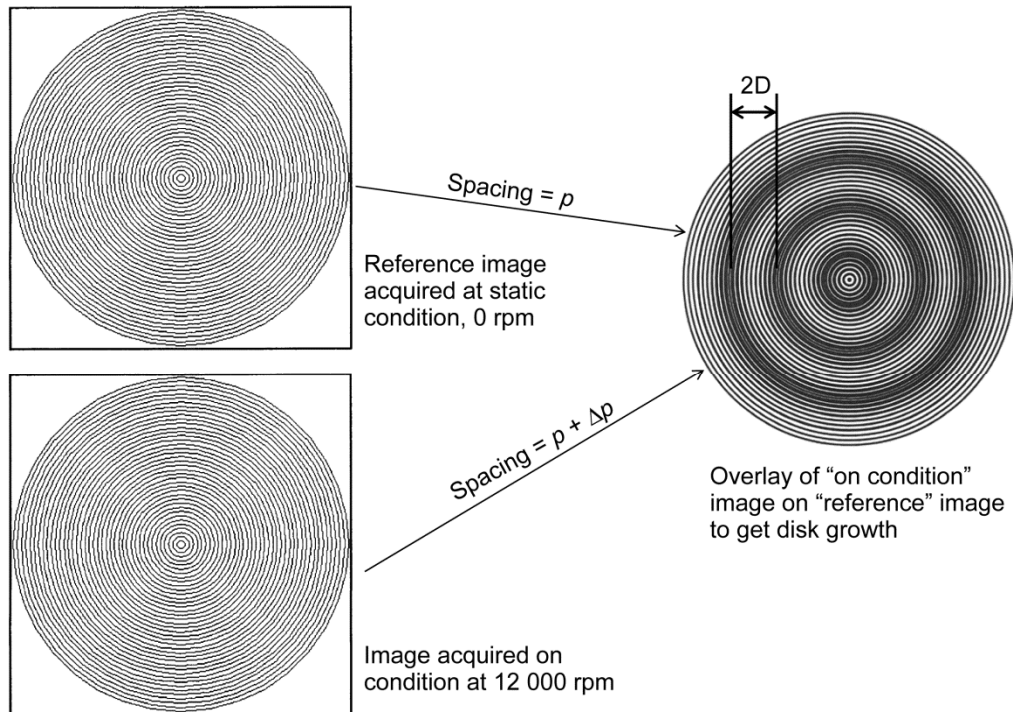
Figure 2.—Moiré concept applied to a rotating disk.

The Moiré effect amplifies small changes and has the potential to make these changes optically measurable by observing the spacing between the dark or light zones of two patterns overlaid on each other. This characteristic is the basis of the experiment to measure radial growth or strain on a rotating disk due to high stresses caused by operation or an anomaly such as a crack. Figure 2 shows the overall concept behind the experiment. The technical approach was to apply a pattern of concentric equally

spaced rings at a known spacing on a subscale turbine engine disk and acquire images of it at both static, 0 rpm, and at a loaded condition of 12 000 rpm. The image that was taken on-condition was then overlaid on the static reference image using image processing software. Registration marks that were placed on the disk were used for sub-pixel alignment. The composite image was then analyzed for the appearance of the dark and light zones due to the radial growth of the disk. Measuring the distance between the dark zones, $2D$, or between a light and dark zone, D , and knowing the initial spacing, p , would allow the calculation of the strain and radial growth that the disk was subject to during operation. To enhance the localized stress that the disk would experience during operation, a 50.8 mm (2 in.) long notch was machined into it to simulate a crack.

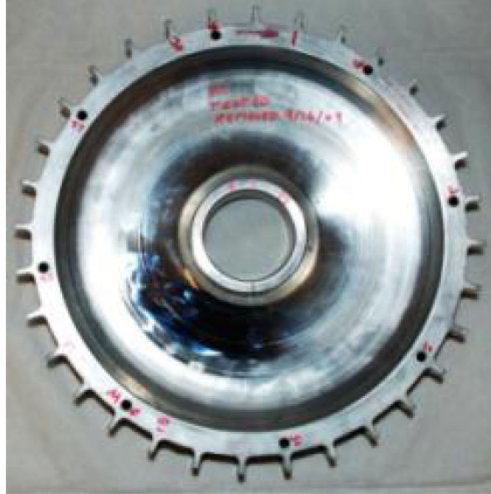
Figure 3.—Subscale engine disk.

The subscale simulated turbine engine disk that was used in this experiment is shown in Figure 3. The disk is 235 mm (9.25 in.) in diameter and has 32 evenly spaced blades. Its geometry is representative of that encountered in turbine engine disks. Its physical dimensions and characteristics are shown in Table 1. This disk has been well analyzed and used in previous fault detection experiments (Refs. 1 to 8) making it a good candidate for use with this experiment.

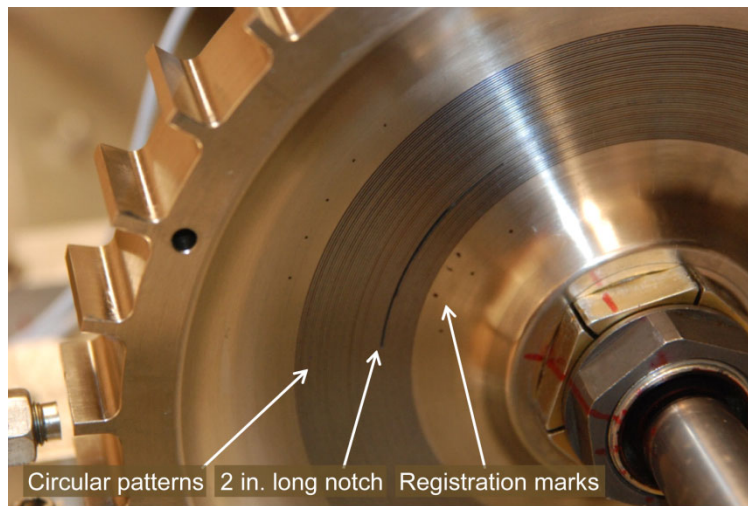
Figure 4.—Subscale engine disk with notch and pattern applied.

The notch and image pattern that was machined onto the disk is shown in Figure 4. The notch was machined into the disk prior to the experiment and was used for previous engine fault and crack detection experiments. The notch is located mid-span on the disk in the thinnest region. It is 50.8 mm (2.00 in.) long, 0.38 mm (0.15 in.) wide, and fully penetrates the disk with a depth of 2.54 mm (0.10 in.). The notch's purpose was to simulate a crack and enhance the localized stress and growth in the area around the crack. While considered large for realistic applications, it has served as an ideal test case in previous proof-of-concept fault and crack detection studies similar to the Moiré concept being investigated in this paper. The pattern that was applied to the disk in order to view the Moiré shift consisted of concentric circles that were 0.254 mm (0.010 in.) wide and uniformly spaced 0.254 mm (0.010 in.) apart.

The pattern was machined on to the disk using a precision lathe. The circles were made just deep enough, ~ 0.08 mm (~ 3 mils), so that a material could be applied to the grooves to provide contrast when imaging. A blue dye used in machining applications was applied to the disk then lightly sanded off, leaving the dye in the grooves to provide the needed contrast for viewing the circular pattern. Registration marks were also added to the disk to facilitate the alignment of the images acquired statically and on-condition. One issue that was encountered with the application of the patterns is that, due to the curvature of the disk's surface, only the flat portion of the disk from a radius beginning at 47.2 mm (1.86 in.) and ending at

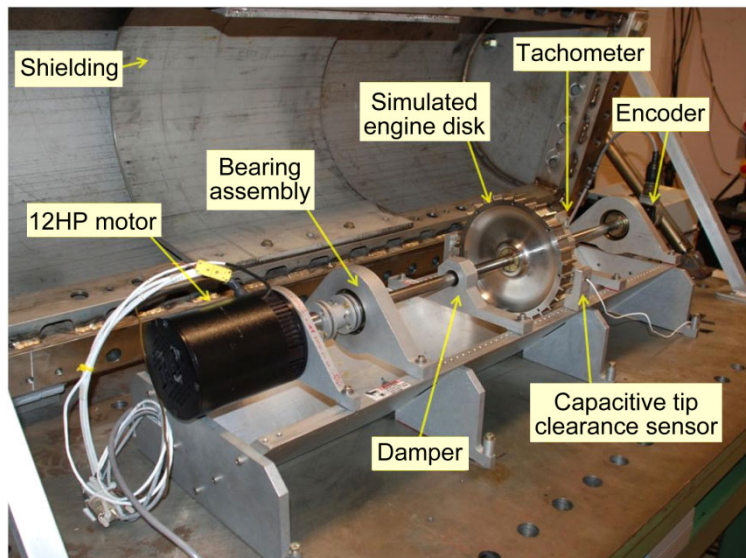
Figure 5.—High precision spin rig.

The NASA Glenn Research Center's High Precision Spin Rig was used to operate the disk for this experiment. The High Precision Spin Rig is shown in Figure 5. The spin rig can accommodate simulated engine rotor disks of up to 235 mm (9.25 in.) in diameter. It has a stainless steel shaft with a length of 781 mm (30.75 in.) and diameter of 20 mm (0.79 in.). The shaft is supported by precision contact ball bearings on each end with adjustable dampers positioned along the length shaft. A custom 12 hp motor is used to operate the spin rig at speeds up to 12 000 rpm. The setup for the experiment is shown in Figure 6. A five (5) Megapixel miniature machine vision digital camera with a 12 and 25 mm lens was used to acquire images of the disk statically and when it was being operated at 12 000 rpm. To capture the image of the disk as it was being spun a 10W white light emitting diode (LED) with pulsed power supply was used as a strobe. A laser 1/rev was used to precisely drive the strobe as a function of rotor location and speed. In-house designed and fabricated pulse delay and pulse width control circuitry was used to condition the 1/rev signal for control of the strobe. The pulse delay was varied in order to image different regions of the disk while it was spinning. The pulse width was adjusted to obtain the crispest image of the disk while it was on test condition. In addition to the optical instrumentation listed above, microwave and capacitive blade tip clearance (BTC) sensors were used to acquire blade tip clearance data. These sensors, shown in Figure 6, were located 180° across from each other on the disk. Two eddy current displacement sensors located 90° apart on the shaft were used to measure shaft location. The purpose of using this additional instrumentation was to compare any radial growth observed optically using the Moiré principle with the radial growth measured by these external sensors. They were also used to further develop crack detection techniques associated with these technologies.

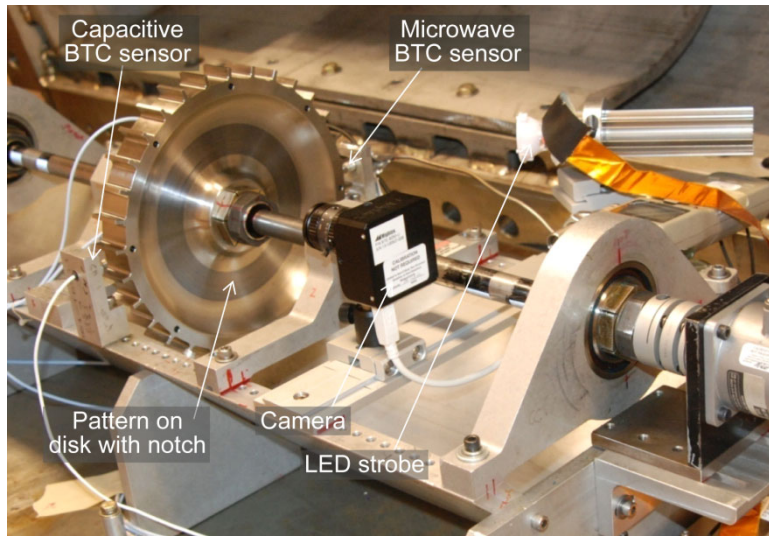
Figure 6.—Setup for Moiré crack detection experiment.

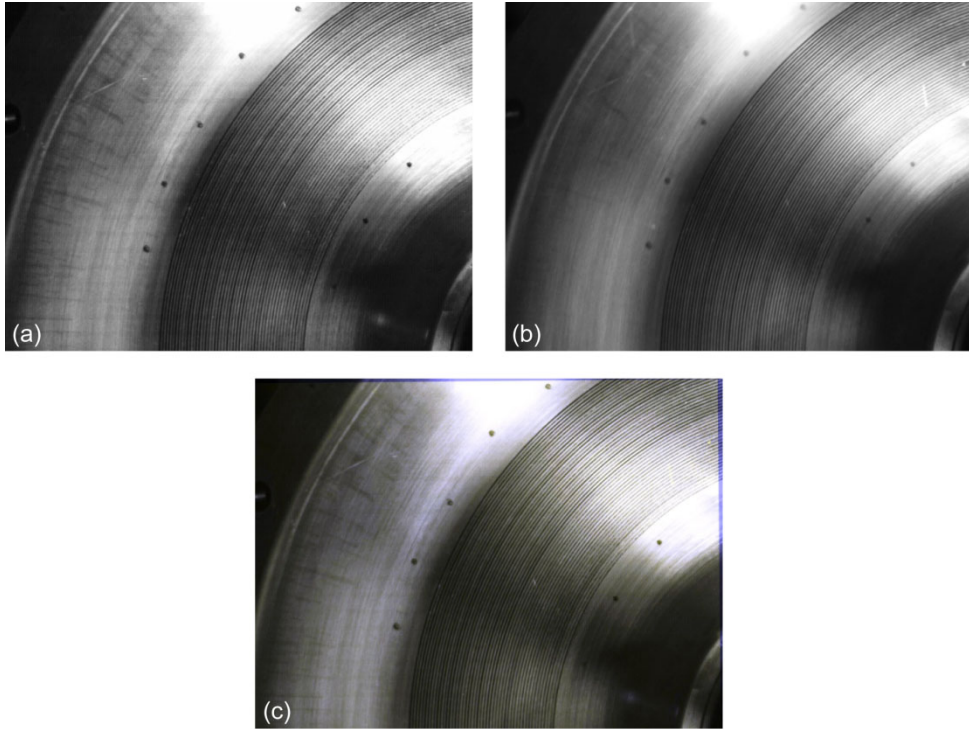
Figure 7.—Baseline region. (a) Static reference image. (b) On-condition image acquired at 12 000 rpm. (c) Composite image.

Figure 7 shows the images that were acquired for the clean, or baseline region, of the disk using a 12 mm lens. Figure 7(a) shows the reference image acquired at static conditions, Figure 7(b) shows the on-condition image acquired at 12 000 rpm and Figure 7(c) shows the resulting composite image obtained by overlaying the two images. For the baseline region of the disk the two images lined up exactly on top of each other and the light and dark zones due to the Moiré shift were not observed. Thus, indicating that very little radial growth was observed during high speed operation, which was expected for this side of the disk.

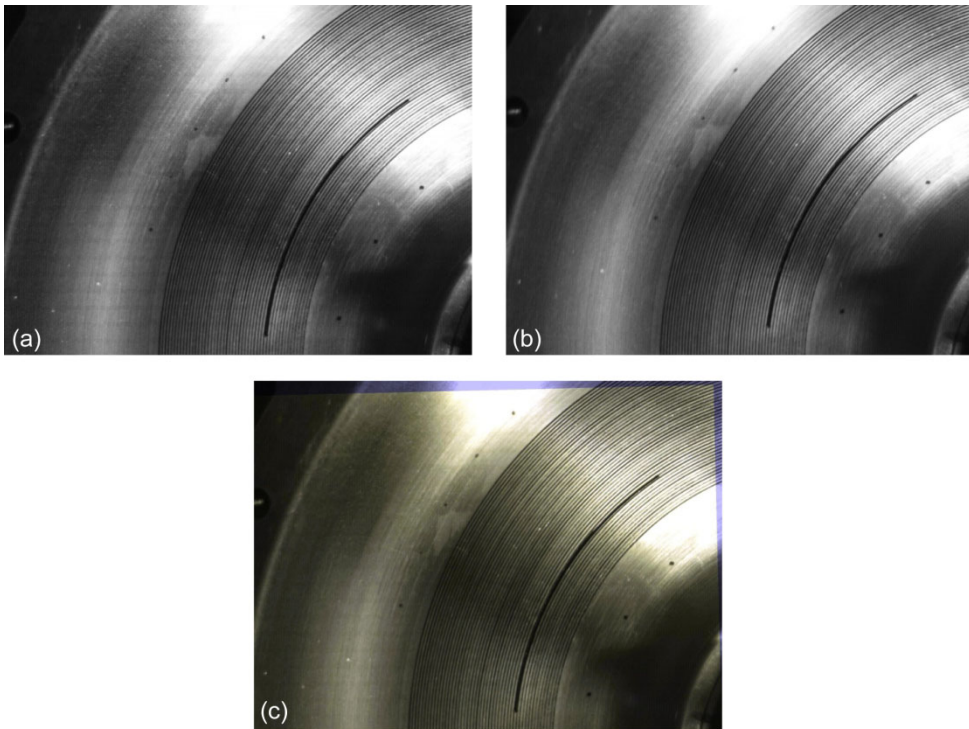
Figure 8.—Notch region. (a) Static reference image. (b) On-condition image acquired at 12 000 rpm. (c) Composite image.

Figure 8 shows the images that were acquired for the region of the disk with the notch using a 12 mm lens. Figure 8(a) shows the reference image acquired at static conditions, Figure 8(b) shows the on-condition image acquired at 12 000 rpm and Figure 8(c) shows the resulting composite image obtained by overlaying the two images. Again, as previously observed the anticipated light and dark zones due to the Moiré shift were not observed. Thus, again, indicating that very little radial growth was optically observed. This was unexpected, as finite element analysis showed that up to a ~0.075 mm (~0.003 in.) localized radial growth of the disk could be observed in the region of the notch under these loading conditions. The expectation was that at least the initiation of a pattern shift would be observable, especially in the rings beginning at the notch region and heading towards the outside edge of the disk.

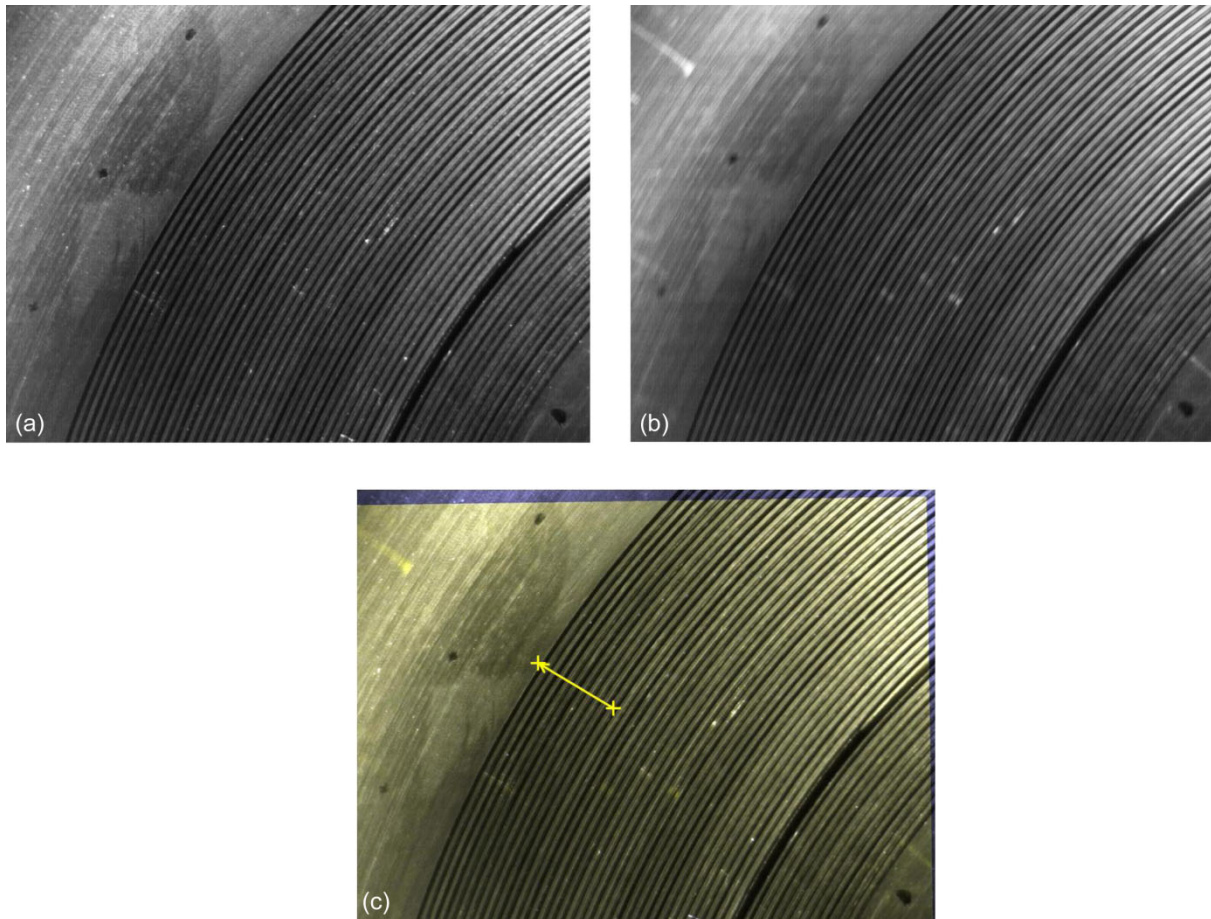
Figure 9.—Notch region with 25 mm lens. (a) Static reference image. (b) On-condition image acquired at 12 000 rpm. (c) Composite image.

To further investigate this concept a 25 mm lens was used in place of the 12 mm lens to magnify the region of interest. The same methodology was used to acquire images in both notch and baseline regions of the disk. The results from the notch region are presented in Figure 9. Figure 9(a) shows the reference image acquired at static conditions, Figure 9(b) shows the on-condition image acquired at 12 000 rpm and Figure 9(c) shows the resulting composite image obtained by overlaying the two images. As in the previous cases the anticipated shift due to any localized radial growth was not observable. The images lined up almost perfectly further verifying that the disk was experiencing very little if any growth due to the notch and the loads induced on it during operation. To further verify this observation a line intensity profile analysis was conducted over the last 10 rings on the composite image to determine if there was a shift due to radial growth of the disk as this would represent the best area to detect any radial growth. The region that was used for the intensity profile is indicated by the yellow line in Figure 9(c).

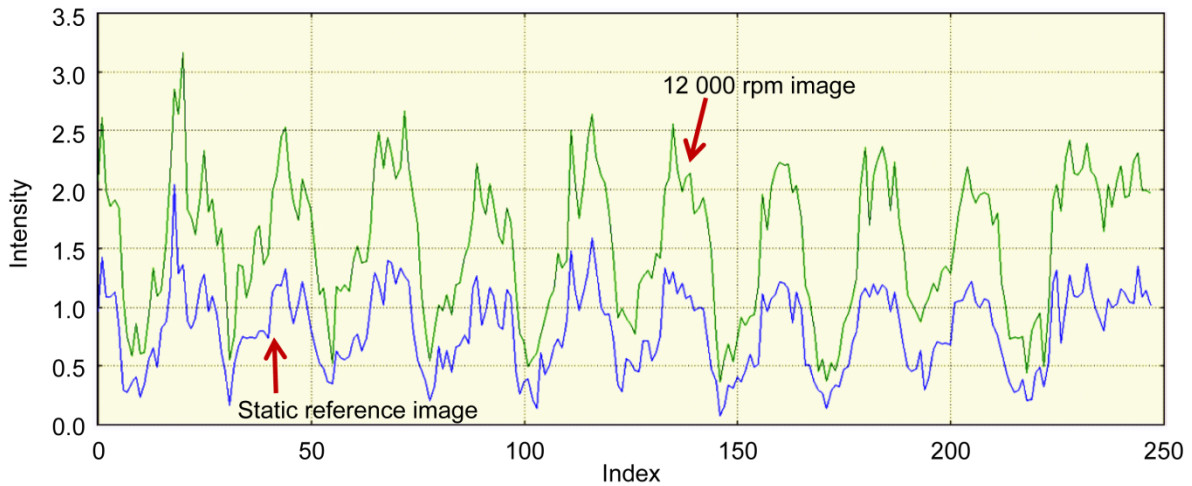
Figure 10.—Intensity profile.

The intensity profile is shown in Figure 10. The green line indicates the intensity for the image that was acquired at 12 000 rpm and the blue line indicates the intensity of the static reference image. The valleys on the chart indicate the location of the grooves or dark lines of the pattern. The peaks indicate the space between the grooves or the light lines of the pattern. From visually analyzing the profile it is evident that the peaks and valleys of the intensity profiles match each other in the x-axis or radial direction on the disk. Again, this verifies that the disk experienced very little if any radial growth during operation.

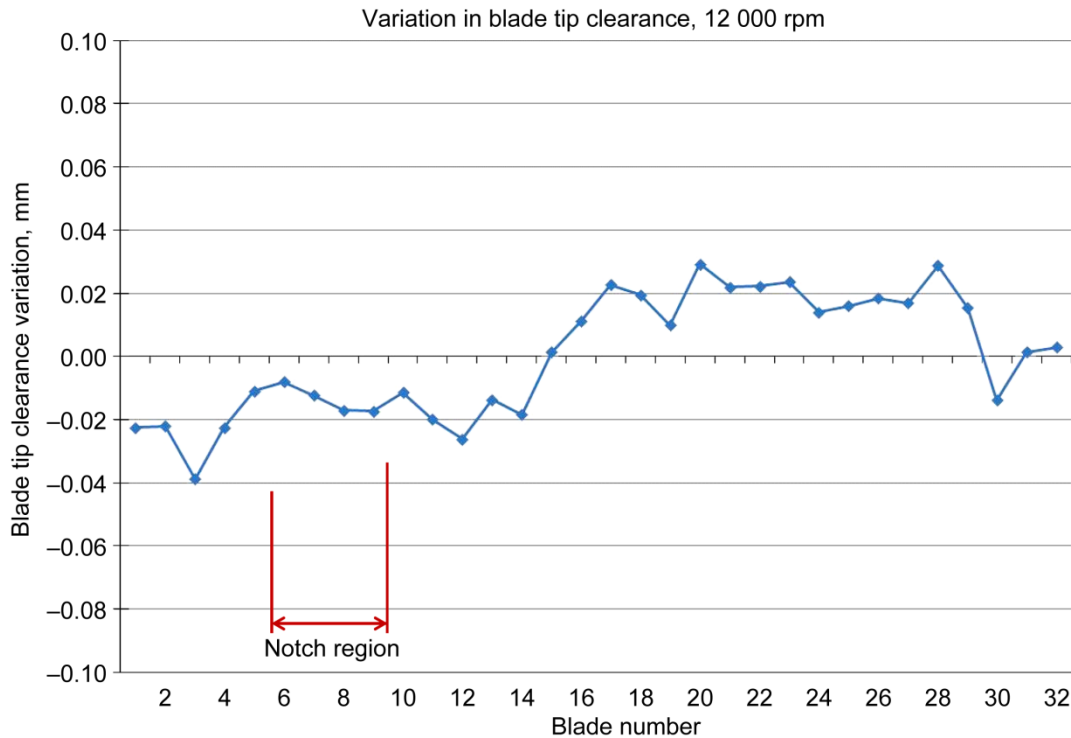
Figure 11.—Blade tip clearance profile.

As part of this experiment blade displacement data sets were acquired using external blade tip clearance and shaft displacement sensors for comparison to the data obtained from the optical technique. Both microwave and capacitive based blade tip clearance sensors were used to measure the disks vibration by monitoring the radial clearance for each blade and hence the radial growth of the disk. These sensors have been used in previous crack detection studies conducted in the spin lab (Refs. 11 and 12). The results measured by the microwave blade tip clearance sensor during this experiment are presented. The variation in blade tip clearance measured over 1 revolution, 32 blades, at a rotational speed of 12 000 rpm is shown in Figure 11. The red line indicates the region of the disk that contains the notch. From analyzing the graph a variation of 0.03 mm (0.001 in.) to -0.04 mm (-0.0016 in.) is observed

during operation of the disk. This minimal variation is thought by the authors to be due more to discrepancies in blade length and shaft wobble caused from Rotordynamics of the spin rig rather than radial growth of the disk. In previous experiments, up to ± 0.03 mm (0.001 in.) of shaft wobble has been measured at steady state operation using eddy current shaft displacement sensors. In addition, in the area of the notch, the blade tip clearance is observed to be stable or actual slightly increasing, which is counter to what would be expected if the disk experienced localized growth in this region. Hence, the external sensor data verified what was observed on the optical data regarding the minimal or lack of radial growth on the disk during operation.
