NASA/TM-2013-218021/Volume I  
NESC-RP-12-00824

# Independent Assessment of Instrumentation for ISS On-Orbit NDE

*Eric I Madaras/NESC  
Langley Research Center, Hampton, Virginia*

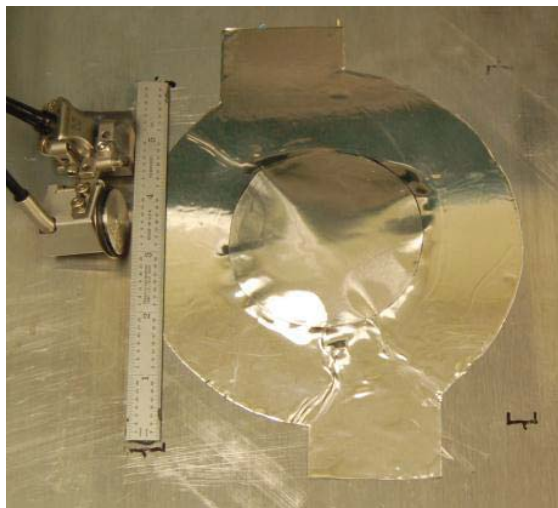
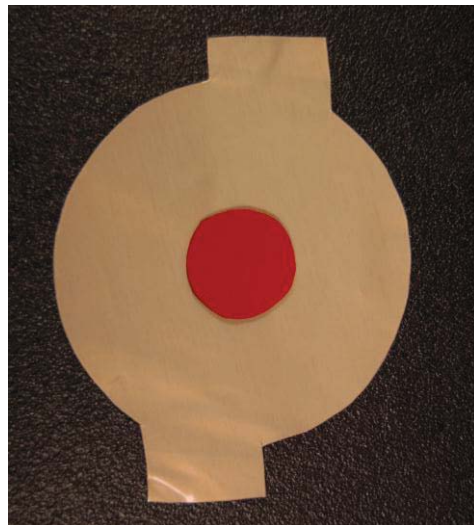
**Figure 7.1-1. PWRK Tape Patch Mock-up**

One IVA PWRK patch utilizes one or two layers of 0.013-inch thick aluminum tape. The shape of the aluminum patch is circular with two aluminum “wings” on the outer edge (see Figure 7.1-1). At the center of the patch is a ~1/8-inch-thick rubber pad that protects the center of the patch from any sharp metal surfaces that might exist at a leak location (see Figure 7.1-1(b)). The patch is placed over the damaged wall, and the astronaut flattens the edges of the tape to make a pressure seal. Because of the rubber pad at the center of the patch, the center will be significantly raised from the ISS pressure wall surface, which causes the tape surface to wrinkle. NDE testing will require that the method either measure through the patch and handle signal artifacts introduced by the unevenness or measure under the patch from several inches away (~4 inches or more). During some of the testing, the effects of the PWRK tape repair patch when imaging indirectly under the patch were emulated by employing a simple 6-inch-wide strip of 0.013-inch tape over the test samples that had manufactured flaws in a straight line. This simplified some of the testing, as the contact of the tape was the issue of concern for those tests.

*(a) Photograph of top side*

*(b) Photograph of underside (the red circle is a rubber pad to protect the center of the patch from rough, torn wall surface)*

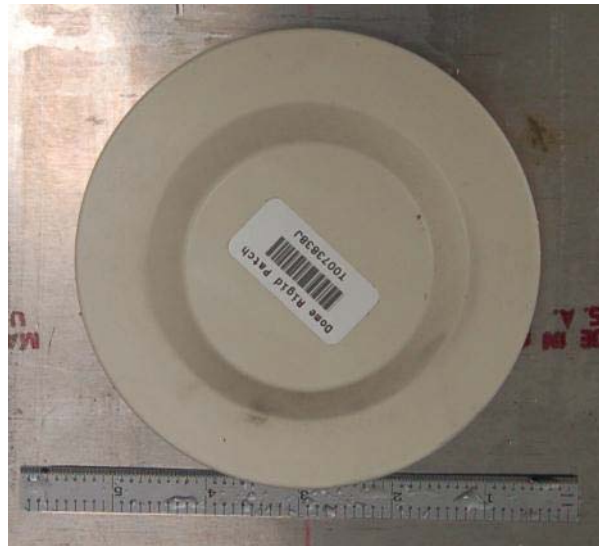
*Figure 7.1-2. PWRK Plate Patch*

will have to transmit the electromagnetic field through the patch, the center of which might be ~1/2 inch above the surface, as well as through the pressure wall to interrogate the pressure wall for defects. Ultrasonic methods will need to send ultrasonic energy along the pressure wall from outside the patch to the area of interest under the patch that will be several inches away (~4 inches or more).

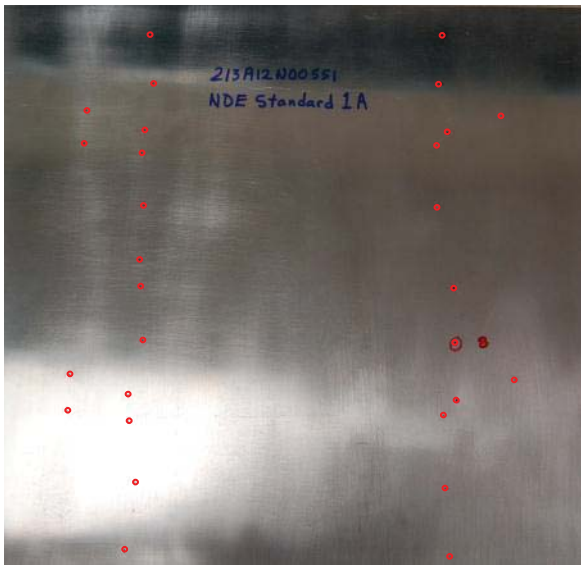
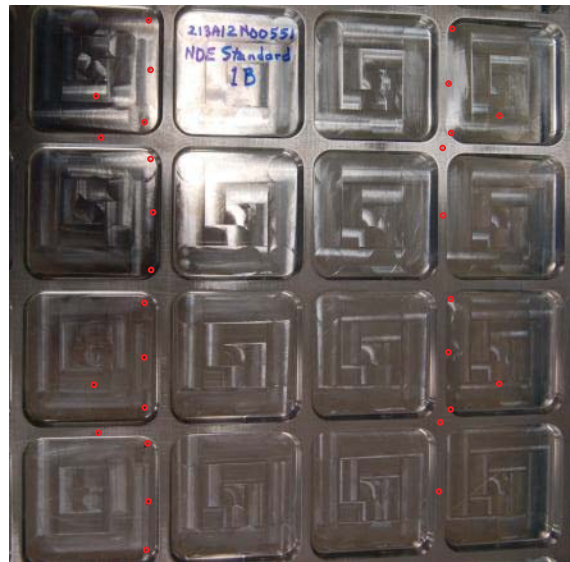
Standards 1A and 1B, which were rib-stiffened plates, represented a typical geometry from the Russian hardware with a small-rib wall separation (~3-inch square, 1/16-inch thin wall) (see Figure 7.1-3). This wall type is found on the Russian SM (Zvezda) and FGB (Zarya). In the case of the SM, the waffle pattern was on the inside of the module; for the FGB, the pattern was on the outside of the module. Standard 1A had flaws generated on the waffle side of the plate, while Standard 1B had the flaws place on the smooth side. To emulate cracks and pits in the FGB and SM standards, EDM notches 0.100 inch long and either 0.010 or 0.020 inch deep were manufactured. To emulate pits, partial through-the-thickness holes were drilled with a 3/64-inch-diameter drill to depths of 0.010 and 0.020 inch. These flaws were mostly located adjacent to the ribs of the waffle pattern.

*(a) SM wall with manufactured flaws (red dots on left side are EDM notch locations; red dots on right side are partial through-the-wall hole locations)*

*(b) FGB wall with manufactured flaws (red dots on left side are EDM notch locations; red dots on right side are partial through-the-wall hole locations)*

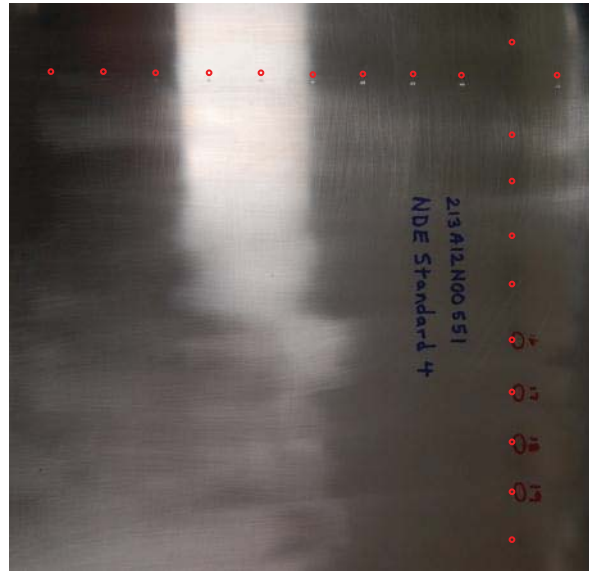
**Figure 7.1-4. Standard 4, with the Same Manufactured Flaw Pattern as in Standard 2 (red dots on right side are EDM notch locations; red dots along top side are partial through-the-thickness hole locations)**

Standard 4 mimicked Standard 2, except that the aluminum plate was only 0.063 inch thick (Russian hardware thickness). In this standard, the EDM notches were either 0.100 or 0.200 inch long with depths ranging from 0.005 to 0.040 inch (see Figure 7.1-4).

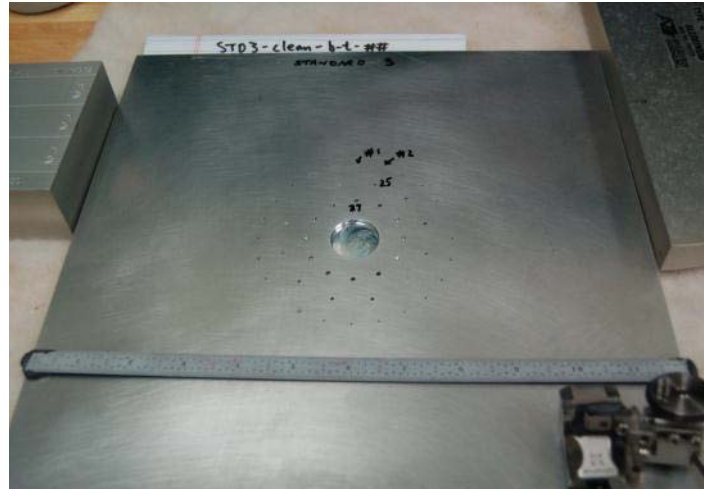
Standard 3 represented a multisite damaged plate that was 3/16-inch-thick aluminum plate and had partial through-the-thickness holes placed in concentric circular patterns (see Figure 7.1-5). The outer circle (4-inch diameter) consisted of 24 0.031-inch-diameter holes ranging in depth from 0.025 to 0.125 inch. Next was a ring (3-inch diameter) of 12 0.063-inch-diameter holes ranging in depth from 0.025 to 0.125 inch. Finally, there was a ring (2-inch diameter) of 12 0.094-inch-diameter holes ranging in depth from 0.025 to 0.125 inch. With this sample, one could begin to understand the effects of multisite damage on the NDE signals and images.

***Figure 7.1-5. Standard 3, with Partial Through-the-wall Holes Organized as Three Rings around 1-inch, Large Flat-bottom Partial Through-hole at Plate Center***

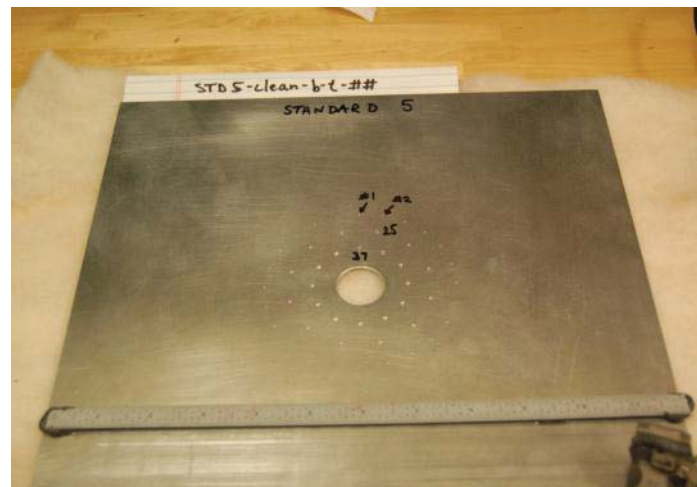
Standard 5 mimicked Standard 3, except that the aluminum plate was only 0.063 inch thick (Russian hardware thickness) (see Figure 7.1-6). In this standard, the holes were in the same patterns and diameters as for Standard 3, but the depths ranged from 0.005 to 0.040 inch.

***Figure 7.1-6. Standard 5, with Partial Through-the-wall Holes Organized as Three Rings around 1-inch Large Through-hole at Plate Center***

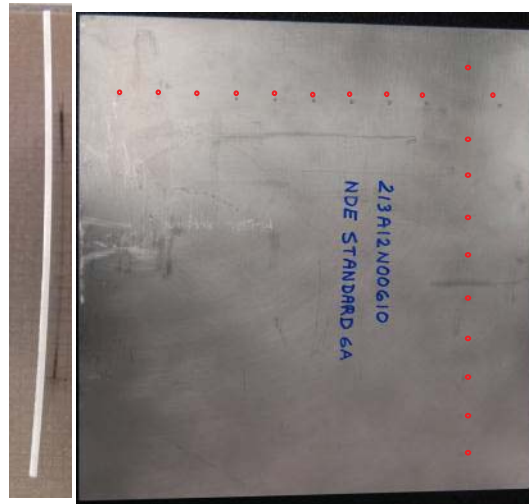
Standard 6A and 6B mimics Standard 2, except that these test standards had an 84-inch-radius curvature in the aluminum plate (see Figure 7.1-7). Plate 6A had the curvature parallel to the

row of EDM notches, while Plate 6B had the curvature parallel to the row of partial through-the-thickness holes. The purpose of this standard was to demonstrate the ability of the NDE method to correctly handle the curvature of an ISS module.

***Figure 7.1-7. Standard 6A, which has the Same Manufactured Flaw Pattern as Created in Standard 2 (red dots on right side are EDM notch locations, and red dots along the topside are partial through-the-wall hole locations; Standard 6B is the same size, except that the EDM notches and partial through-the-thickness hole locations are transposed; the photo on the left side indicates the curvature of the plate)***

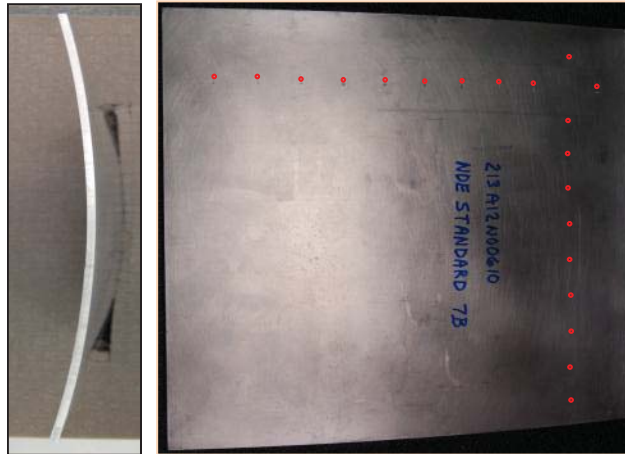
Standard 7A and 7B mimicked Standards 6A and 6B, except that the radius of curvature was more severe at 25 inches (see Figure 7.1-8). The purpose of these standards was to demonstrate the ability of the NDE method to correctly handle the small radii of curvature found in some parts of the ISS modules.

*Figure 7.1-8. Standard 7B, which has the Same Manufactured Flaw Pattern as Created in Standard 2 (red dots on the left side are EDM notch locations, and red dots along the topside are partial through-the-wall hole locations; Standard 7A is the same size, except that the EDM notches and partial through-the-thickness hole locations are transposed; the photo on the left side indicates the curvature of the plate)*

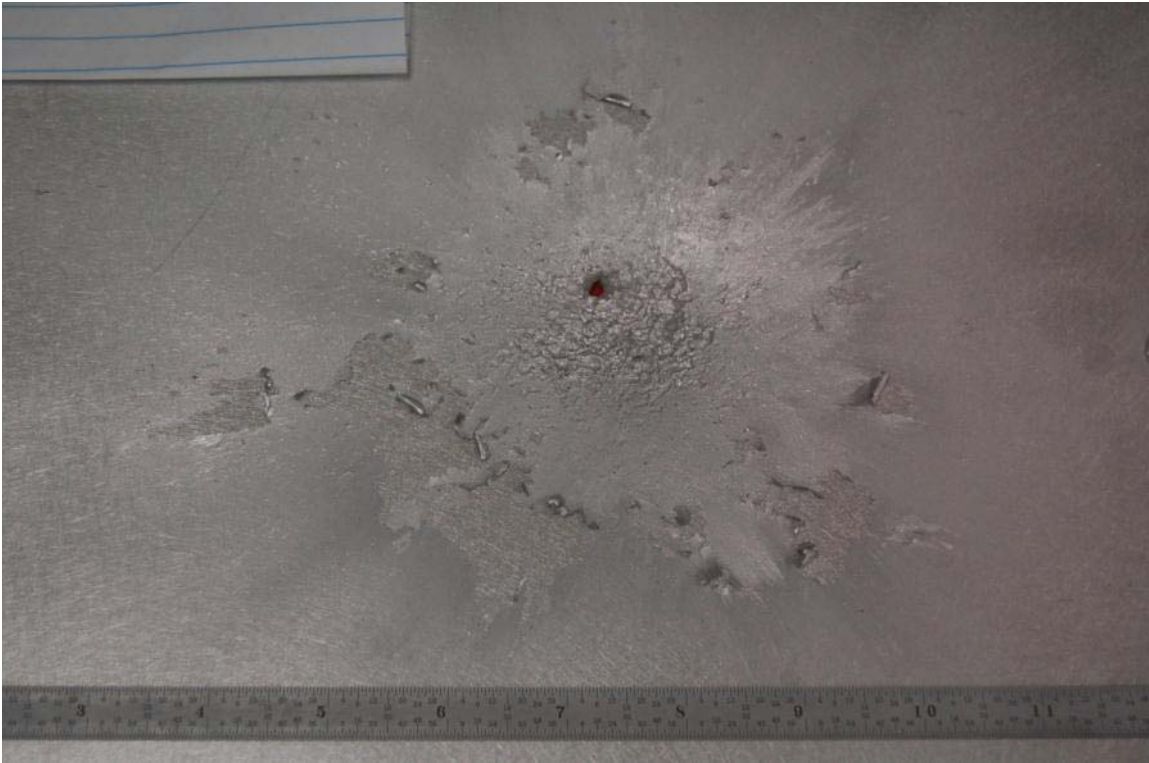
Figure 7.1-9 is a photograph of an impact-damaged plate, numbered 186. This plate had one small penetration and a small region of severe pitting, and the surface was also deformed.

***Figure 7.1-9. Backside of Impact Plate 186 (this plate shows one visible penetration, a region of deformation of the plate, and a small area of pitting)***

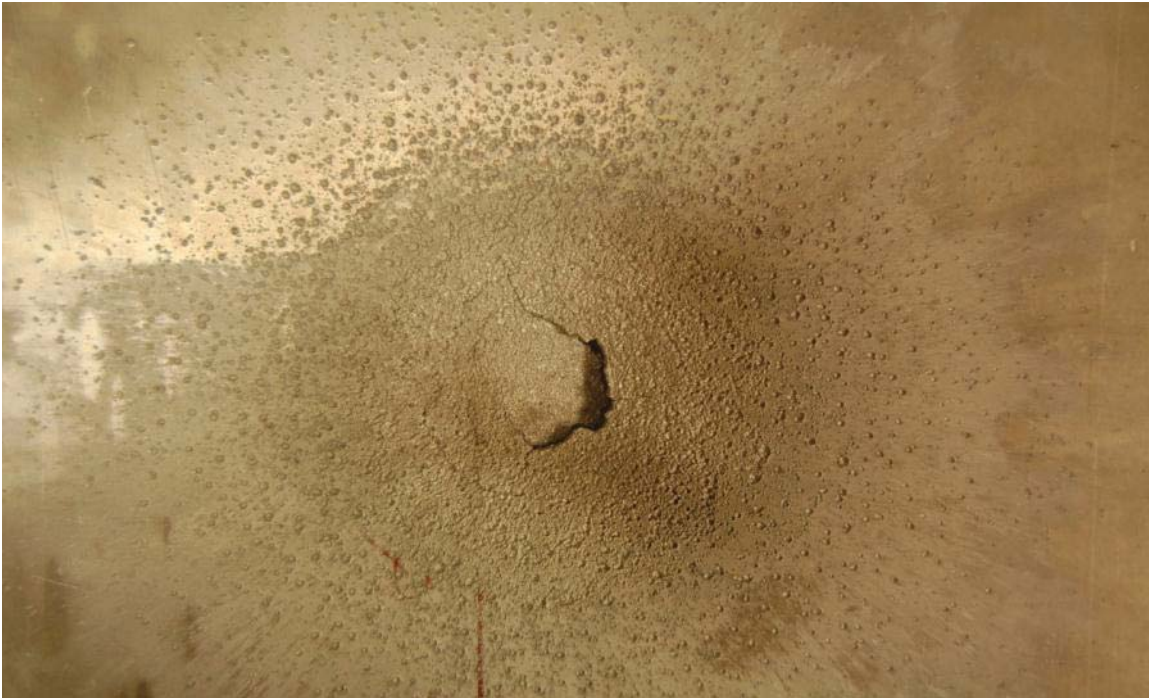
Figure 7.1-10 is a photograph of an impact damaged plate, numbered 1900. This plate had one large penetration (>1 inch) and a large region of severe pitting; further, the surface was heavily deformed. The penetration was in the form a large, long C-shaped crack.

***Figure 7.1-10. Backside of Impact Plate 1900, a 1/8-inch-thick Panel (this plate shows major cracking at the plate's center; the whole center region is deformed, pushing away from the backside; and there is extensive pitting around the center regions)***

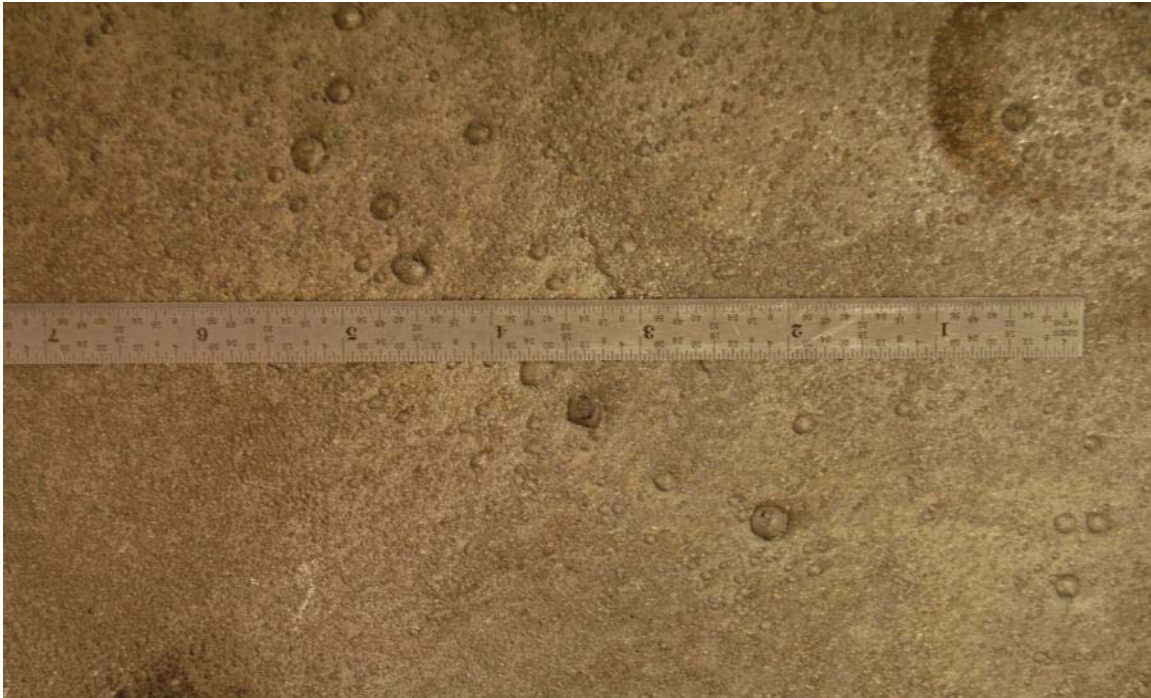
Figure 7.1-11 is a photograph of an impact-damaged plate, numbered 1907. This plate had several small penetrations and a large region of pitting. There were numerous small bumps corresponding to deep pits and the small penetrations. The small penetrations often had small short cracks emanating from them.

***Figure 7.1-11. Backside of Impact Plate 1907 (this plate shows extensive pitting across most of the plate (~15-inch radius of debris damage); a few larger pits, seen as an arc across the photo, are actually minor penetrations in the form of short cracks)***

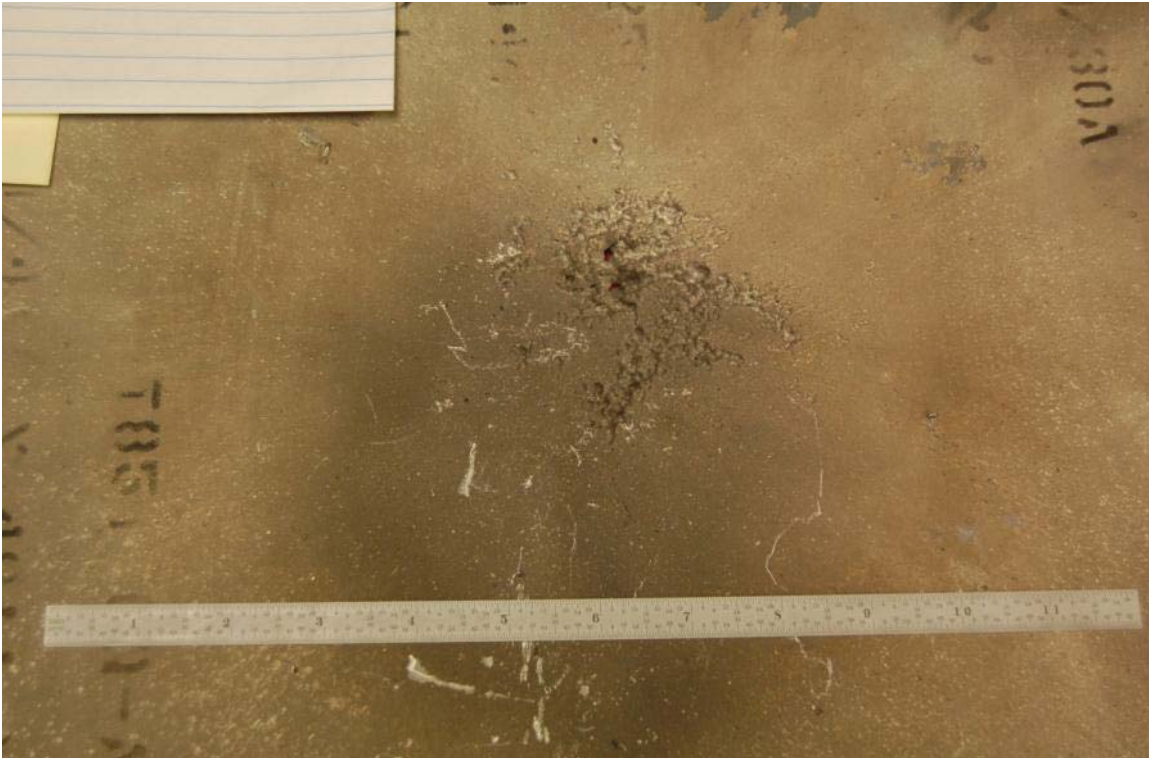
Figure 7.1-12 is a photograph of an impact damaged plate, labeled T3. This plate had several small penetrations and a small region with severe pitting.

***Figure 7.1-12. Backside of Impact Plate T3 (his plate shows major pitting near the center of the plate; a few larger pits are penetrations through the plate)***

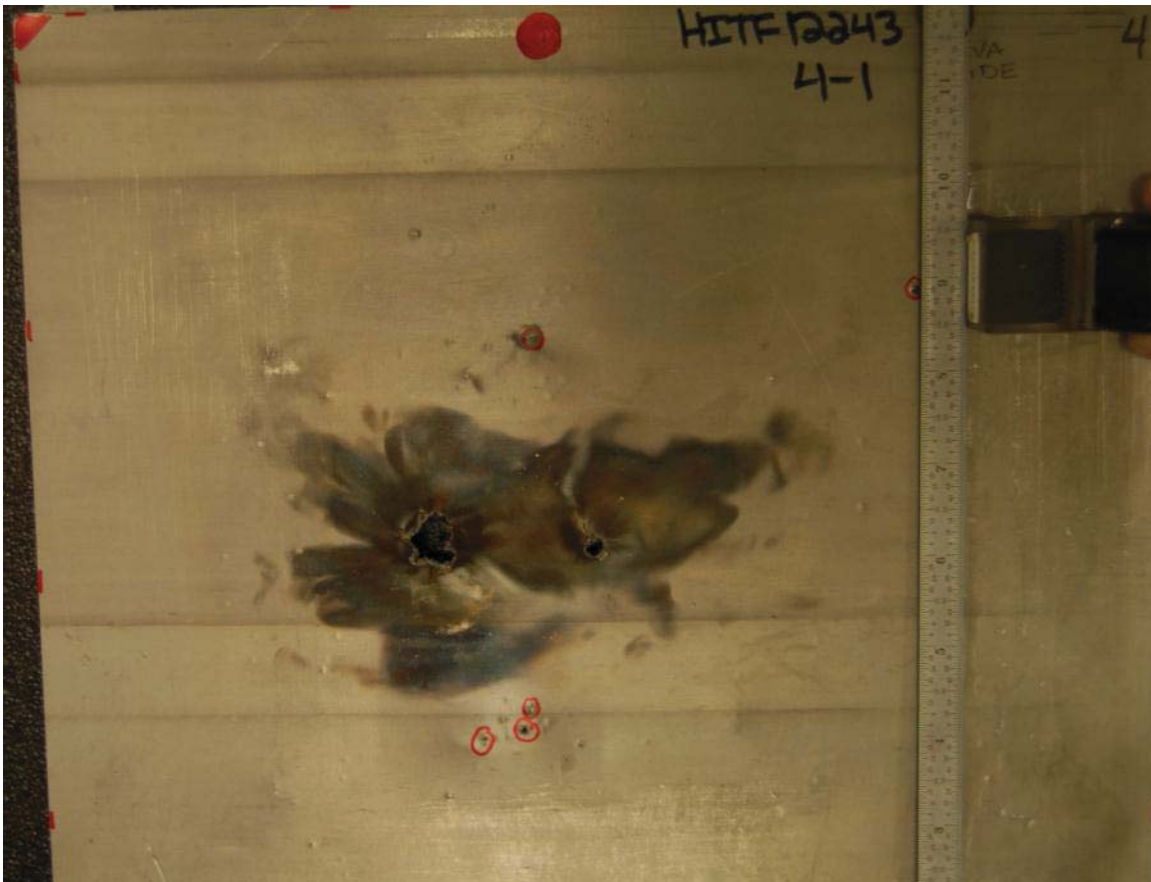
Figure 7.1-13 is a photograph of backside of impact plate 243. This plate represents the FGB wall configuration and was impacted with a hypervelocity projectile on the waffle side of the plate. There were several small penetrations, some of which are highlighted in red, as well as two major penetrations. This plate shows major pitting near the center of the plate. A few larger pits were penetrations through the plate. The areas in between the waffle walls showed deformation.

**Figure 7.1-13. Backside of Impact Plate 243, which Represents FGB Wall and was Impacted with a Hypervelocity Projectile (the impact was performed from the waffled side of the plate; because of the thin wall, there are many small penetrations, some of which are highlighted in red, as well as two major penetrations; this plate shows major pitting near the center of the plate, and a few larger pits are penetrations through the plate; the areas in between the waffle walls show deformation)**

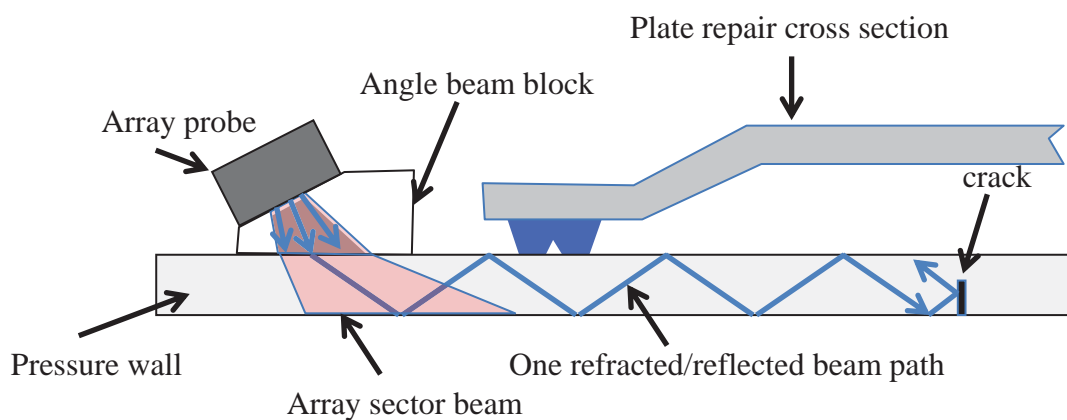
**Figure 7.1-14. Phased Array-angle Beam Block Probe Geometry for Scanning under a Patch Repair**

Phased array instruments are high-end ultrasonic testing instruments that allow significant flexibility in testing. For the concepts of operations that were envisioned in this series of tests, there will be a repair patch covering the area of concern, as discussed in Section 7.1.2. With ultrasonics, there will be a need to be able to inject ultrasonic energy into the pressure wall outside the repair area and have that energy travel in the pressure wall into the region of interest. This will be accomplished by having the array probe mounted on an “angle beam” block that will direct the energy in the direction desired (see Figure 7.1-14). Many beam angles are available from an array probe, and those many angles are denoted in the figure as the array sector beam. Each single beam from the array probe will result in the beam being refracted at the angle beam

block to pressure shell interface, according to Snell's Law. If the component under test is thin, then each beam will be reflected repeatedly against the top and bottom of the pressure wall as it transmits toward the region of interest. This concept will allow the ultrasonic energy to pass under a repair patch (denoted as a plate repair cross section in this figure) and to interrogate the region of interest. In the case of the tape repair patch, the presence of the tape and adhesive causes additional attenuation at each reflection off the aluminum-to-tape interface.

beam (see Figure 7.1-14), a range of beam paths is used and averaged to produce a more stable image of the underlying structure. Each ultrasonic device tested was equipped to display A-scans, B-scans, and C-scans. Only one of the instruments tested supported the Top-scan feature, but it was considered a significant improvement for less skilled operators.

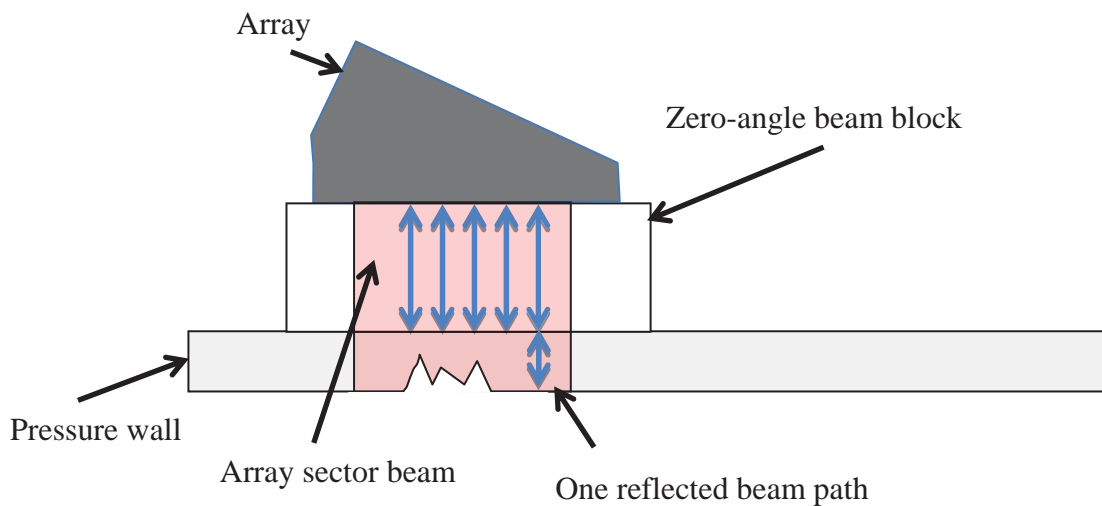
**Figure 7.1-15. Phased Array Zero-angle Beam Block Probe Geometry for Scanning Pressure-Wall Thickness**

For areas where the repair patch does not interfere with the ultrasonics beam path, in addition to the angle beam block a zero-angle beam can be used (see Figure 7.1-15) to produce a C-scan. Using this probe configuration, a direct thickness map of a damaged outer wall would be possible. The advantage of this configuration is that wide swaths of the plate are measured at one time. This method is also applicable to scanning of bond lines. For both the B-scan and C-scan, when the probe is coupled with an accurate encoder wheel it is expected that an accurate map of the damage area will be possible.

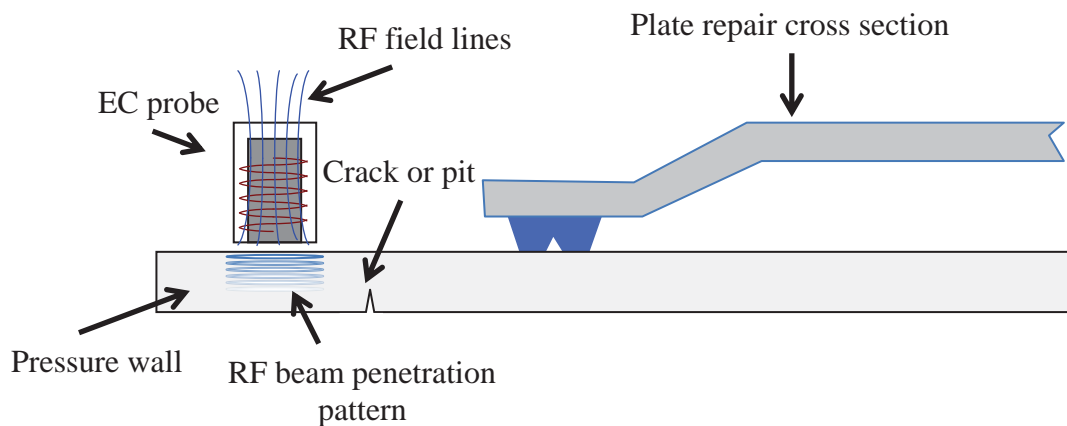
**Figure 7.1-16. EC Probe Geometry for Scanning near Patch Repair**

The ability to manufacture thin EC arrays on flexible substrates is one feature that is attractive for imaging purposes on the ISS. Two of the units tested for this assessment were able to support array imaging, while the third device incorporated a rapid mechanical scanning system. C-scan styled images based on array probes or rapid mechanical scanning instruments increase throughput significantly.

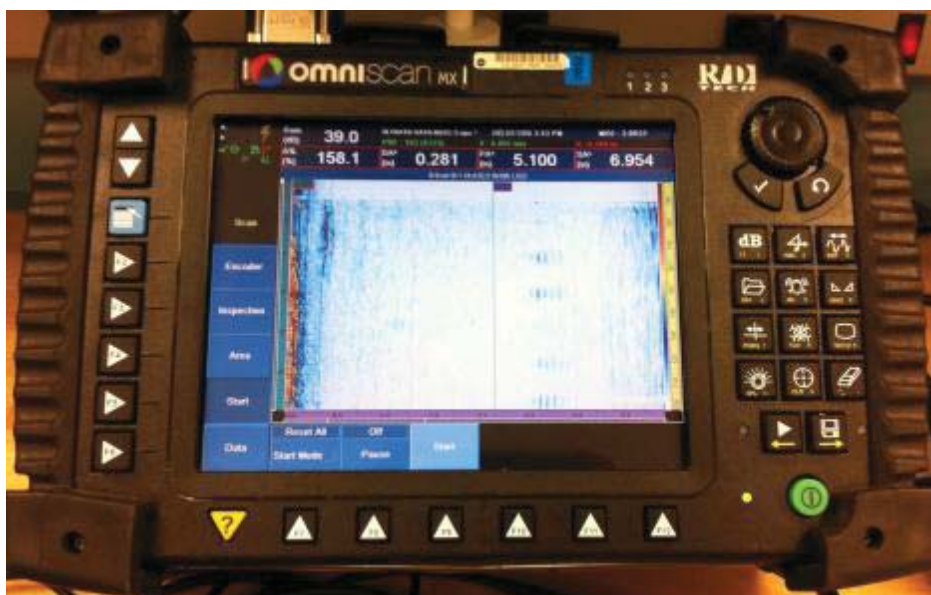
**Figure 7.1-17. Olympus Omniscan MX UT Model**

The system has physical menu buttons on the left and bottom sides (see Figure 7.1-17). These buttons activate menu items on the screen. There is a keypad and a click wheel on the right for setting values. The keypad on the right also can be used to activate specific operation controls. The menu buttons often activate additional submenus, which may activate another layer of submenus.

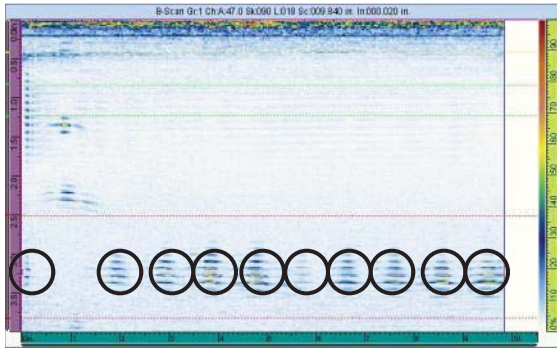
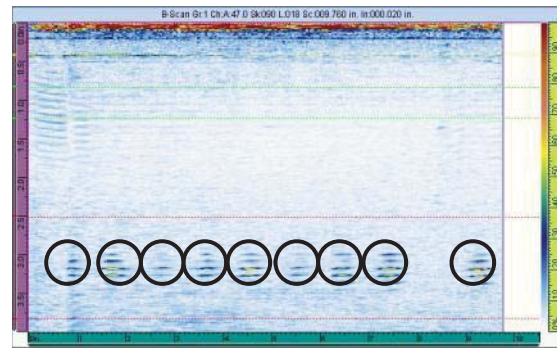
(a) Row of notches detected with layer of tape covering the area to emulate effects of PWRK tape patch

(b) Row of partial through-the-thickness holes detected with layer of tape covering the area to emulate effects of PWRK tape patch

**Figure 7.1-18. Angle-beam Scans of Standard 2 (B-scan image representations show the distance the ultrasonic beam travels (Y-axis, with the top at  $y = 0$  and the bottom at  $y \sim 4$  inches) and the physical horizontal probe position (X-axis, 0 to 11 inches); the variations in the intensity represent the beam's echo strength)**

Figure 7.1-18 shows the results of scanning the simplest standard used in this testing, Standard 2. Figure 7.1-18(a) shows a linear B-scan across a row of notches, scanned from 4 inches away from the notches, while 7.1-18(b) shows a similarly configured linear B-scan across a row of partial through-the-thickness holes. The black circles highlight the location of the EDM notches and the partial through-the-thickness holes in the images. In a B-scan image, the reverberation of the signal causes the short horizontal lines that appear in the echo from a flaw. Both of these scans were performed using an angle beam phased array setup. In addition, the test standard also had a layer of 0.013-inch aluminum tape applied to the scanned area to emulate the effect of the PWRK tape patch. For that scanning configuration, the tape caused between 6 to 10 dB of signal loss compared with the same scans without the tape present, where the reflections of the ultrasonic beam between the top surface and the tape were lossy. Scanning with a PWRK plate patch or scanning without a patch had more signal-to-noise and sensitivity/resolution. As can be seen, all of the holes and notches were detected with this instrument. The smallest hole was 1/32 inch in diameter and 0.025 inch deep. The smallest notch was 0.032 inch long and 0.025 inch deep. This compares favorably with detection requirements specified under

NASA-STD-5009 for conventional scanning methods [ref. 4]. The signal form caused by the flaw in the figure represents the local reverberation pattern of the ultrasonic echo. That pattern will shift around slightly for different beam angles, but the overall echo location should be constant.

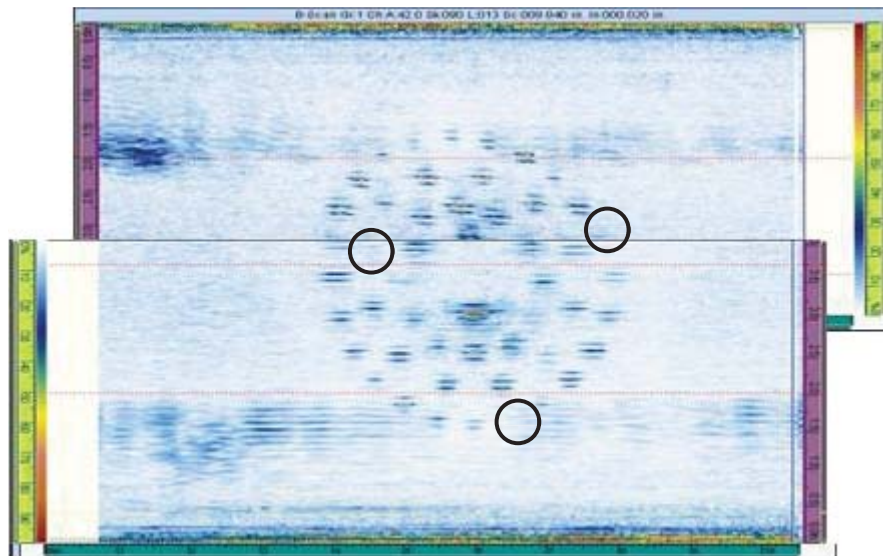
*(a) Image of partial through-the-thickness holes detected without a PWRK patch present*

*(b) Image of partial through-the-thickness holes detected with PWRK tape patch*

*(c) Composite image using image from panel (a) and complementary image made from opposite side of tape patch*

**Figure 7.1-19. Angle-beam Scans of Standard 3**

Figure 7.1-19 shows a series of angle beam B-scans images made on Standard 3. This panel represents multisite damage in the form of partial through-the-thickness holes (emulating pits in the material). The holes were drilled in a series of concentric rings of holes, with the largest diameter holes in the inner ring and the smallest diameter holes in the outer ring.

Figure 7.1-19(a) shows that all of the holes near the transducer are detected. As the signal travels further along the plate, detection degrades in part due to interference from holes in the beam's path as well as from signal diffraction and attenuation. The black circle indicates a location where the location of a hole is uncertain.

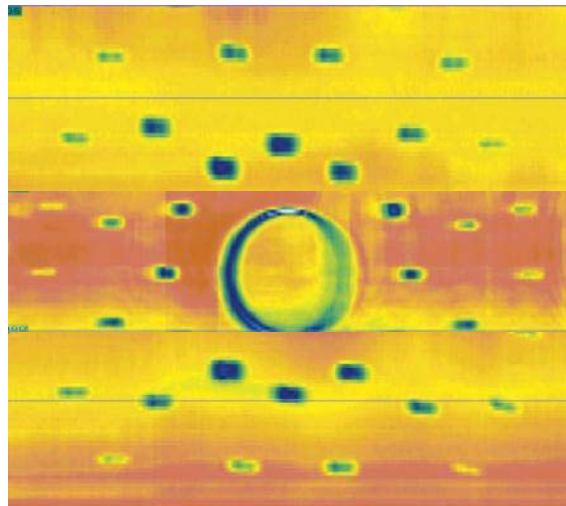
***Figure 7.1-20. Composite Image from Five Zero Beam C-scans of Standard 3***

Figure 7.1-20 shows a composite image of five 0-degree beam C-scans of Standard 3. This image shows that this system can detect pits without the presence of a repair patch. This would be the case for imaging hidden damage that extends beyond the patch repair area, which is common for some types of MMOD damage. By setting certain imaging parameters, the C-scan can be set up so that the depth of the pits would be resolvable.

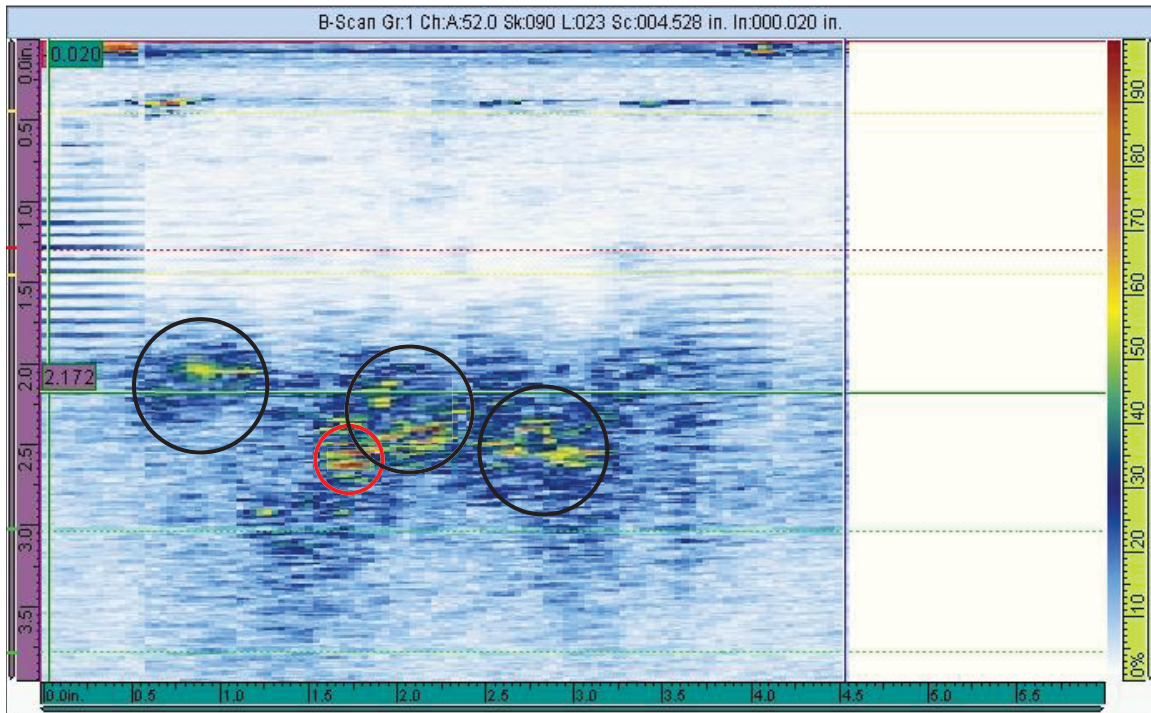
*Figure 7.1-21. Angle Beam B-scan Image of Impact Plate 186 without Repair*

Figure 7.1-21 shows an angle beam B-scan image of Sample 186, which shows an impact region that includes one penetration, deformation, and pitting in the region of impact. The yellow and red signals represent the deepest damage regions, including the through-the-wall penetration. This type of scan does not allow specific differentiation of the damage type, whether it is a penetration or a pit, but it does allow location of damage. The red circle highlights the penetration, and the black circles highlight regions of severe pitting.

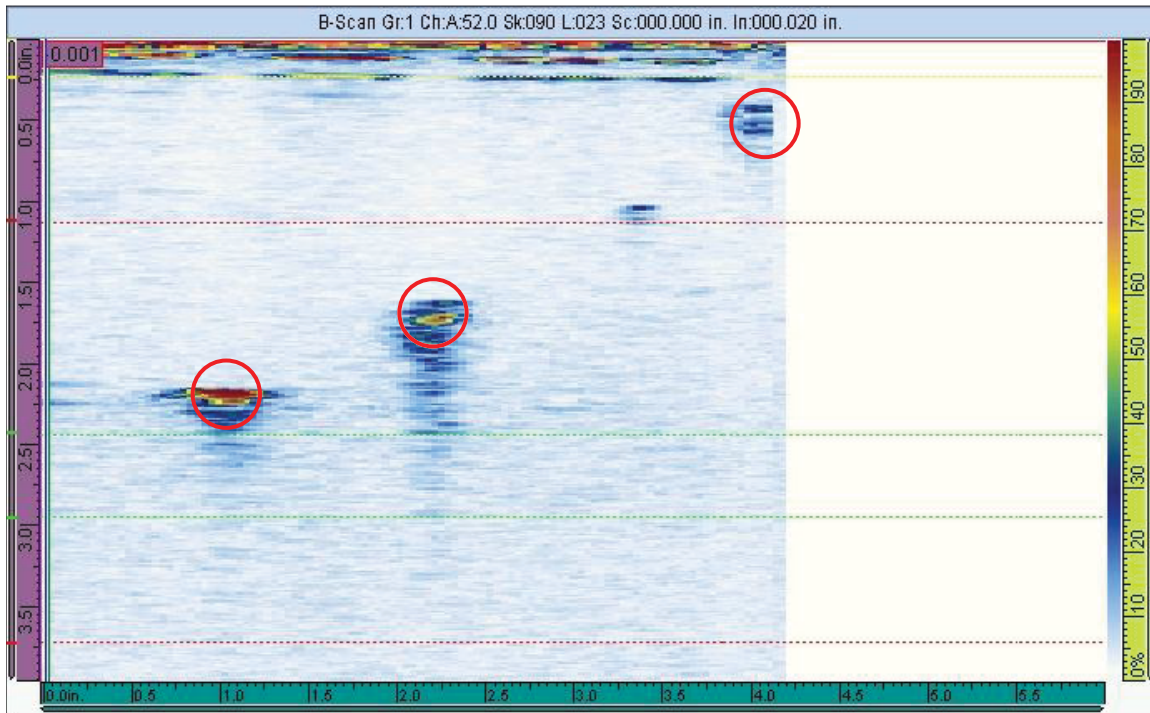
*Figure 7.1-22. Angle-beam B-Scan Image of Impact Plate 1907 without Repair*

Figure 7.1-22 shows an angle beam B-scan image of impact plate 1907. This plate had an extensive damage region with a few deep pits, some of which penetrated through the sample and are seen as the dark blue, yellow, and red colors in the figure, circled in red. A smaller probe was useful for scanning this plate because of the uneven surface caused by some of the dents. The deepest dents are evident in the image in the proper position.

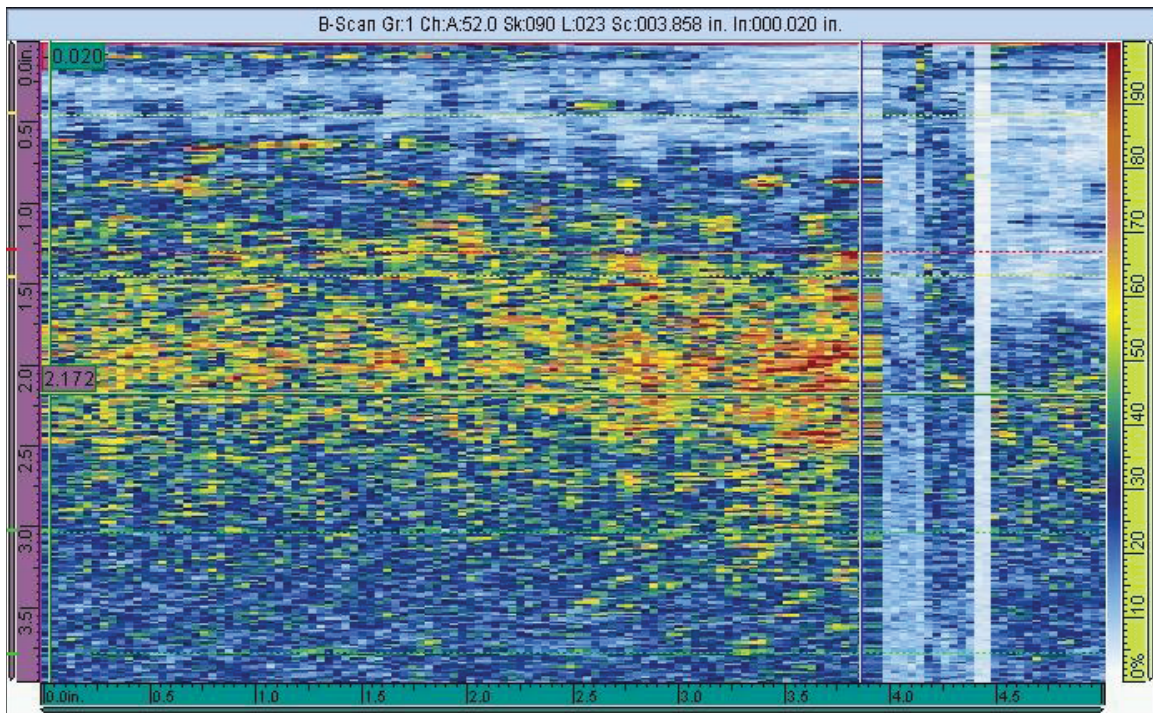
*Figure 7.1-23. Angle-beam B-Scan Image of Impact Plate 1900 without Repair*

Figure 7.1-23 is an angle beam B-scan image of impact plate 1900. The top of the image represents the position  $y = 0$ ; the bottom of the image represents a distance of  $\sim 4$  inches from the probe. This plate was  $1/8$  inch thick, the same as the Russian and U.S. hardware wall thicknesses. It suffered broad area damage in the form of severe pitting, as well as a large crack at the center of the plate. For this configuration, the pitting damage scattered the signal so strongly that the signal was quickly attenuated before it could travel the necessary distance to the center of the sample where a critical, large crack was located. In this figure, the red, yellow, and green signals represent the severe pitting of the damage. As the distance reaches about 2.5 inches from the probe, the beam's signal is falling into the noise, and damage is no longer being imaged clearly. If the signal had not been attenuated, the critical crack would have been seen at the bottom of the scan. The artifacts on the left side of the image are caused by the operator losing contact between the probe and the sample. While a 0-degree scan can also image the severe pitting, it would be unable to image the center region under the patch because of the surface deformation. It could only scan areas outside the patch area.

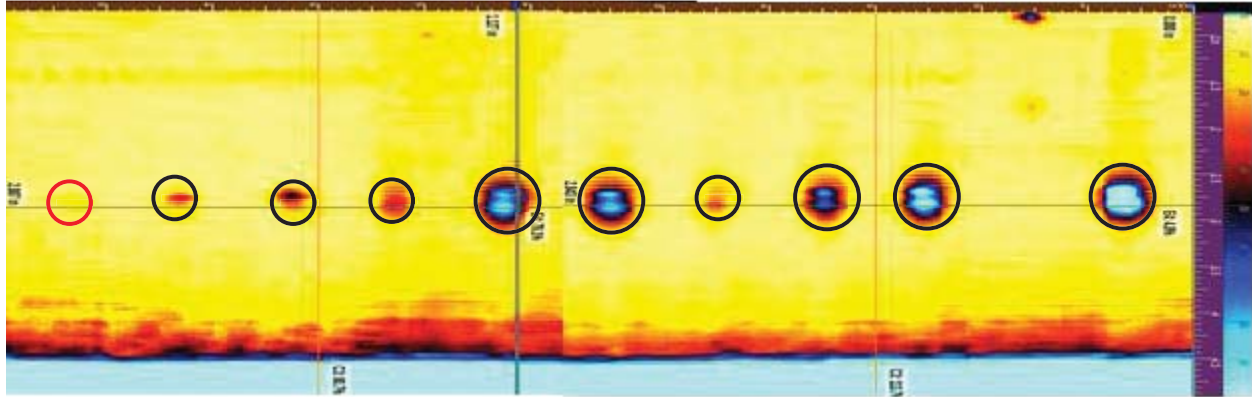
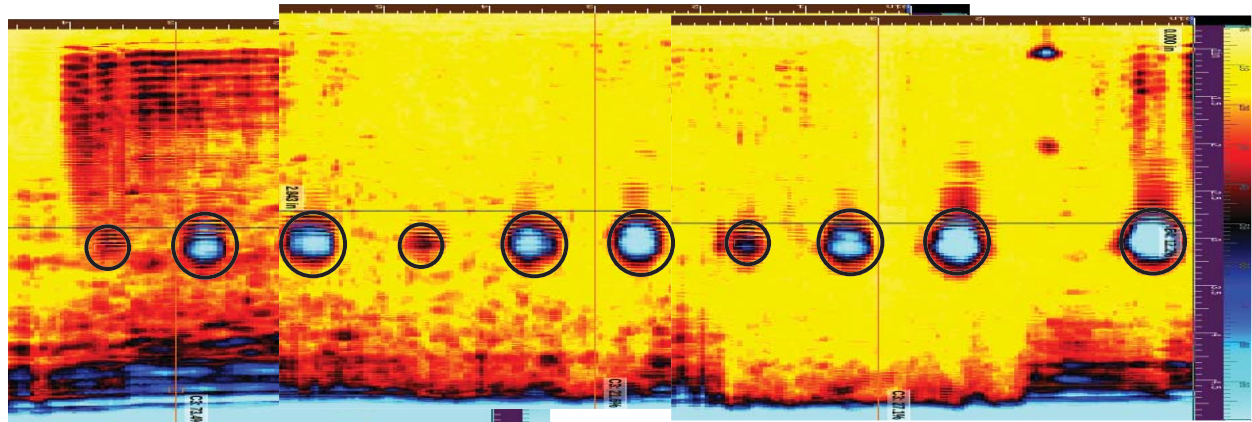
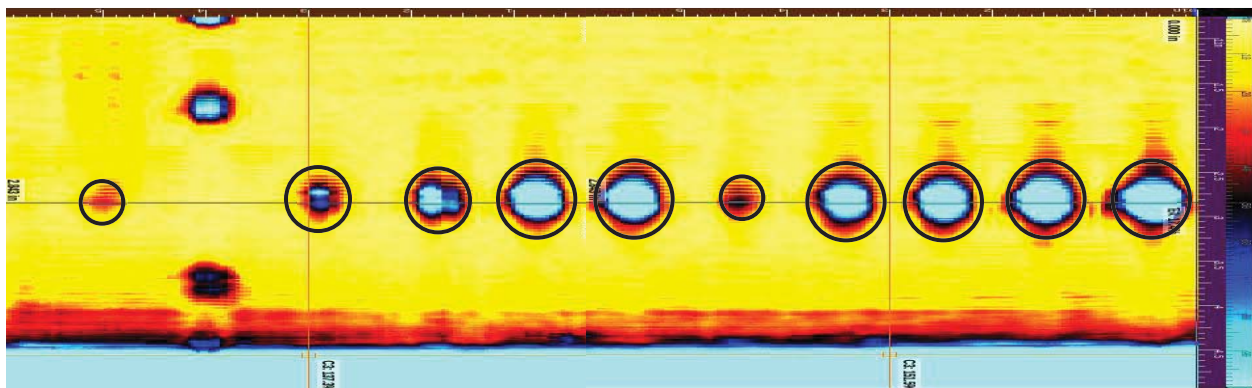
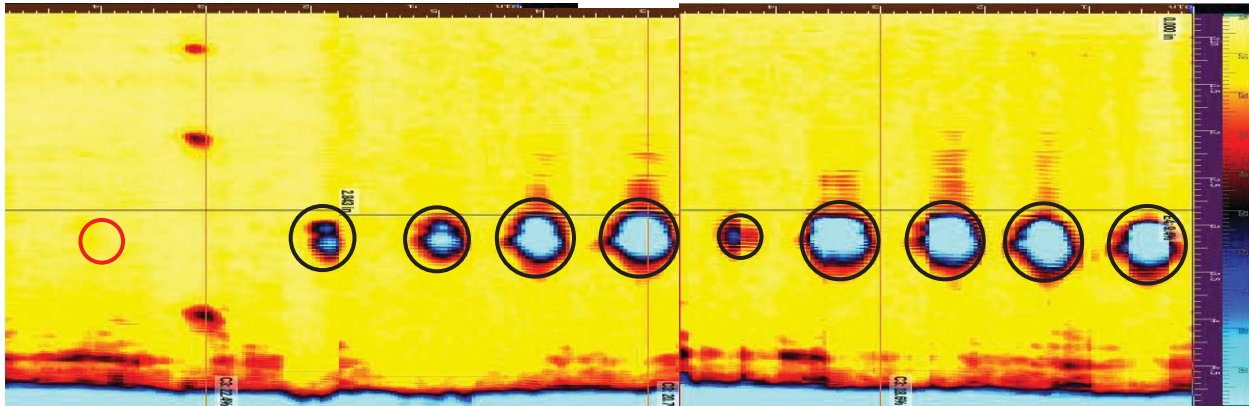
(a) Holes with tape repair

(b) Holes with repair plate

(c) Notches with tape repair

*d) Notches with repair plate*

**Figure 7.1-25. Top-scan Images of Standard 2**

Figure 7.1-25 shows several scan views of Standard 2 in a Top-scan mode. In each of these images, the probe is just beyond the edge of the tape at the top of the images. The top of the figures represents  $y \sim 1$  inch, and the bottom is about 4.5 inches from the probe. Panel (a) represents a Top-scan of the row of partial through-the-thickness holes in the plate with 0.013-inch aluminum tape on the surface (marked with circles). The smallest hole (0.032 inch in diameter and 0.025 inch deep), marked by a red circle, is barely detectable (near the noise floor). As was mentioned in the Omniscan MX testing, the tape added about 6 to 10 dB of signal loss. Panel (b) represents the same region shown as a composite image, made with the plate patch. The increased signal gain that was lost in the tape patch is evident. All of the holes were detected in that scan and are marked with circles. Panel (c) represents a scan of the row of EDM notches in the plate with 0.013-inch aluminum tape on the surface. The EDM notches are marked with circles. The smallest hole (0.032 inch in diameter and 0.025 inch deep) is easily detected. Panel (d) represents the same region shown as a composite image, but with the plate patch. All of the detected notches in the scan are marked with black circles. The one notch not detected is marked with a red circle and is the smallest notch (0.032 inch in length and 0.025 inch deep). The variability in these images reflects the operator's skill and shows that the flaw detection limit is at the 0.032-inch length and 0.025-inch depth. In all these scans, the effects of the Top-scan imaging make for a more easily viewed image.
