NASA/TM-2013-218021/Volume I  
NESC-RP-12-00824

# Independent Assessment of Instrumentation for ISS On-Orbit NDE

*Eric I Madaras/NESC  
Langley Research Center, Hampton, Virginia*

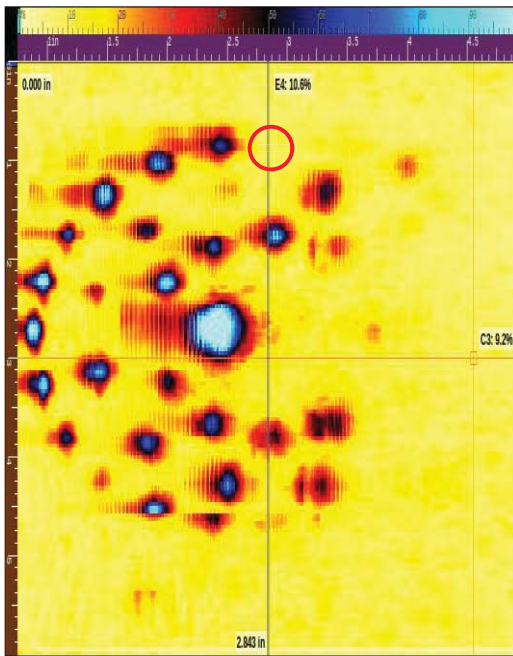
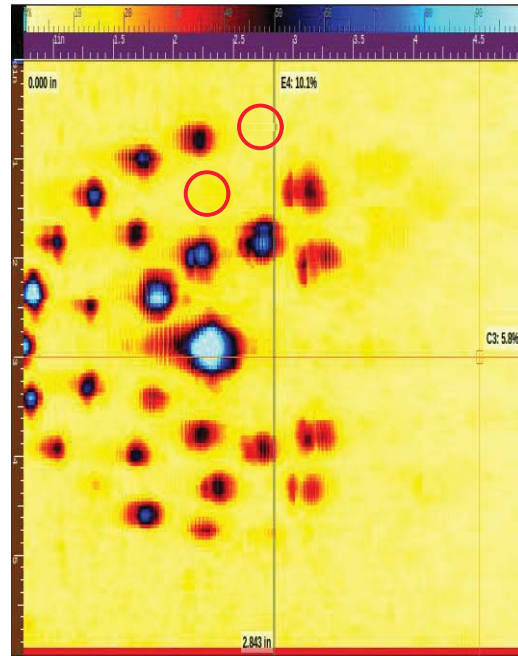
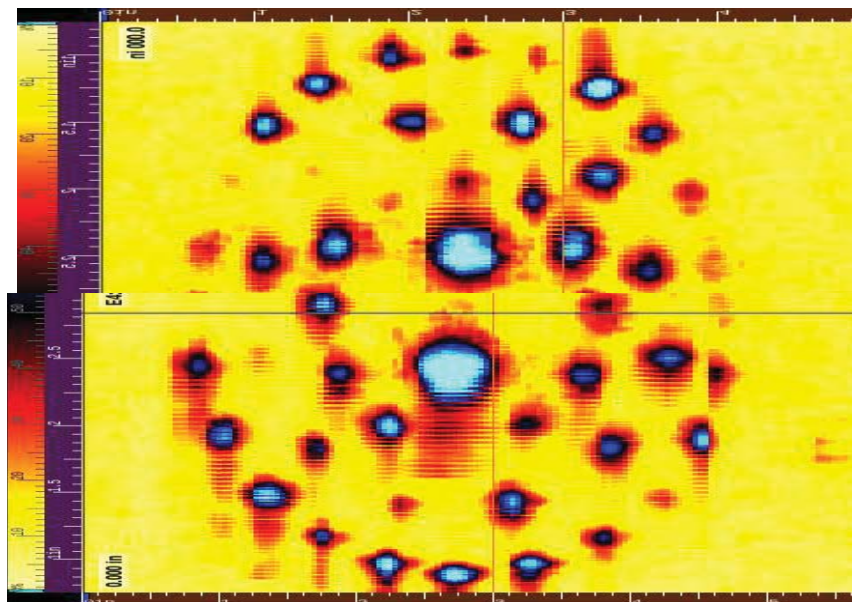
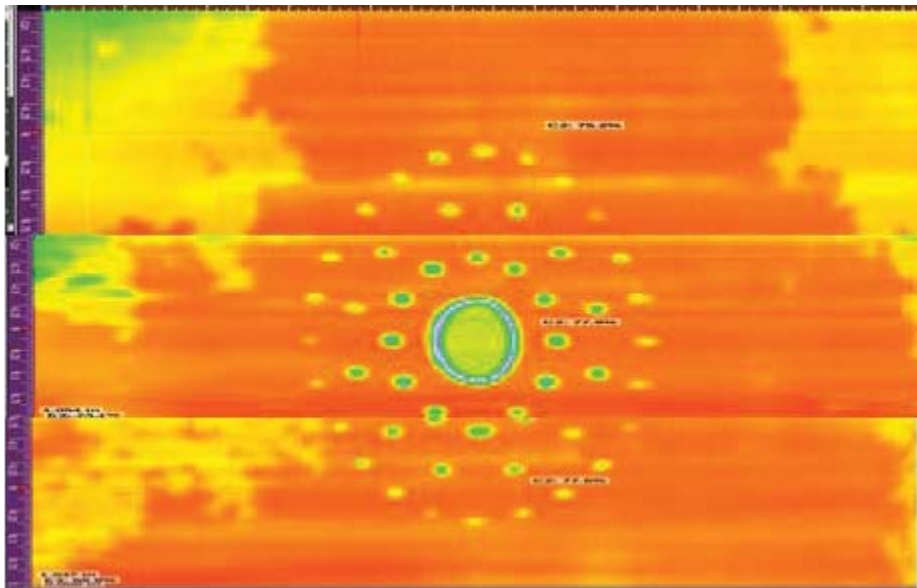
(a) Angle beam Top-scan, scanning from right to left without any repair on Standard 3

(b) Same view as panel (a), except for the addition of the PWRK tape repair patch

(c) Composite view, with one Top-scan operated from bottom to top and the other in the reverse orientation

(d) A Composite view of 0-degree C-scan with ultrasonic energy traveling straight down into the sample and back out  
**Figure 7.1-26. Views of Standard 3**

Figure 7.1-26 shows a series of angle beam Top-scan images made on Standard 3. This panel represents multisite damage in the form of partial through-the-thickness holes (pits). The holes were drilled in a series of concentric rings of holes, with the largest diameter holes in the inner ring and the smallest diameter holes in the outer ring. Figure 7.1-26(a) shows that all of the holes near the transducer were detected. As the signal traveled further along the plate, detection degraded, in part due to interference from holes in the beam's path, and from signal diffraction and attenuation. Figure 7.1-26(b) shows the effects of placing 0.013-inch aluminum tape on the sample. One of the shallower holes (0.063 inch in diameter and 0.025 inch deep) was lost in the noise, while the remaining holes were detected. Figure 7.1-26(c) shows the detection of all of the holes in the full composite image. This image demonstrates that by utilizing multiple scans one could capture a full image of the area under a patch. Figure 7.1-26(d) shows a composite image of three 0-degree beam scans of Standard 3. This image shows that this system can detect pits without the presence of a repair patch. This would be the case for imaging hidden damage that extends beyond the patch repair area, which is common for some types of MMOD damage. By setting certain imaging parameters, this C-scan can be set so that the depth of the pits would be resolvable.

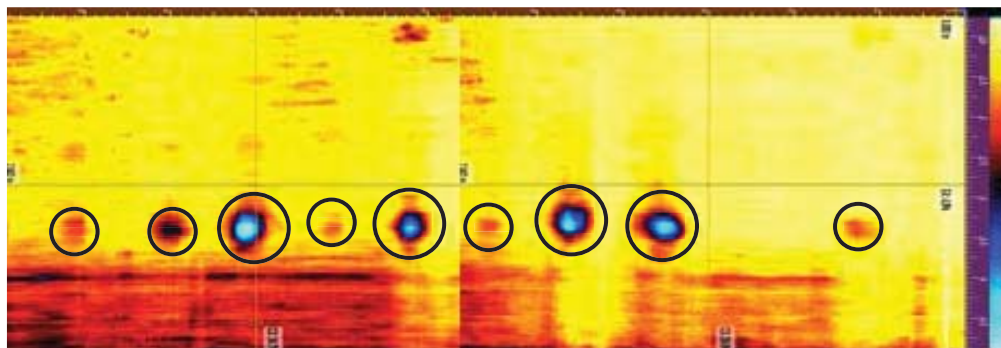
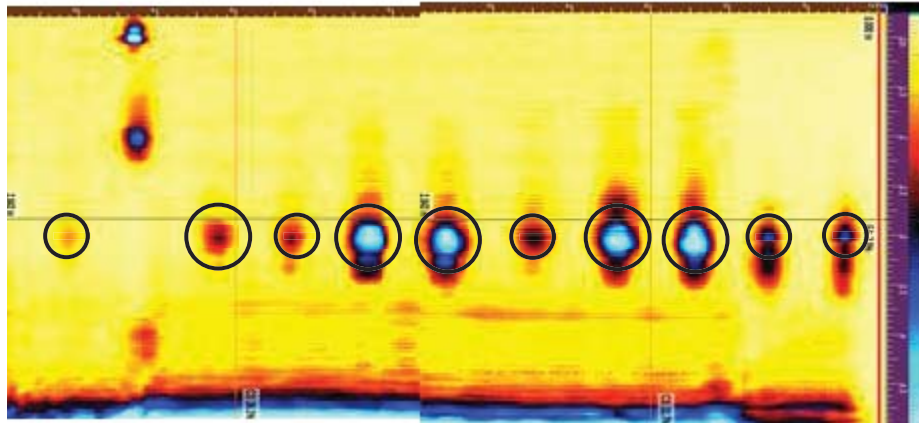
(a) Images from Standard 7A holes with a PWRK plate repair

*(b) Images from Standard 7B EDM notches with a tape repair*

**Figure 7.1-27. Top-scan Images from a Curved Sample**

Figure 7.1-27 illustrates that ability of these arrays to operate on curved surfaces. When water is used as a couplant, the issue becomes whether the water layer can stay in contact with a curved surface and the probe as scanning is conducted. The surface tension of water causes water to stick to both surfaces. Another question is whether the curvature causes image degradation. In Figure 7.1-27(a), the image indicates the ability to detect all of the partial through-the-thickness holes in the sample with the long axis of the probe in contact with the smallest curvature of the ISS pressure wall. This image was made on the 25-inch-radius curvature surface with a PWRK plate repair. Figure 7.1-27(b) shows the ability to image EDM notches with a WPRK tape repair in place. Again, all of the holes were visible; hence, the system appears to be able to handle the 25-inch curvature with adequate clarity.

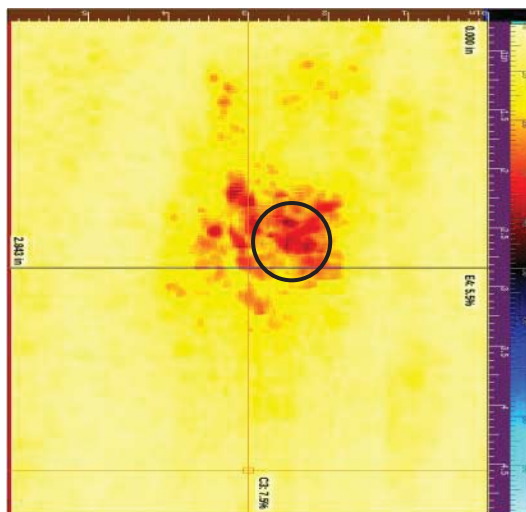
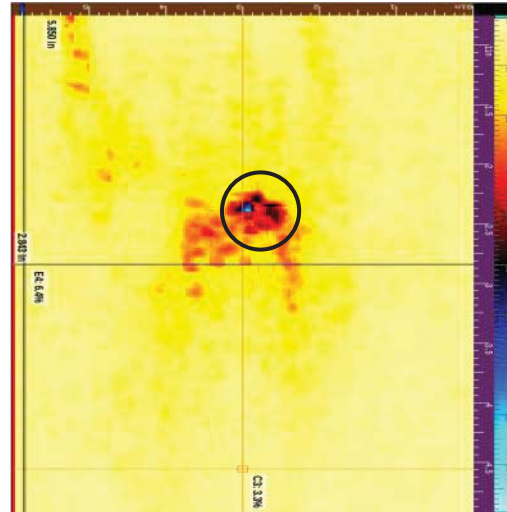
*(a) Scanning from the direction bottom toward the top*

*(b) Scanning from the direction top toward the bottom*

**Figure 7.1-28. Angle Beam Top-scan Images of Impact Plate 186**

Figure 7.1-28 shows two image views of impact plate 186, which had a central region of damage, deformation, pitting, and one penetration. Panel (a) was scanned in a bottom to top direction, while panel (b) was scanned from the opposite direction. One of the images was flipped so that the orientation of the damage is the same in both images. The circle highlights the region of the penetration. The effect of the intervening damage regions modifies an image and is a strong argument for making multiple images from different directions to attain the most quantitative data.

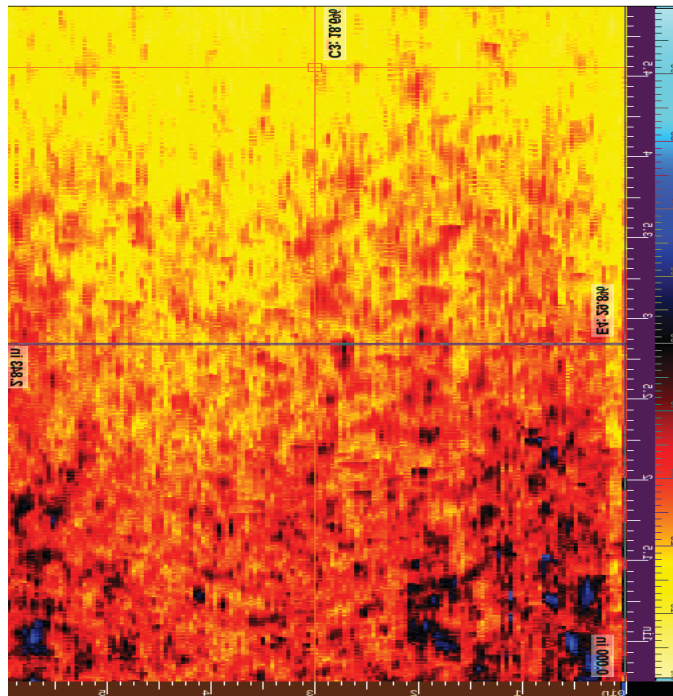
**Figure 7.1-29. Impact Plate 1900 with Plate Patch**

Figure 7.1-29 shows an attempt to image damage in impact plate 1900 with a PWRK repair plate in place. The image shows the limitation of the angle beam scans when trying to travel long paths with badly damaged surfaces. In this image, the probe is at the bottom of the image with  $y \sim 1$  inch at the bottom and  $y \sim 4.5$  inch at the top of the image. As a result of the strong scattering from the damage, the bottom of the image indicates significant pitting and damage, shown as the black and blue regions at the bottom; however, the ultrasonic beam has been strongly attenuated by the scattering, so it has failed to penetrate all the way to the center and top area, which contains a long critical crack-like structure. Hence, there is no reflected signal making it back to the transducer. The yellow signals at the top of the image represent weak signals.

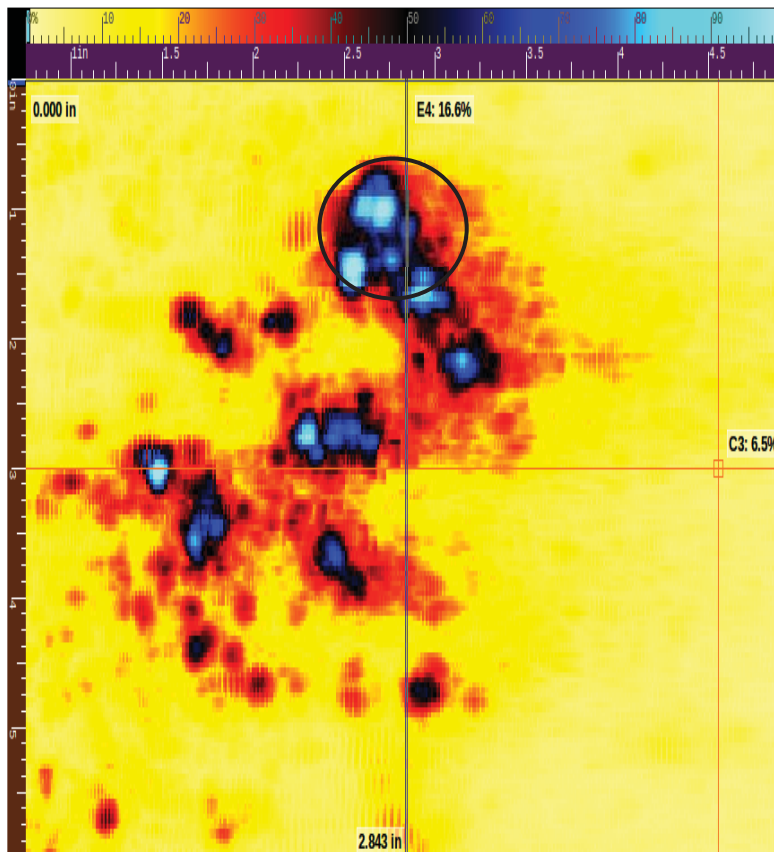
***Figure 7.1-30. Top-scan Image of Impact Plate T3 (image was scanned from left to right)***

Figure 7.1-30 shows the Top-scan image results of impact plate T3, which has a local region of deep pits and a single penetration. Rows and groups of deep pits were detected. The deep pits are imaged as blue regions. The penetration lies in the circled region.

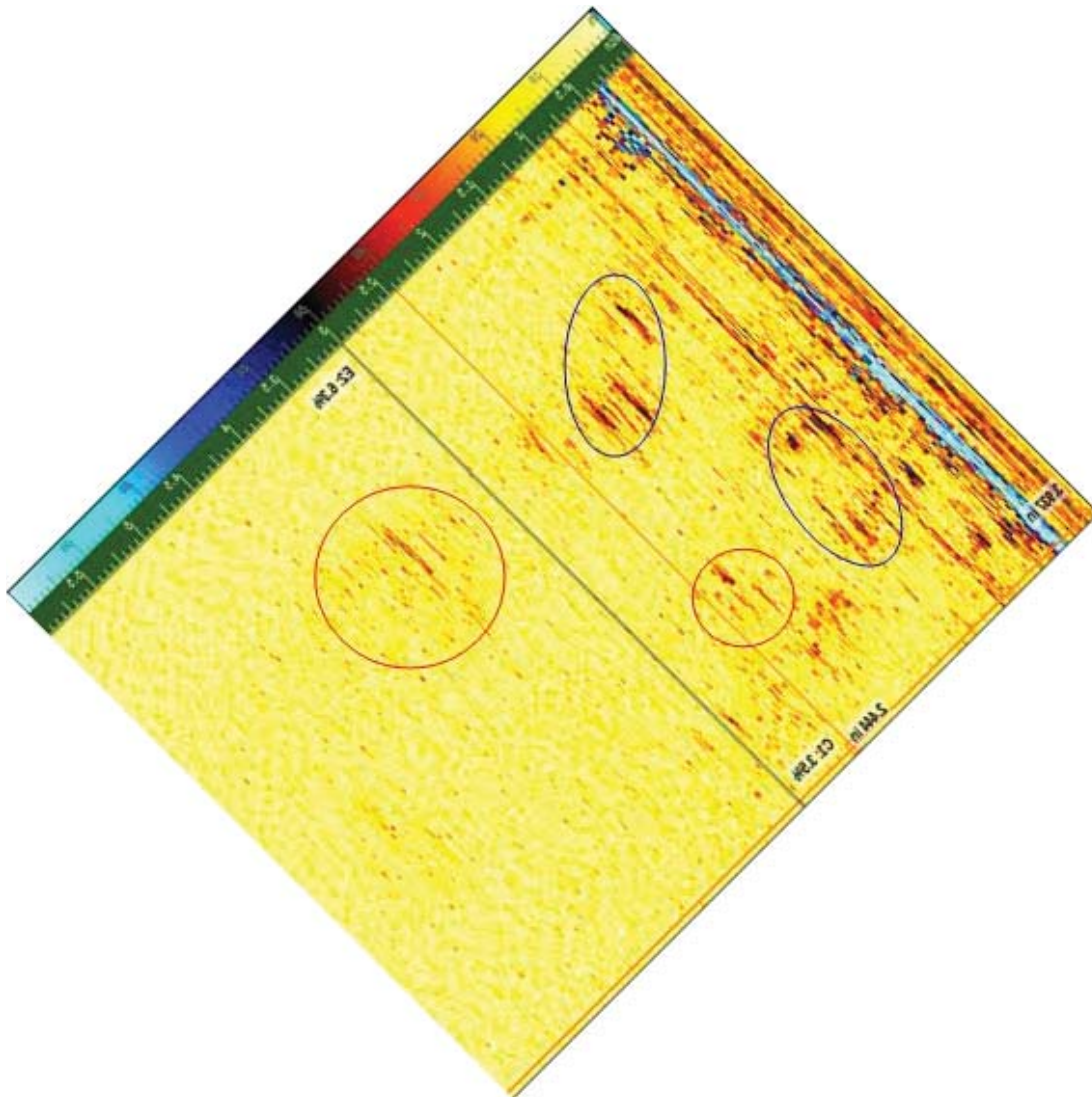
**Figure 7.1-31. Impact Plate 243 (FGB Impacted Plate) (a single-element angle beam scan (B-scan) was made by scanning at 45 degrees to the rib structure; the damaged areas are identified with red circles (holes) and blue ovals (regions of pitting and small penetrations))**

Figure 7.1-31 shows one of the most difficult impact samples to scan with ultrasonics. This panel is an emulation of the FGB skin. The figure indicates several regions of damage, including two large penetrations. The major difficulty with this sample was the presence of the rib structures, which caused large reflections. If a scan was performed perpendicular to these ribs, the reflections were so large that they disguised any damaged regions while highlighting the ribs. The ability to image the rib patterns is helpful for understanding the orientation of the damage relative to the structure, but at the cost of detecting damage that is close to the ribs. By scanning at 45 degrees to the ribs, most of the energy is lost in the reflections, and the reflections from the ribs miss the probe; thus, the important signals (i.e., those from the damaged areas) are greatly reduced. The array probes do not have enough energy to penetrate to and reflect off the damaged regions. By using a single-element angle beam transducer, a much larger pulser signal is allowed, which allows the signal to penetrate farther, but the flaw indications in the image still are not strong. In Figure 7.1-31, indications that correspond to the damaged areas are highlighted. The red circles indicate large penetrations. The blue ovals are regions where extensive pitting and small penetrations exist.

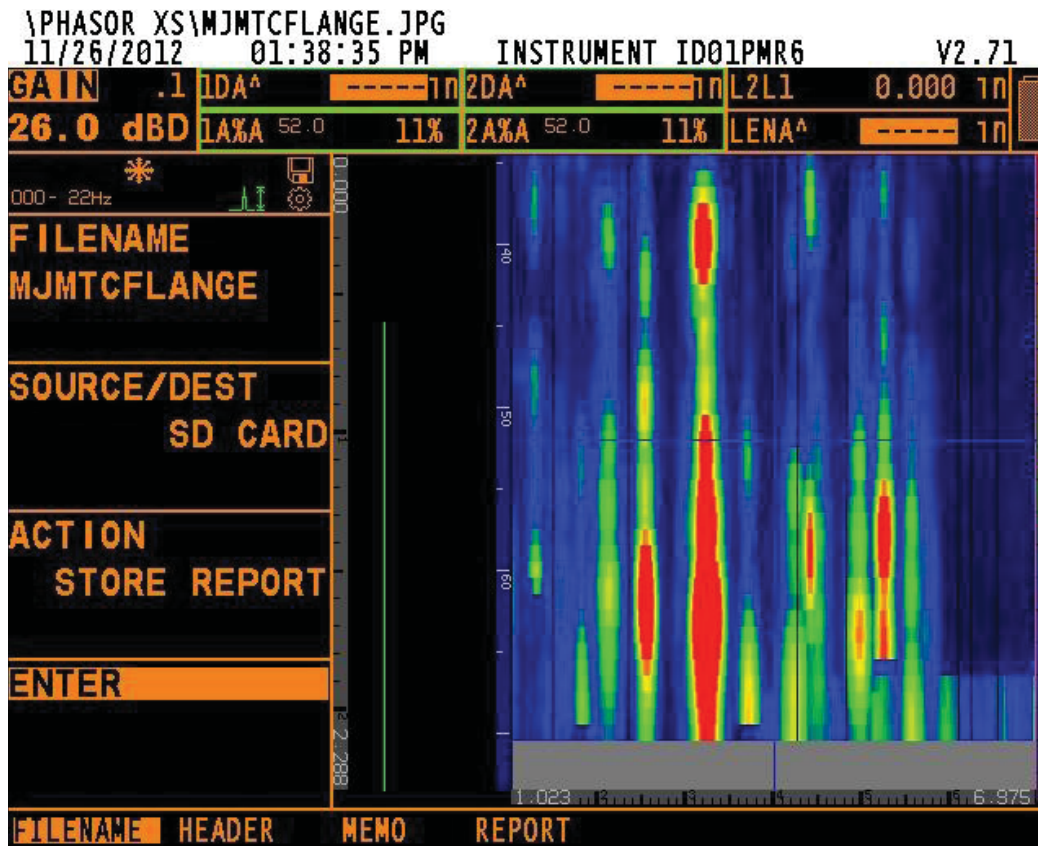
*Figure 7.1-33. A B-scan Image of Standard 3 showing the Results of Imaging the Multisite Partial Through-the-thickness Holes*

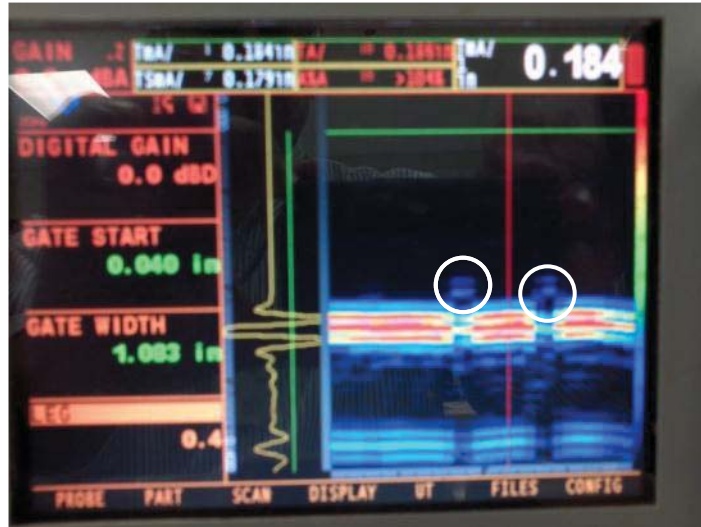
*Figure 7.1-35. A B-scan Image of Impact Test Plate 1907 showing the Results of Imaging the Pits Through-the-Thickness of the Plate without a Repair Patch*

Figure 7.1-35 is a B-scan image of impact test plate 1907, which had several deep pits on its backside. In this slice of the plate, two indications of deep pits are seen at the center and on the right side of the scan. The echoes occur slightly above the strong back wall, indicating a measure of their depth (see white circles). Shallow pitting on the backside of the panel was too small to detect in this image.

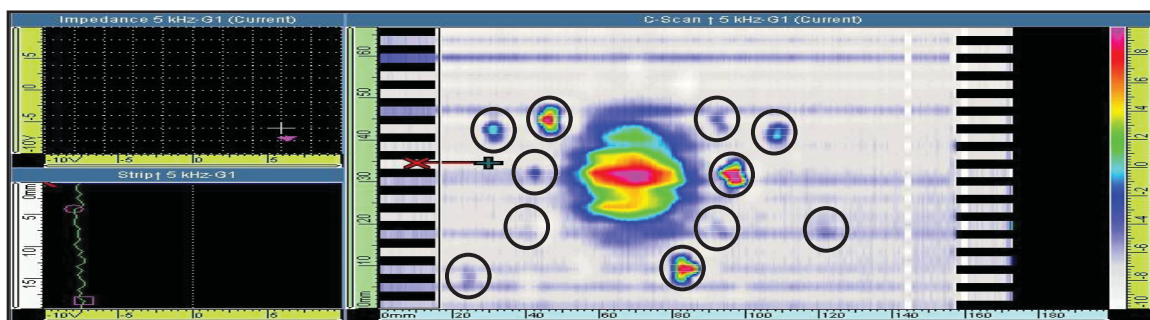
Figure 7.1-38 is an EC C-scan image of Standard 3, which is a thicker panel (Standard 4 is 0.1875 inch thick). The deep flaws are visible and are identified with black circles. The center hole, which is 1 inch in diameter, only has 0.0875 inch of metal remaining (0.100-inch deep hole). The deepest holes (0.125 inch) leave only 0.0625 inch of metal remaining. In the first ring of holes (with diameters of 0.094 inch), there are three holes with a depth of 0.0625 inch and three holes with a depth of 0.0875 inch; these are seen in the correct orientation in the figure. In the next ring, with 0.063-inch-diameter holes, two holes have a depth of 0.125 inch and two have a depth of 0.100 inch; these are seen in the correct locations in the second ring. For the smallest holes (the outer ring, 0.063-inch-diameter holes) only two of the five holes with a depth of 0.125 inch are seen as faint indications. The other three holes are outside the scan dimensions. The 0.100-inch-deep holes are not seen at the 0.063-inch-diameter hole size.

**Figure 7.1-38. EC C-scan Image of Partial Through-the-thickness Holes in Standard 3, showing the Detected Deeper Partial Through-the-thickness Holes on a Thick Test Plate (3/16-inch) without Patches**

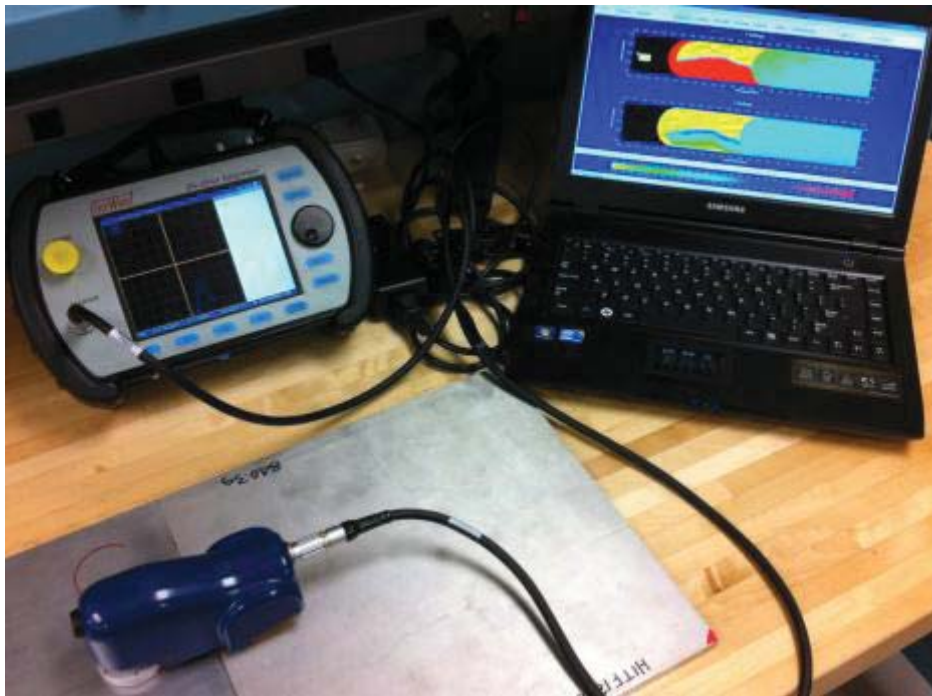
***Figure 7.1-39. UniWest 454A ECS3 System with Laptop Computer, which Records Data and Displays Images***

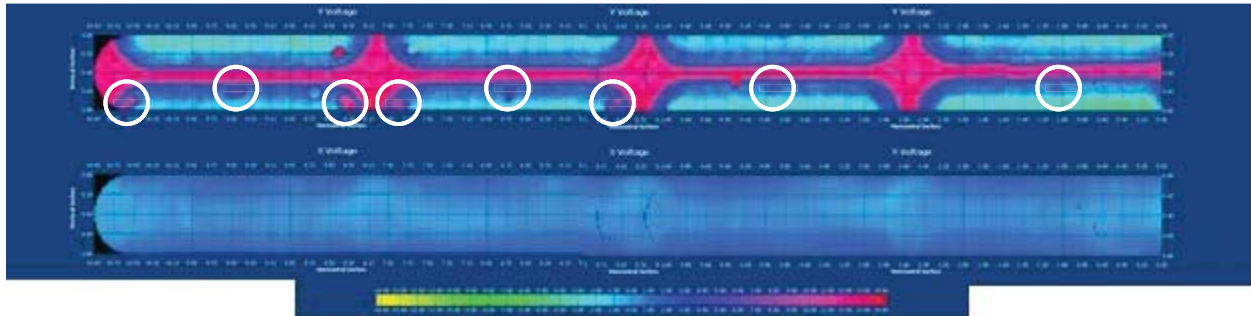
Figure 7.1-40 shows that hidden EDM notches were detected on the far side of Standard 1B. The resolution is sufficient to detect the orientation of the flaws. The rib pattern is easily seen in the top half of the image. The top half of the image is the conductivity image, while the bottom half of the image is the probe liftoff image. In these scans, the liftoff images should be uniform. In panel (a), white circles highlight the detectable flaws. The flaws that are 0.010 inch deep and those in the corners of the rib patterns are of questionable detectability, while the 0.01-inch-deep notches along the ribs are detectable (on the right half of the image). All of the 0.02-inch-deep notches (on the left side) were easily resolved. Panel (b) is an image of the same region as in panel (a), but with 0.013-inch tape applied to the surface. While the grid pattern might be vaguely discernible, none of the flaws can be resolved with any certainty.

*(a) Detected notches (indicated with white circles) on Standard 1b without any patches*

*(b) Effect of application of 0.013-inch aluminum tape on the test plate*

**Figure 7.1-40. EC C-scan Images of EDM Notches in Standard 1B, the FGB Patterned Test Plate**

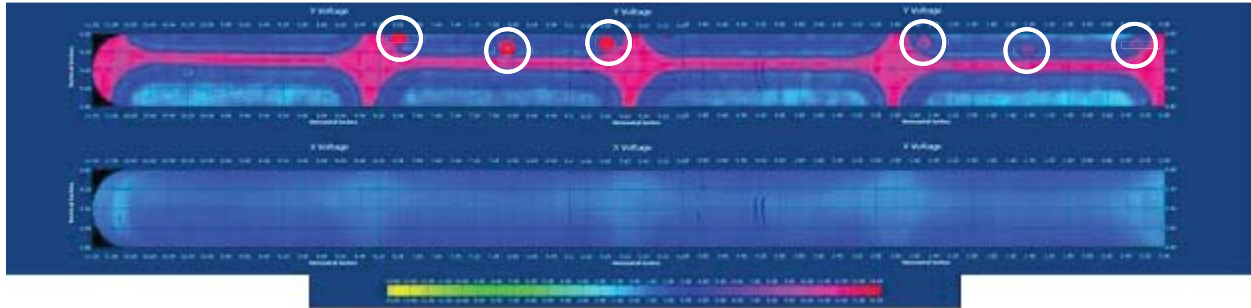
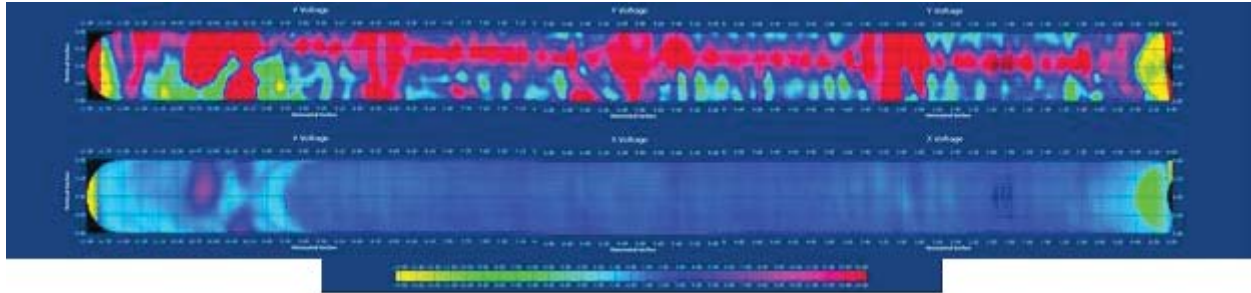
*(a) Detected holes on Standard 1b without any patches*

*(b) Effect of putting 0.013" aluminum tape on the test plate*

**Figure 7.1-41. EC C-scan Images of Partial Through-the-thickness Holes in Standard 1B, the FGB Patterned Test Plate**

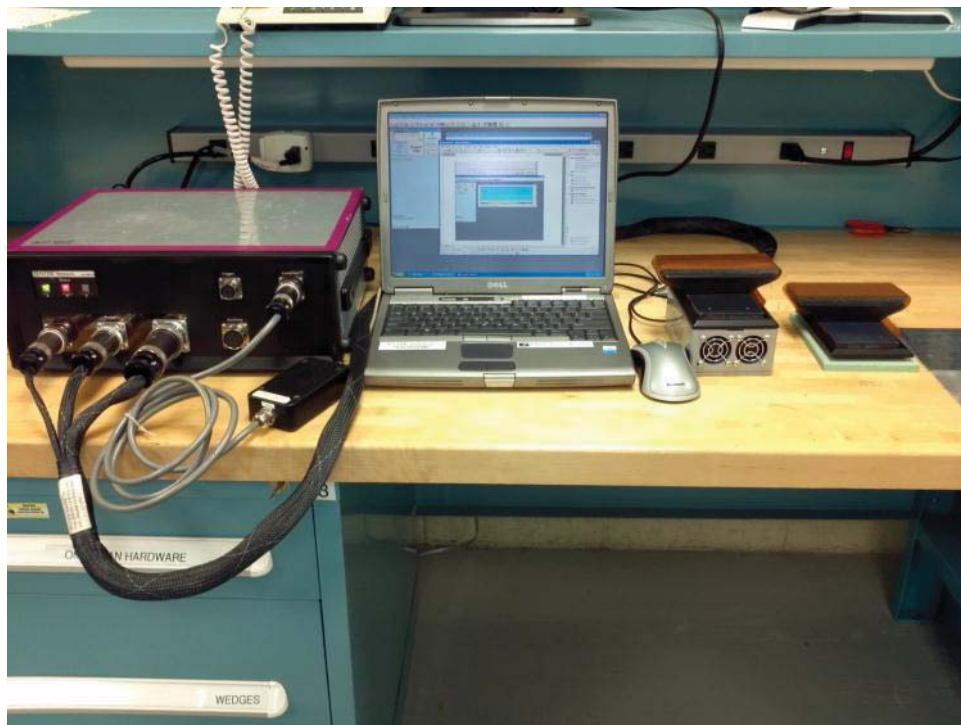
The Jentek MWM-Array GridStation used was a laboratory bench unit (see Figure 7.1-43). Jentek Sensors, Inc. is developing smaller models for portable use, but the model used in this testing was deemed adequate for demonstration purposes. The MWM-Array is an inductive sensor and is based on the original MWM<sup>®</sup> developed at the Massachusetts Institute of Technology in the 1980s [ref. 8]. A rapid multivariate inverse method converts the impedance data measured with an MWM-Array into images of surface geometry (from the liftoff response), stress and microstructure changes (based on the permeability response), and metal loss from a combination of the liftoff and wall thickness images. While most EC devices are designed to work at high frequencies for the purpose of finding small surface cracks, the GridStation was designed to work at low frequencies.

**Figure 7.1-43. Jentek GridStation MWM System**

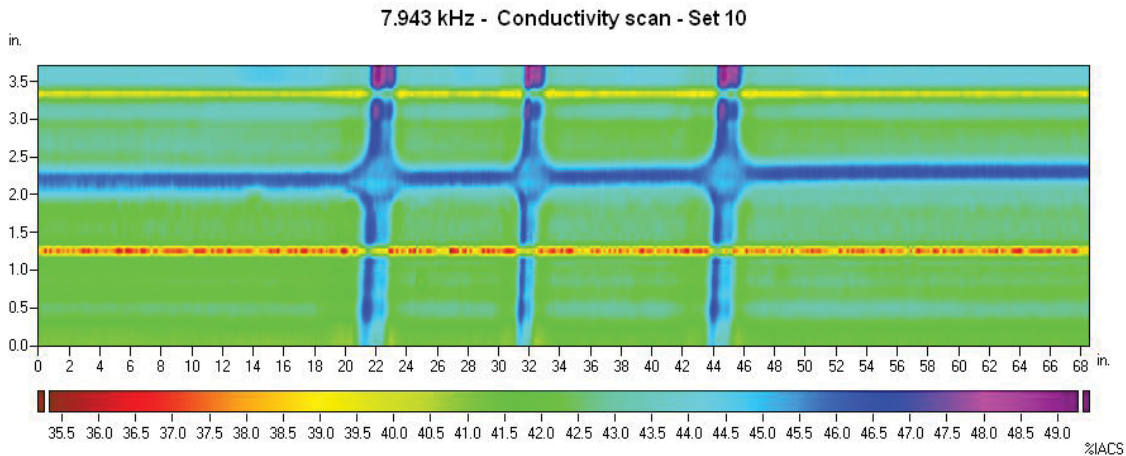
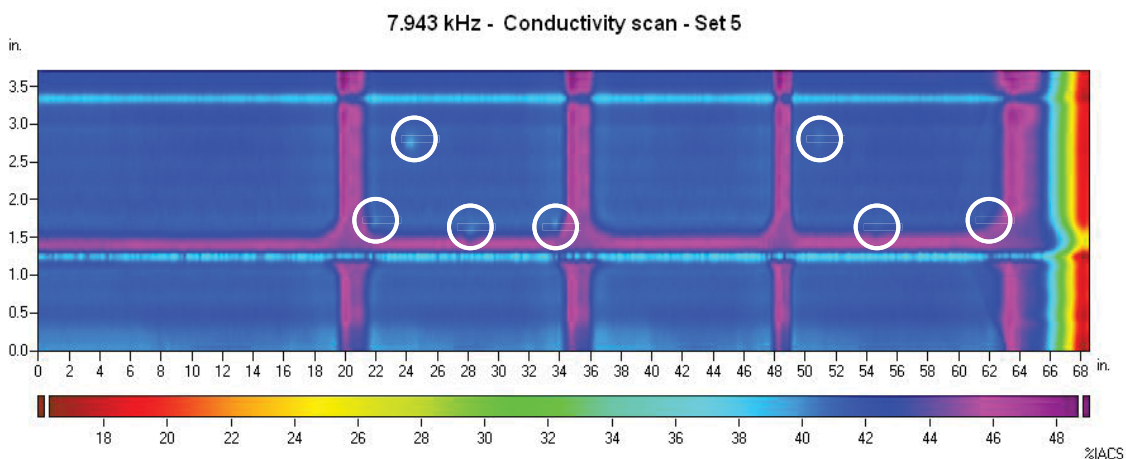
The GridStation system that the NESC used during testing did not have an encoder with the test system. In the following figures, scanning was performed by operating in a “time” mode (instead of using the encoder for position, the image position was advanced at a constant rate). By moving the array probe at a constant speed, a fairly consistent scan can be generated.

(a) Notches

(b) Partial through-the-thickness holes

**Figure 7.1-45. Jentek GridStation EC C-scan Results from Scans on Standard 1B (the waffle grid pattern is fully visible in each figure; some partial through-the-thickness holes are detectable in panel (b), while EDM notches are not visible in panel (a); In both panels, there are two horizontal lines representing bad sensors in the linear array)**

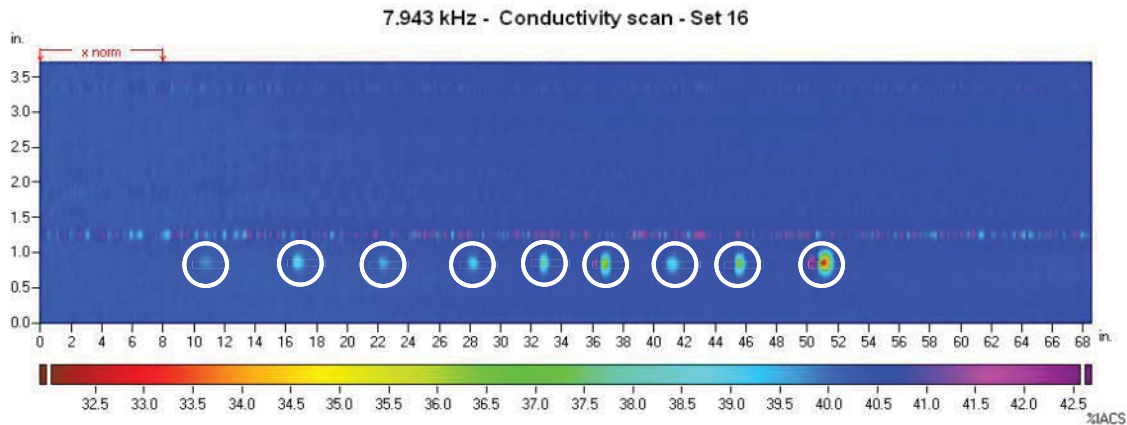
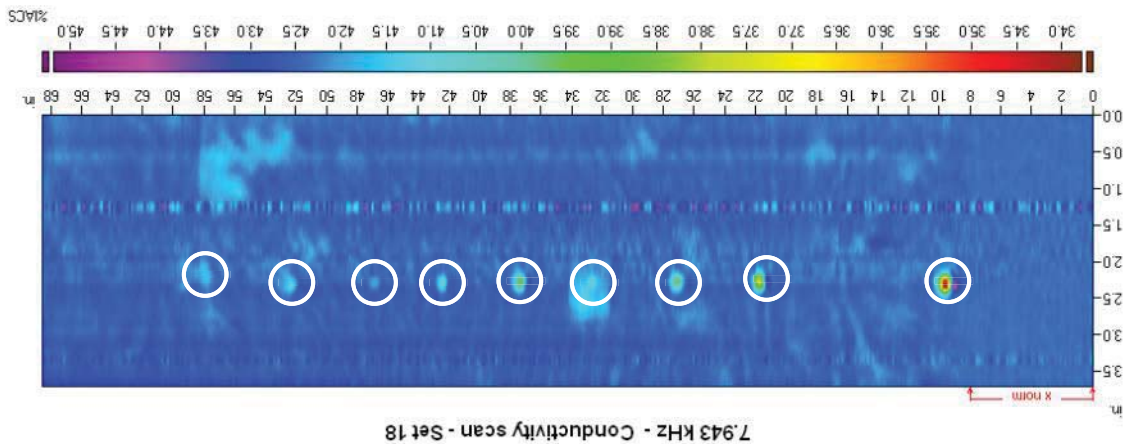
(a) View of plate without patches

(b) View of test plate with tape over test region, emulating the effects of a PWRK tape patch (the effects of the presence of the 0.013" aluminum tape are visible)

Figure 7.1-46. Jentek GridStation Results from Scans on Standard 4 of Partial Through-the-thickness Holes

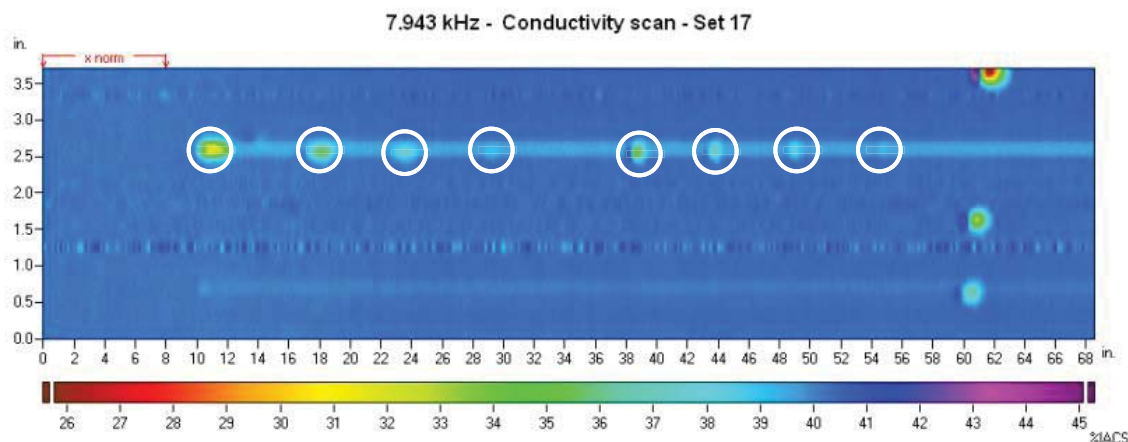
*Figure 7.1-47. Jentek GridStation Results from Scans on Standard 4 of EDM Notches (partial through-the-thickness holes on right side of scan are also visible)*

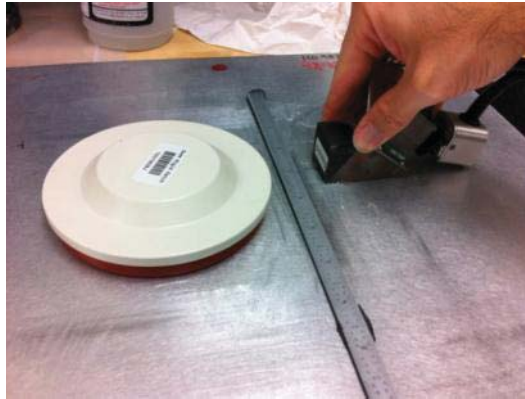
The majority of the astronaut feedback centered on the operation of the NDE hand-held scanner/encoder. Several different techniques and encoder configurations were evaluated with mixed results. In all cases, the need was identified for a method to identify the specific area of a panel to be scanned. The use of rulers, tape, Sharpie markers, and cameras were all potential suggestions to provide reference points, which would be necessary to obtain repeatable scan results. Most crew members felt that using a guide or ruler increased scanning accuracy (see Figure 7.2-1).

***Figure 7.2-1. Scanning using a Metal Ruler as a Guide***

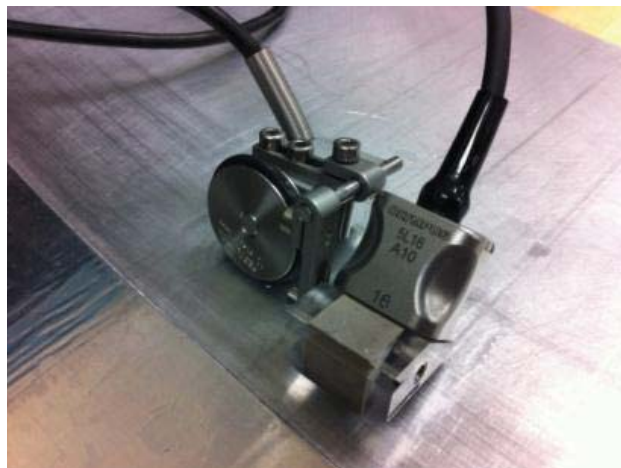
Most crew members felt that an optical or noncontact scanner would work better than the wheel/mechanical encoder. Alternatively, a time-based scan could be used as a backup method, in the event that a mechanical encoder did not work in microgravity. See Figures 7.2-2 through 7.2-4 below for example probes and encoders used during the evaluation.

***Figure 7.2-2. Ultrasound Array with Mechanical Wheel Encoder***

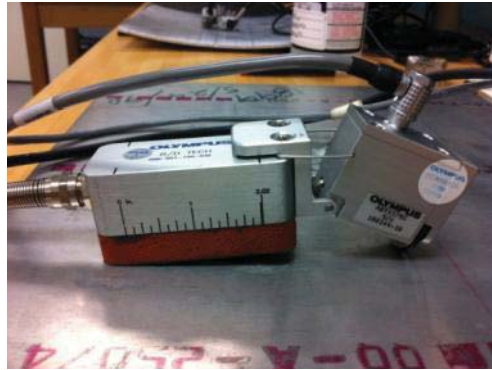
*Figure 7.2-3. Large EC Probe with Mechanical Wheel Encoder*

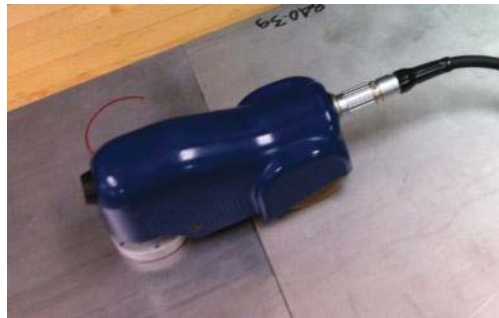
*Figure 7.2-4. Large EC Probe (wheel encoder is housed in the blue casing)*

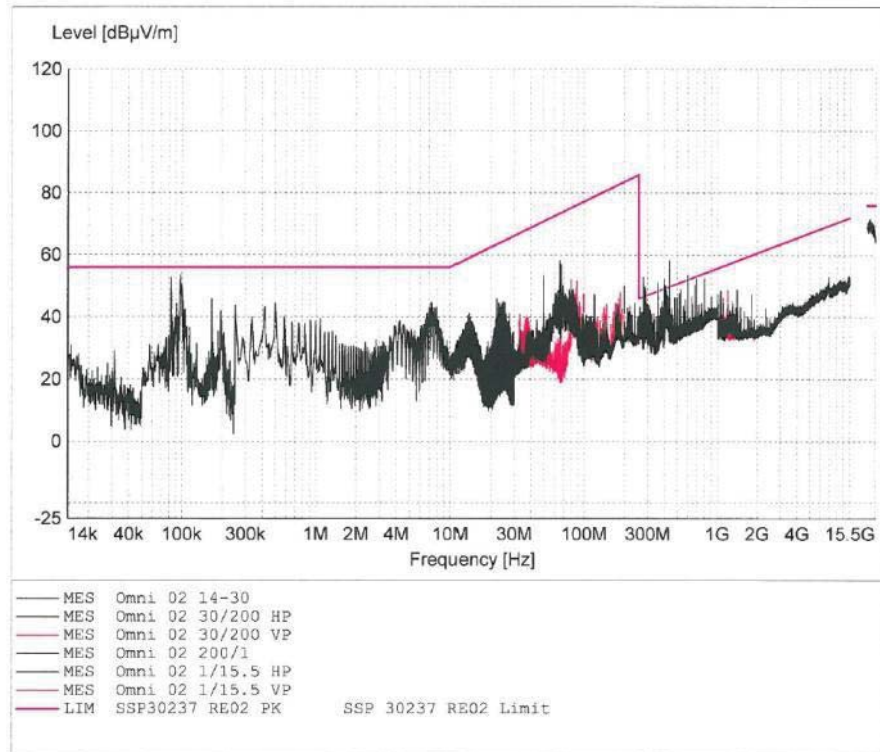
For the Omniscan MX unit, there were ten emission failures in the horizontal polarization of the RE02 testing in the frequency range of 280 to 600 MHz. The failures occurred while the unit was powered on and running. The largest margin was 8.385 dB at 440.200 MHz (see Figure 7.3-1). Note that in Figures 7.3-1 through 7.3-4, failures are indicated when the data exceeds the purple limit line.

**Figure 7.3-1. RE02: OmniScan MX, Hardware Powered On**

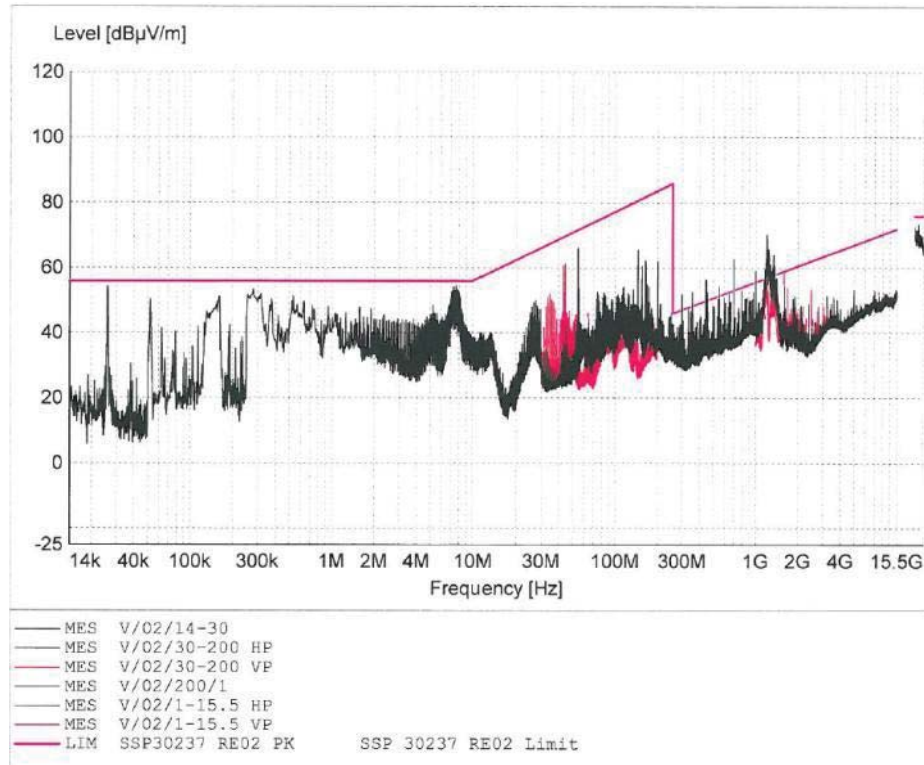
For the Sonatest Veo unit, there were 32 emission failures in the horizontal polarization of RE02 in the frequency ranges of 300 to 700 MHz and 1000 to 1365 MHz. There were also six failures in the vertical polarization of RE02 in the frequency range of 1186 to 1365 MHz. The failures occurred while the unit was powered on and running. The largest margins were 13.189 dB at 1200 MHz (horizontal) and 6.559 dB at 1200 MHz (vertical) (see Figure 7.3-2).

Figure 7.3-2. RE02: Sonatest VEO, Hardware Powered On

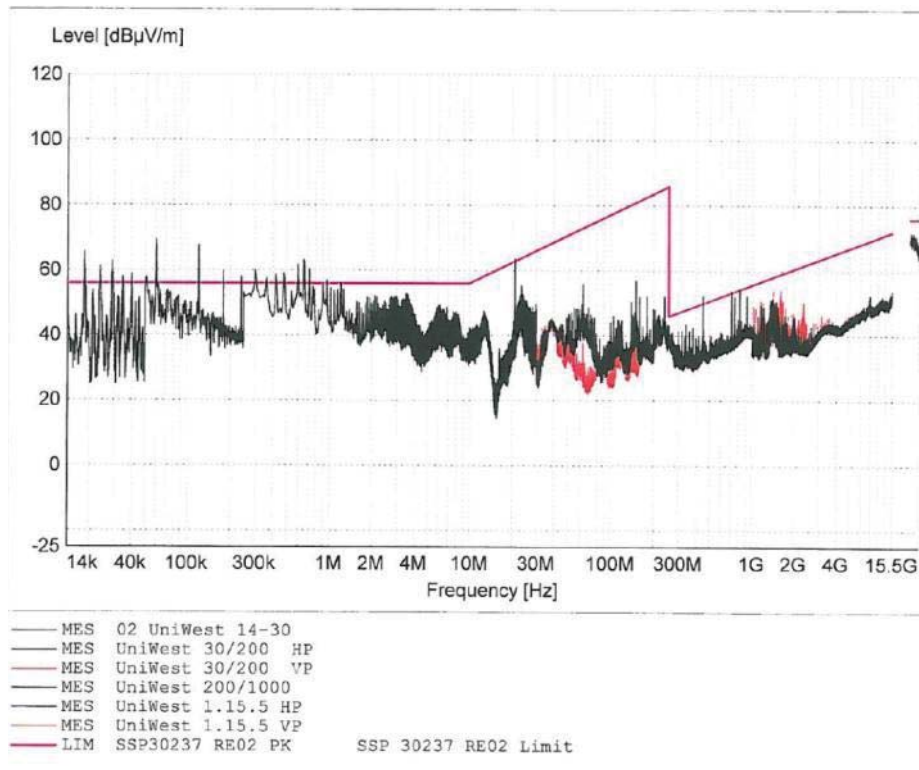
For the UniWest 454A ECS3 system, there were five failures in the horizontal polarization of RE02 in the frequency range of 450 to 700 MHz. There were also 21 failures in the vertical polarization of RE02 in the frequency range of 0.0185 to 21 MHz. The failures occurred while the unit was powered on and running. The largest margins were 2.273 dB at 451.6 MHz (horizontal) and 13.38 dB at 0.06 MHz (vertical) (see Figure 7.3-3).

**Figure 7.3-3. RE02: UniWest, Hardware Powered On**

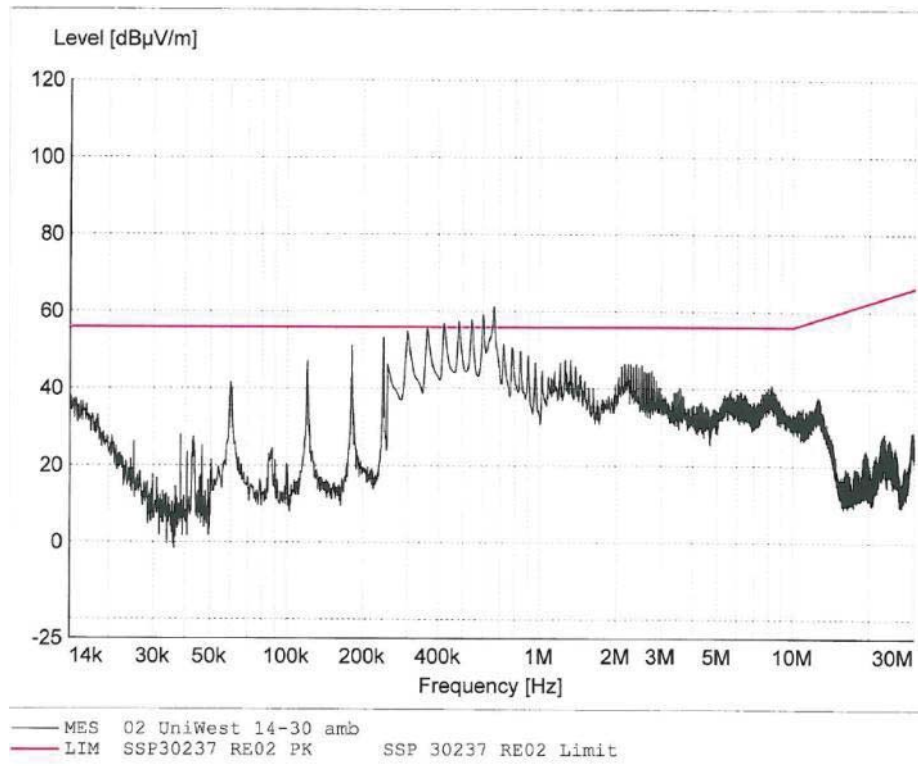
The configuration with AC powered on and equipment under test (EUT) powered off was also tested. This configuration had five failures in the vertical polarization of RE02 in the frequency range of 0.42 to 0.66 MHz. The largest margin was 5.29 dB at 0.66 MHz (see Figures 7.3-3 and 7.3-4).

**Figure 7.3-4. RE02: UniWest, AC Power On, EUT Off**

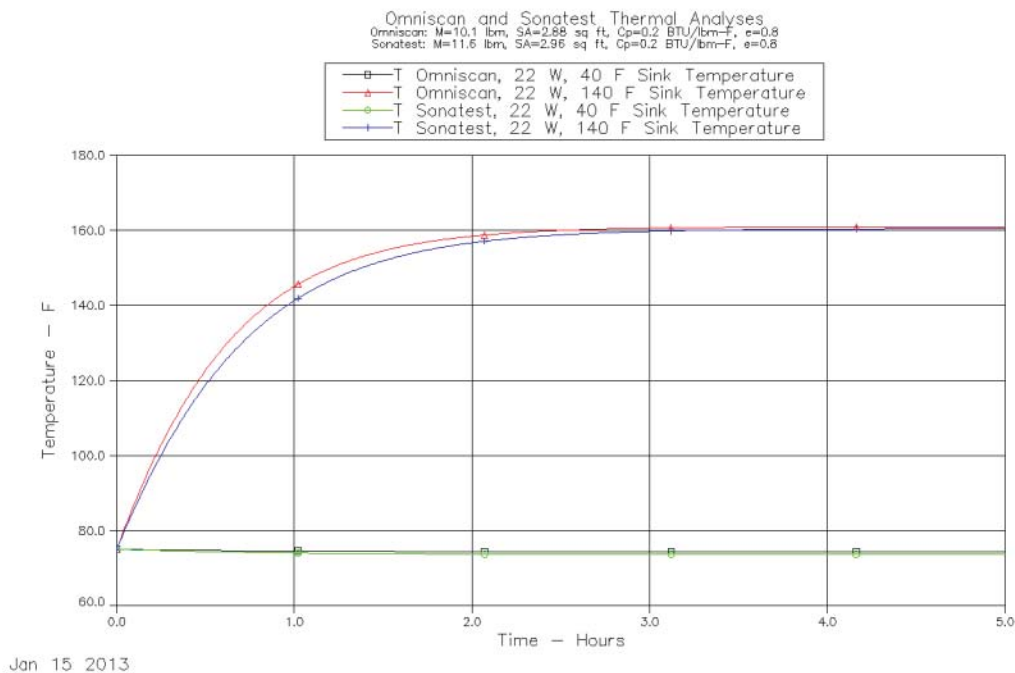
Using these broad assumptions, it was modeled to show that the units generated about the same amount of heat (see Figure 7.3-5). However, the Sonatest VEO uses a fan for cooling, but the OmniScan MX does not use a fan. Thus, in a vacuum environment, the OmniScan may perform somewhat better. Both units will work during a cold cycle when the ISS is out of the sun for an extended period of time. Neither unit will operate for long in a hot cycle when the ISS is in the sun for an extended period of time. During a hot cycle, the units will exceed touch temperature within 30 minutes.

**Figure 7.3-5. Thermal Analysis Results**

5. The surface area of each unit was based on the dimensions shown in the respective user manual specifications: Omniscan, 12.6 inches × 8.2 inches × 5.0 inches; Sonatest Veo, 8.66 inches × 13.19 inches × 4.52 inches.
6. The mass of each box was taken from the respective specifications given in the user's manuals: Omniscan, 10.1 lbm; Sonatest with one battery, 11.6 lbm.
7. The 22-watt heat load measured from the power inverter test was evenly distributed over the outer dimensions of each unit.
