Title : **Nonlinear Dynamic Behaviour of Impact Damage in a Composite Skin-Stiffener Structure**

Submitted to : 9<sup>th</sup> International Workshop on Structural Health Monitoring 2013

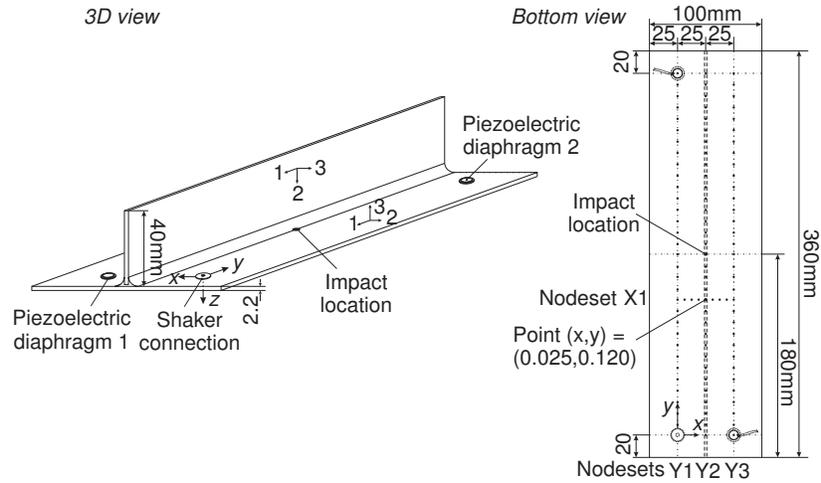
Figure 1: Three dimensional and bottom view of the composite skin-stiffener structure with a butt-joint stiffener. The dimensions, the measurement points (dots) and the impact location are indicated.

The structure investigated in this research is a thermoplastic skin-stiffener structure, as depicted in Figure 1. The butt-joint concept, developed by Fokker Aerostructures [1] is employed: the skin and stiffener are connected via an injection moulded filler and co-consolidated in the final manufacturing step. Both the skin and the stiffener are built from 16 individual plies of unidirectional carbon AS4D fibre reinforced thermoplastic (PEKK) material with a  $[0/90]_{4,S}$  layup. The filler is made from PEKK and contains 20% short carbon fibres.

The set-up and data acquisition systems used for all experiments are schematically illustrated in Figure 3. The structure is freely suspended and the excitation is done with an electro-mechanical shaker. A laser vibrometer, mounted on an  $x/y$  traverse system, measured the velocities at different points at the skin of the structure (see Figure 1), both before and after the impact damage was introduced.

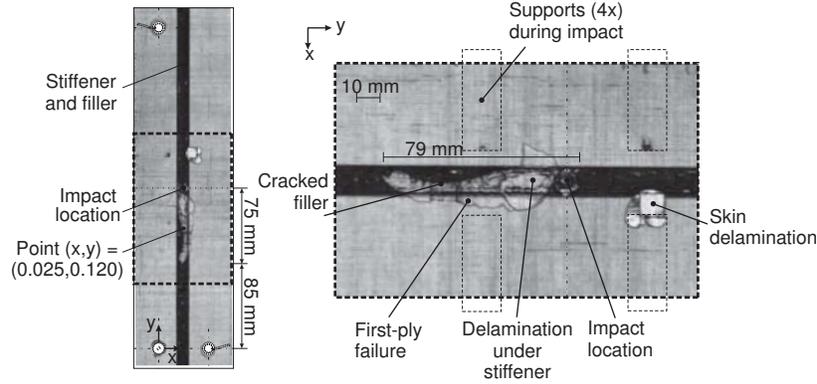
Figure 2: Ultrasonic C-scan of the impact damaged skin-stiffener structure, showing a complex combination of failure mechanisms near the skin-stiffener interface.

The damage scenario analyzed is a delamination between skin and stiffener: the most critical, but also a likely spot for a delamination to occur. Damage was introduced by utilizing a falling weight impact device and applying a repeated impact up to 15J. The ultrasonic C-scan in Figure 2 reveals a delamination at the interface between the skin and stiffener accompanied by a limited amount of failure between the first and second ply of the skin. Local delaminations were also introduced underneath one of the supports that was used during the impact testing.

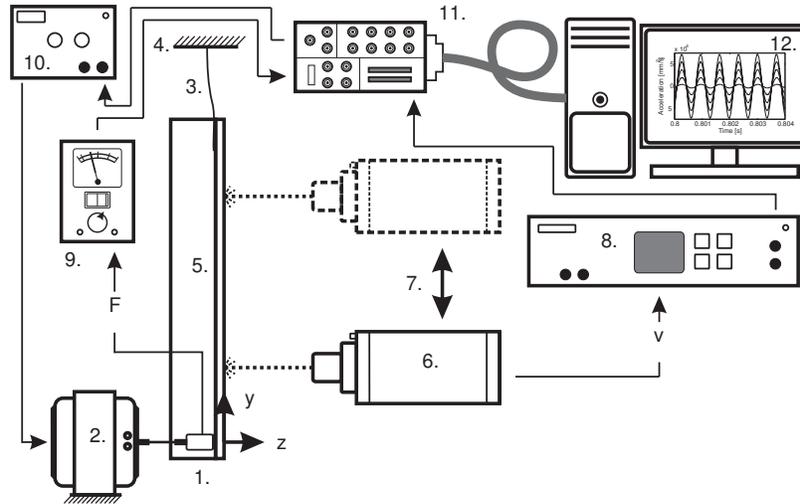
Figure 3: Experimental set-up

Description	Hardware	Description	Hardware
1 Force transducer	PCB 208C02	7 Traverse system x / y	
2 Shaker	B&K 4809	8 Laser Vibrometer: controller	Polytec OFV 5000
3 Wired suspension		9 Condition amplifier	PCB Model 480D06
4 Fixed frame		10 Power amplifier	Dynakit Mark III 60W (2x)
5 Composite skin-stiffener structure		11 Data acquisition	NI PCI-6110E
6 Laser Vibrometer: sensor head	Polytec OFV-505	12 Computer with Labview Data Acquisition software

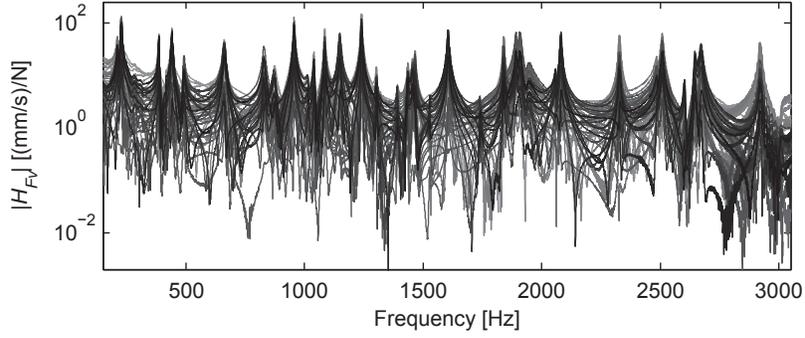
Figure 4: The magnitude of the frequency response functions for all 51 ( $3 \times 17$ ) measurement points of the pristine structure.

Figure 4 shows the magnitude of the total set of frequency response functions (FRFs) of the pristine structure. The operational deflection shapes of the structure are extracted at the natural frequencies – the sharp peaks in the FRF – with the help of peak picking. At these frequencies, the complex operational deflection shapes become predominantly real valued and are a close approximation of the associated mode shape. The 4<sup>th</sup> and 6<sup>th</sup> bending modes revealed to be of particular interest. The associated frequencies are  $f_4 = 1456\text{Hz}$  and  $f_6 = 2328\text{Hz}$  for the pristine and  $\hat{f}_4 = 1455\text{Hz}$  and  $\hat{f}_6 = 2340$  for the damaged structure. The 6<sup>th</sup> natural frequency of the damage structure is unexpectedly higher than that of the pristine structure, which is caused by a shaker replacement, resulting in an increase of some of the natural frequencies. The type of deflection shape remained unchanged.

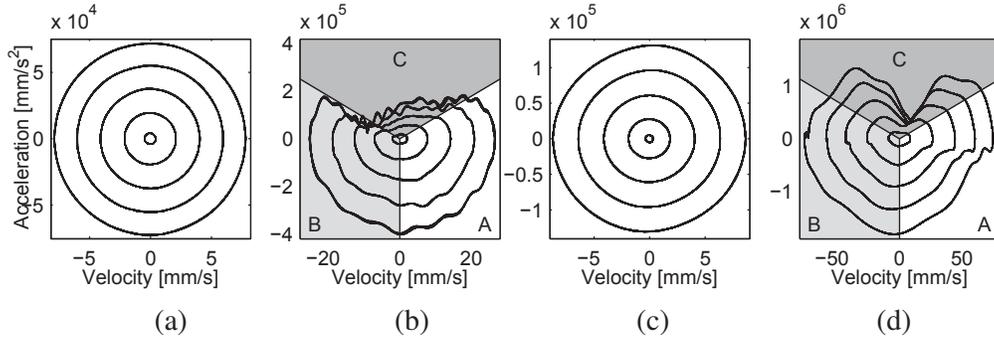
Figure 5: Phase portraits measured at  $(x, y) = (0, 0.25, 0.120)$ m of (a,c) the pristine and (b,d) the damaged structure for a forced excitation at (a,b) the 4<sup>th</sup> bending mode ( $f = 1456$ Hz,  $\tilde{f} = 1455$ Hz) and (c,d) the 6<sup>th</sup> bending mode ( $f = 2328$ Hz,  $\tilde{f} = 2340$ Hz) and five excitation amplitude levels. The capitals refer to the opening (A), closing (B) and contact (C) phase.

Phase portraits measured at  $(x, y) = (0.025, 0.120)$ m (center of the damage, see also Figure 1 and Figure 2) of the pristine and damage structure are made for excitation frequencies of  $f_4$ ,  $\tilde{f}_4$ ,  $f_6$  and  $\tilde{f}_6$ . The phase portraits, shown in Figure 5, are based on the (measured) velocity and (calculated) acceleration responses. Each trajectory represents a different excitation amplitude. The concentric circles for the pristine structure, indicate that the motion is periodic, stable in the sense of Liapunov [9] and purely harmonic. The damaged structure also shows periodic and stable motion, but the bending deformation is harmonically distorted by the skin-stiffener damage. The motion approaches nearly fundamental harmonic behavior for the lowest excitation amplitude, while the harmonic distortion increases with increasing excitation amplitude. The damage causes the motion of the skin at the damaged region to behave dynamically nonlinear for the bending modes considered. The nonlinearities mainly occur at one side of the phase portrait while the rest of the motion remains fairly linear.

These physical events are linked to sections in the phase portrait (Figure 5(b) and (d)) with the help of the associated displacement, velocity and acceleration waveforms for the skin at the damaged region. The skin showed a  $\mathcal{O}(10\mu)$ m peak-to-peak displacement at the location  $(x, y) = (0.025, 0.120)$ m for the highest excitation amplitude considered.

The phase portrait of the 6<sup>th</sup> bending mode shows a relatively smooth cycle compared to that of the 4<sup>th</sup> bending mode. The latter contains more high frequency components. The explanation for these difference can be found in the difference in the way the contact between skin and stiffener is (re)established. The relative difference in velocity is just one of the parameters, the location of the damage with respect to local nodes and anti-nodes of the mode shape is another parameter. The contact type can be described as either ‘clapping’ (with high frequency components) or ‘rolling’ (smooth).

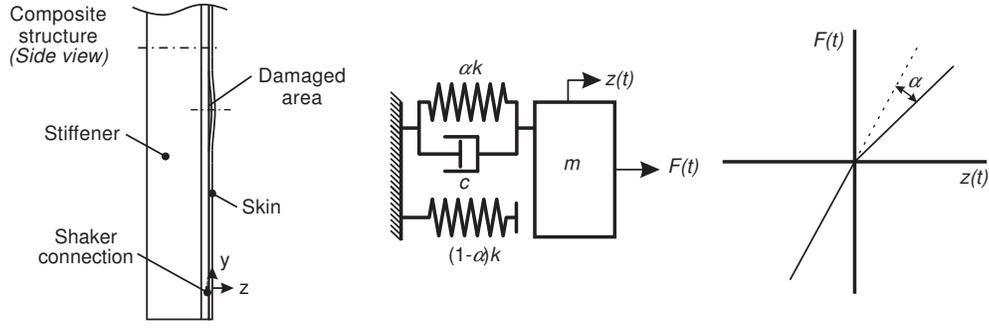
Figure 6: Delaminated skin-stiffener structure represented by a single degree of freedom bilinear mass-spring-damper system.

The dynamic behaviour of the skin-stiffener damage is represented by a mass-spring-damper system with a bilinear stiffness, depicted in Figure 6. The nonlinearity is introduced by a bilinear stiffness, representing the difference in bending stiffness for an opened delamination and a closed delamination. Note that it is assumed in this model that the motion of the stiffener is negligible compared to that of the skin. The governing dynamic equation reads:

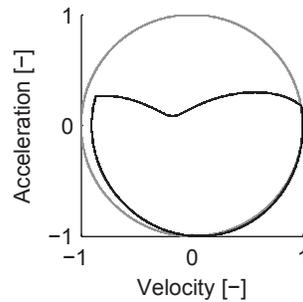
Figure 7: Analytical normalised phase portraits for a linear (gray) and bilinear (black) single degree of freedom mass-spring-damper system ( $m = 1\text{kg}$ ,  $k = 10^6\text{N m}^{-1}$ ,  $c = 50\text{Ns m}^{-1}$ ,  $\alpha = 0.2$ ).

The model parameters are chosen arbitrary in this first step ( $m = 1\text{kg}$ ,  $k = 10^6\text{N m}^{-1}$ ,  $c = 50\text{Ns m}^{-1}$ ,  $\alpha = 0.2$ ). The driving frequency is the natural frequency associated with the stiffness during opening of the delamination ( $\alpha k$ ;  $f = 71\text{Hz}$ ). The normalised phase portraits are presented in Figure 7. The correspondence between the phase plot of the 4<sup>th</sup> bending mode and the analytical model is very good in qualitative sense. The correspondence with the phase portrait of the 6<sup>th</sup> bending mode is less, since the transition between the two stiffnesses is non-smooth, whereas it is expected that this is the case in reality ('rolling' contact assumption) and the assumption of a rigid stiffener is violated for this mode. It can be concluded that the model qualitatively supports the explanations given here for the experimental observations.
