# **MATERIALS, MANUFACTURING AND TEST DEVELOPMENT OF A COMPOSITE FAN BLADE LEADING EDGE SUBCOMPONENT FOR IMPROVED IMPACT RESISTANCE**

Katherine M. Handschuh<sup>2</sup>, Sandi G. Miller<sup>1</sup>, Matthew J. Sinnott<sup>2</sup>, Lee W. Kohlman<sup>1</sup>, Gary D. Roberts<sup>1</sup>, J. Michael Pereira<sup>1</sup>, and Charles R. Ruggeri<sup>1</sup>

<sup>1</sup>NASA Glenn Research Center, Cleveland, OH 44135

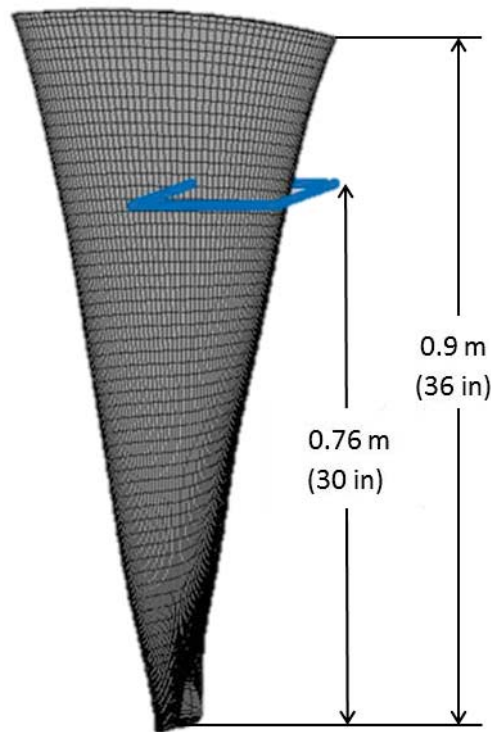
Figure 1. Blade optimized for aerodynamics and highlighted cross section chosen for test article

Material performance was evaluated through impact testing of a leading edge test article derived from the geometry of an aerodynamically optimized fan blade. The optimized blade utilized a modern fan blade design for a high-bypass ratio, low pressure ratio fan for a large commercial transport aircraft. This blade geometry was chosen to drive the design of the leading edge test article. The region represented by the test article is called out in Figure 1. The thickness profile of the test article was half scale of the thickness profile of the blade at 0.76 m (30 in) fan radius, where the blade width was 30.5 cm (12 in). This region of a blade was chosen as the FAA impact test requirements specify the impact location to be 50% or more from the root of the blade for large flocking bird impacts, where this profile chosen is 83% from the root. [1]

The profile of the test blade is shown in Figure . It should be noted that the last 3.8 cm (1.5 in) at the mid-blade location was adjusted to be flat and parallel in order to clamp into the test

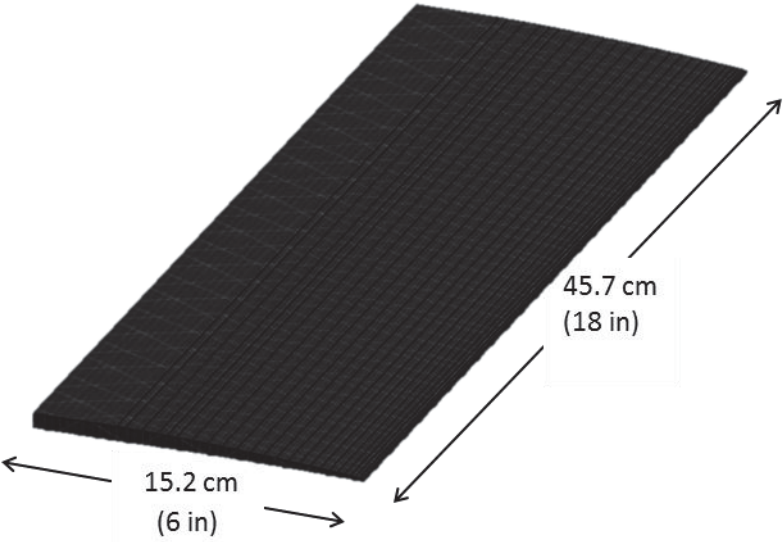
Figure 3. Leading edge blade shape and dimensions

fixture. The profile was then extended in the blade radial direction (referred to later as the axial direction) to 45.7 cm (18 in) in length, as shown below in Figure , to create the leading edge blade test article. The profile was designed to compare various material modifications; not to demonstrate an optimum design in either geometry or lay-up configuration. The simplified geometry decreases manufacturing complexity while maintaining a leading edge profile. The changing thickness of the cross section requires ply drops across the blade from 50 plies thick at the base to two plies at the leading edge.

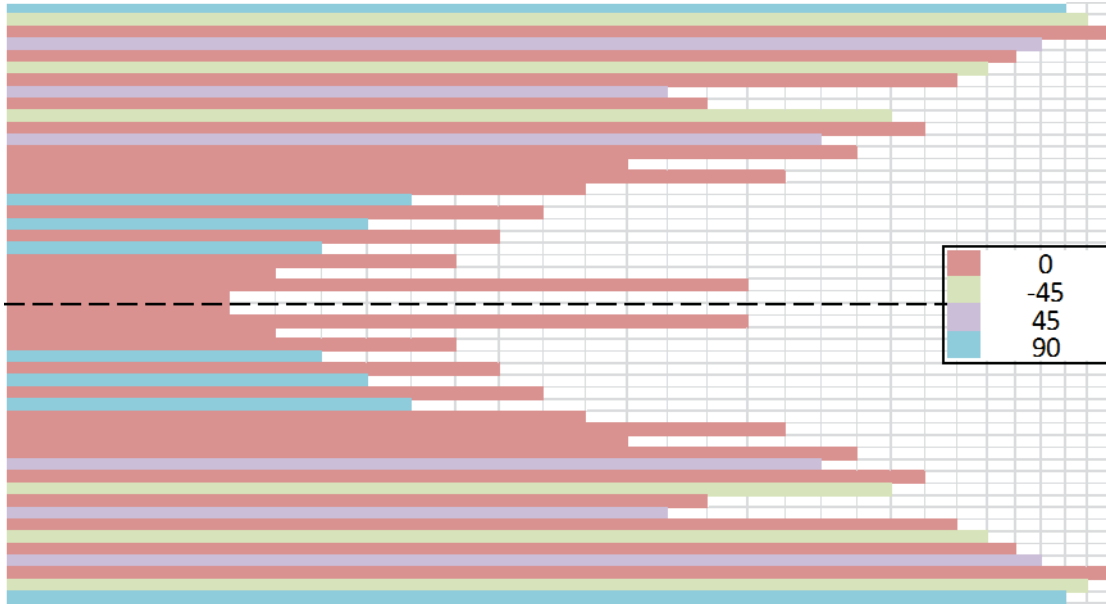
Figure 4. A2 ply lay-up, through thickness view

The A1 and A2 design configurations were based on results reported in reference 3; where leading edge fibers were oriented at a  $[0/90]_s$  with respect to the axial direction of the blade. It was suspected that impact damage to this blade was minimal due to the increase in elastic modulus resulting from both  $0^\circ$  and  $90^\circ$  ply orientations at the leading edge. While the configurations given in Table 1 describe the lay-up at the blade root, ply drops throughout the test article were chosen such that the leading edge ply configuration for designs A1 and A2 was  $[90/-45/0/+45]_s$  with respect to the blade axial direction. The difference between A1 and A2 is the addition of six  $90^\circ$  plies at the center of the A2 thickness, a modification which was based on the results of A1 panel impact testing. In this study, initial panels were used to evaluate the impact test set-up and method, with a focus on impact induced damage rather than damage resulting from test configuration including boundary conditions. The ply orientations and locations of ply drops for design A2 can be seen in the cross section view, Figure 4; the length of each section is proportional to show the relative locations of the ply drops.

The gradient in thickness of the blade profile requires ply drops throughout the structure. In panels A1 and A2, the ply drops were arranged in an accordion drop pattern; shown in Figure 4 for panel A2. This design was anticipated to reduce the shear plane that might develop, for example, with a step pattern ply drop.

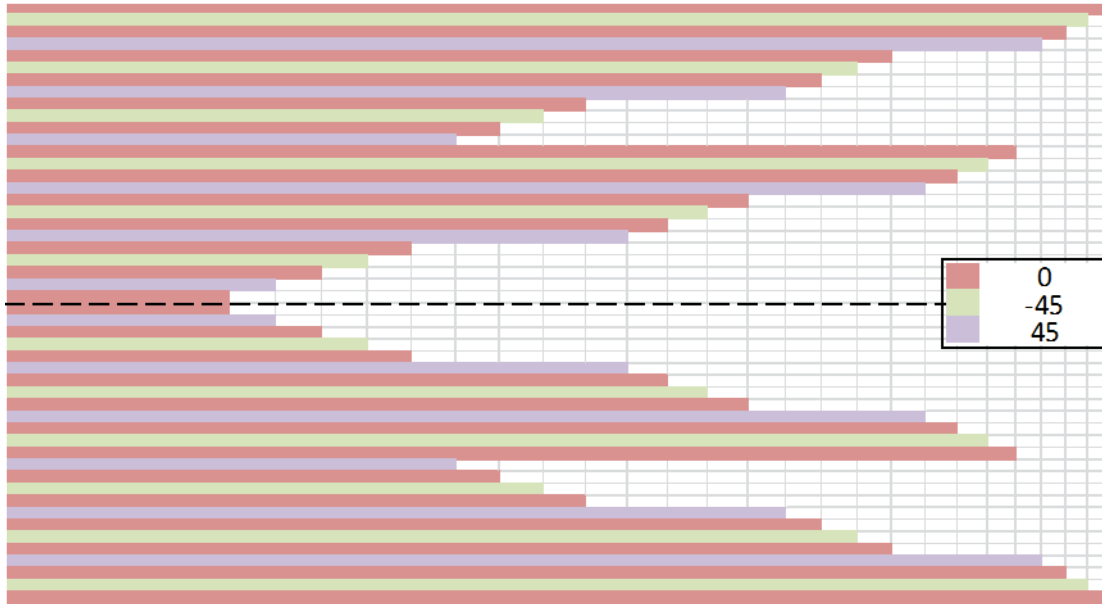
Figure 5. B1 ply lay-up design 50 plies total with symmetry

The B1 design was established to provide a systematic approach to the ply termination points, allowing better balance between +45° and -45° terminations across the ply drops. The only difference between designs A3 and B1 is that ‘A’ has ‘accordion pattern’ or random ply drops while ‘B’ is a systematic ply drop pattern. The ply drop location and the lay-up configuration of the B1 type is in Figure

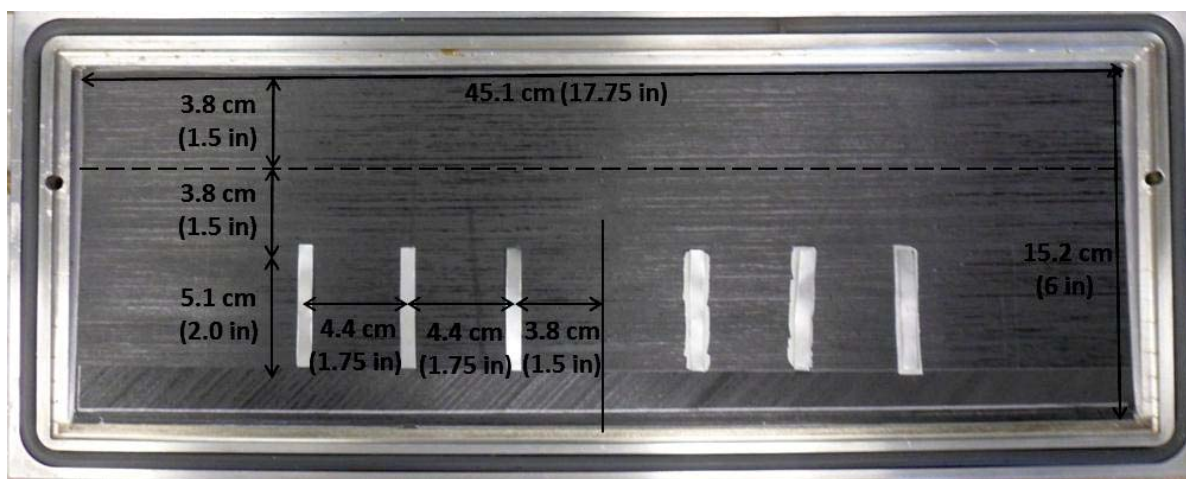
Figure 6. Location of SMA, right with polyurethane veil

Two separate blades were fabricated to evaluate impact resistance of subcomponents containing (1) a thermoplastic polyurethane veil for interlaminar toughening, and (2) SMA strips for eventual camber change application. Six SMA strips were incorporated into the blade test article to evaluate their influence on impact damage tolerance. The strips were not ‘trained’ and therefore unable to change shape. Test specimen C007 included the embedded Nickel-Titanium strips at the locations identified in Figure 6. The 5.1 cm (2 in) long and 6.4 mm (0.25 in) strips were placed in cut-outs of the 0° ply shown in Figure 6. The strips on the right half of the blade were covered by the polyurethane veil material on either side of the SMA. The veil was cut to extend beyond the SMA borders by approximately 2.5 mm (0.1 in) around each side.

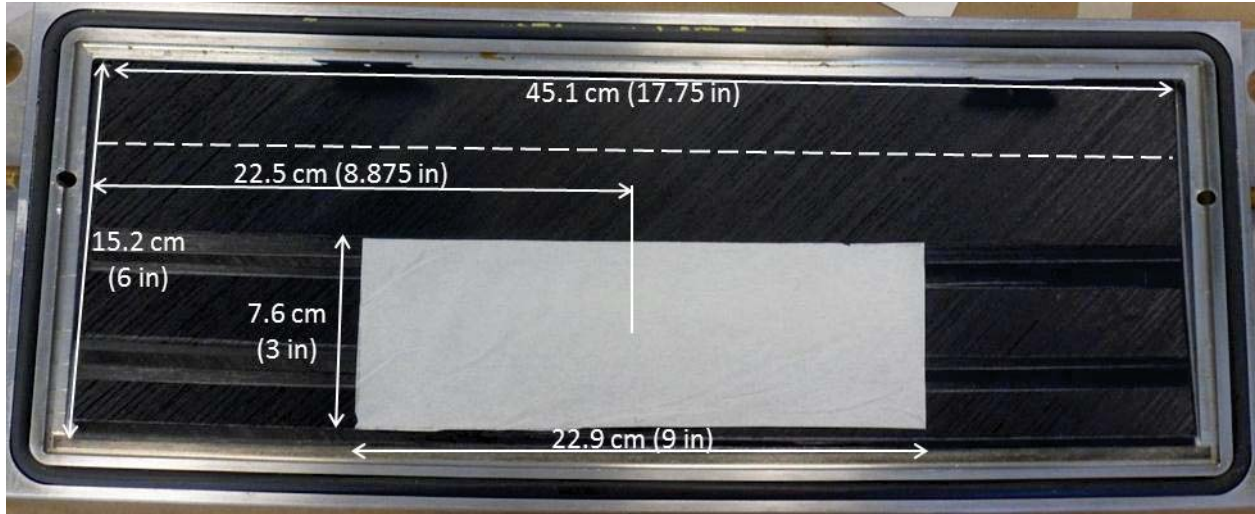
Figure 7. Location of 7.6 cm (3in) polyurethane veil layer

The test article containing a thermoplastic polyurethane (TPU) veil interleave was prepared to evaluate impact resistance imparted by increased interlaminar strain capability of the structure. As seen in Figure , the toughening veil was 22.9 cm (9 in) long and placed in the midsection of the length. Three layers of TPU were added to the blade in the locations labeled in Figure . Two of the layers were 7.6 cm (3 in) wide and the other was 5.1 cm (2 in) wide. The veil placement was chosen to cover a significant portion of ply terminations; reducing free edge stresses.

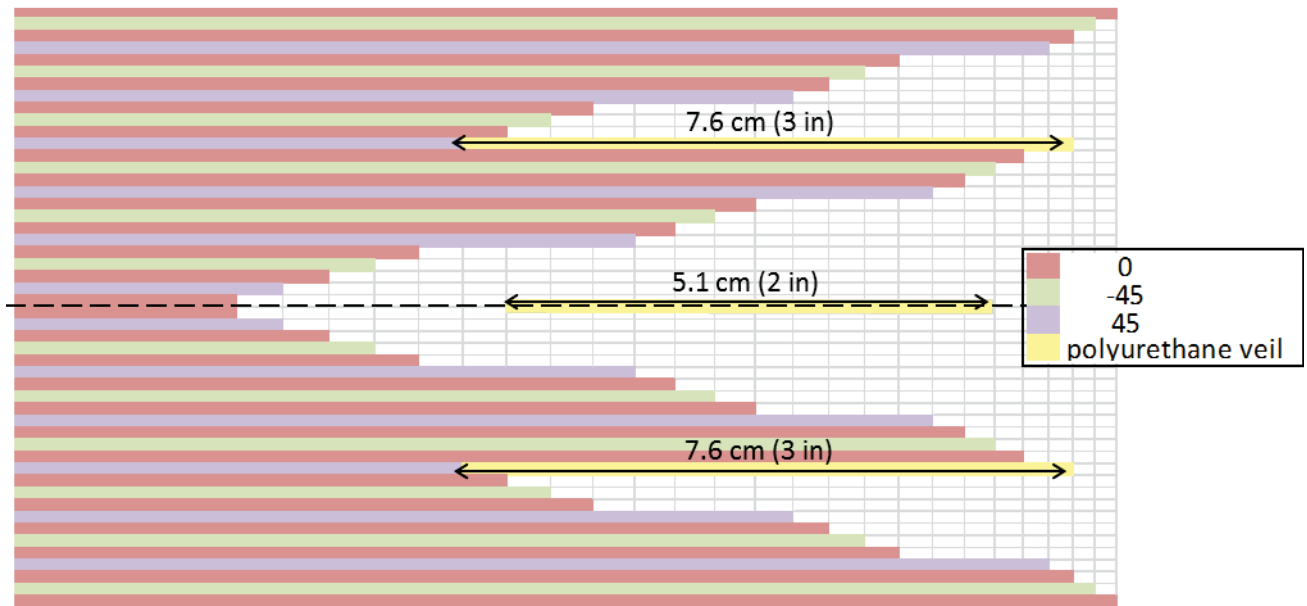
Figure 8. Polyurethane veil toughened specimen

Test article C008 included the TPU veil interleave for damage tolerance. Three sheets of the interleave material were added across the major ply drops to improve interlaminar fracture toughness at these locations. Veil location was outlined in Figure 8. As seen from Figure 15, there was very little visual damage to the C008 test article. No delamination at the leading edge was noted in the interleave region. As with many of the test articles, a small delamination was observed near one end of the leading edge in an unmodified region due to flexural wave reflection. This failure mode was observed in many of the leading edge tests and is considered an artifact of boundary conditions, occurring after the initial impact. Figures 17a-17c, which show thermography images used to characterize the post-test damage to the blade.

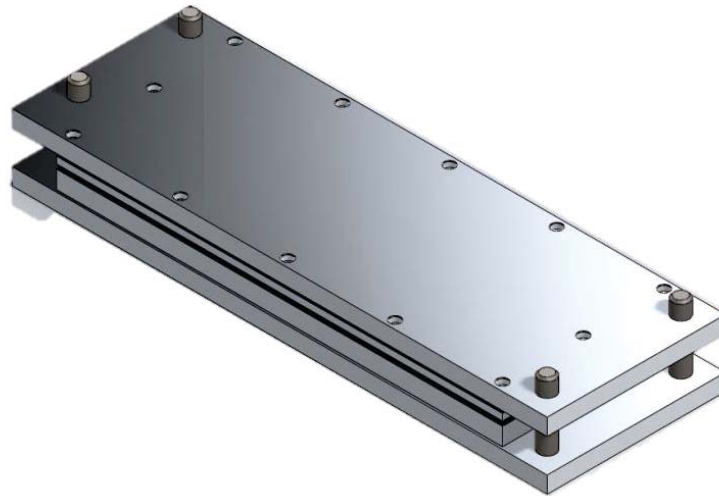
Figure 9. 3-D model of mated die mold

The IM7/8551-7 pre-impregnated tape was cut according to the ply lay-up designations for each panel. An aluminum mold was custom designed to fabricate the leading edge specimen described in this paper. The mold was a mated 7075 Aluminum die, shown in Figure , and was

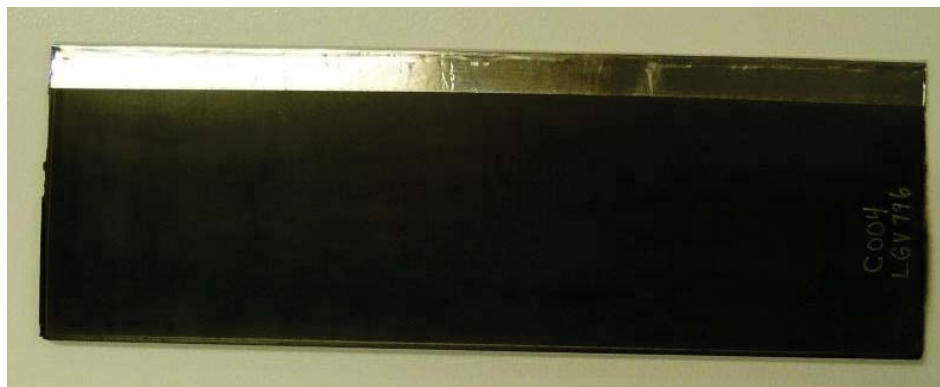
Figure 10: Prepared leading edge test article

In an effort to protect the leading edge from extensive break-out damage, leading edge protection was applied in the form of an industrial aluminum foil adhesive tape. The aluminum foil tape was 0.25 mm (0.01 in) thick and 5.1 cm (2 in) wide and adds approximately 20 g of mass to the edge of the blade. The adhesive tape was placed 2.5 cm (1 in) from the leading edge on the concave side of the blade, rolled over onto the convex side, then smoothed and flattened. A fully prepared test article is shown in Figure 10.

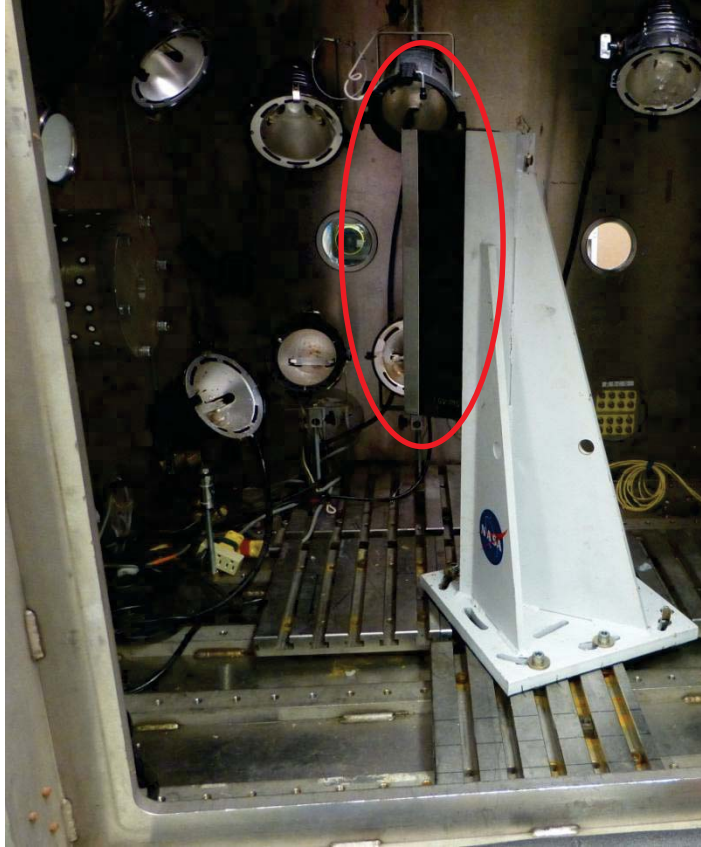
Figure 11. Impact testing fixture secured in impact chamber

The projectile velocity and orientation of the leading edge test article were derived from computer simulation of the relative motion of a fan blade and bird during a bird strike event. The blade was clamped along the axial direction at the flat section for cantilevered impact testing. The leading edge specimen and fixture set up for impact testing is shown in Figure 1. The impact location was at the leading edge of the blade where the angle of impact was measured as 66° from the perpendicular to the projectile path at the thickest part of the blade. The blade tip was orientated approximately 24° off of the projectile's path, shown in Figure 12a. and schematically in 12**Error! Reference source not found.**b. Between the blade and the fixture there is a 15.2 cm (6 in) section of clay added to reduce additional pressure loading on the fixed portion of the blade. This was added to deflect the gelatin away from the clamped area.

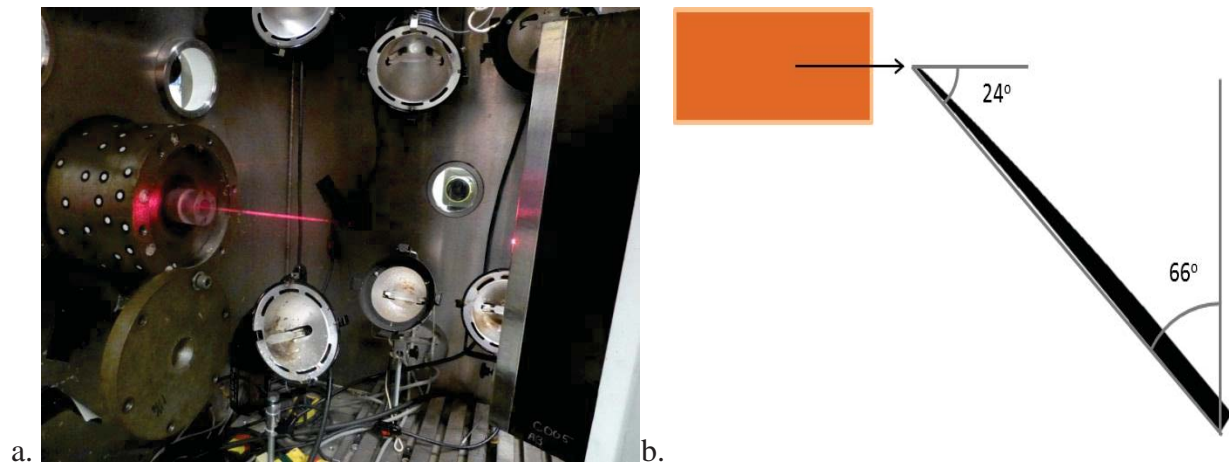
Figure 12 (a) Location of impact on the leading edge, and (b) Scaled schematic, top view, of the projectile path and the blade

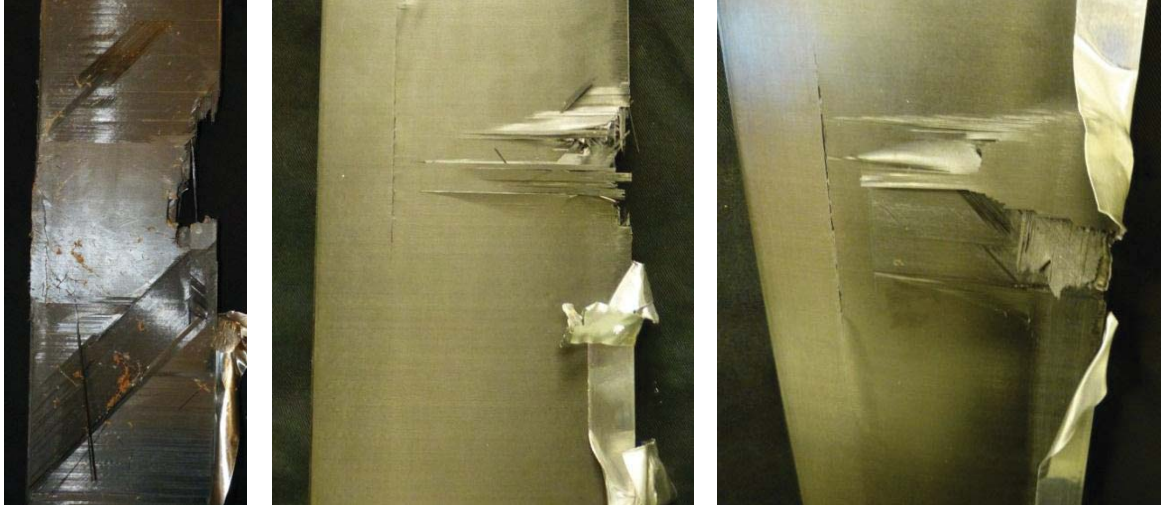
Figure 13 (a) Delamination and break out of C001, (b) leading edge of C002, and (c) broken out section of C003

The first test samples, C001-C002, were fabricated with the A1 ply configuration  $[90/(-45/0/+45/0)_3/0_{12}]_s$ . C001 received the most significant damage on impact- with some of the damage attributed to the test set-up. On impact testing, sample C001 broke where it was clamped in the fixture, as shown in Figure 13a. The damage at the clamp was attributed to the gelatin projectile driving into the space between the blade and the securing clamp, increasing pressure at the clamp and resulting in failure. Additional damage included peeling of the aluminum tape leading edge protection at the impact site. As a result, a section of the leading edge was fully broken out. As a result of the leading edge protection failure, the 90° outer plies delaminated from the leading edge of the blade and were sheared off.

Based on the results of the C001 impact test, the C002 set-up was modified to reduce pressure build-up at the clamp site by including a clay ramp to distribute the load of the projectile. The results of this minor change had a significant effect on the test results. C002 did not fail at the clamp, although a fracture line was apparent, and leading edge damage was limited to localized delamination at the impact site, Figure 13b. The aluminum tape leading edge protection again peeled off on impact; however there was no global surface delamination of the outer 90° plies; as seen in the C001 test article.

The third composite blade, C003, was fabricated with the A2 lay-up pattern, to decrease the possibility of shearing at the clamp. The A2 ply configuration  $[90/(-45/0/+45/0)_3/0_3/(90/0)_3/0_3]_s$  has added 90° plies at the root of the blade in an effort to strengthen this region and minimize damage at the clamp site. Fracture in the region of the clamp was again visible, and significant damage to the leading edge is shown in Figure 13 (a) Delamination and break out of C001, (b) leading edge of C002, and (c) the broken out section of C003.

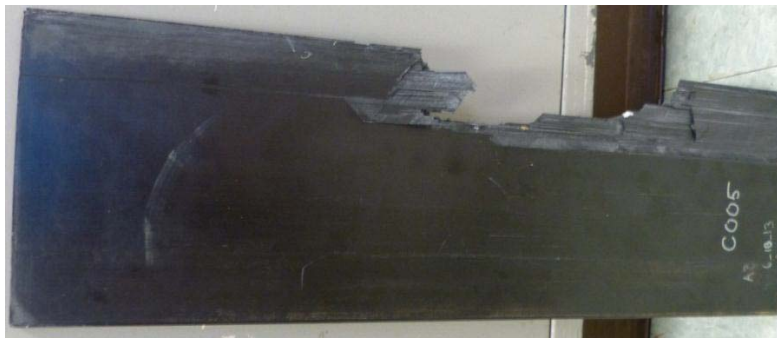
Figure 14. C005 Impact Damage

The C005 test article was fabricated with an A3 lay-up,  $[(0/-45/0/+45)_6/0]_s$ , with accordion style 'A' type ply drops. The general randomness of the ply drops resulted in an uneven mixture of  $+45^\circ$ s and  $-45^\circ$ s at ply drops. As a result, this test article had significant damage, including a broken out section at the leading edge measuring approximately 17.8 cm (7 in) by 3.8 cm (1.5 in), Figure . It was speculated that the leading edge section on the concave side of the blade failed at the outer major ply drop. The fracture location coincided with an uneven mixture of  $+45^\circ$  and  $-45^\circ$  plies; potentially compounding the damage. Following the initial impact, reflection of flexural waves traveling in the 45.7 cm (18 in) direction caused the leading edge material to peel away.

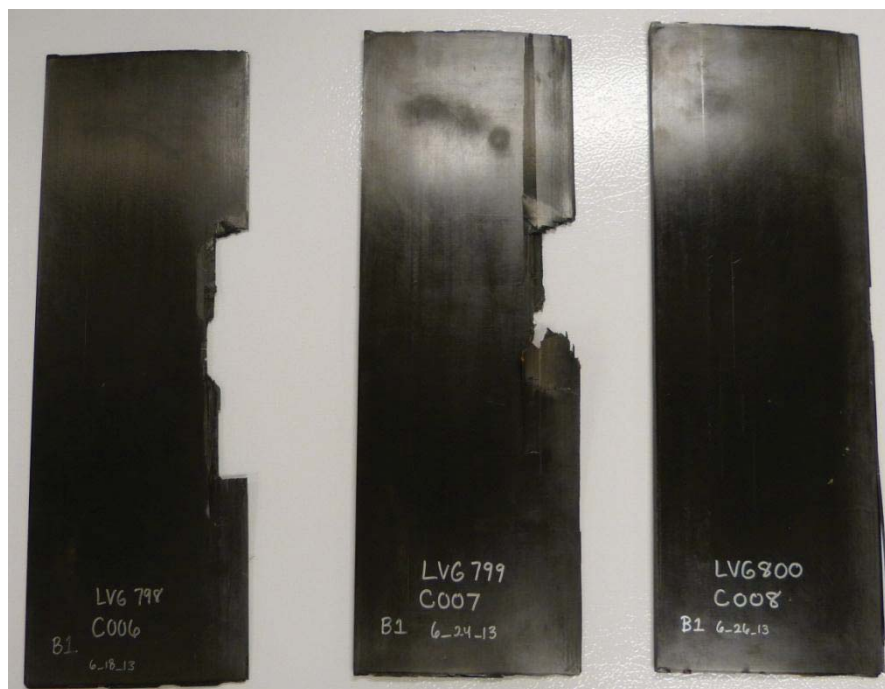
Figure 15. C006, C007, and C008 after impact

The ply configuration and ply drop pattern of articles C006-C008 are described by the B1 lay-up;  $[(0/-45/0/+45)_6/0]_s$ , and repeating 'B' pattern ply drops. Still, significant damage resulted on C006: a broken out section of 2.5 cm (1 in) by 17.8 cm (7 in) at the leading edge is shown in Figure . There was no global delamination in the blade only localized damage surrounding the broken out section and at the leading edge free corners. As in C005, the leading edge protection peeled off on testing. C006 served as a baseline compared to blades C007 and C008.

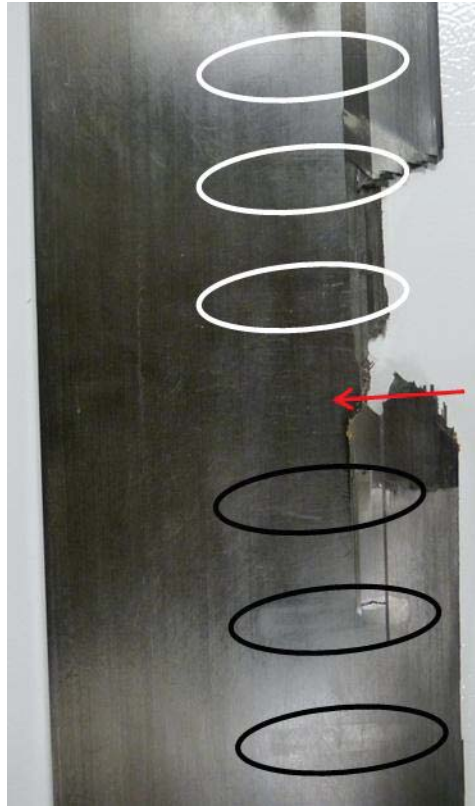
Figure 16. Close up of C007 impact zone, impact location shown by red arrow, SMA strips with TPU indicated by black ovals, plain SMA strips indicated by white ovals

Test blade C007 was fabricated to contain six strips of SMA ribbon. The ribbon was inserted into cut-outs from the carbon fiber. Three strips were inserted just below the impact site, and three strips inserted just above the impact site (Figure 16, impact location shown with red arrow). For comparison, the strips below the impact side included a piece of the TPU veil (Figure 16, indicated by black ovals); as described in the experimental section. Leading edge damage was noted in this sample on impact; as shown in Figure 16. The section of broken-out composite measured 3.8 cm (1.5 in) by 7.6 cm (3 in) and visible propagation of damage was observed on the upper section of the blade where SMA had been inserted without TPU veil. The lower SMA pieces which were surrounded by veil. In this blade visible damage stopped near the second SMA ribbon.

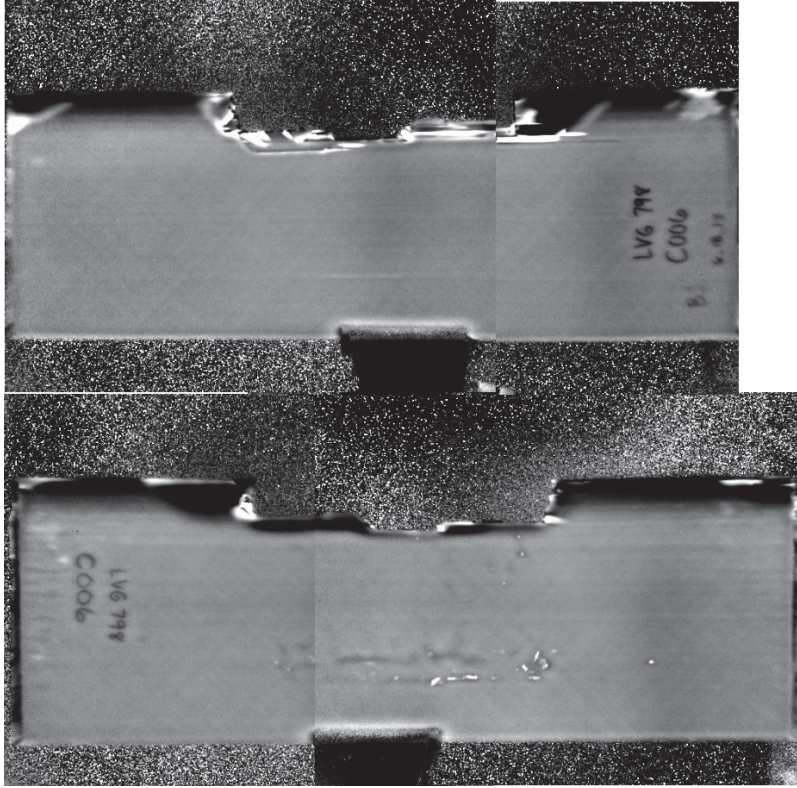
Figure 17a. Thermography images of the baseline composite blade. Upper image corresponds to the back surface and the lower image corresponds to the front surface.

The thermal image in Figure 17a shows damage to the baseline blade was limited to break-out at the impact site. The dark area along the leading edge is an artifact of the test, due to the thinness of the blade at the leading edge. Similar damage is seen within the SMA incorporated blade (Figure 17b), where impact energy was again absorbed at the impact site, leading to material loss. The image shows retention of material on the side of the impact closest to the SMA covered with toughening material. Additional work is necessary to assess the contribution (if any) of the thermoplastic veil to that material retention. In the toughened blade the leading edge maintained its integrity, allowing more energy to be transferred into the blade, resulting in greater overall deformation in the form of large oscillatory flexing. The increased bending of the blade in board of the impact location appeared to result in some delamination just beyond the placement of the toughening veil, as evidenced by the thermal image of the toughened blade (Figure 17c). Increased flexing and bending was observed in the toughened blade, relative to the baseline, in high speed videos of the experiments. As a result, the mid-blade delamination appeared to only occur in the ‘toughened’ blade.

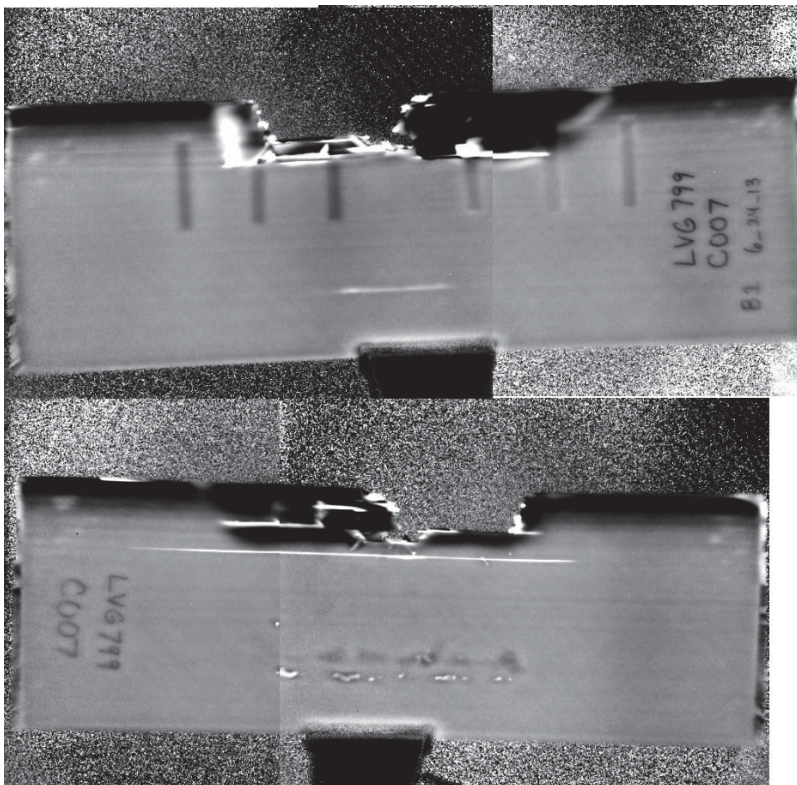
Figure 17b. Thermography images of the SMA incorporated blade. Upper image corresponds to the back surface and the lower image corresponds to the front surface.

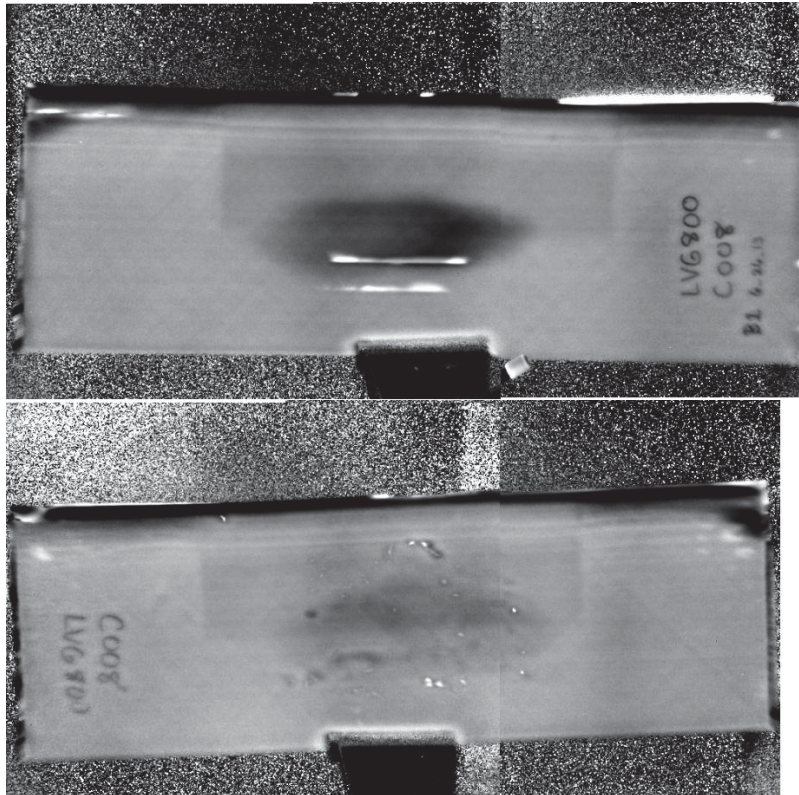
Figure 17c. Thermography images of the thermoplastic veil incorporated blade. Upper image corresponds to the back surface and the lower image corresponds to the front surface.
