# Real time fatigue damage growth assessment of a composite three-stringer panel using passive thermography

## ABSTRACT

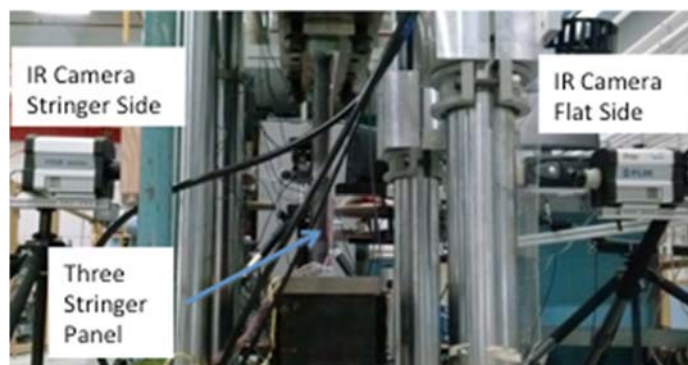
Figure 2. Three-stringer panel setup for passive thermography inspection of both flat and stringer sides.

The thermal measurement setup is shown in Figure 2. The basic system consists of two infrared (IR) cameras operating in the 3–5 micrometer infrared band and an image data acquisition computer. The infrared cameras were configured

with 25 mm germanium optics. The focal plane array sizes for the cameras were from 640x512 to 1024x1204. The passive inspection captured the thermal variations during the fatigue loading. The setup required a Plexiglas® shield to contain fragments if ultimate failure occurred. The IR cameras were located behind the shield with the lens positioned in front of a viewing hole. The added benefit of the shield is it also filters out spurious IR background sources. The cameras were triggered externally using the load signal from the test machine. The sinusoidal load signal was offset corrected and the zero crossover points were used to produce a TTL trigger signal. The trigger signal was converted to a series of pulses using a pulse generator. The infrared cameras were operated at a frequency range of 16 to 90 Hz depending on acquisition time duration. Higher frequencies were used to capture the damage progression as the panel approached ultimate failure. The image data are displayed in real time and stored directly to a hard drive with minimal frames dropped. This provides the capability to acquire frames for an extended period of time (hours if required).
