Atomic Force Microscope Observation of Growth and Defects on As-Grown (111) 3C-SiC Mesa Surfaces

Philip G. Neudeck, Andrew J. Trunek¹, and J. Anthony Powell²

NASA Glenn Research Center,

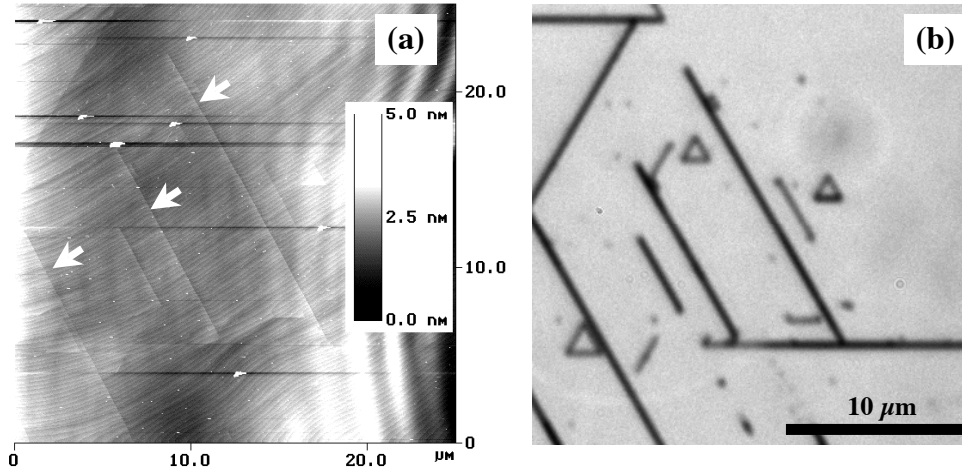
Fig. 1: Stacking faults on a defectively grown 3C-SiC heterofilm surface revealed by (a) AFM of as-grown surface and (b) post-oxidation optical micrograph.

We have previously reported that SD's threading a 4H-SiC substrate mesa subsequently result in a defective 3C heterofilm, and that the presence of SF defects can greatly enhance 3C heterofilm growth rate [1-3,5]. Fig. 1a shows an AFM of a small region of the as-grown epitaxial surface of a defective 3C-SiC film grown on a 4H mesa threaded by a SD on Sample 1. A pattern of 0.25 nm height steps generally flows from the upper left corner with downstep direction toward the lower right of the Fig. 1a AFM image. Superimposed on the 0.25 nm step pattern are a series of line features (some denoted by arrows in Fig. 1a), most of which are sub-0.25 nm (i.e., sub-bilayer) height perturbations in the surface. Fig. 1b shows an optical micrograph of the same region following over 5 hours of dry thermal oxidation. The dark lines visible in Fig. 1b are well known to arise from enhanced oxidation that occurs where SF's intersect the surface of a 3C-SiC film [8]. Given the exact correspondence of the pattern of linear features in Figs. 1a and 1b, we conclude that SF's can be observed by AFM on as-grown 3C-SiC films. SF features were also observed by AFM on additional samples, including some Sample 2 mesas.

The vast majority of steps observed by AFM on as-grown 3C surfaces were 0.25 nm (i.e., a single Si-C bilayer) in height. Macrosteps were occasionally observed on mesas with SF defects. Most macrosteps formed when 0.25 nm 3C growth steps piled-up along a SF. An example of such pileup can be seen in Fig. 3b of [5]. However, most SF's, including those shown in Fig. 1, did not produce macrosteps. Because growth steps in Fig. 1a flow across the SF's, instead of

emanating outward from the SF's, we conclude that the faults shown in Fig. 1 are not a primary nucleation source of new bilayers on this 3C-SiC mesa surface. However, it is worth noting that we have observed enhanced inward growth of new bilayers from mesa edges for some instances where SF's intersect the sidewall edge of a 3C mesa [5]. Given the variety of behaviors noted above, further studies are clearly necessary for better understanding of SF's in the 3C-SiC film growth process. It is important to note that the majority of 3C-SiC heterofilms grown by step-free surface heteroepitaxy (on SD-free 4H/6H mesas) are free of SF-defects [1-4].

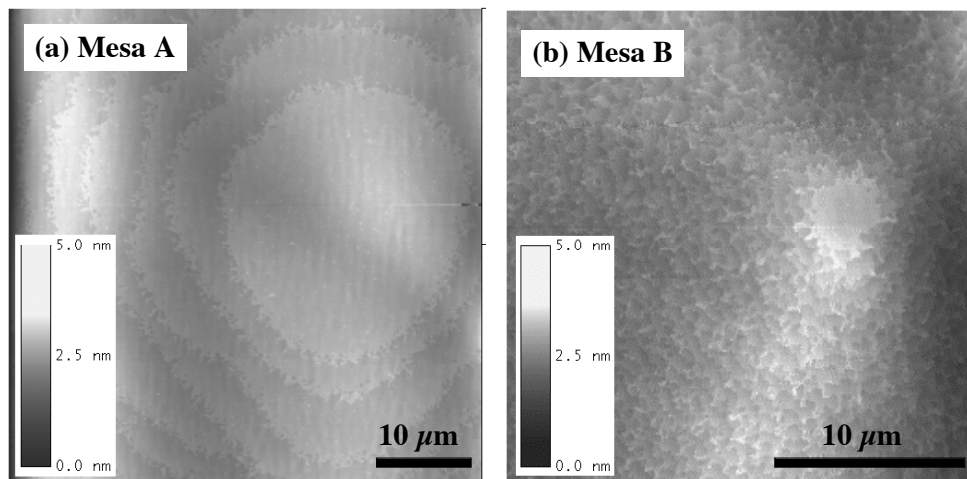
Fig. 2: AFM scans showing the topmost terraces from nearby (a) Mesa A and (b) Mesa B on the same wafer following higher supersaturation growth Run 2A. Both step patterns consist of concentric steps with jagged edges, but the step density is close to 10X greater for Mesa B.

AFM measurements revealed significant differences in step structure between growth under higher and lower supersaturation conditions. Fig. 2 shows two examples of step structure observed on nearby mesas (Mesa A and Mesa B) after higher supersaturation Run 2A. Both step patterns have very rough edges and are generally concentric with the topmost terrace residing in the interior of the mesa shape. However, Mesa B clearly shows a much higher ($\sim 10X$) step density than Mesa A.

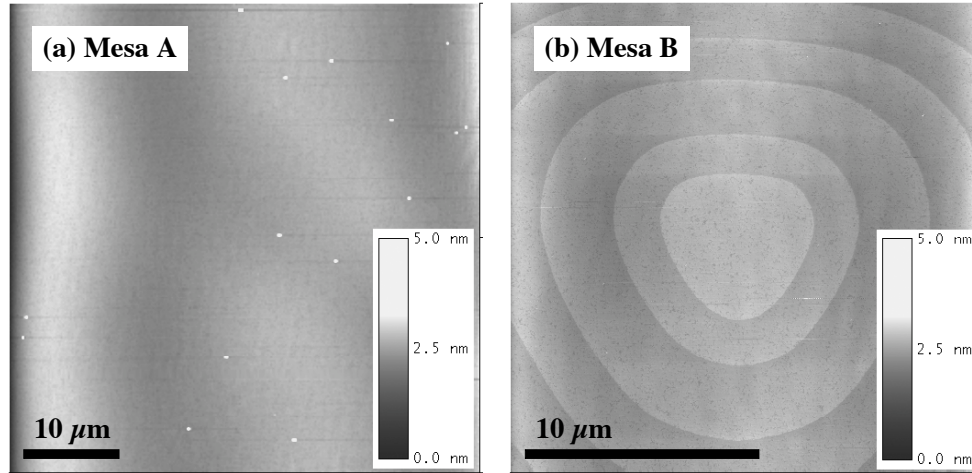
Fig. 3: AFM scans showing the same Mesa A and Mesa B of Fig. 2 following lower supersaturation growth Run 2B. No steps were detected anywhere on Mesa A. The concentric step pattern of Mesa B is consistent with bilayer growth by defect-assisted terrace nucleation.

Fig. 3 shows AFM scans of the same mesas following a short-duration low supersaturation growth Run 2B. As shown in Fig. 3a, no surface steps were detected on Mesa A. Thus, terrace nucleation was effectively suppressed, enabling the first reported formation of a step-free 3C-SiC mesa surface. In contrast, Mesa B (Fig. 3b) shows a well-ordered concentric pattern of 0.25 nm high steps. The concentric step pattern and higher step density of Fig. 3b is consistent with our previous observations of defect-assisted terrace nucleation on a very thin 3C-SiC growth surface [5]. We hypothesized that dislocations (threading edge) lower terrace nucleation energy leading to the observed concentric step pattern, but transmission electron microscopy (TEM) studies are not yet complete [4,5]. Most of the mesas observed at this stage were step-free (Fig. 3a), or exhibited far lower step density than shown in Fig. 3b.

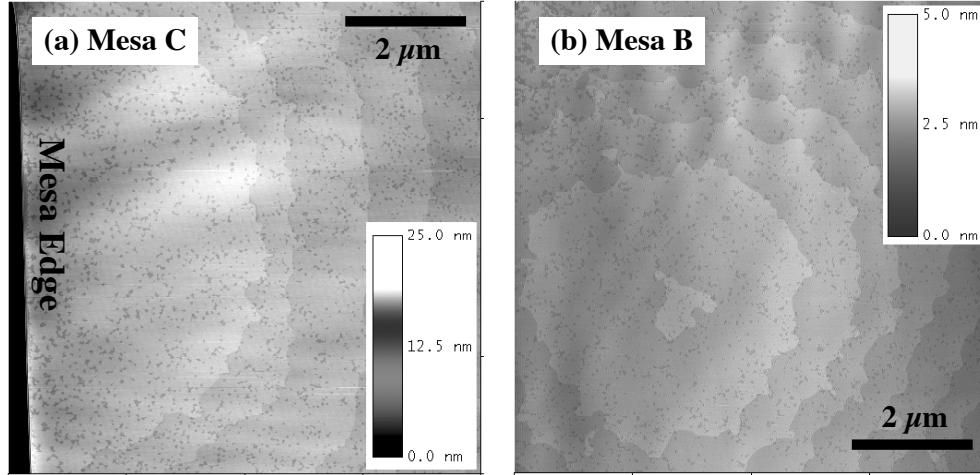
Fig 4: AFM scans showing the topmost terraces from two nearby mesas following higher supersaturation growth Run 2C. The topmost terrace shown in (a) on Mesa C emanates from the side edge of the mesa, whereas the topmost terrace shown in (b) on Mesa B arises in the interior presumably due to defect-assisted nucleation.

Following substantial additional growth under higher supersaturation conditions (Run 2C), a rough step structure was again observed (Fig. 4). Under higher supersaturation conditions, nuclei of larger size are more likely to form on terraces prior to joining the main stepfronts [9]. The higher reactant concentration should facilitate more rapid stepflow expansion of existing nuclei and steps. These factors would favor a much rougher observed “non-equilibrium” stepfront expansion, consistent with our observations. Growth at lower supersaturation, where terrace nucleation is effectively suppressed, maintains a much smoother “equilibrium” stepfront. Under these conditions, we surmise that mobile surface adatoms are able to diffuse to fill kink sites in the slower expanding stepfront, thereby enabling the smooth stepfront structure.

In a significant number of cases after Run 2C, the top of the step pattern was observed to originate from mesa edge regions. Fig. 4a (Mesa C) shows one example of this behavior. The observed trend for new bilayers to proceed inward from mesa edges on thicker 3C films suggests that enlarging 3C mesa sidewall facets may increasingly impact the evolution of thicker 3C crystals. An examination of the crystal structure of 3C-SiC reveals that all mesa sidewall/edge facets will have a higher percentage of surface carbon atoms than (the 0% of) the (111) silicon-face of the mesa top surface. The reported nucleation probability of carbon-terminated SiC surfaces is substantially higher than for silicon-terminated surfaces [9]. Therefore, we propose that growth of new 3C crystal material (i.e., nucleation of new bilayers) on mesa edge/sidewall facets should occur more readily than on the Si-face top surface. As 3C mesa film thickness increases, the area of 3C edge/sidewall facets increases. Thus, we believe that it is possible that

mesa edge/sidewall facet growth may begin to impact evolution of thicker 3C mesa crystals, even when edge/sidewall facets have much smaller surface areas than the mesa top. Further studies are needed to experimentally verify or refute the proposed edge/sidewall growth model. In other cases, nucleation (and therefore the topmost observed terrace) takes place in the interior region of the mesa top surface. Fig. 4b shows the topmost terrace of Mesa B, so we surmise that nucleation is defect-assisted in this case.
