Dynamic Open-Rotor Composite Shield Impact Test Report

*Silvia Seng and Charles Frankenberger
Naval Air Warfare Center Weapons Division, China Lake, California*

*Charles R. Ruggeri, Duane M. Revilock, J. Michael Pereira, and Kelly S. Carney
Glenn Research Center, Cleveland, Ohio*

*William C. Emmerling
FAA William J. Hughes Technical Center, Atlantic City International Airport, New Jersey*

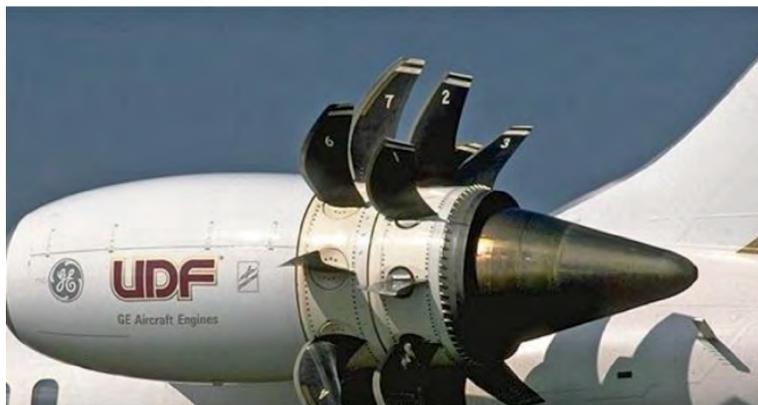
Figure 1.—General Electric (GE) unducted fan demonstrator.

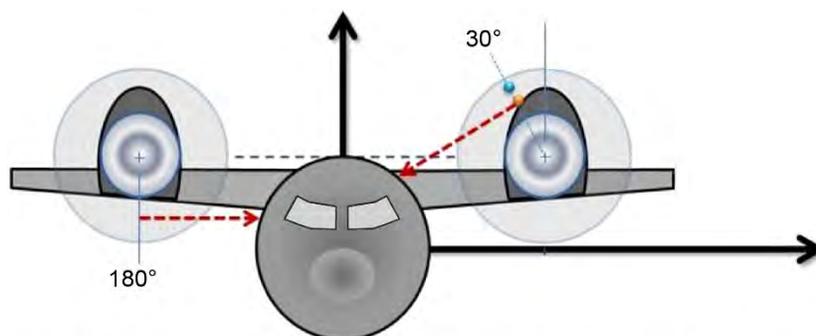
Figure 2.—Open-rotor wing-mounted engine configuration and NASA analysis impact locations.

The analysis was conducted in two parts. In the first part a trajectory analysis was conducted. The aircraft and engine geometries were modeled to determine what release angles would result in the worst-case impacts to the fuselage. The release angles providing a velocity vector perpendicular to the fuselage skin and having the highest impact velocity were found to be a release angle of 30° (blade rotating counterclockwise) or 180° from the top (blade rotating clockwise), as shown in Figure 2. The full details of the analysis are described in Reference 1.

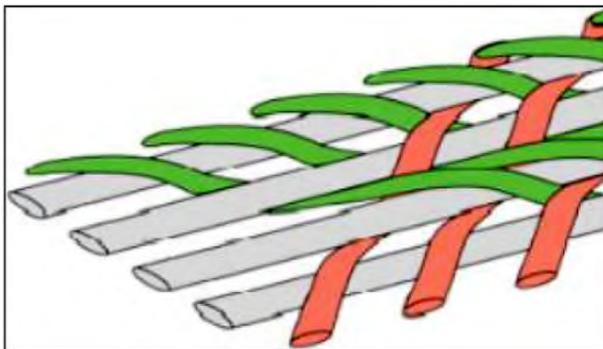
Figure 3.—Triaxial braid pattern of carbon fiber prepreg used for composite shields.

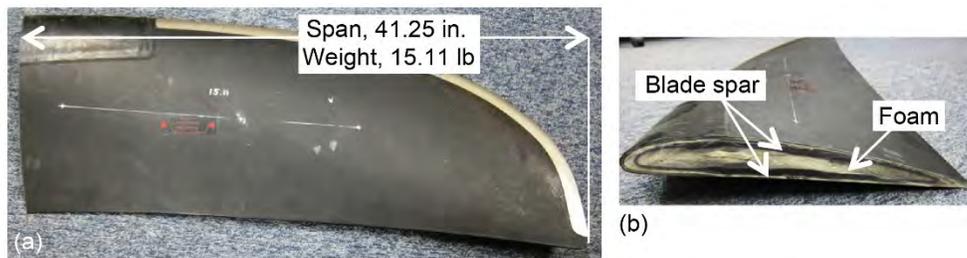
Figure 5.—Candidate blade configuration for shield impact. (a) Outer blade length and weight. (b) Blade cross section.

The blades used for this testing (see Figs. 4 and 5) were similar in design and materials to those that could be used for open-rotor engines. A modern propeller was used as the surrogate with the outer portion acting as the open-rotor fan blade-off simulation. The blades have a polyurethane foam core, sandwiched between carbon fiber spars, with composite reinforced skins. A thin strip of metal protects the leading edge from small, “nominal,” foreign object damage, such as small debris from unimproved runways (see Figs. 4 and 5).

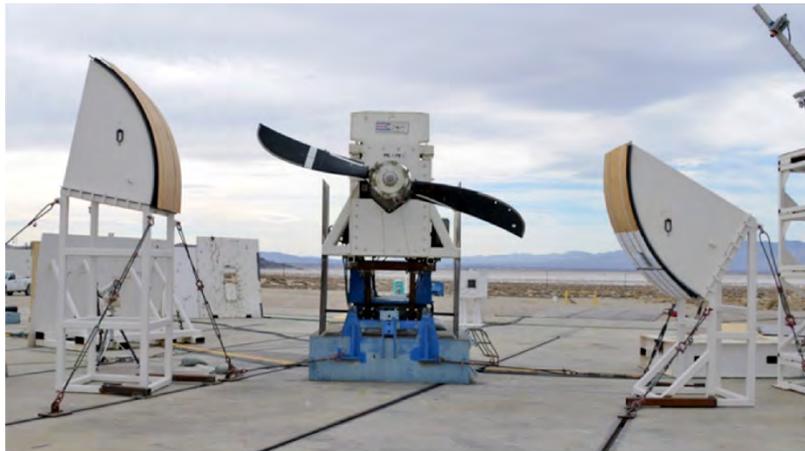
Figure 6.—Spin rig on T406 spin fixture.

A single test event was conducted. Two blades were mounted to the rotor hub and spin rig on the WSL spin fixture, shown in Figure 6. The spin fixture is a T406 engine and gearbox that are capable of providing the 1108 rpm speed required for this test. The two blades were explosively released at 8° past vertical. Two 4- by 8-ft composite panels were located approximately 124 in. from either side of the centerline of the spin fixture, so that they were centered on the predicted blade release trajectories. The fuselage structure was not represented.

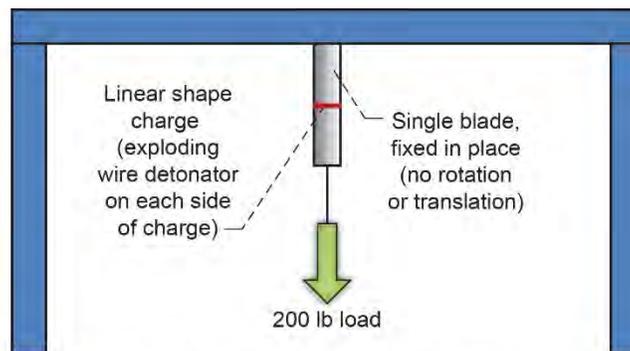
Figure 7.—Test setup to investigate effectiveness of linear shape charge.

A single blade was fixed to an overhead mounting structure (Fig. 7). The blade was not allowed to rotate. A weight was suspended from the end of the blade. The suspended weight was meant to encourage separation, but was much smaller than the centripetal forces on the blade at 1108 rpm (200 lb for the pretest investigation and over 26 000 lb estimated for the blade in motion).

A witness board was placed adjacent to the blade to represent the spin fixture. The damage to the witness board was used to evaluate the damage from the detonation of the linear shape charge. A 600 grain/ft linear shape charge was placed along the chord of one side of the rotor blade, closest to the

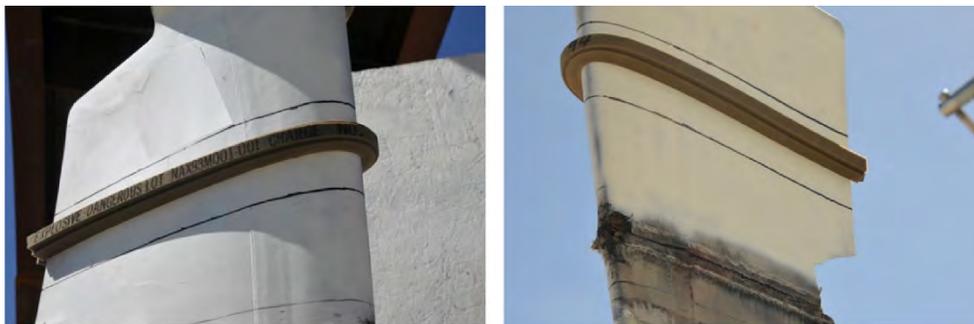
Figure 8.—Blade with shape charge around full circumference.

Because the shape charge did not completely sever the blade, the test was repeated with the shape charge cord around the full circumference of the blade (Fig. 8). The second test was performed on the same blade, several inches above the location of the first test. The blade was completely severed by the linear shape charge cord around the full circumference of the blade. The spars appeared to have visibly delaminated some on either side of the linear shape charge. A large piece of the blade trailing edge (aft of the carbon spars) separated from the remaining blade section; however, this appears to be a result of damage from the first test.

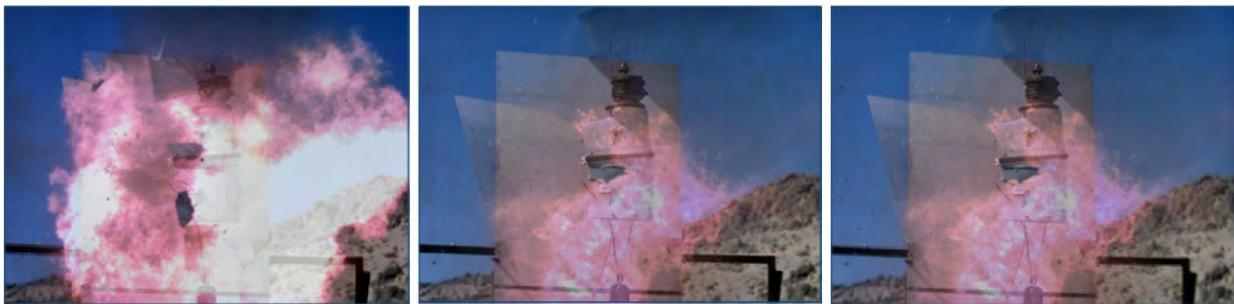
Figure 9.—Shape charge detonation, full-circumference configuration.

Test instrumentation was limited to one high-speed video camera, a safety video, and a firing line. The shape charge resulted in a significant fire ball, but it did not impart significant force on the blade. Figure 9 shows the blade root section rotating as a result of the blast, but does not propel the blade vertically. Likewise, the outer span of the blade merely falls away from the cut. Review of the severed blade section reveals a relatively clean cut with composite delamination reaching approximately 1 in. away from the cut line (Fig. 10).

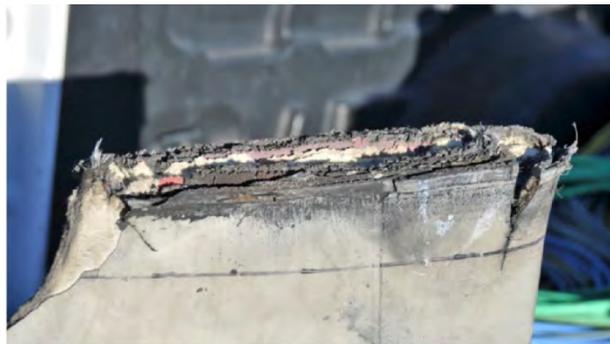
Figure 10.—Blade section at cut line.

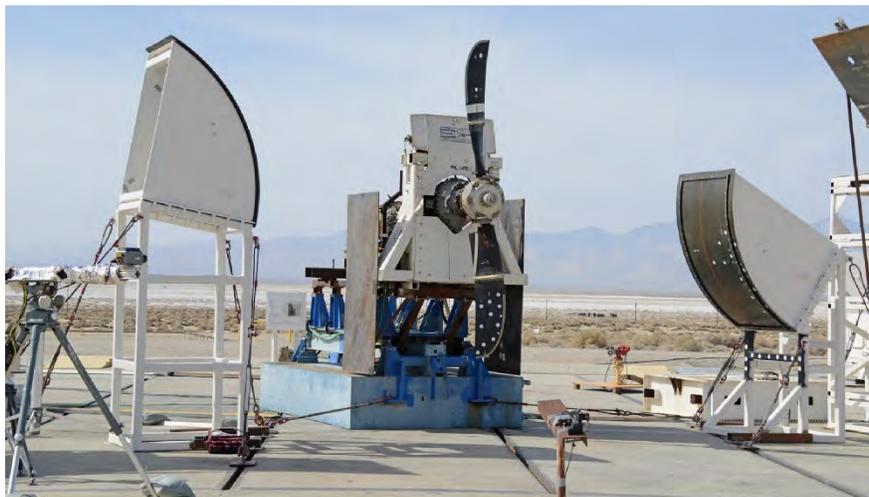
Figure 11.—Open-rotor fan blade-off test rig.

The T406 engine was mounted to the WSL engine test stand with the open-rotor fan blade-off test rig attached as shown in Figure 11.

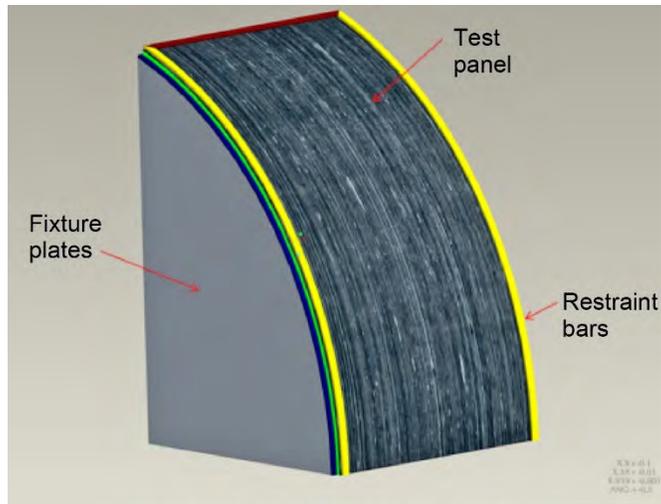
Figure 14.—Panel support fixture.

The panels were held in a test fixture that replicated the boundary conditions of the NASA analysis as shown in Figures 14 and 15. The panels were fixed in all three translation axes and simply supported on half-round bars that allowed the edges to rotate about the support frame interface (Fig. 15). The panels were restrained along all four edges utilizing 3/8-in. bolts, spaced approximately every 4 in. around the frame, and tightened down with sufficient force to restrain the panel in the translation axis. A rubber gasket was inserted between the restraint bars and the composite panels to minimize stress concentrations in the panels.

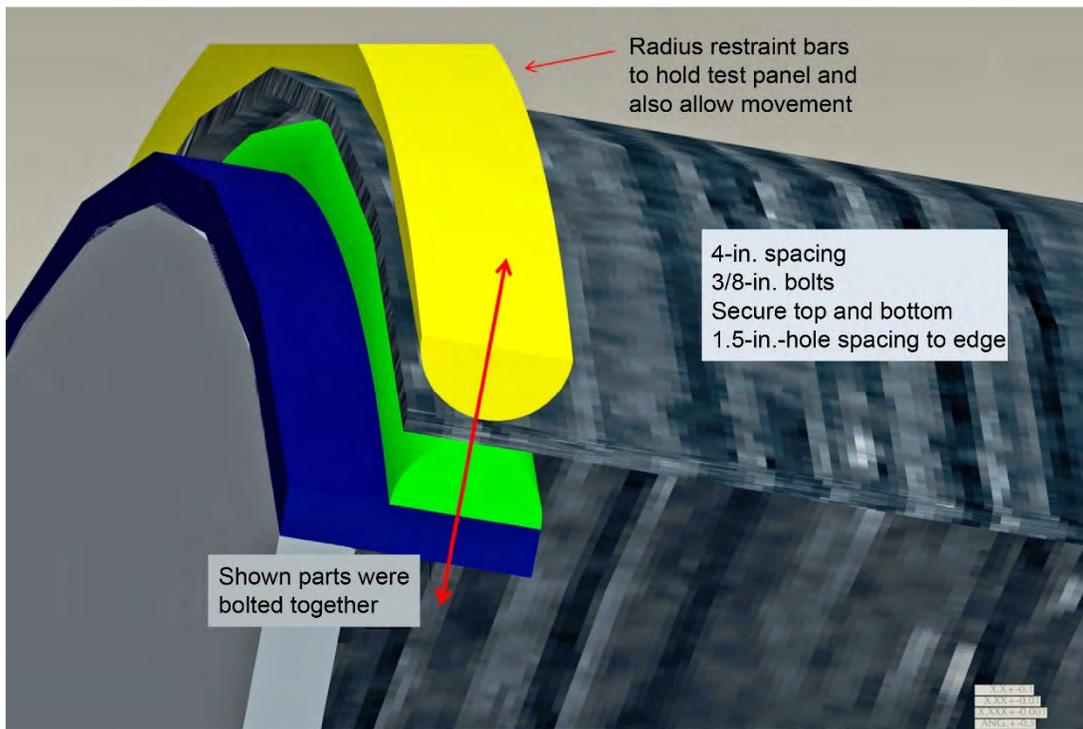
Figure 15.—Panel attachment concept.

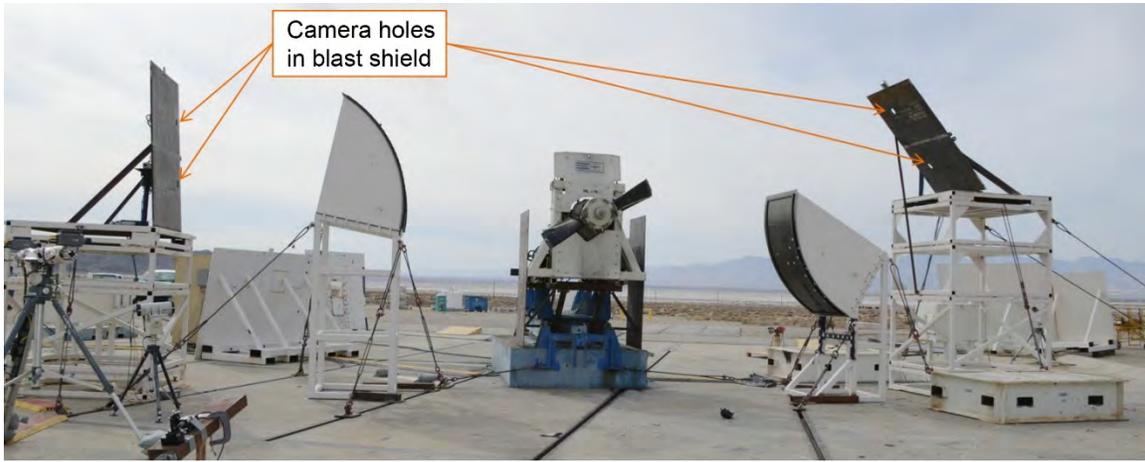
Figure 18.—High-speed camera locations for digital image correlation; four cameras, two per panel.

The six cameras provided by NASA were operated in pairs. Two cameras were placed behind each test panel to record the blade impact. The third camera pair was placed forward of the test fixture, looking aft, to capture the release of the blade and impact on the composite panel. The cameras were located behind steel blast shields to protect them from debris from the impact of the blade into the panels. Lighting was provided to illuminate the fuselage panels to ensure the maximum frame rate and desired shutter speeds could be achieved. The cameras were placed in fixed positions and calibrated to provide the DIC. The DIC software was used to process video images from which the displacement of the panel was calculated.

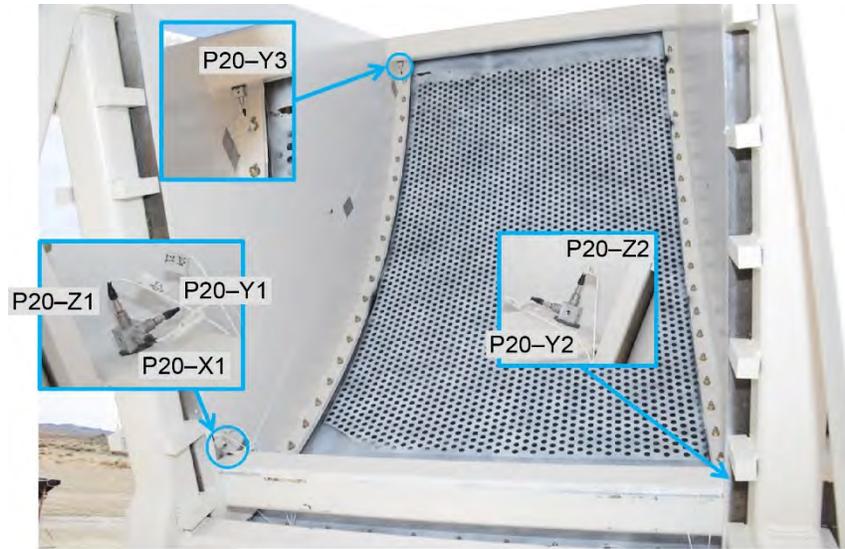
Figure 19.—20-ply panel accelerometer locations.

The accelerometers were installed in the same locations and orientations on each panel support structure; their locations on the 20- and 24-ply panels are shown in Figures 19 and 20, respectively. For each panel, three accelerometers were placed in the lower left corner of the frame (viewed from the concave side of the panel): (1) P20–X1 and P24–X1 for the 20- and 24-ply panels, respectively, are aligned with the fuselage (“x-axis”); (2) P20–Y1 and P24–Y1 are aligned in the tangential (“y-axis”) orientation; and (3) P20–Z1 and P24–Z1 are aligned in the radial (“z-axis”) orientation. Two accelerometers were placed in the lower right corner of the panels (viewed from the concave side of the panel): (1) P20–Y2 and P24–Y2 aligned in the tangential orientation and (2) P20–Z2 and P24–Z2 aligned in the radial orientation. Finally, one accelerometer was placed in the upper left corner: P20–Y3 and P24–Y3 aligned in a near-tangential orientation, as shown in Figure 21. The accelerometers were used to collect backup data to compare with the NASA analysis data. The accelerometer data are presented in Appendix C.

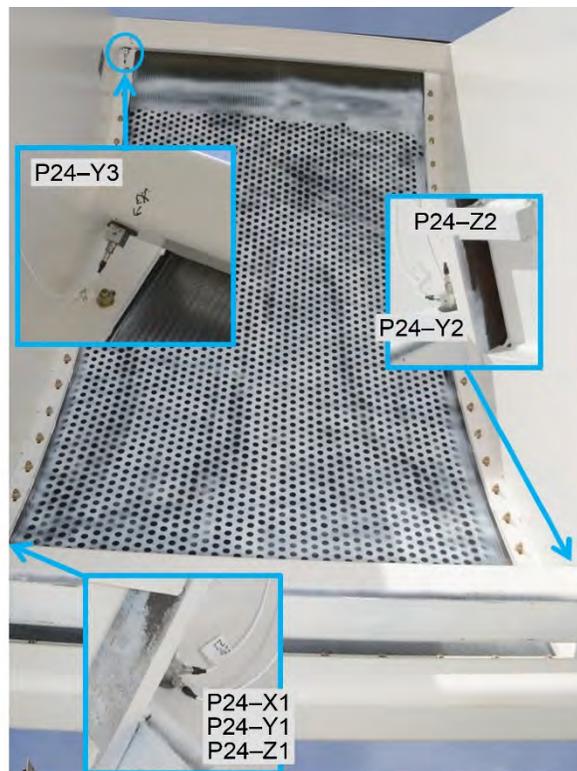
Figure 20.—24-ply panel accelerometer locations.

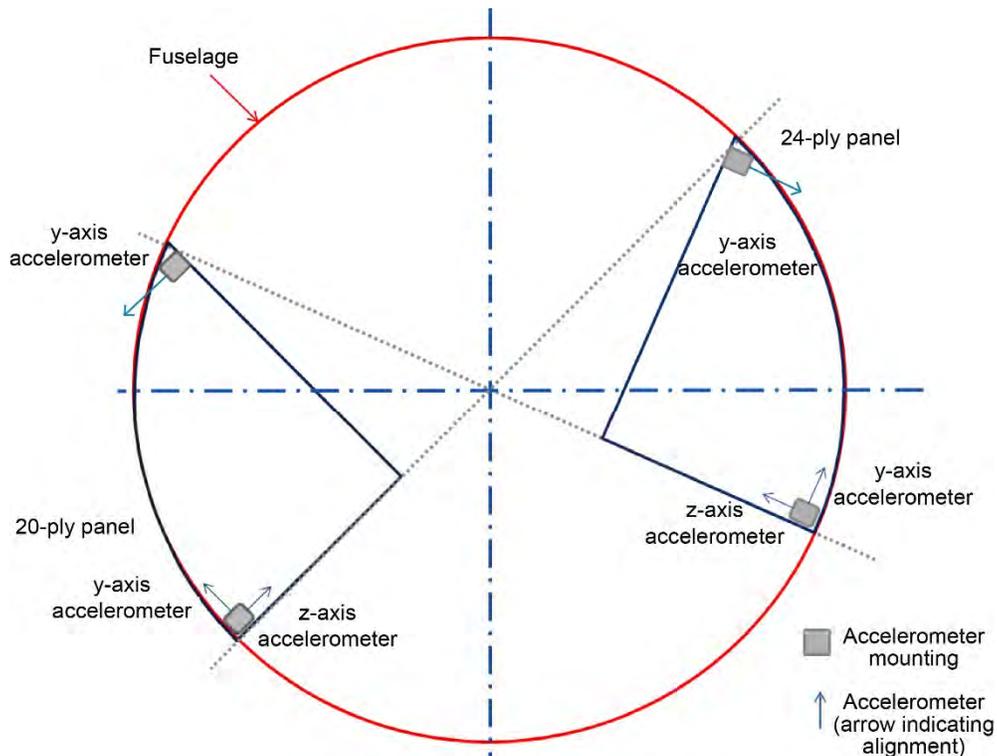
Figure 21.—Accelerometer orientation (not to scale).

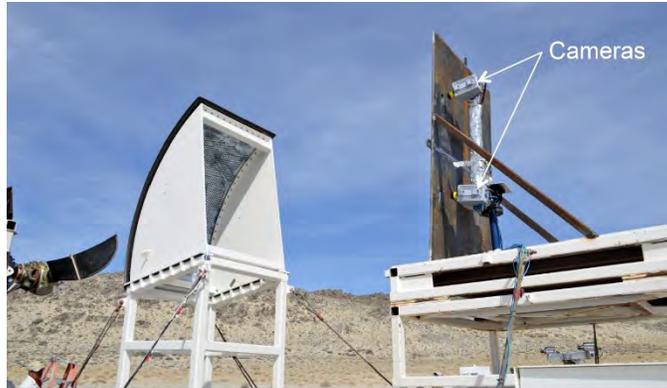
Figure 22.—Photogrammetry camera setup for 24-ply panel.

Three pairs of high-speed digital video cameras were used to quantitatively measure the full-field deflection of the back side of each test panel as well as the kinematics of one of the released fan blades. The commercial DIC software ARAMIS (GOM mbH, Germany) was used to compute the three-dimensional panel deflections and in-plane strains based on images obtained from a calibrated pair of cameras focused on the back side of each panel. The panels were painted with 0.625-in.-diameter black dots, on 1-in. centers, on a white background. For the 20-ply panel a pair of Photron model SA5 cameras (Photron USA, San Diego, CA) were mounted on a tripod behind the panel in such a way that the whole panel was visible. These cameras had a resolution of 832 pixels along the length of the panel and 600 pixels across the width, a frame rate of 15000 frames/s and an aperture time of 1/59000 s. For the 24-ply panel, a pair of Photron model SA1.1 cameras was used, in a similar configuration. The camera resolution along the length of the panel was 704 pixels and 448 pixels across the width. The frame rate was 18000 frames/s and the aperture time was 1/49000 s. The system used on the 24-ply panel is shown in Figure 22.

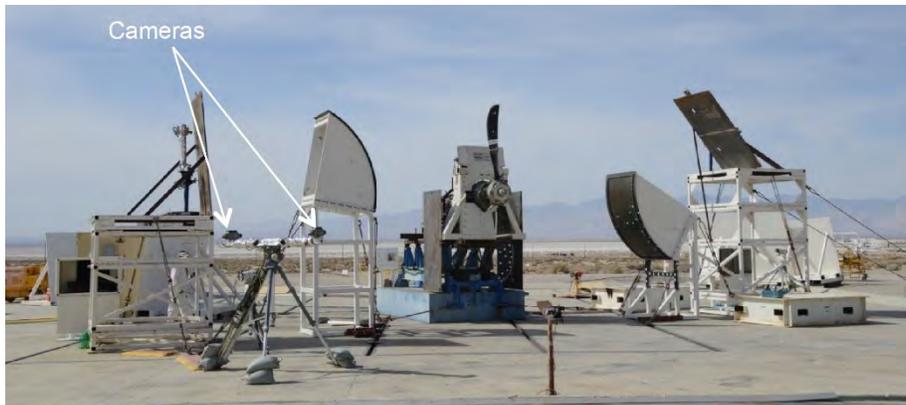
Figure 23.—Cameras used to measure blade kinematics.

To measure the kinematics of the blade impacting the 20-ply panel, the commercial software PONTOS (GOM mbH, Germany) was used in conjunction with a pair of Phantom V7.3 cameras (Vision Research Inc.). The camera pair was mounted forward and to the right of the engine axis viewing the area from the blade release to the panel impact. These cameras had a frame rate of 12500 frames/s, a horizontal resolution of 768 pixels, a vertical resolution of 504 pixels, and an exposure time of 20 μ s. Figure 23 shows the camera pair location relative to the test hardware and Figure 24 shows a representative frame from the video after blade release and prior to impact. The white dots on the blade and the test article were individually tracked in order to obtain blade linear and angular velocity during the test. However, because of the large amount of light generated from the explosive charges used to release the fan blades and the resulting overexposure of the images, only a portion of the free flight of the blade segment could be tracked.

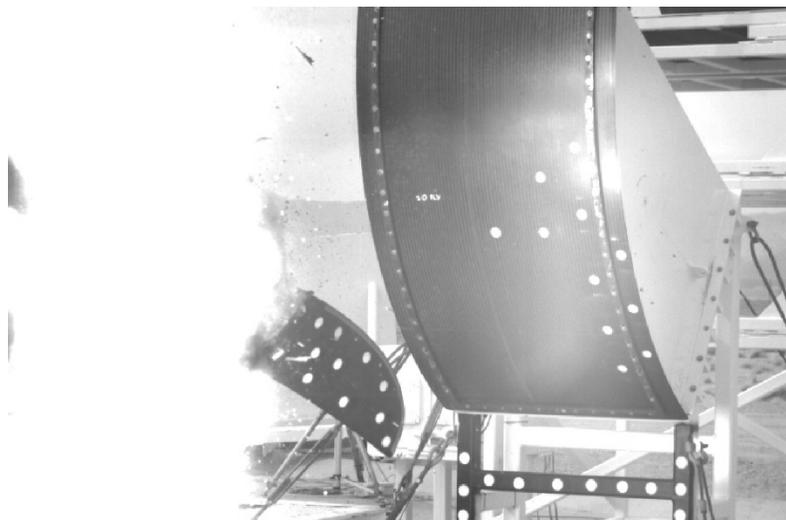
Figure 24.—Still image from one video camera used to track blade.

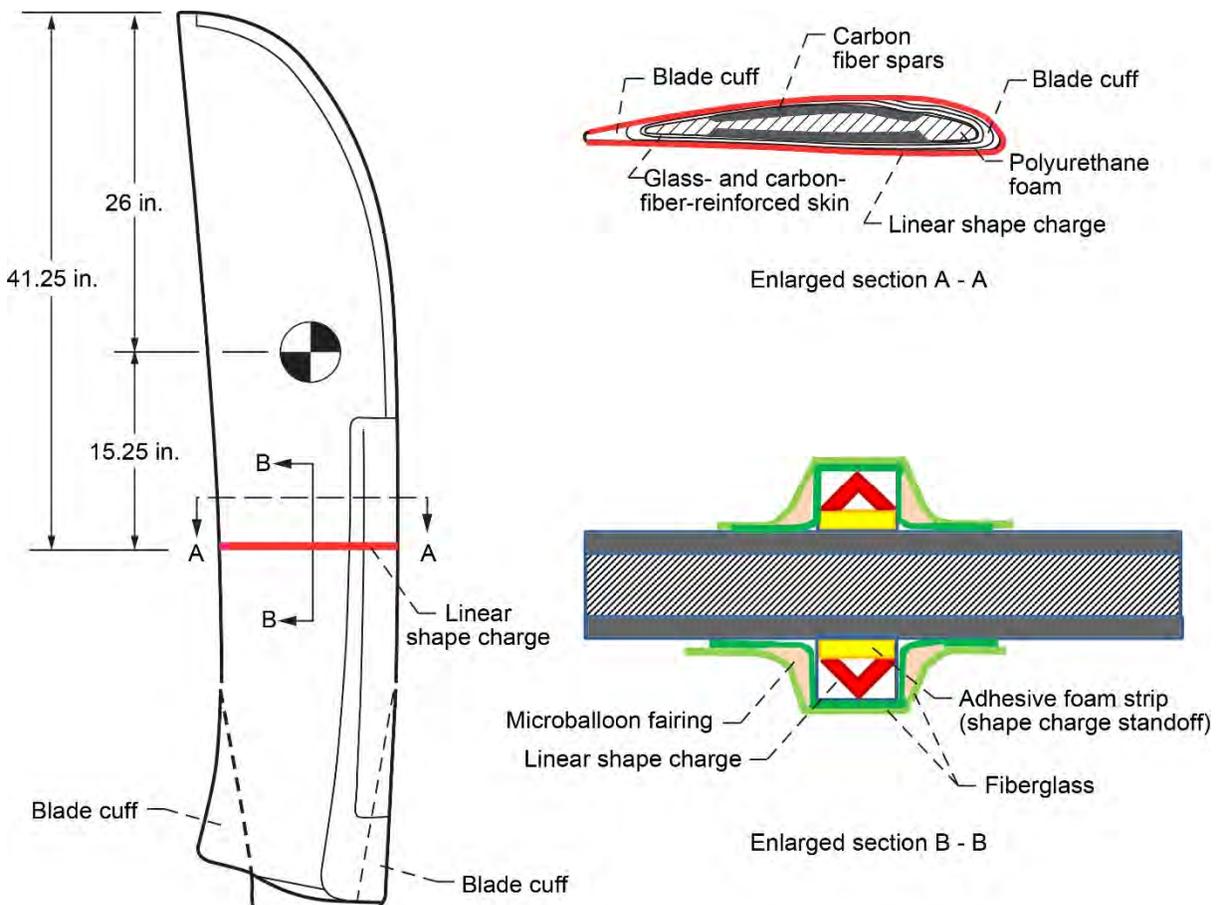
Figure 26.—Shape charge installation and released blade dimensions.

Placement of the shape charge is indicated in Figure 26. Exploding-wire detonators were placed on either end of each linear shape charge. The two detonators provided redundancy, allowing the full length of the explosive to fire if any single wire had broken or if there had been a discontinuity in the linear shape charge.

The linear shape charge has a foam adhesive strip to provide the proper standoff distance to the material to be cut. To attach the shape charge more securely to the blade, a layer of fiberglass was placed over the shape charge. Additionally, microballoon filler was used to provide support, and a second layer of fiberglass was applied (Figs. 26 and 27).

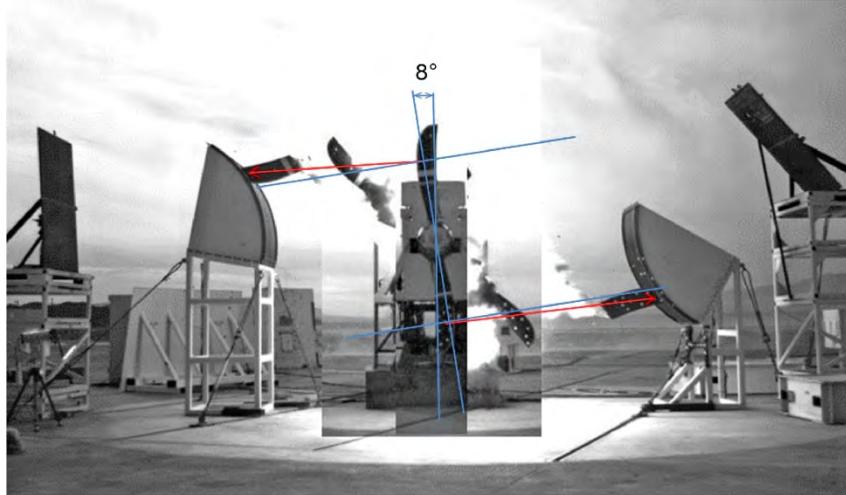
Figure 28.—Blade release with release angles.

Figure 28 shows a composite photograph of the release of the blades just before shape-charge detonation, just after the shape charges were fired, and at first impact of the blades against the composite panels. The upper blade impacted the 24-ply panel and resulted in cracks, but no penetration. The lower blade impacted the 20-ply panel and, as predicted, penetrated the panel. The test results showed good correlation to the NASA analysis.

Testing was conducted on February 20, 2014. All facility systems functioned nominally, and the blades were released as intended, at 8° past vertical (Fig. 28). The test conditions are noted in Table IV. The blades separated as intended and struck the composite test panels.

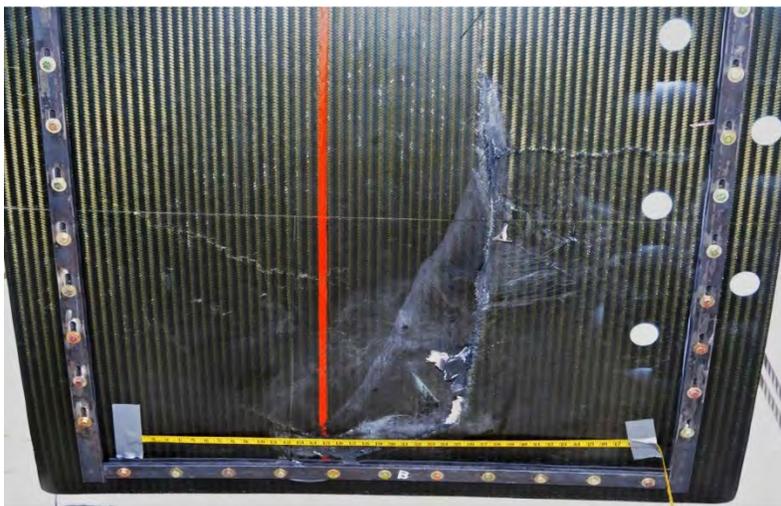
Figure 30.—20-ply composite panel postimpact damage, front side.

The release angle of the lower blade was 188°. The blade released cleanly from the hub and rotated about the CG of the released fragment. The trajectory of the blade was approximately 4° above horizontal. The blade impacted tip first, with the length of the blade along the velocity vector. The blade caused a large tear in the panel, approximately 45 in. vertically and 12 in. horizontally, and penetrated completely (Figs. 30 to 33). Two additional horizontal cracks, visible in Figure 30, caused delamination but did not penetrate the full thickness of the composite. After passing through the panel, the blade impacted the mount frame and deflected upwards from the test panel mounting fixture. Upon recovery of the blade on the test pad, the tip was missing and the residual length of the blade was only 36 in. (Fig. 34).

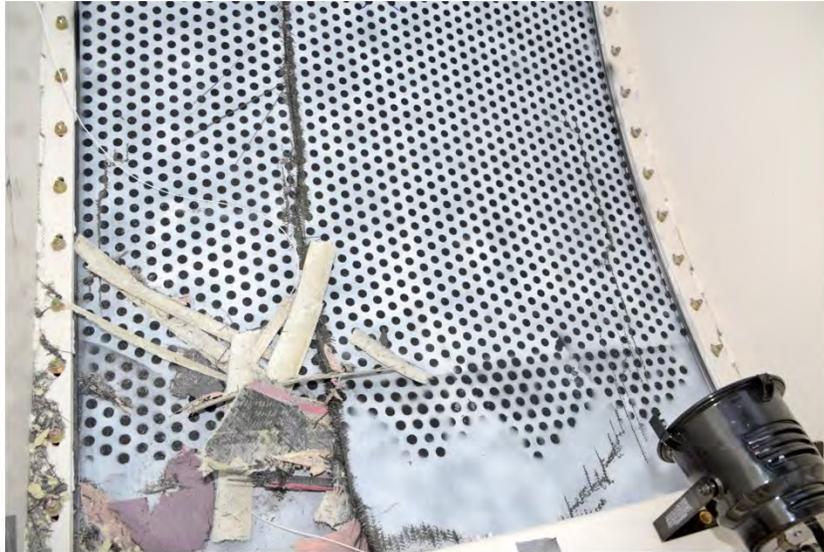
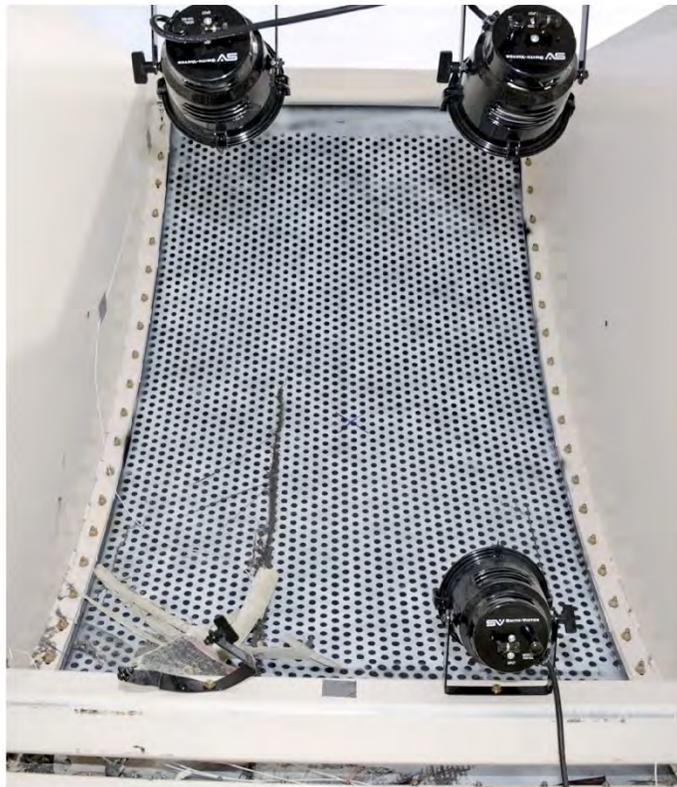
Figure 31.—20-ply composite panel, back side. (a) Lower right corner. (b) Full panel.

The back side of the panel had a matching crack vertically but had additional vertical and horizontal cracks along the bottom of the panel and up both sides of the panel that did not penetrate the full thickness of the panel (see Figs. 31 and 33).

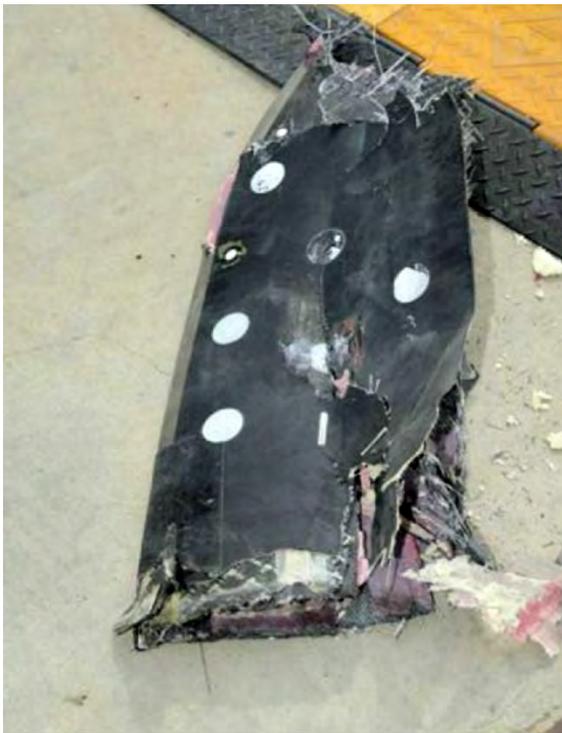
Figure 34.—Lower blade after penetration of 20-ply composite panel.

The residual velocity of the blade after penetration of the panel was not determined because of the limited view of the back side of the composite panel. The tip of the blade was missing. The trailing edge was also damaged, but it is unknown at what point this damage occurred: upon impact with the panel or subsequent impacts with the lighting frame or the test pad. Material from the blade was wedged into the crack in the panel and was removed prior to NDI.

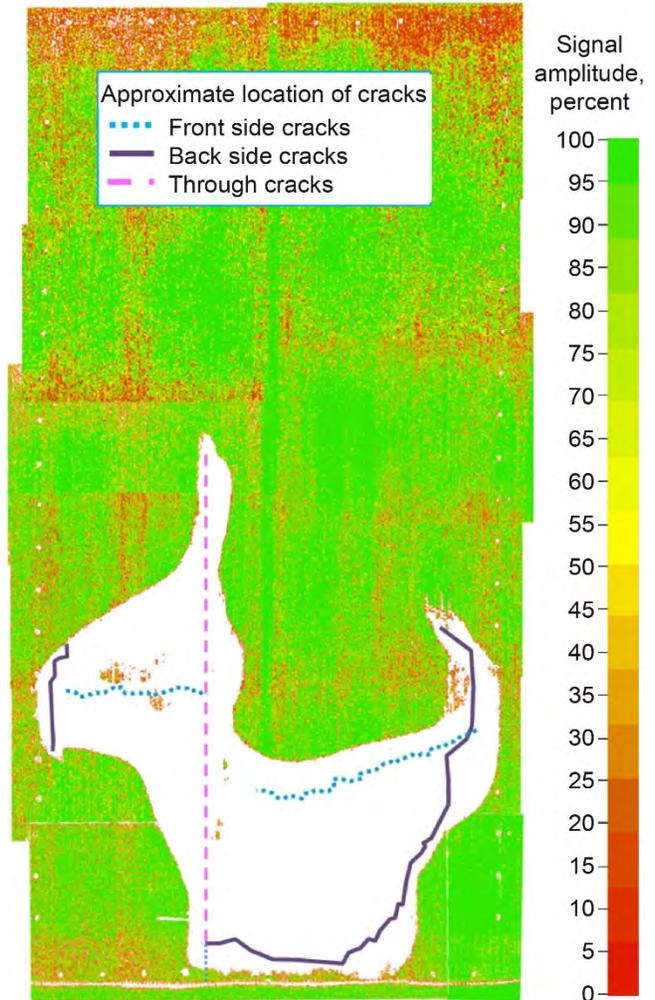
Figure 35.—Posttest ultrasonic nondestructive inspection of 20-ply composite panel, back side.

Ultrasound nondestructive inspection (NDI) of the 20-ply composite panel, shown in Figure 35, indicates a large area of delamination. The signal transmission scale is shown with the figure. No transmission at all (indicating delamination) is shown as white. The red dots throughout the green background are noise and are not indicative of damage. The small white holes along the border of the scan are the bolt holes for mounting the panel to the test fixture. The large white area on the scan indicates a large area of delamination, which corresponds to the visible cracks in the composite panel. The small patches of signal transmission within the large delaminated area may indicate partial damage or “kissing disbands”; however, this could not be determined from the ultrasound NDI. A thin line just below the bottom attachment of the panel to the fixture may indicate damage due to the mounting structure. A thin white line protruding from the lower left area of the delaminated area was caused by a thin piece of material protruding from the crack, which blocked transmission of the signal, not a delamination.

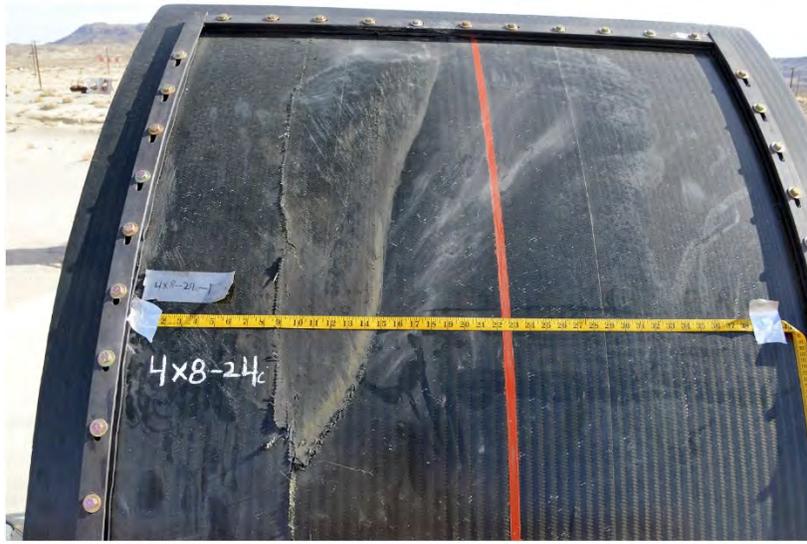
Figure 36.—24-ply composite panel postimpact damage, front side.

The release angle of the upper blade was 8° . The blade released cleanly from the hub and rotated about the CG of the released fragment. The trajectory of the blade was approximately 4° below horizontal. The blade impacted tip first, with the length of the blade aligned with the velocity vector. The blade caused tears on both the front and back of the panel, but the tears were not aligned with one another and did not penetrate the panel completely. The damage to the composite panel is shown in Figures 36 to 39. Tears on the front side are visible in Figure 36, and tears on the back side are indicated by the arrows in Figure 37.

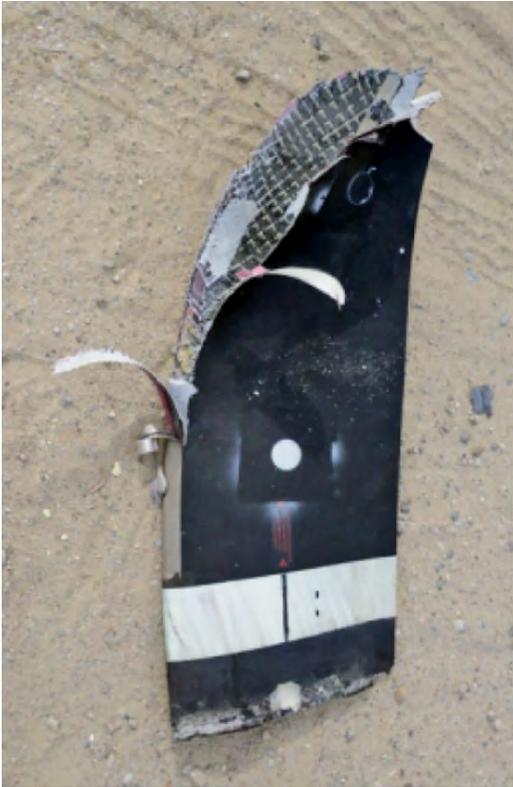
Figure 40.—Upper blade after impact on 24-ply composite panel.

The blade deflected upwards after impact and landed on the test pad. The tip and leading edge of the blade were crushed on impact, and the remaining tip and leading edge had no residual strength (Fig. 40). The residual length of the blade was 41 in. and weighed 11.2 lb.

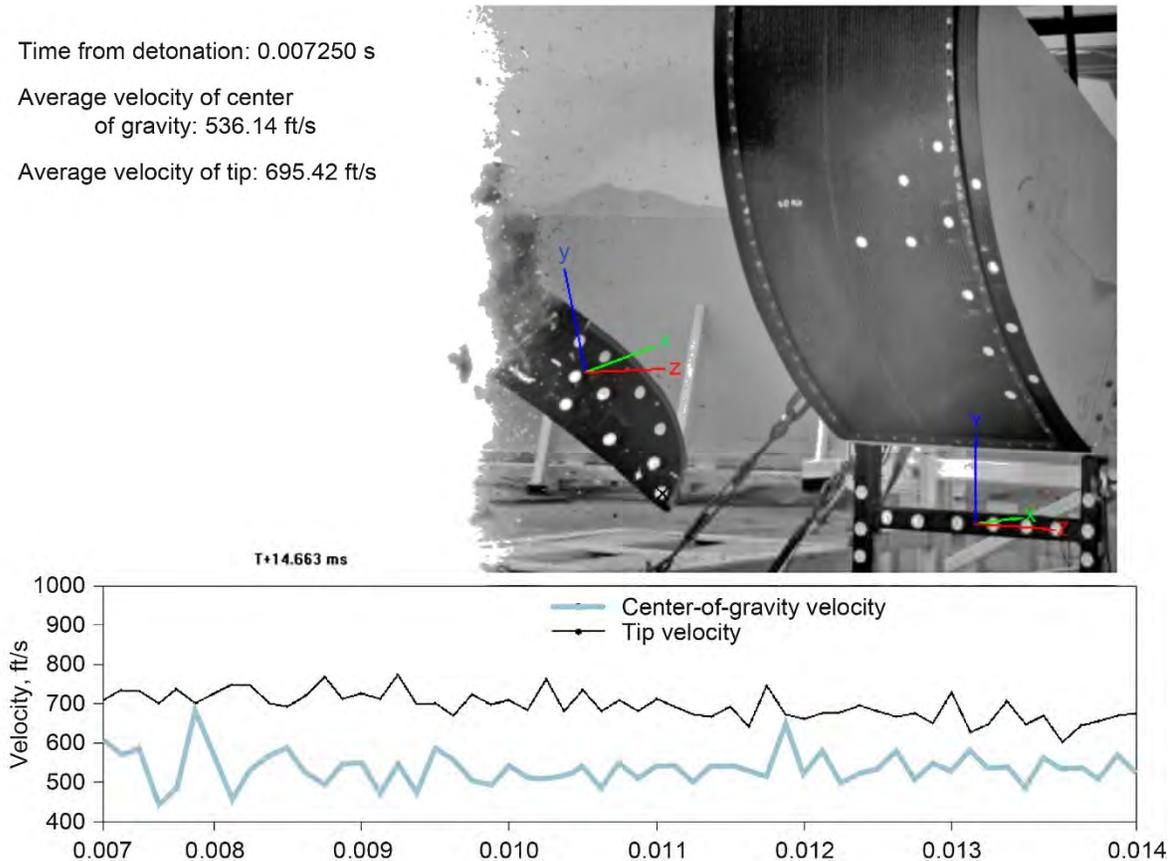
Figure 42.—Computed resultant velocity for two points on blade impacting 20-ply panel.

Photogrammetric measurements of the blade kinematics yielded the blade velocity, which impacted the 20-ply panel while in free flight. Figure 42 shows the resultant velocity as a function of time for the point estimated to be the blade CG (blue line) and a marker point near the blade tip (black line). There is some noise in the results, but the average resultant velocities over the measured time were 536 ft/s for the CG and 695 ft/s for the point near the tip.

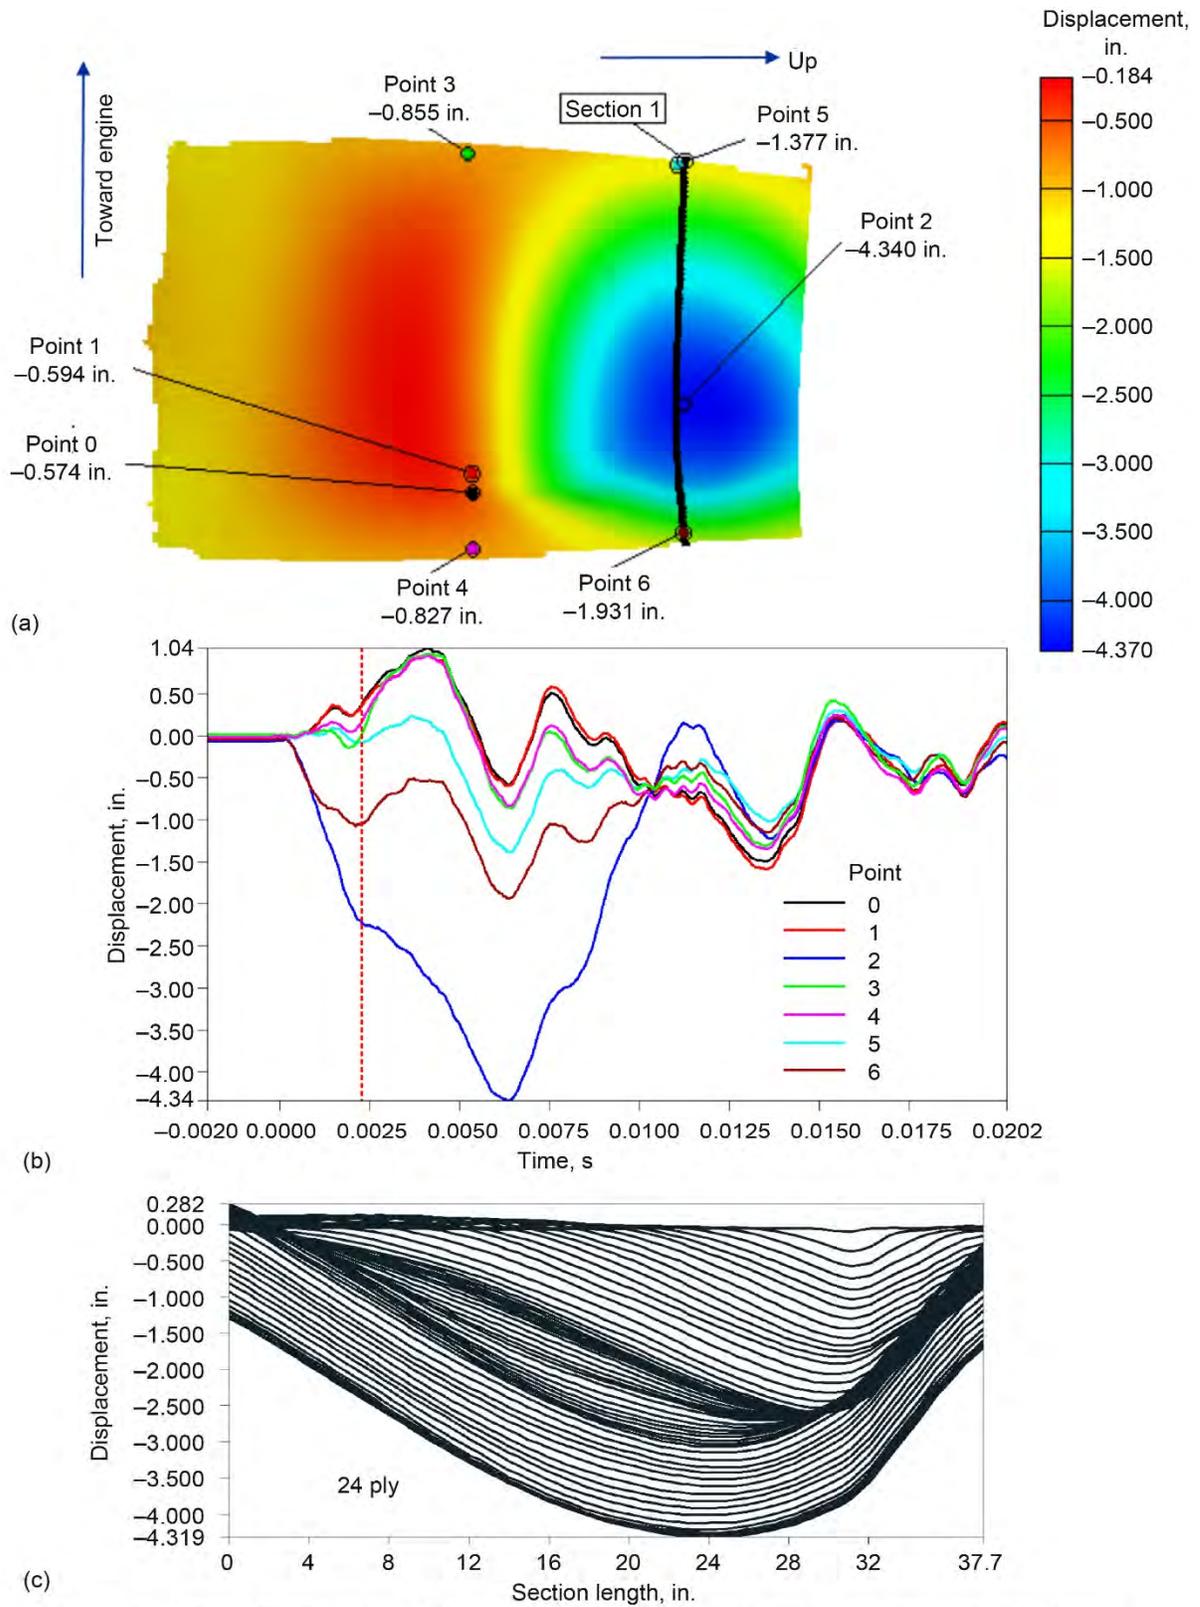
The blade did not penetrate the 24-ply panel, but cracks were generated both on the front and back sides of the panel. Two main cracks were generated on the back side as shown in Figure 39. Radial displacements for the 24-ply panel are shown in Figures 45 and 46. Figure 45(a) shows a contour plot of the radial displacement at the time of maximum panel deflection. This is the total displacement, including any contribution from the motion of the test fixture. A number of points are indicated in the figure. The points labeled “0” and “1” span the first crack that formed on the back side of the panel shown in Figure 39 between 2 and 2.5 ms after impact. A time history of the radial displacement of three of the indicated points is shown in Figure 45(b). Note that during the time of impact the displacement at point 2 is radially inward as would be expected, but the displacements at points 0 and 1 are outward indicating a highly dynamic process. The dashed vertical line in Figure 45(b) indicates the time at which the crack that formed between points 0 and 1 occurred. Figure 45(c) shows the radial displacement along the line labeled “Section 1” shown in Figure 45(a) for a number of consecutive frames up to the point of maximum deflection. Note that there is significant radial displacement at both ends of the segment line, which are near the fixture frame. This indicates that there is some motion in the frame itself. Although the motion of the frame is likely not a rigid-body motion, an attempt to measure the displacement of the panel relative to the frame was made by averaging the displacement of four points located at the corners of the measurable area and subtracting that motion from the overall deflection (Fig. 46). This measure of displacement relative to the frame is shown in Figure 46(a). Relative to the average of the four points, the maximum radial displacement is just over 2.6 in. This relative measure of radial displacement is shown as a function of time in Figure 46(b) for the seven points shown in part (a). There is a significant difference in the relative displacement shown in Figure 46(b) compared with the total displacement of the points shown in Figure 45(b).

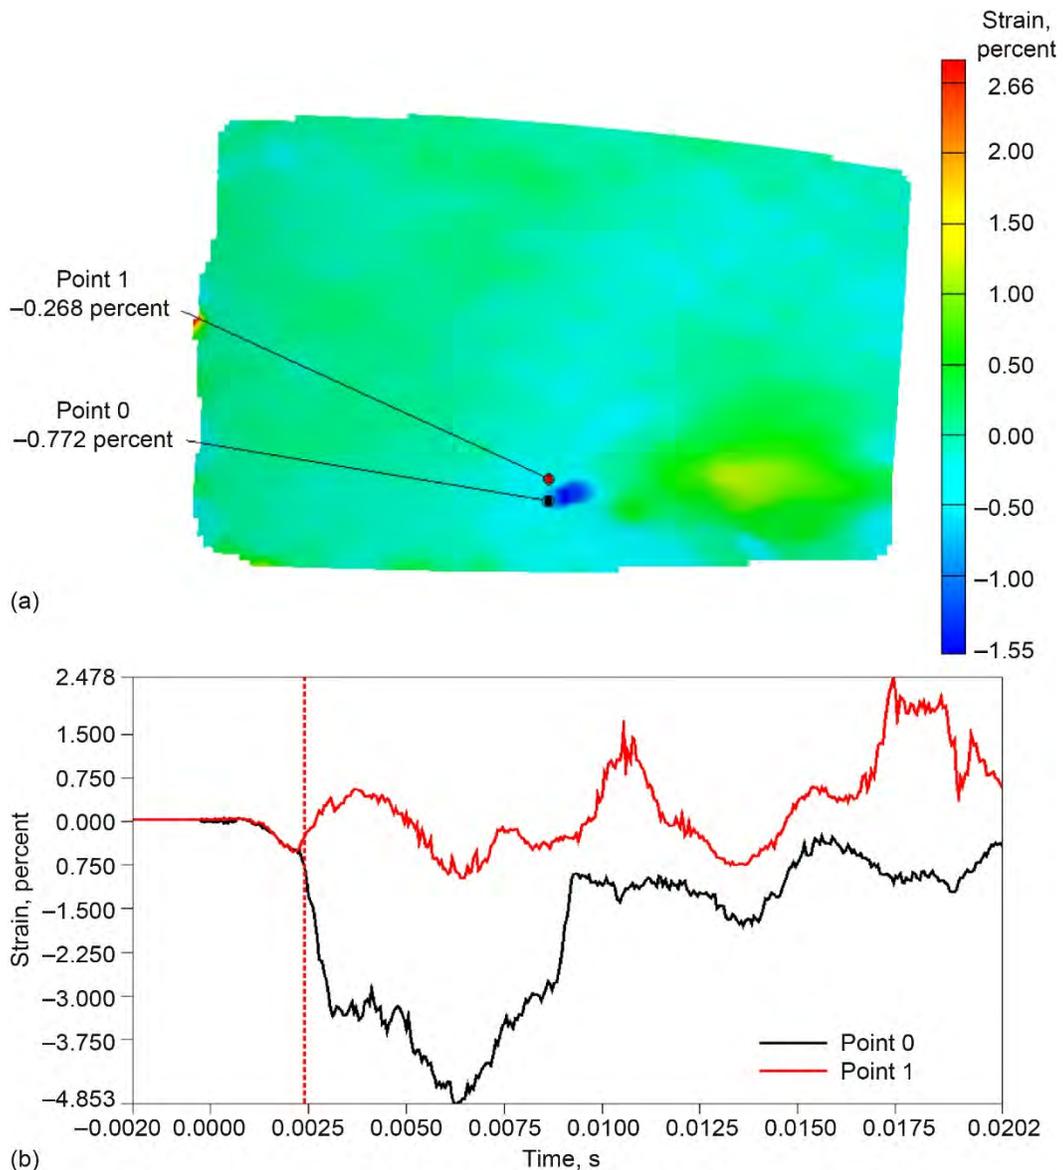
Figure 49.—Strain in y-direction in 24-ply panel during blade impact. (a) At time first crack initiates. (b) At points labeled in part (a) as function of time.

Strains in the 24-ply panel are shown in Figures 49 to 51. The strain in the y-direction (transverse to the cracks) at the time of the first crack initiation in the 24-ply panel is shown in Figure 49(a). In the region of the formation of the first crack, between the points labeled “0” and “1,” the strain in the y-direction is compressive. The y-direction strain at these points is plotted as a function of time in Figure 49(b). Because of the limited resolution of the cameras, it was not possible to measure the strain at the exact location of crack initiation.

Figures 49(a) and (b) show that at the time of the first crack initiation this region was in a compressive strain state.
