Dynamic Open-Rotor Composite Shield Impact Test Report

*Silvia Seng and Charles Frankenberger
Naval Air Warfare Center Weapons Division, China Lake, California*

*Charles R. Ruggeri, Duane M. Revilock, J. Michael Pereira, and Kelly S. Carney
Glenn Research Center, Cleveland, Ohio*

*William C. Emmerling
FAA William J. Hughes Technical Center, Atlantic City International Airport, New Jersey*

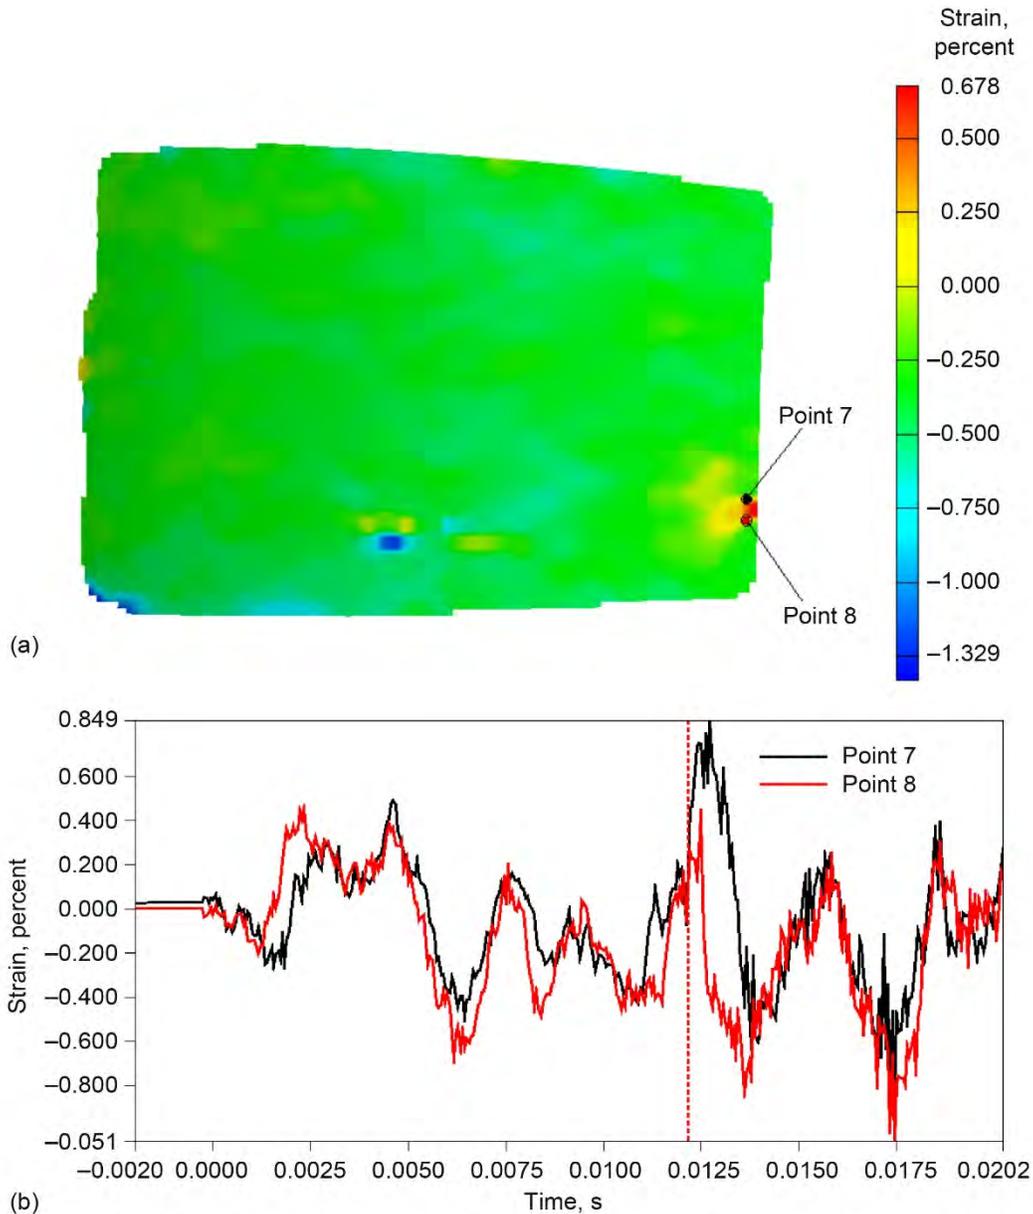
Figure 50.—Strain in y-direction in 24-ply panel during blade impact. (a) At time second crack initiates. (b) At points labeled in part (a) as function of time.

Figure 50(a) shows a contour plot of the strain in the y-direction (transverse to the panel cracks) at the time the second crack initiated. The second crack initiated at the panel boundary, which was outside of the computable area, so it was not possible to compute the strain at the initiation site. However, as seen in the figure, the transverse strain is generally positive in this region, indicating that the crack initiated as a result of tensile transverse strain. Figure 50(b) shows the strain in the y-direction for the two points indicated in part (a), as a function of time.

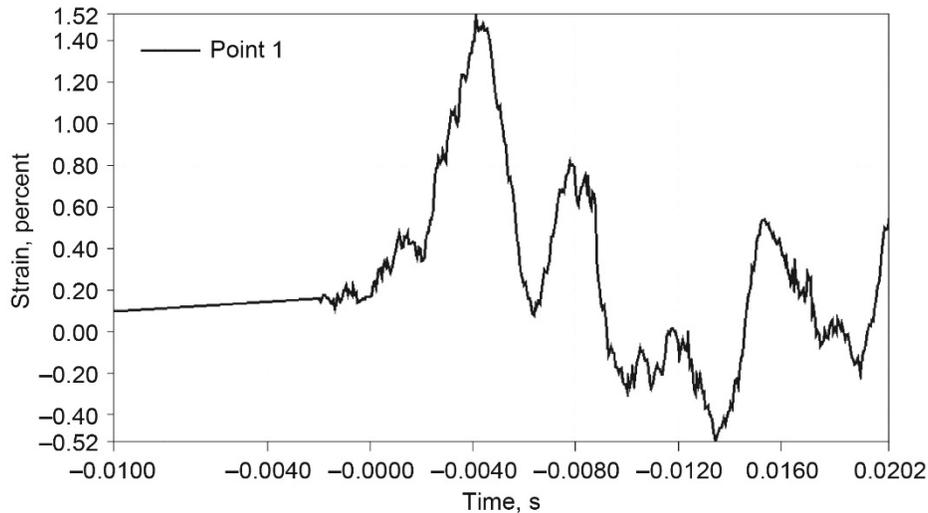
Figure 51.—Maximum principal strain at point of maximum deformation of 24-ply panel.

The maximum principal strain at the point of maximum deformation (indicated by point 2 in Figure 46(a)) is shown in Figure 51. No fracture occurred on the back side of this panel at this location. Unlike the 20-ply panel, there is no significant strain generated from the blast from the shape charge prior to impact. This is likely due to the differences in panel orientation. As shown in the figure, at the point of maximum deformation the panel undergoes a maximum strain of approximately 1.5 percent without fracture.

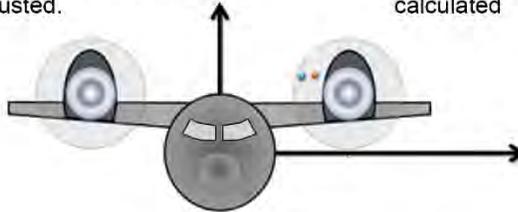
Figure 52.—Generic aircraft configuration with open-rotor system.

- Fuselage penetration model
 - Macro requires fragment release points with respect to an origin at the center of the fuselage.
 - Therefore, the water line values are adjusted as seen at WL 233.
 - The butt line and fuselage stations are not adjusted.
- Open rotor center, first rotor
 - FS 590
 - BL ±188
 - WL 85
- Fragment release points calculated

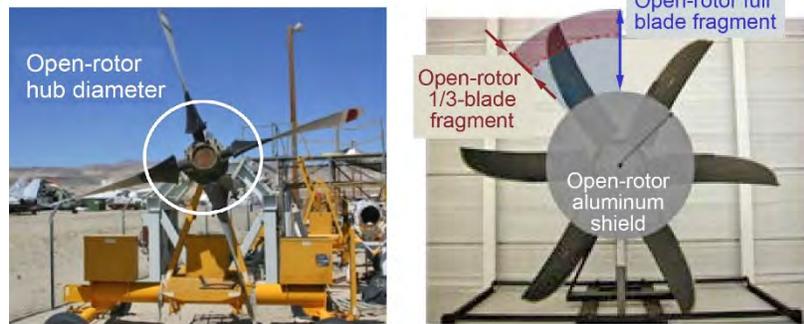
Figure 53.—Generic blade configuration for open-rotor system impact tests.

Two generic blade configurations were used in this analysis (Fig. 53). An aluminum blade was used for reference purposes and a composite blade was defined to better represent current open-rotor configurations. The open-rotor system was sized based on input from industry (Table V). The blade parameters are provided in Table VI. The second rotor blade was roughly a 20-percent-scaled version of the first blade. Spacing between rotors was defined at 15 in. from rotor 1 centerline to rotor 2 centerline. The rotor-to-rotor distance for modern open-rotor engines was not publicly available when this work was initiated, so a distance similar to the 1980s unducted fan was used in this analysis. More recent information indicates that modern open-rotor engines have a rotor-to-rotor centerline distance 2 to 3 times that used in this analysis. This will increase shield area and weight beyond those published in this report.

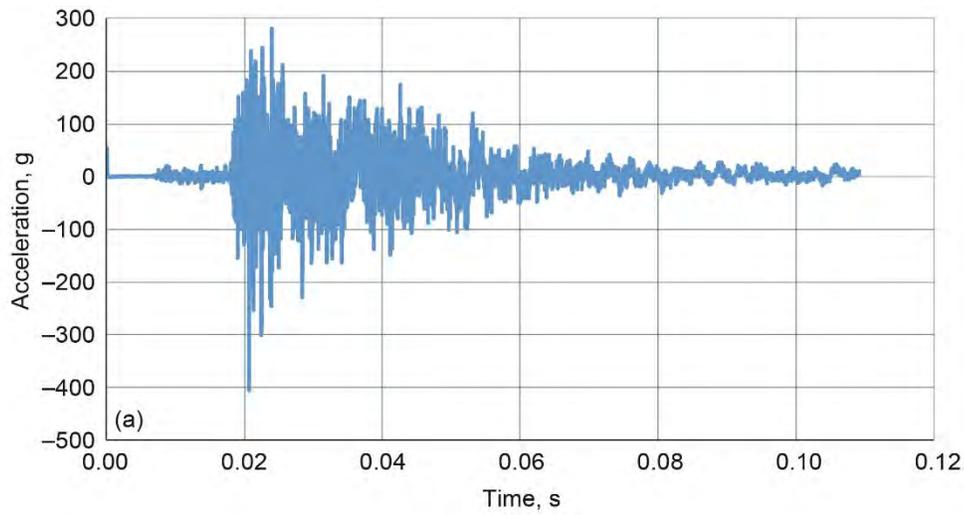
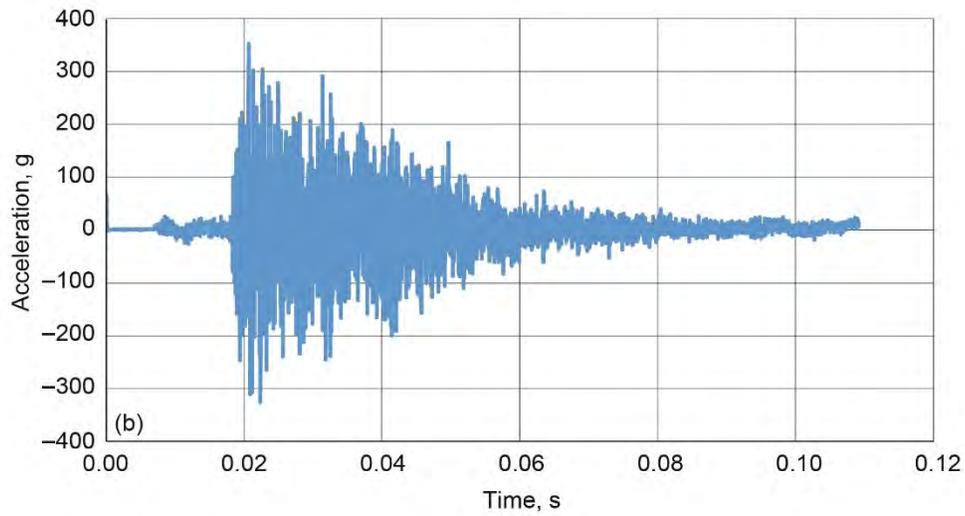
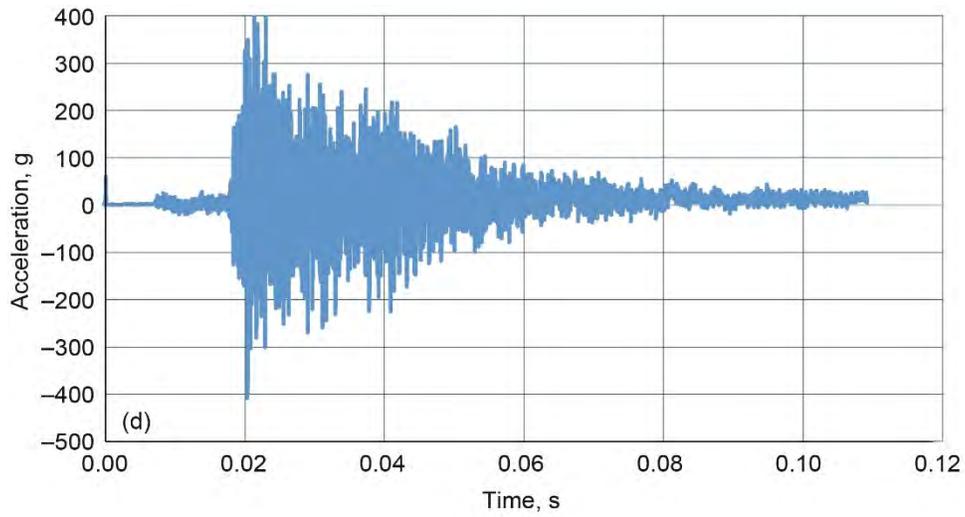
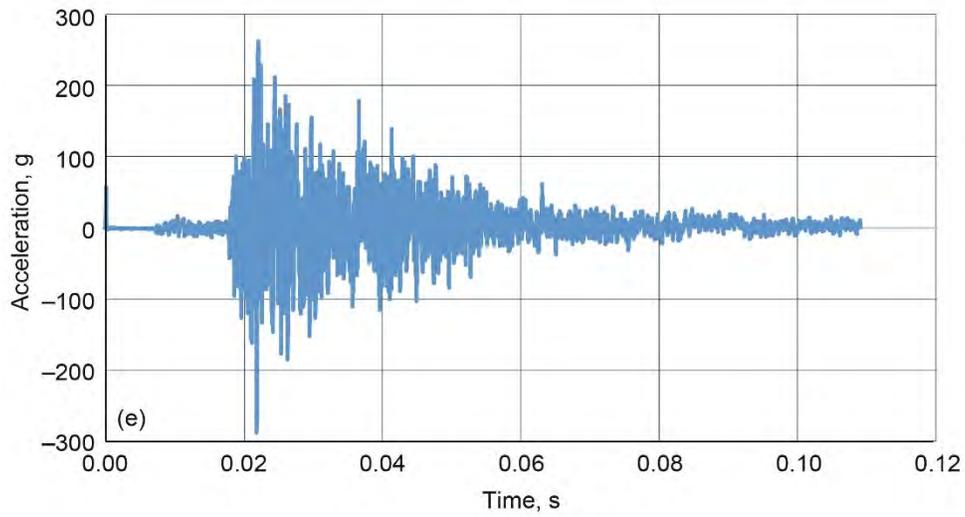
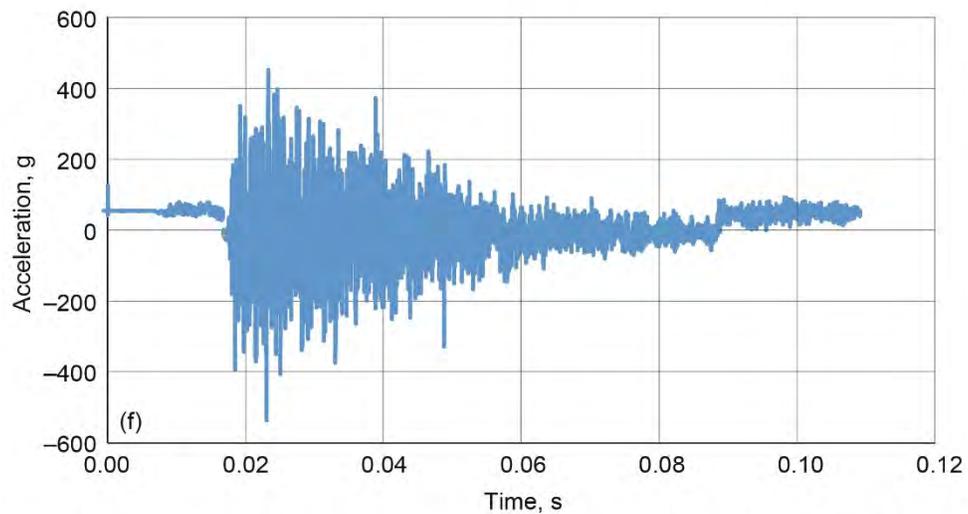
Figure 60.—Accelerometer response for 24-ply panel. (a) P24–X1. (b) P24–Y1. (c) P24–Z1.

Figure 60.—Concluded. Accelerometer response for 24-ply panel. (d) P24–Y2. (e) P24–Z2. (f) P24–Y3.

Two sets of plots are provided, six for each shield to show the accelerations recorded during the test. Approximately 0.11 s of data was recorded at 100 000 samples per second for each channel. There is a significant difference in the level of the signals for the 20-ply panel and the 24-ply panel. In the test, the released blade impacted the frame of the 20-ply panel after penetrating the shield. This resulted in very high measurements on the 20-ply accelerometers and clipping on two of the channels. The 24-ply shield was not penetrated. The raw accelerometer data for the 12 accelerometers are shown in Figures 59 and 60 for the 20- and 24-ply panels, respectively. The acceleration response for the 12 channels begins with a low value prior to detonation of the charge releasing the two blades. After detonation there is an increase in response, likely due to the pressure pulse from the detonation. Impact of the blade occurs at approximately 0.018 s, when the acceleration increases dramatically and then gradually decreases to a low level at approximately 0.1 s.

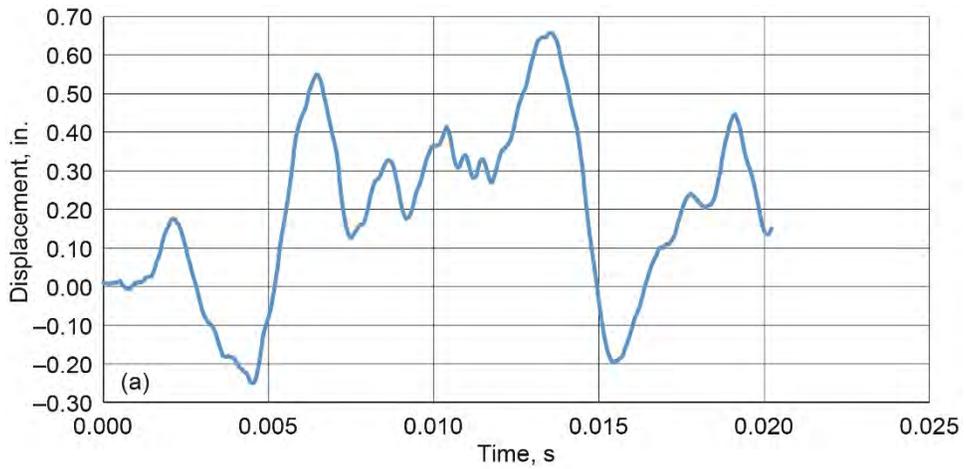
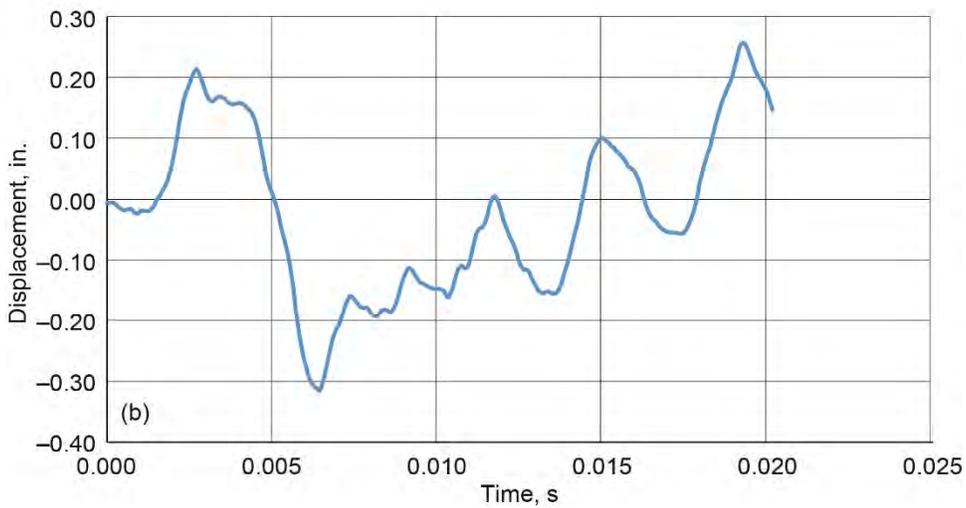
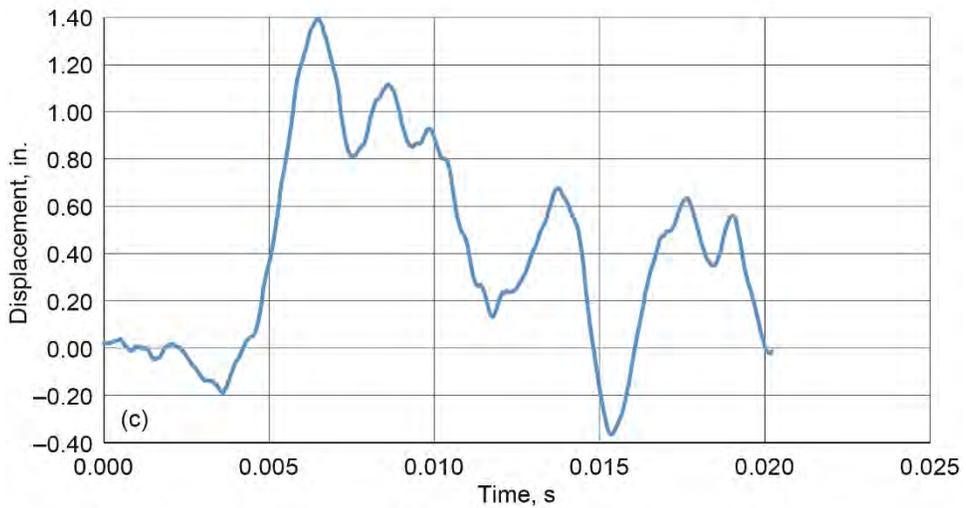
Figure 65.—Displacement of point 11 (see Fig. 63) on 24-ply panel. (a) Circumferential. (b) Axial. (c) Radial.

DIC was available during the test. In order to define the stand movement, the displacement was computed at a number of points on the perimeter of the 24-ply panel. The locations of points where displacements were measured are shown in Figure 63. The circumferential, axial, and radial displacements are provided for points 10 to 13 in Figures 64 to 67 for the four corners of the shield. The positive directions of axial and circumferential displacements are shown in Figure 63. Positive values of radial displacements are out of the page. In the plots, time 0 is the time of the first impact of the blade on the panel. This corresponds to a time of approximately 0.018 s in Figure 60. These displacements are located very close to the accelerometer locations. Computations were only possible up to 0.02 s after impact because of severe vibrations at the camera location making it impossible for the ARAMIS (GOM mbH, Germany) software to accurately track the pattern on the panel. Maximum displacement of the panel occurred at approximately 0.0065 s after impact, as shown in Figure 45.

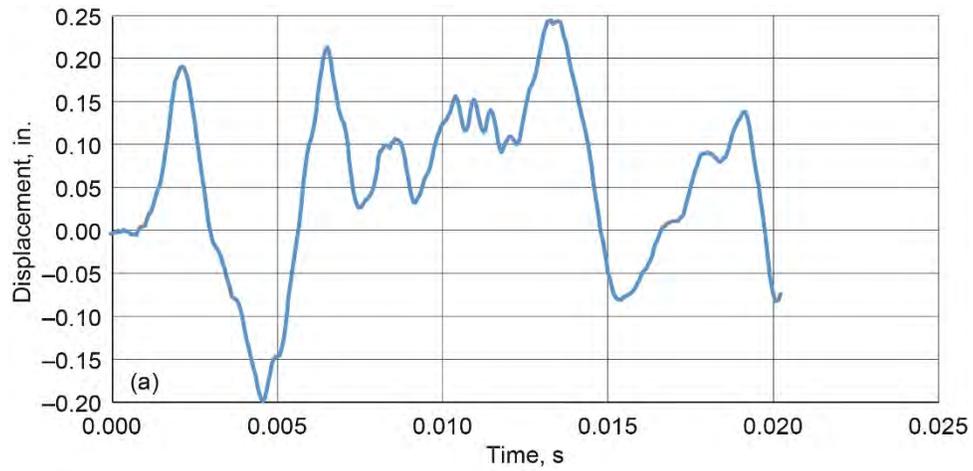
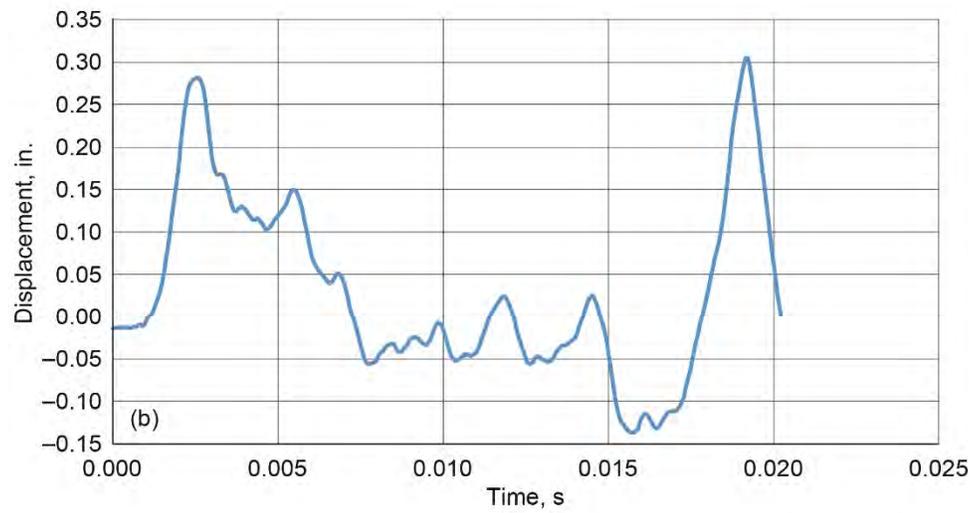
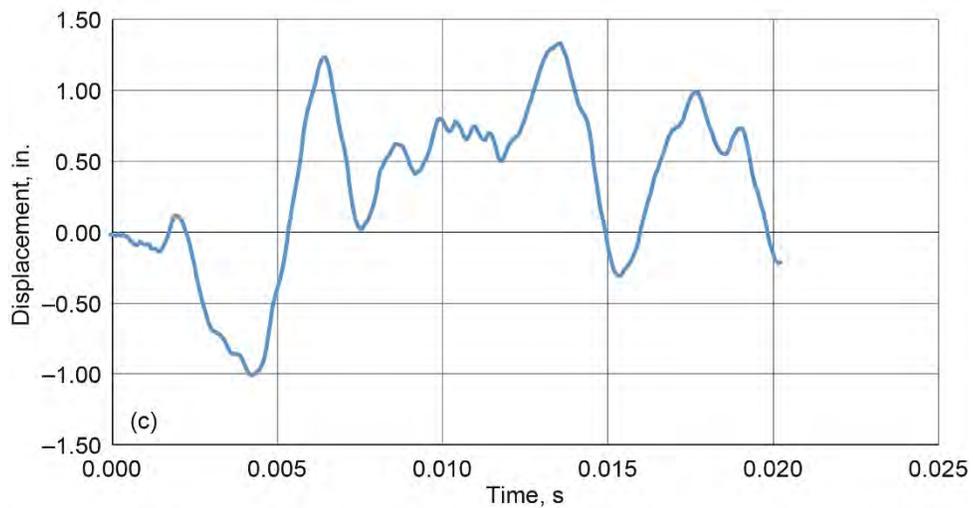
Figure 66.—Displacement of point 12 (see Fig. 63) on 24-ply panel. (a) Circumferential. (b) Axial. (c) Radial.

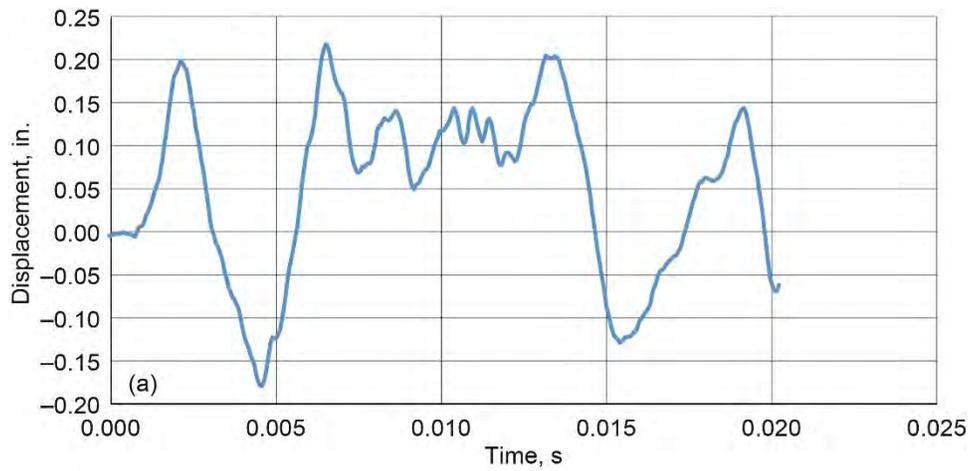
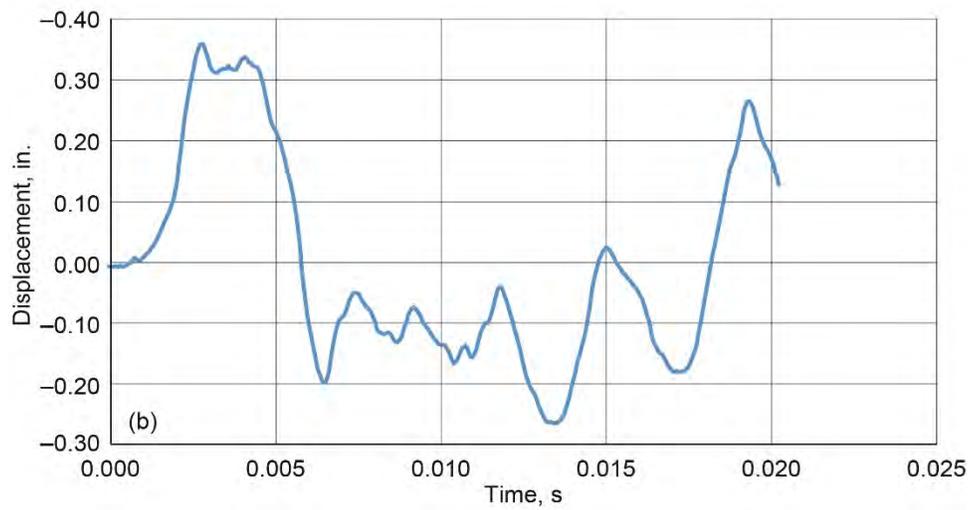
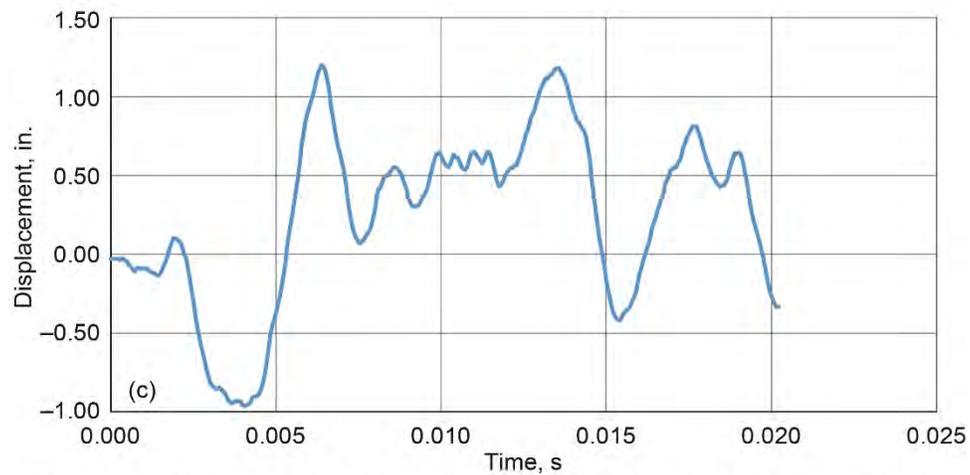
Figure 67.—Displacement of point 13 (see Fig. 63) on 24-ply panel. (a) Circumferential. (b) Axial. (c) Radial.
