# Combining Passive Thermography and Acoustic Emission for Large Area Fatigue Damage Growth Assessment of a Composite Structure

Joseph N. Zalameda\*<sup>a</sup>, Michael R. Horne<sup>b</sup>, Eric I. Madaras<sup>a</sup>, and Eric R. Burke<sup>a</sup>,

<sup>a</sup>NASA Langley Research Center Hampton, VA 23681-2199;

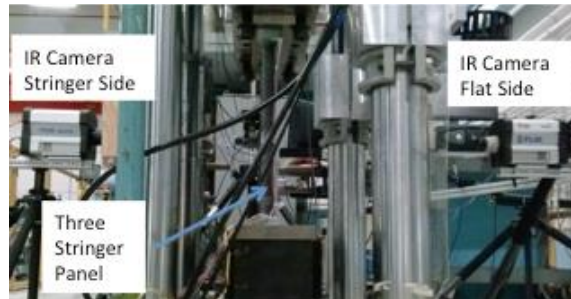
Figure 4. Three-stringer panel setup for passive thermography inspection of both flat and stringer sides.

The thermal measurement setup is shown in Figure 4. The basic system consists of two IR cameras operating in the 3–5

micrometer IR band and an image data acquisition computer. The IR cameras were both configured with 25 mm germanium optics. The focal plane array sizes for the cameras were from 640x512 to 1024x1204. The passive inspection captured the thermal variations during the fatigue loading. The setup required a Plexiglas® shield to contain fragments if ultimate failure occurred. The IR cameras were located behind the shield with the lens positioned in front of a viewing hole. The added benefit of the shield is it filters out spurious IR background sources. The cameras were synchronized using the load signal from the test machine. The sinusoidal load signal was offset corrected and the zero crossover points were used to produce a TTL trigger signal. The trigger signal was converted to a series of pulses using a signal generator. The IR cameras were operated at a frequency range of 16 to 90 Hz depending on acquisition time duration. Higher frequencies were used to capture the damage progression as the panel approached ultimate failure. Example unprocessed thermal images of the flat side are shown in Figure 5. The bright areas indicate the heated damaged sites.
