Applications of Advanced Nondestructive Measurement Techniques to Address Safety of Flight Issues on NASA Spacecraft

3rd IEEE International Workshop on Metrology for Aerospace
Florence, Italy

Bill Prosser

June 22, 2016

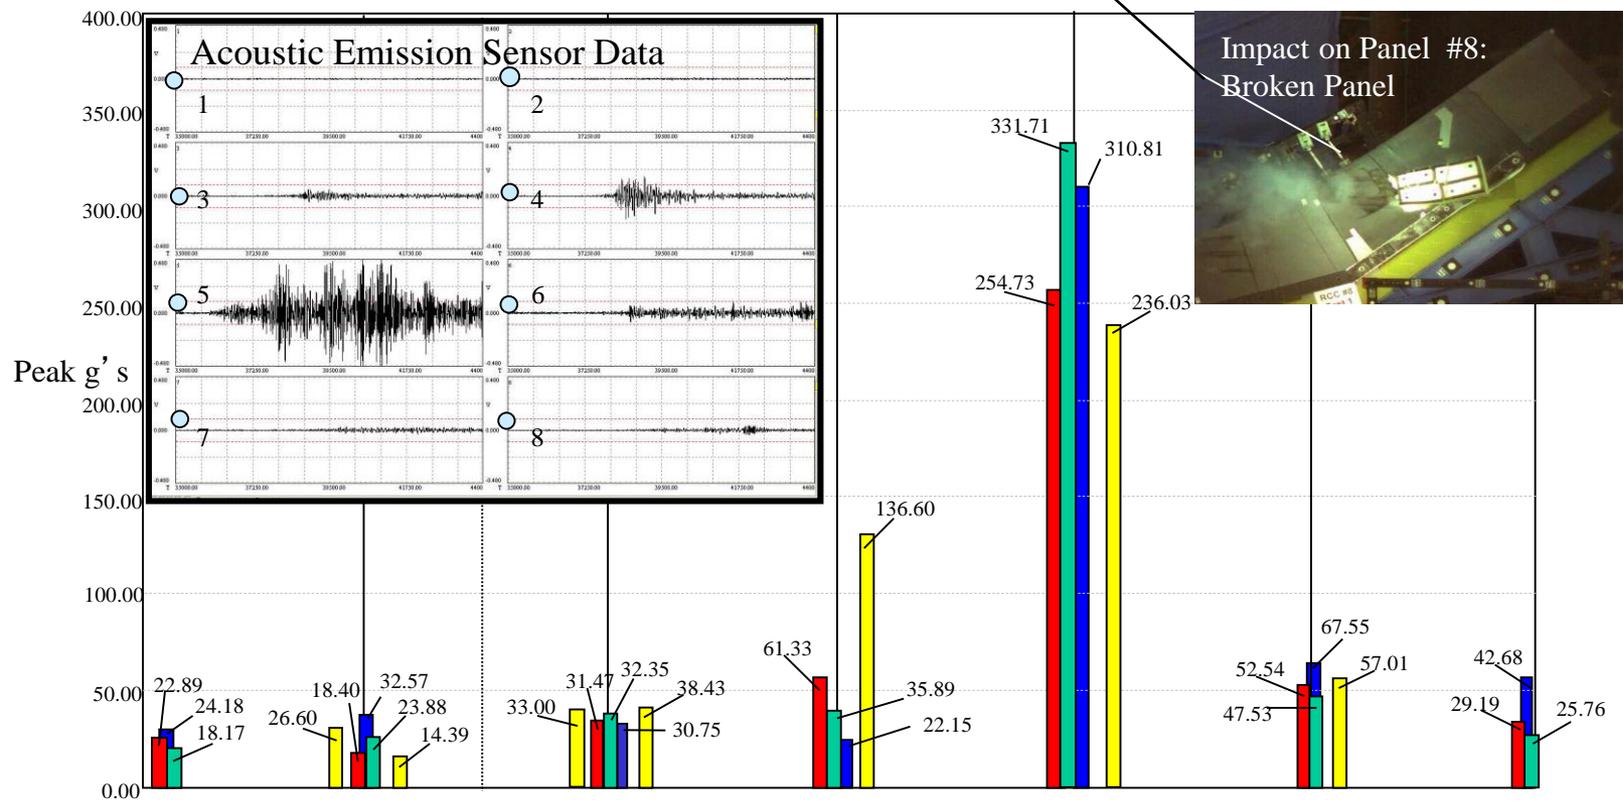
RCC Panel 8 Acoustic Signals

AE Sensors

Accelerometers

- J1
- J2
- J3
- Triax

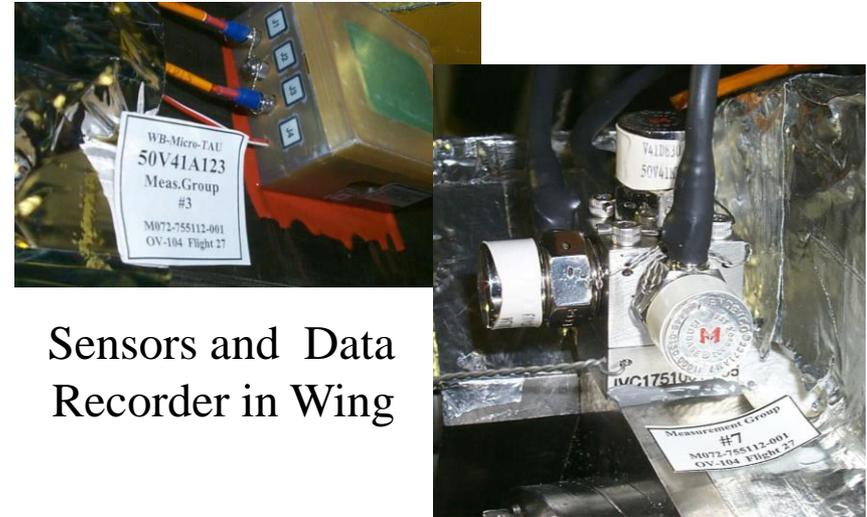
Sensors and Data Recorder in Wing

- Installed on all Shuttles
- Successfully flown on all flights after *Columbia*
- Detected small impacts during ascent
 - Small amplitude, nondamaging
 - Likely popcorn foam
- Detected several small MMOD impacts

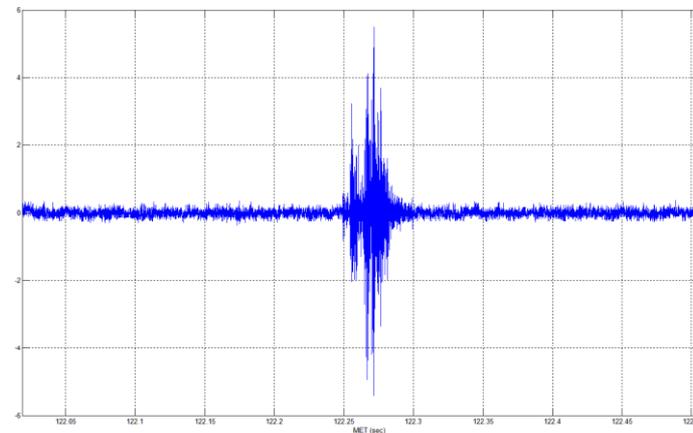
WLEIDS
probable
impact
signal

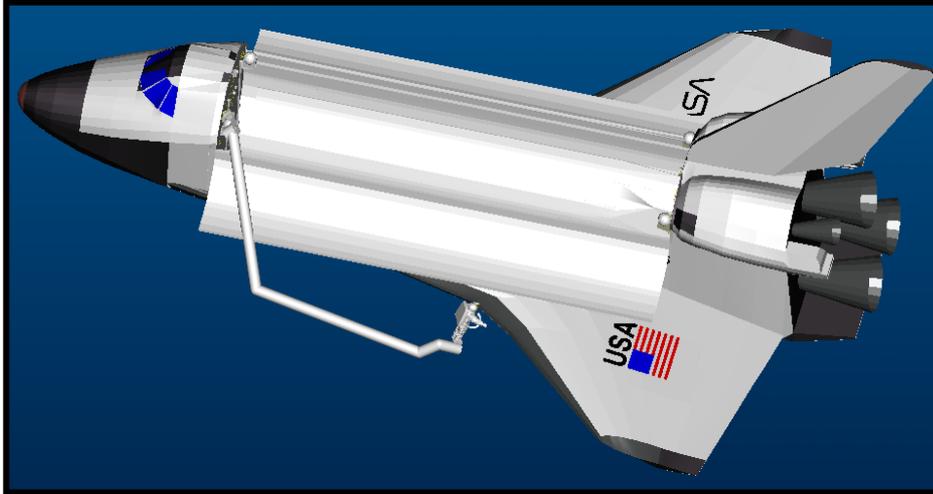
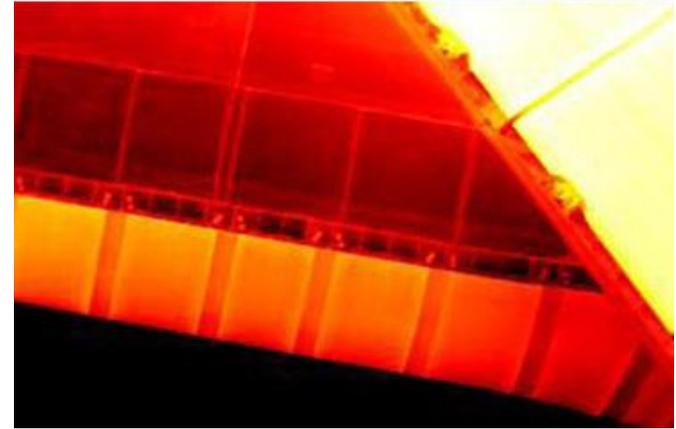
Images of wing leading edge

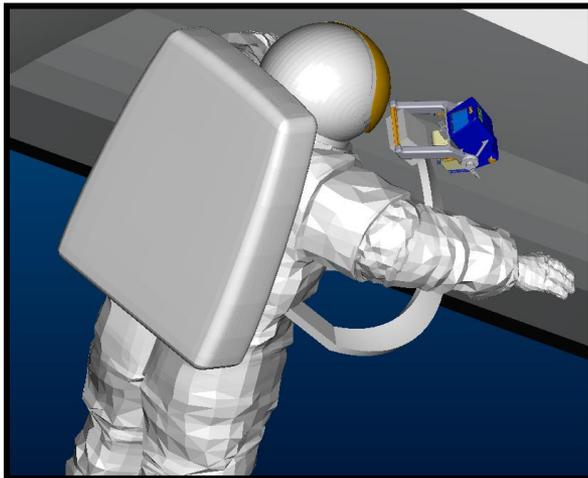
Illustrations
of on-orbit
thermal
camera
deployment

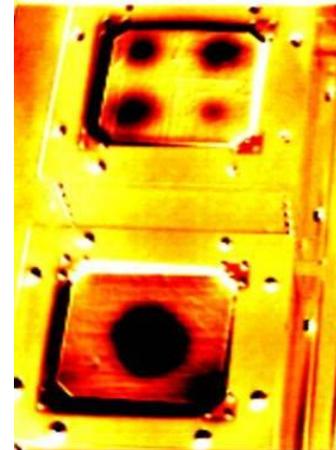
Images
of RCC
samples in
payload bay

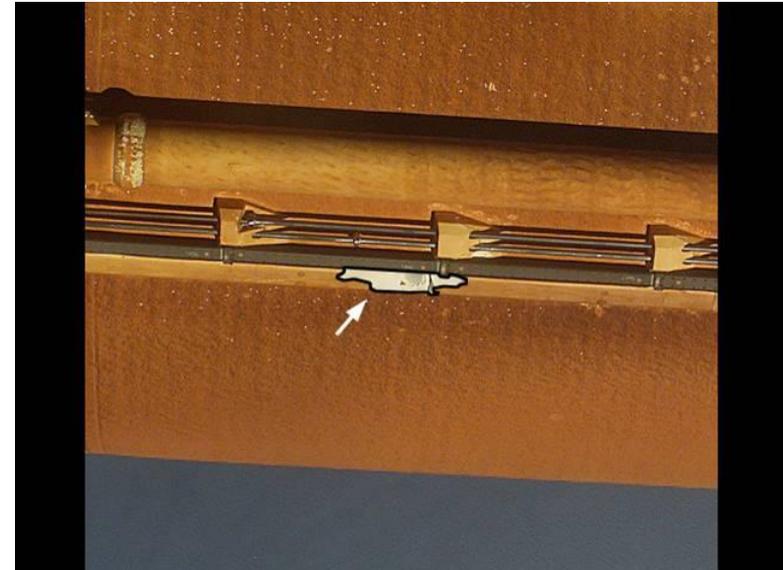
Foam Loss on STS-114

- ET TPS (foam) inspection identified as critical need after Columbia accident
- Foam proved very difficult to inspect
 - Low density and highly porous
 - High attenuation for acoustic waves
 - Poor thermal conductor
- NESC funded effort to develop and validate new NDE inspection methods
 - Backscatter Radiography
 - Terahertz Imaging
 - Shearography

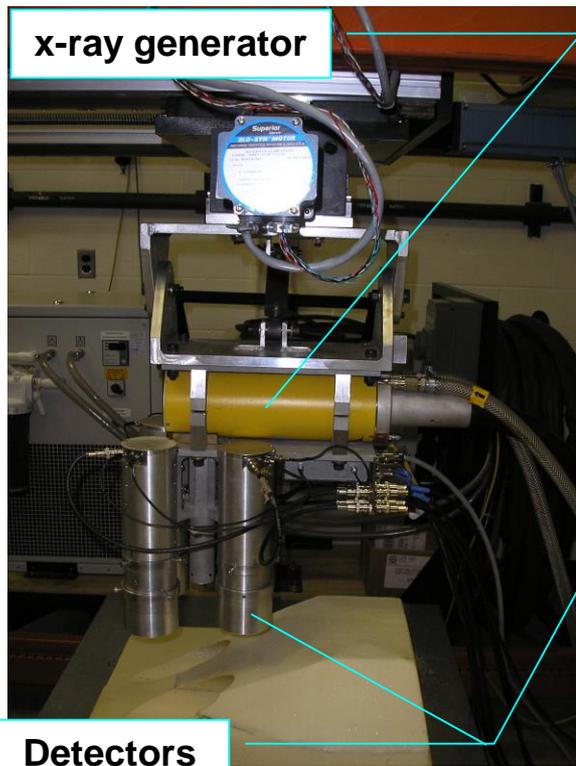
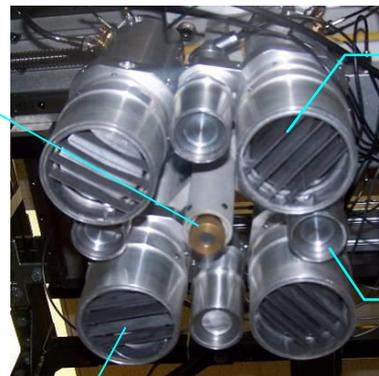
- Collimated beam of x-rays interact with sample molecules
- Backscattered x-rays are emitted (Compton Scattering), possibly after multiple subsequent scattering events, and detected by collimated detectors
- The collimated detectors provide some preferential sensitivity to selected depth
- The x-ray beam and detectors are scanned across the part to generate a 2-D presentation of the internal features of the foam

NaI detectors

YSO detectors

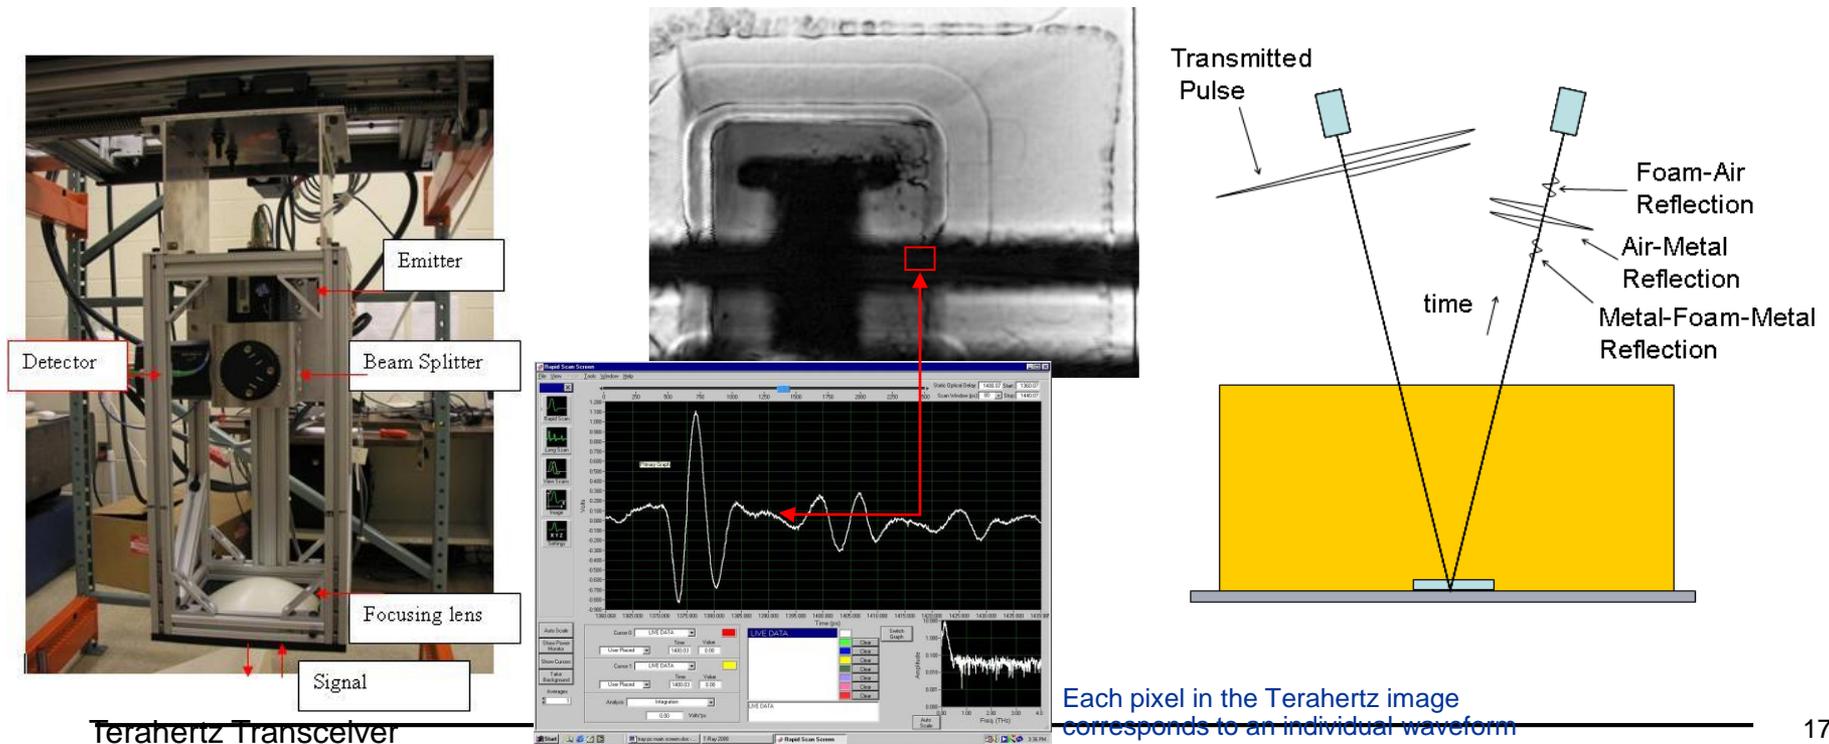
Terahertz Imaging

- Terahertz inspection uses high frequency RF energy in the band between microwave and infrared
- Terahertz beam is transmitted through object and reflects off the aluminum substrate
- The terahertz beam is scanned across the part to generate a 2-D presentation of the internal features of the foam
- Due to foam attenuation and system losses, received pulse is around 0.2 THz (2 – 3 THz transmitted)
- Presence of defects produces changes in amplitude, phase and power spectral density of received beam
- Less attenuation can indicate less material such as the presence of a void but in reality there are complex refracting effects occurring in the foam, making interpretation more challenging

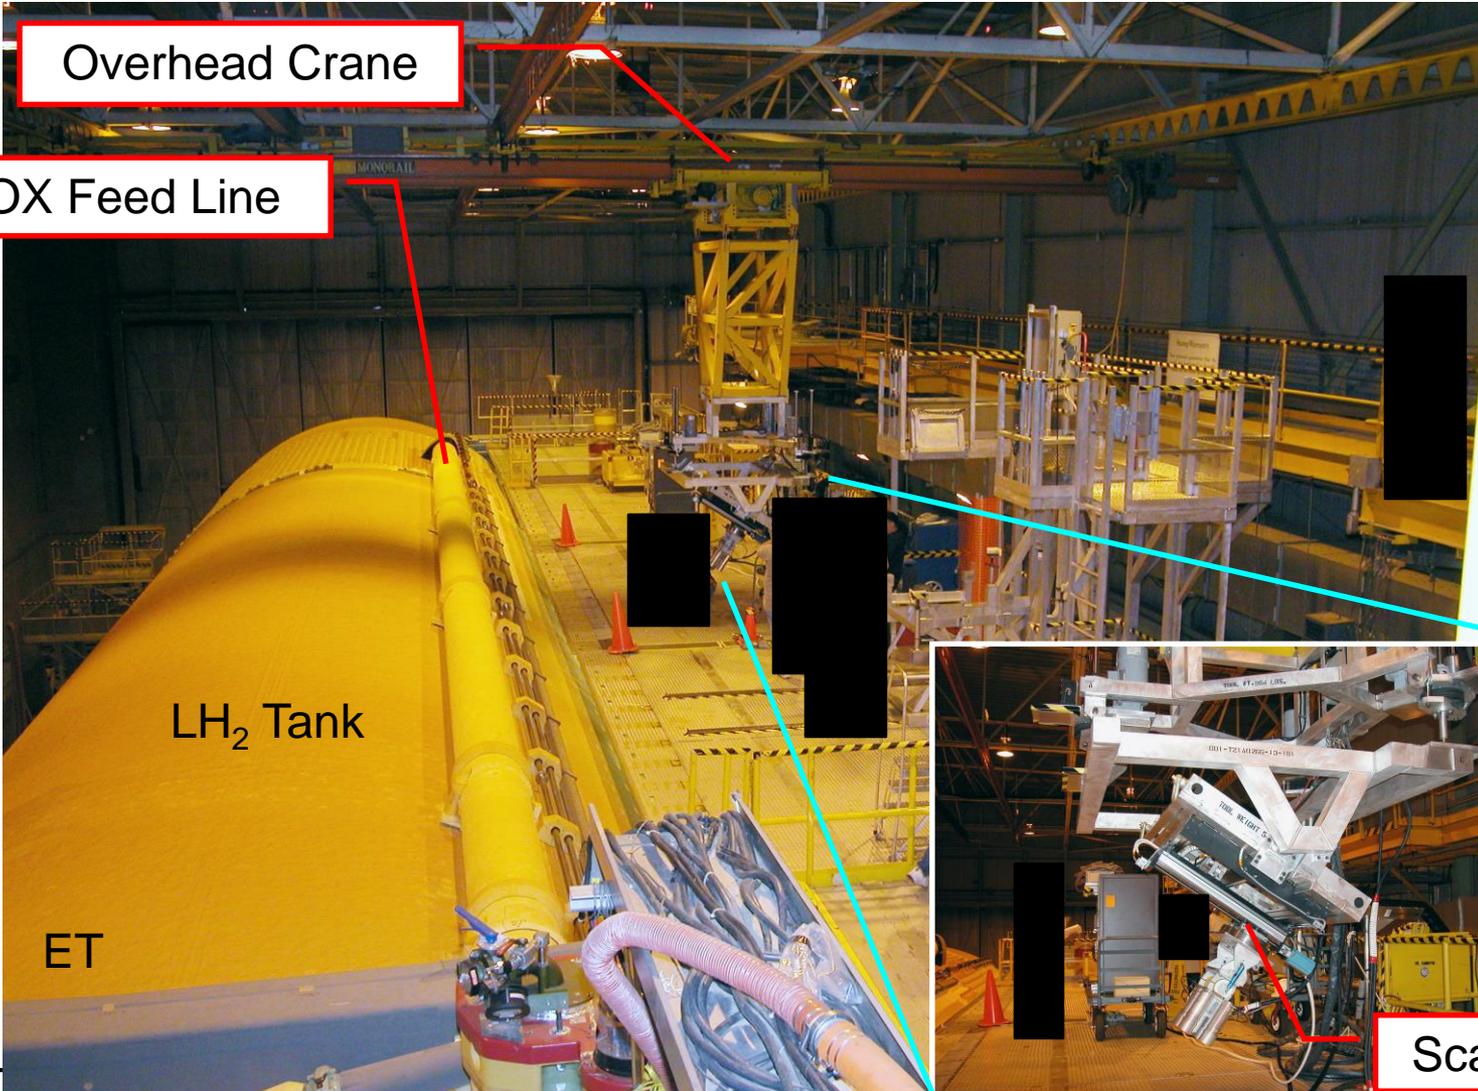
ET Inspection System

Overhead Crane

LOX Feed Line

LH₂ Tank

ET

Scanner

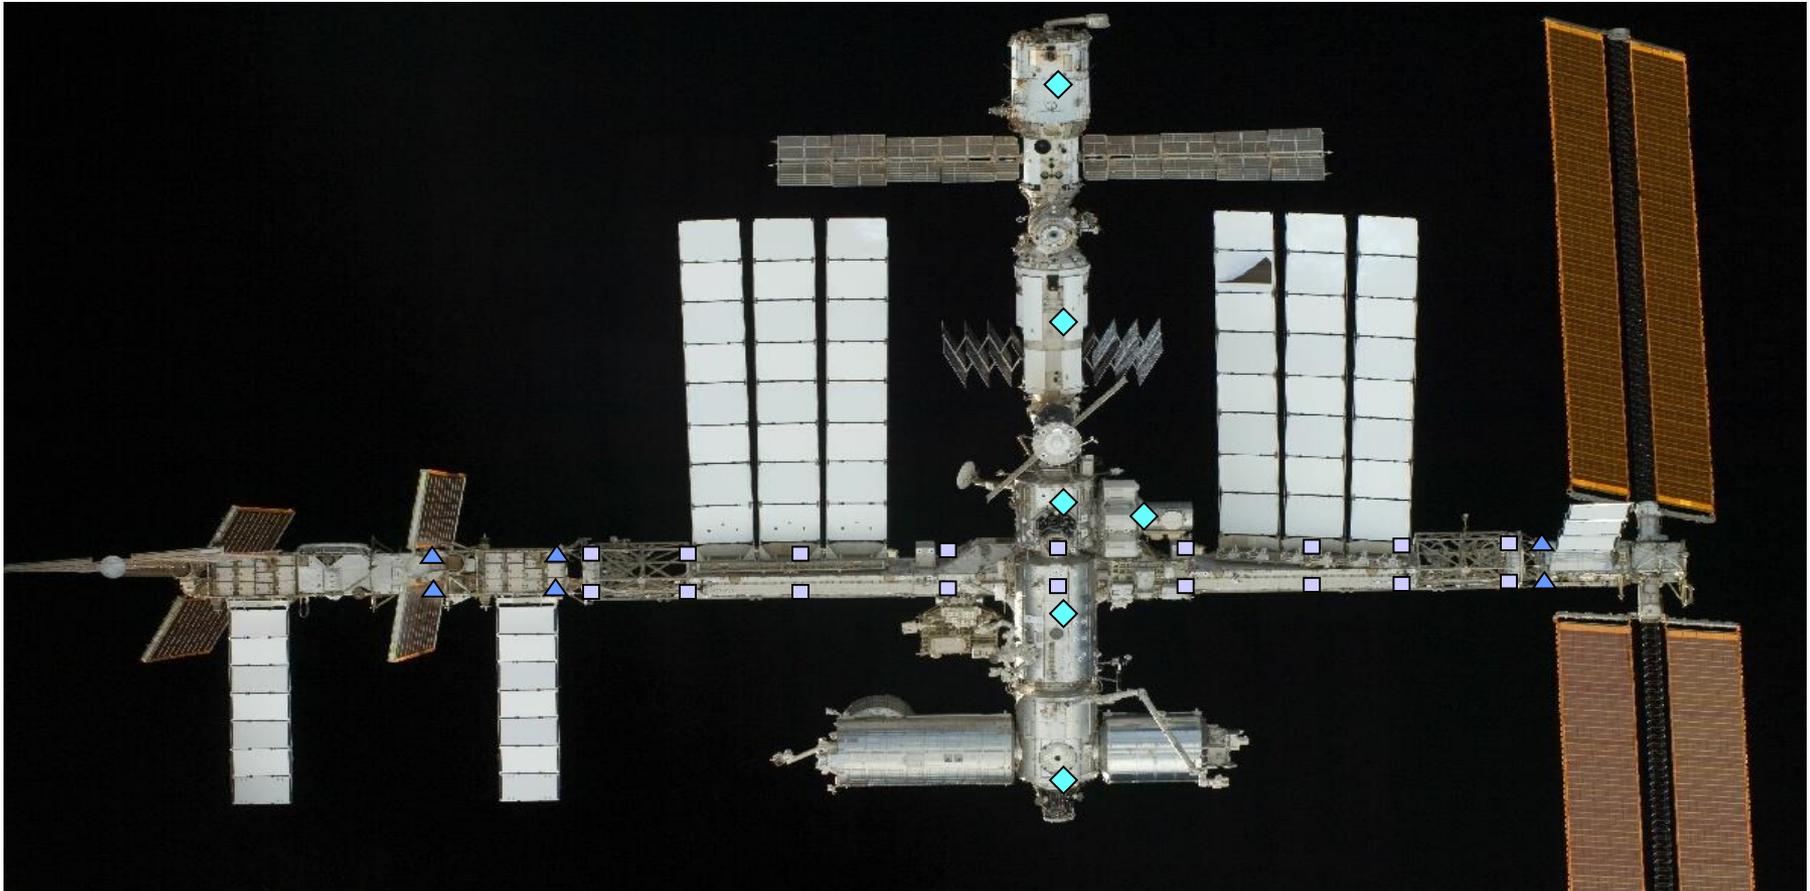
International Space Station Structural Health Monitoring

◆ IWIS □ SDMS ▲ EWIS
Current accelerometer count on ISS is 81 (SDMS: 33 EWIS: 30 IWIS: 18)
Used to monitor docking/undocking, reboost, crew exercise/activity

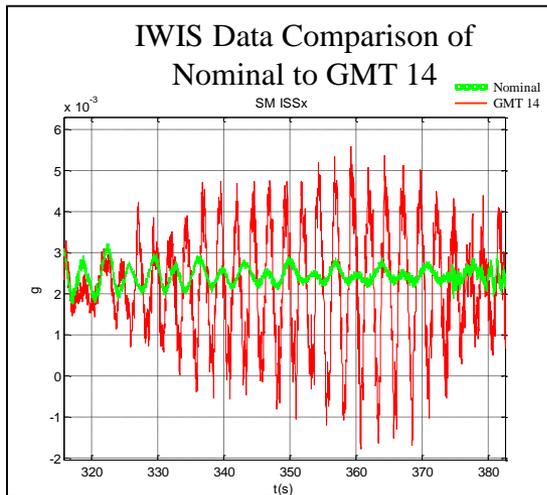
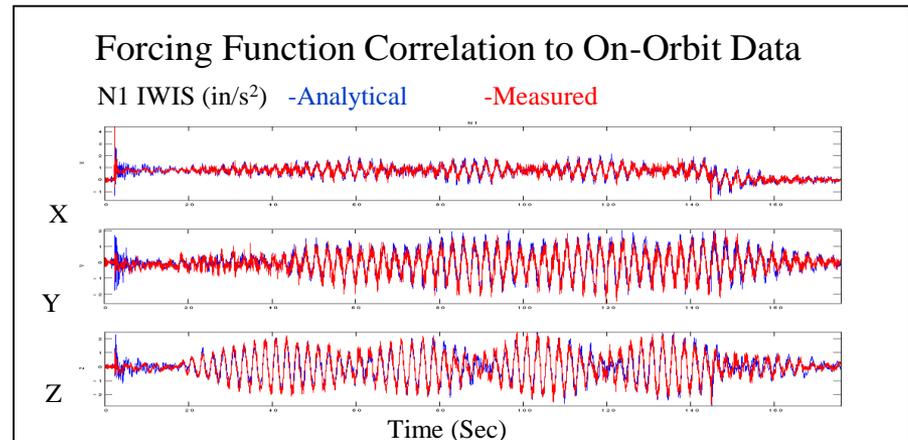
ISS Reboost Anomaly

- IWIS data alerted Loads Team to occurrence of anomaly during reboost
- Data from near reboost thrusters used to simulate analytical forcing function to calculate loads used for structural strength and life assessments

Final calculated loads were cleared
for upcoming events and 15-year life
despite exceeding limit loads

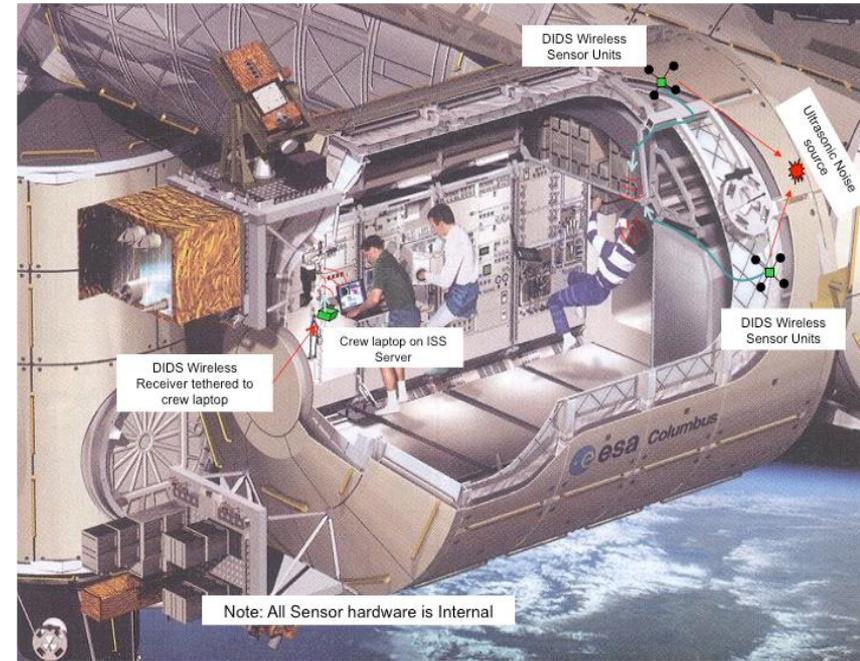
ISS MMOD Impact and Leak Detection

- No impact detection capability available
- Limited leak detection capability
 - Pressure sensors and hatch closing procedure
 - Handheld ultrasonic leak detector
- Distributed Impact Detection System (DIDS)
 - Multiple structure borne (AE) sensors
 - Battery powered data acquisition with wireless data transmission
- Ground testing on ISS Node 1 Structural Test Article, Flight Nodes 2 and 3, and Soyuz
 - Leak signal and background noise assessment
 - Wave propagation studies
- Background ultrasonic noise measurements obtained on ISS
 - Noise levels below required threshold for leak detection
 - Successfully located noise sources

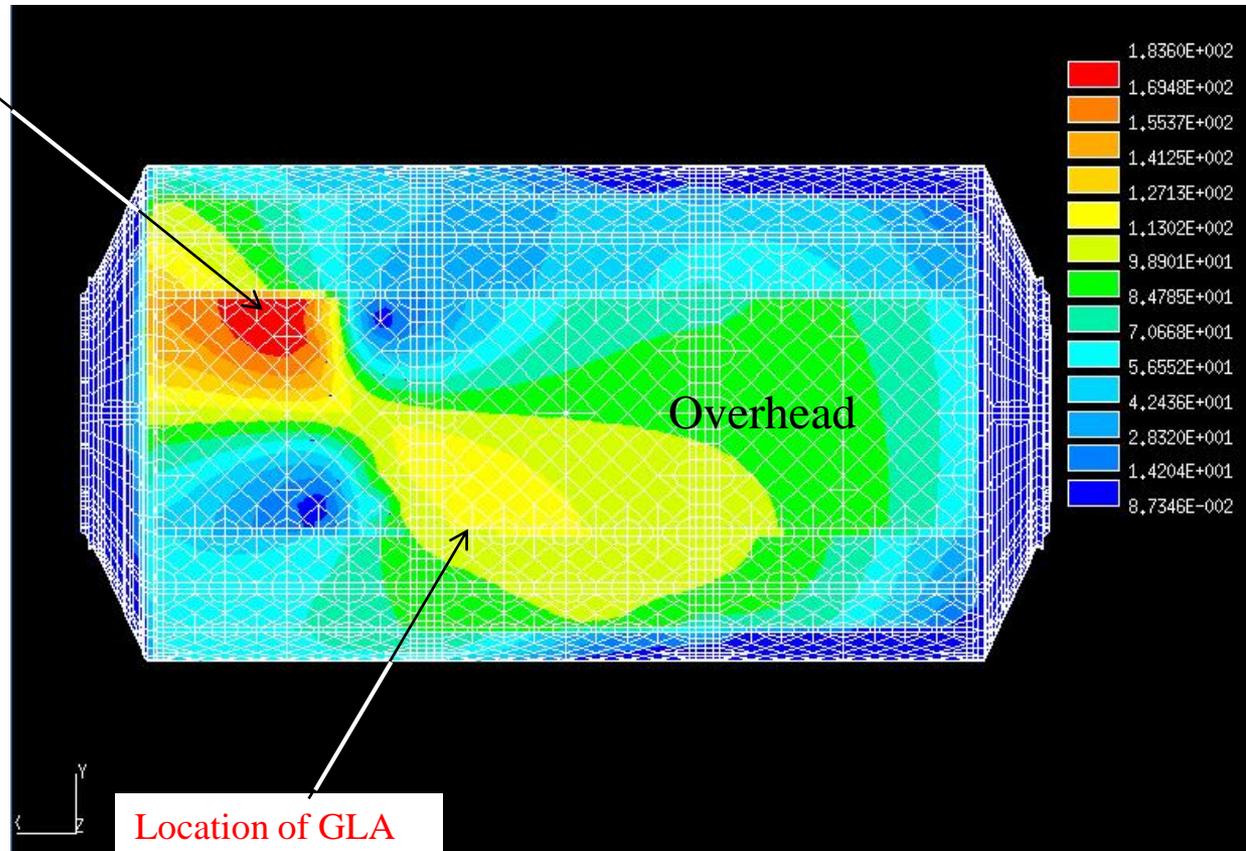
Ultrasonic Background Noise Tests

Note 1: Location Estimates for Sounds Recorded between 12 AM and 3 AM GMT on May 15, 2013
Crew was active during this time period.

US Lab FEM Model

Location of GLA
(General Luminary Assembly) on LAB1OS1 panel in hallway

Location of GLA
on LAB1OP3
panel in hallway

Note 2: Ultrasonic Background Noise Levels in the US Lab are below critical leak sound levels.

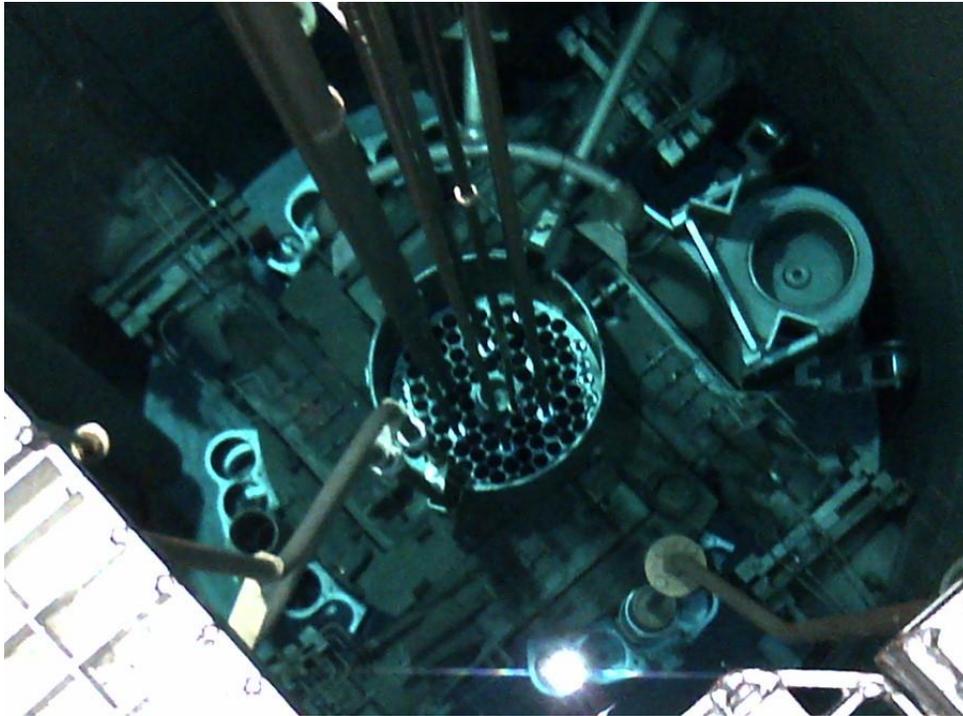
Nuclear Reactor Neutron Ray Source

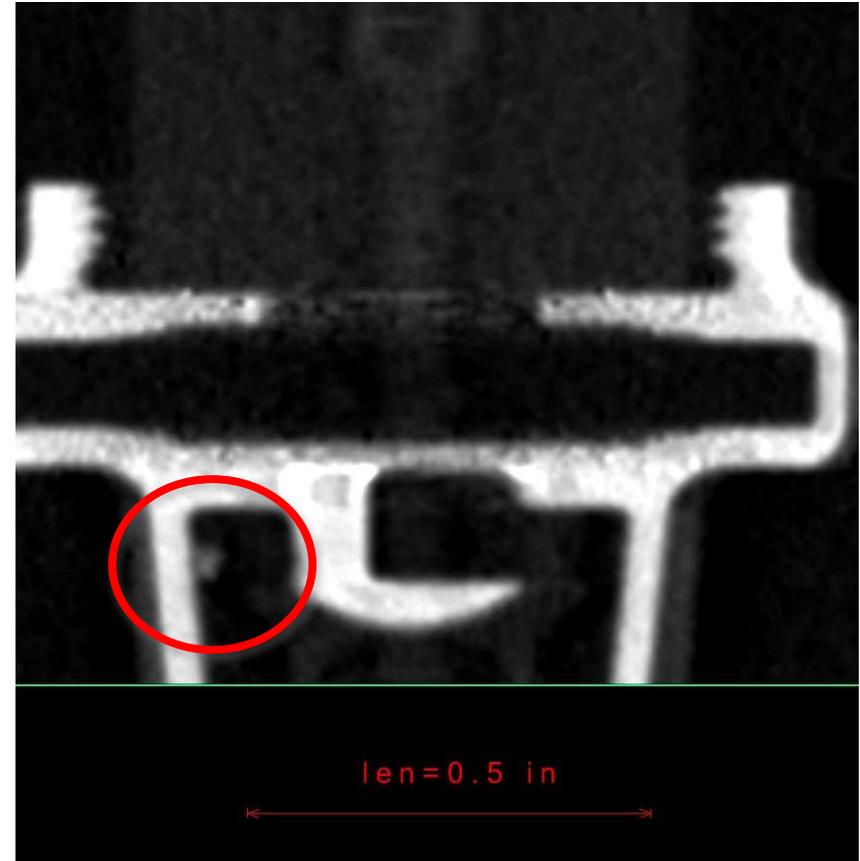
Neutron CT image of spacesuit component showing contamination

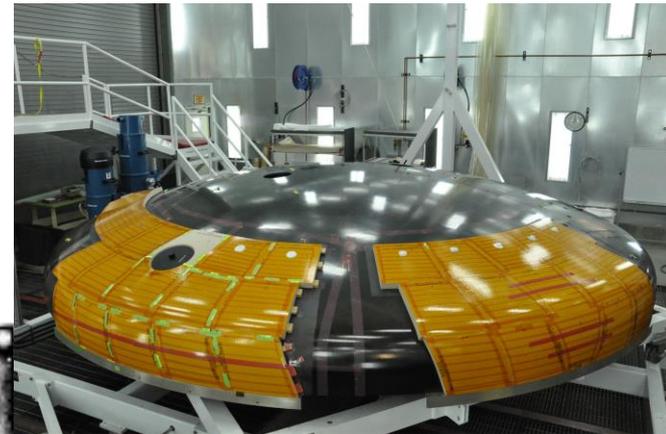
Orion Heatshield Bond Verification

- New Orion Heatshield Architecture Comprised of Bonded Blocks of TPS Material
- Integrity of Bondline Critical
- Proposed Approach Includes Process Control, Proof Testing, and NDE
- Multiple NDE Methods
 - THz for missing adhesive material
 - UT for disbonds
 - BSX for gap filler voids

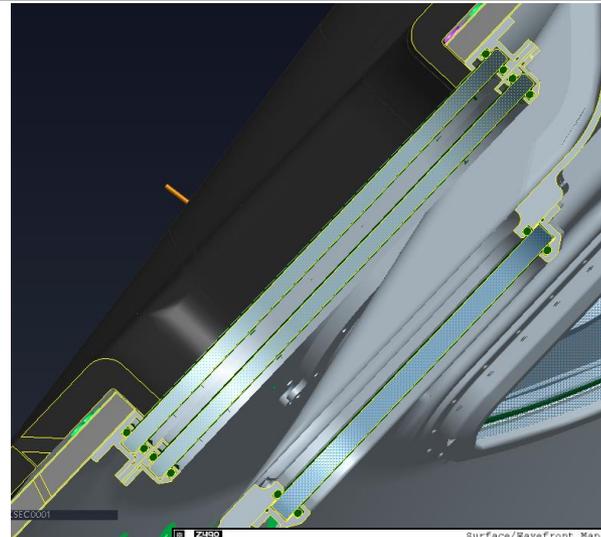
Orion Window Inspection

- Verification of Minimal Distortion of Spacecraft Windows
- Optical Interferometer Based Distortion Measurement System
- Custom Scanning System

Forward window composed of two fused silica panes and one acrylic pane

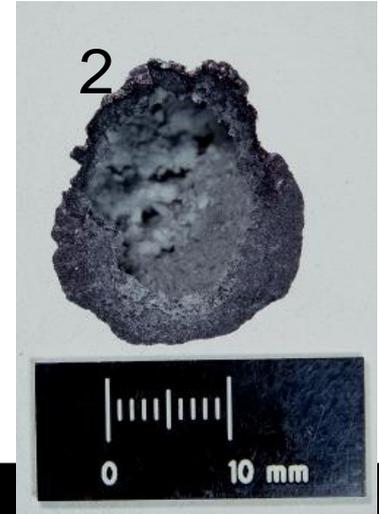
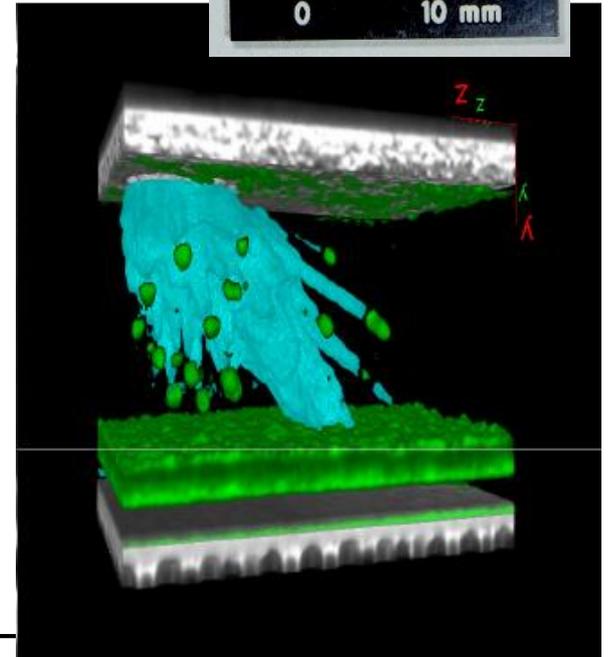
ISS Visiting Vehicle Inspection

- TPS damage due to prolonged exposure to MMOD while docked at ISS is the number one contributor to LOC risk for Soyuz, and future SpaceX Dragon and Boeing CST-100 Commercial Crew vehicles
- Assessing approaches to minimize risk
 - Development of Damage Assessment and Decision Plan
 - Evaluating various inspection/detection methodologies
 - On-board impact detection
 - Survey inspection using currently available ISS assets
 - New technologies for focused inspections
