## **Terra Mission Operations: Launch to the present (and beyond)**

Session 5: Earth Observing System (EOS) Terra I

Reference: SPIE Paper Number: 9218-21

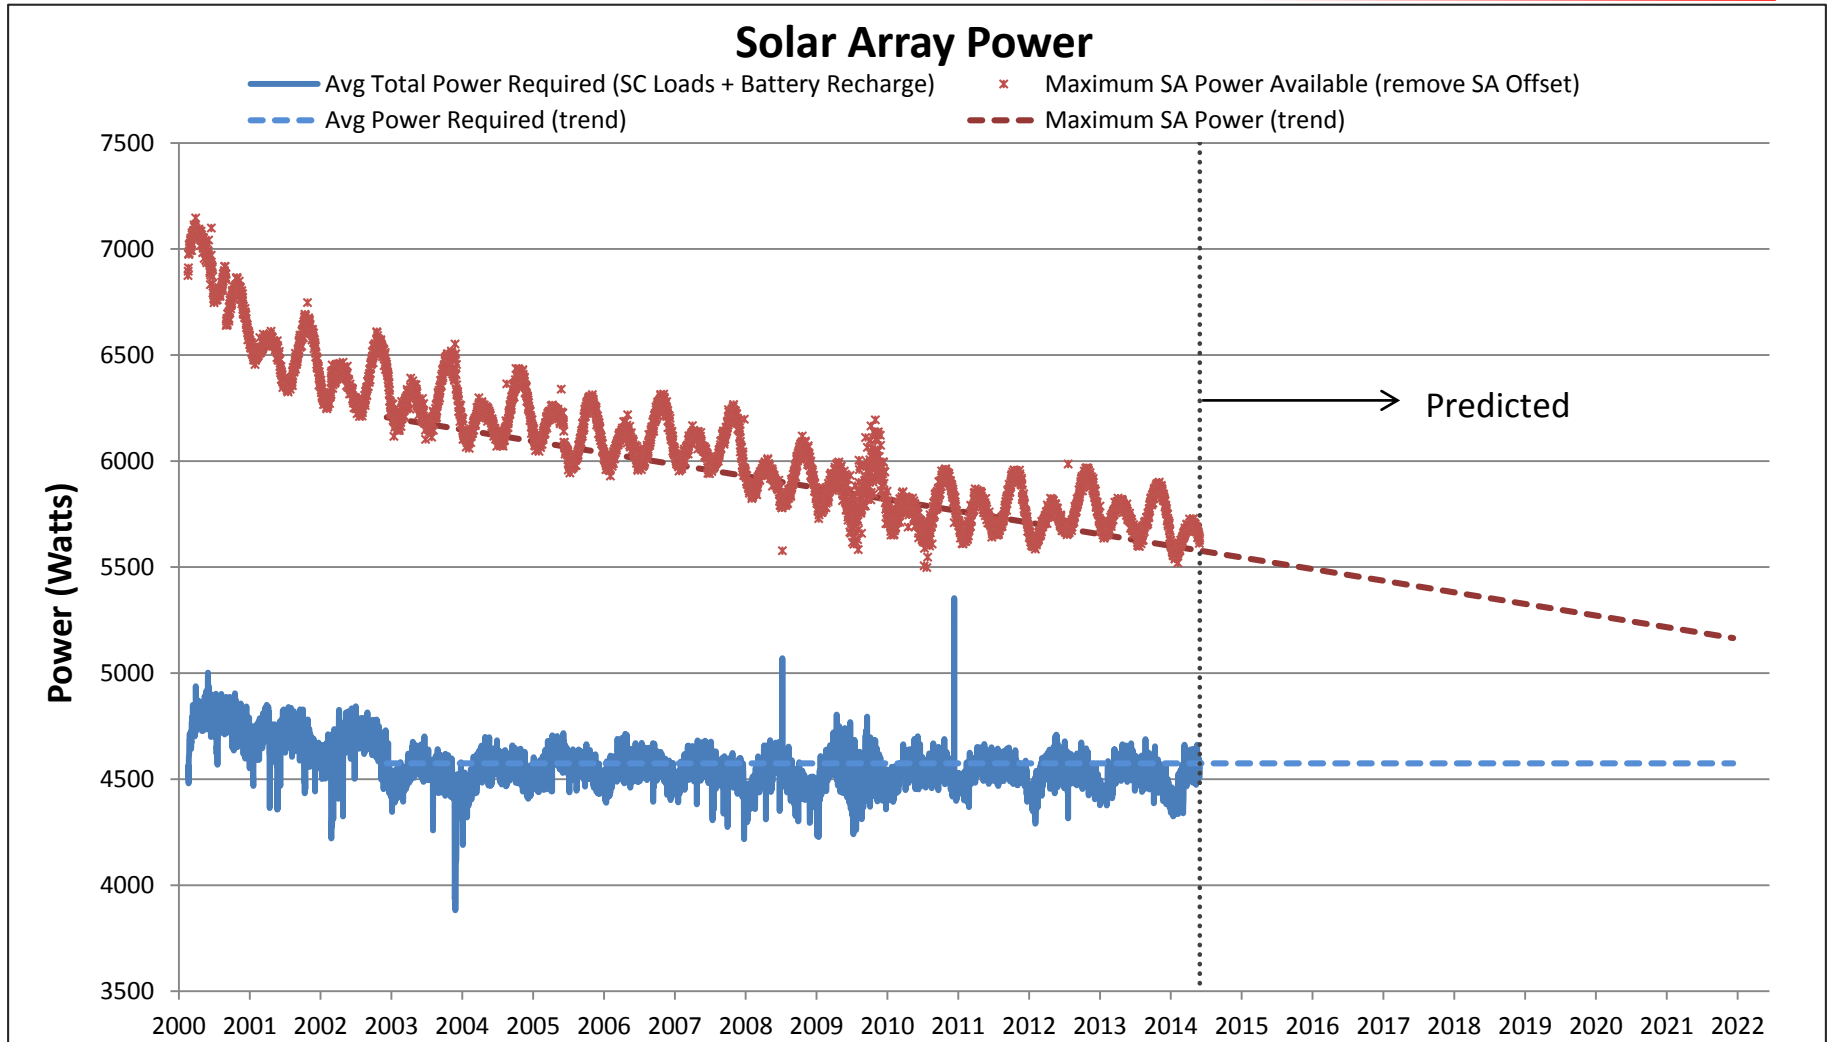
# SA Power Prediction

- Avg. Total Power Required is the power needed to support SC loads and battery charging
- **Assuming the current rate of SA power degradation, and assuming the same load required, Terra's SA should be able to support the power requirements through 2022+**

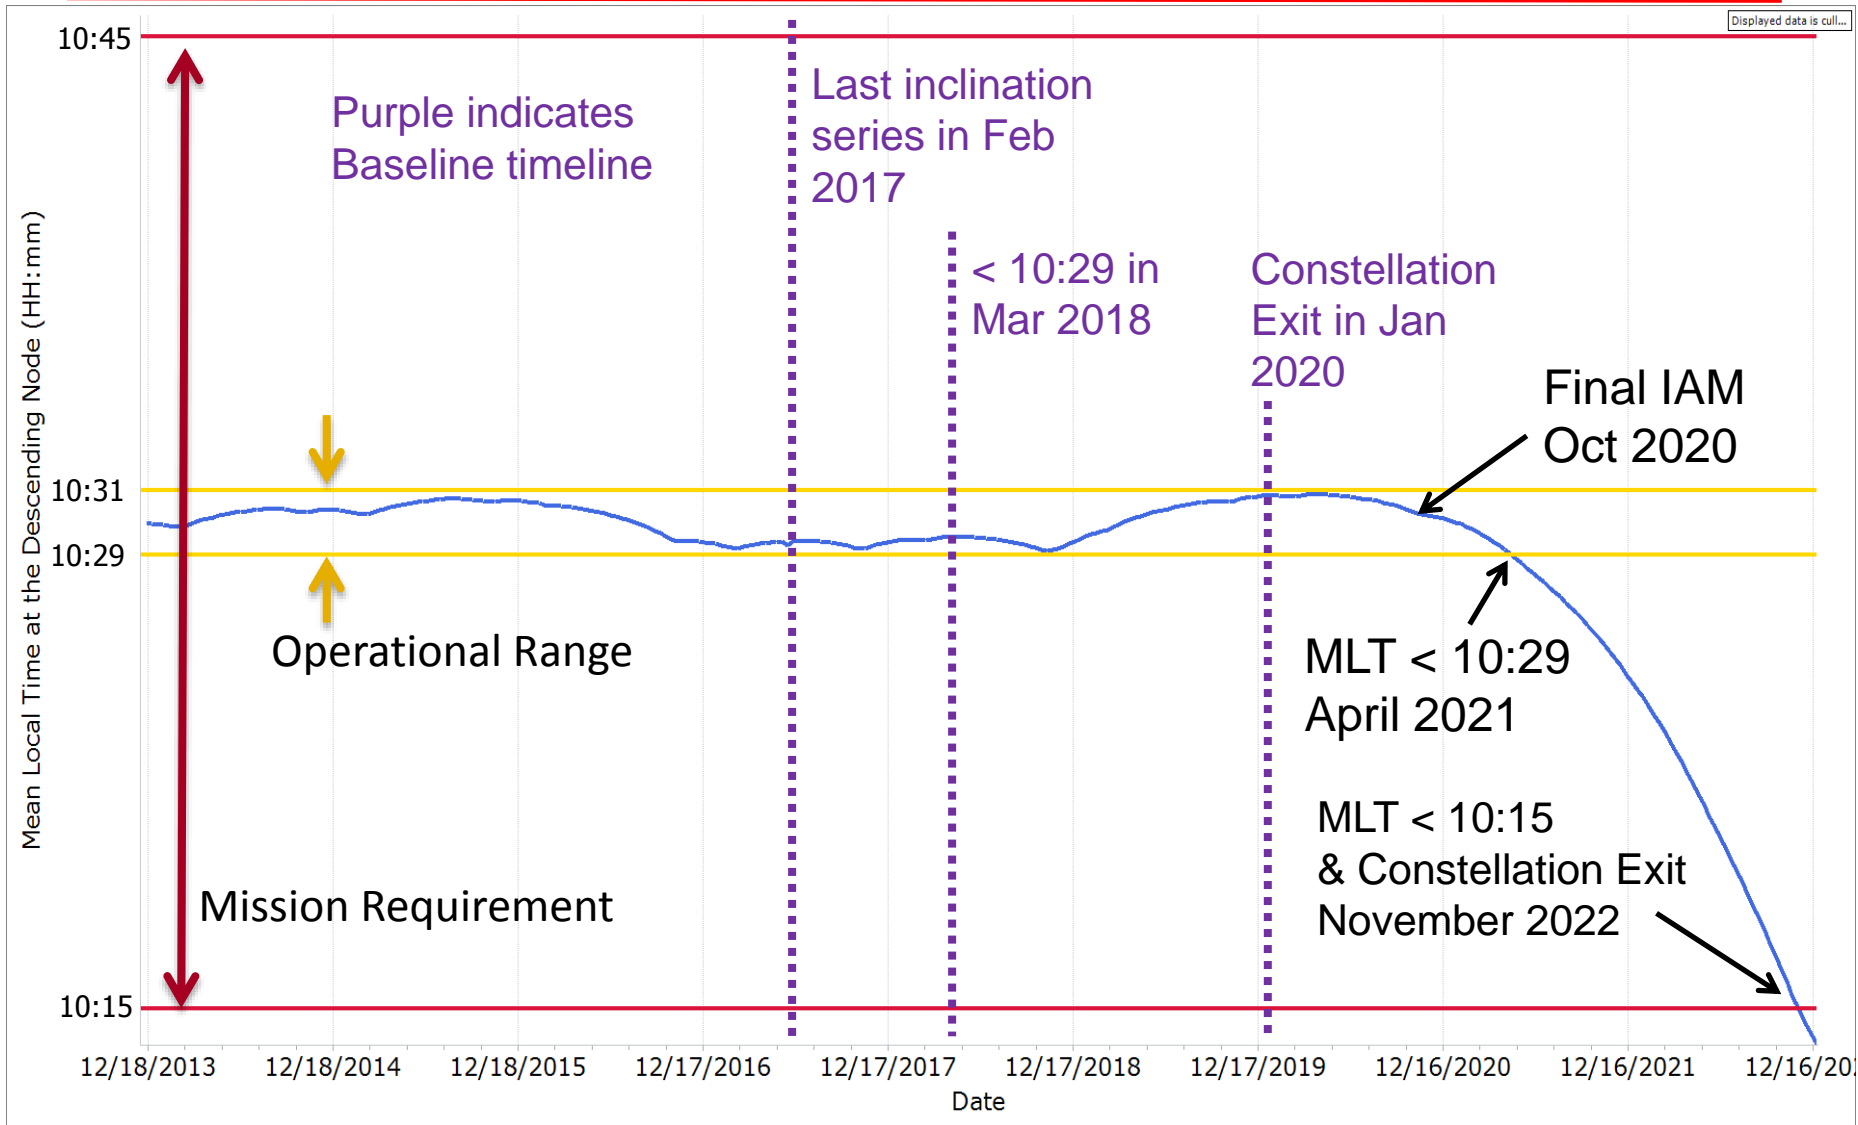
## Proposed Constellation Exit Plan

\*After Nov 2022 not Level 1 compliant
