Title: **A Biaxial-Bending Test to Observe the Growth of Interacting
Delaminations in a Composite Laminate Plate**

Authors: Mark McElroy
Wade Jackson
Mark Pankow

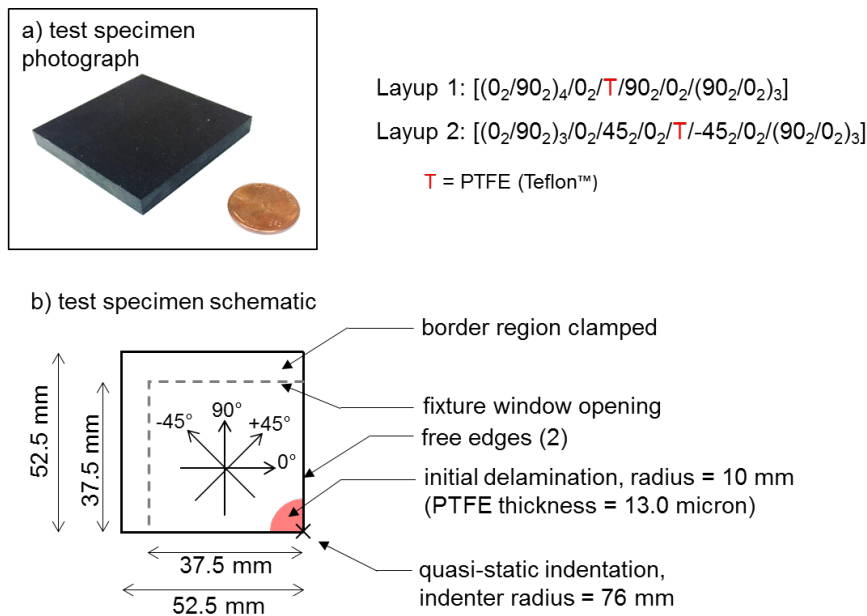
Figure 3. Test specimen description.

The CFRP test specimens were manufactured using an IM7/8552 carbon fiber-epoxy material system and cured according to the manufacturer's instructions [17]. The specimen geometry is described in Figure 3. Two layups were tested and the results are presented in this paper. The two layups selected were chosen so that migration could be studied through both 90° fibers and -45° fibers. Square plates (105 mm × 105 mm) were manufactured with a circular Polytetrafluoroethylene (PTFE) insert (13 micron thick, 10 mm radius) located at the center point of the plate at the interface designated by "T" in Figure 3. The plates were then cut symmetrically about the center point to create four 52.5 mm × 52.5 mm square test specimens, each with a quarter circle PTFE insert in one corner.

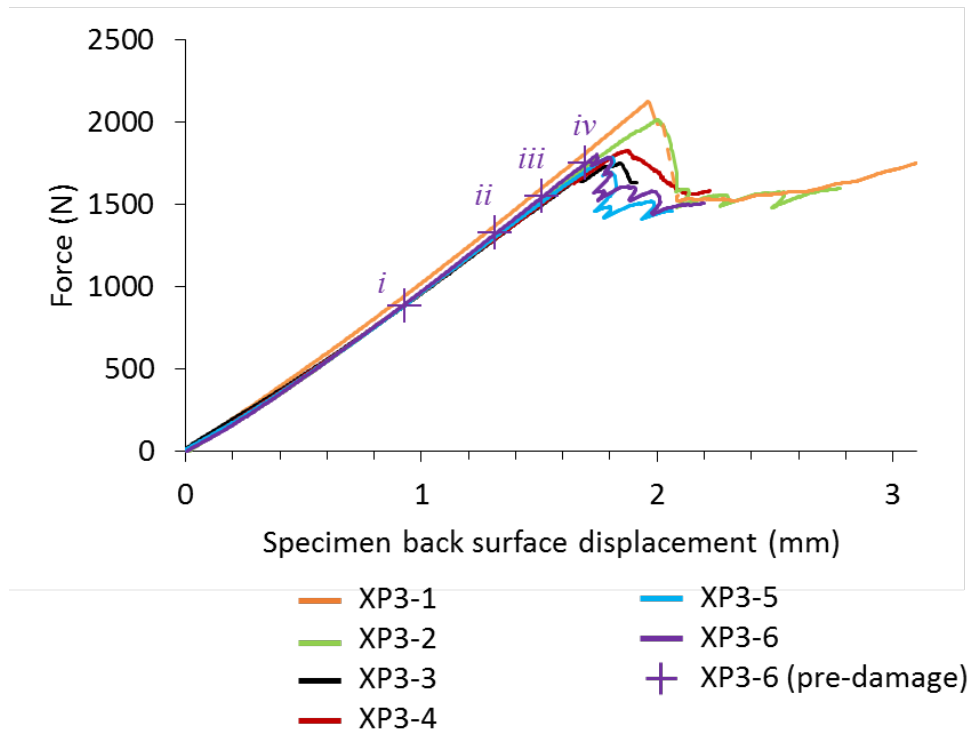
Figure 5. Force-displacement data from Layup 1.

Force-displacement data for all of the Layup 1 specimens tested are plotted in Figure 5. The curves from the tests where multiple load cycles were performed are plotted by showing only the regions from each load cycle that do not overlap with another. This manner of plotting multiple load cycles is illustrated in Figure 6, using specimen XP3-2 as an example. In Figure 5, for specimen XP3-6, the maximum forces for several “pre-damage” load cycles (as described in the Test setup section) are identified by points *i-iv*.

Damage behavior is consistent between all tests, though some variance can be seen in the force required for damage initiation (i.e., variance in the toughness at the PTFE boundary). After an initially elastic regime, the subsequent damage growth stability was dependent on how much strain energy had built up before initiation. In cases where the critical force was higher, initiation was followed first by unstable delamination growth and then eventually continued stable growth. In cases where the critical force was lower, damage growth was stable throughout. Dashed portions of the curve in all of the force-displacement plots in this paper are used in instances where, due to brief unstable growth and a resulting rapid deflection for a small amount of time, the deflection transducer lost contact with the specimen.

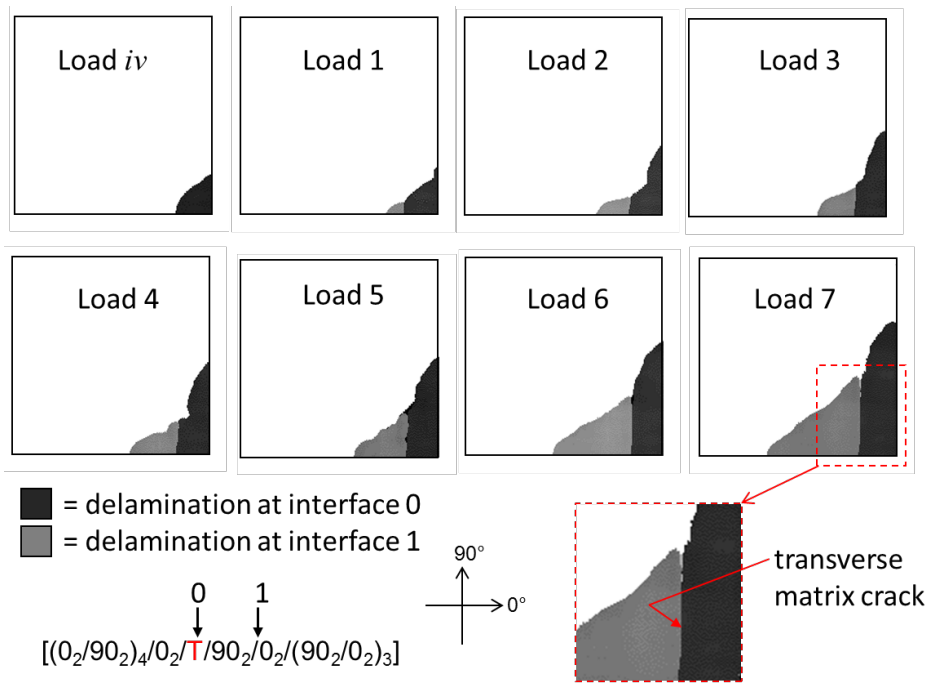
Figure 7. UT scans of damage in Layup 1.

UT scans are shown in Figure 7 from the “top” (i.e., loaded) side of test specimen XP3-6 for loading conditions from “pre-damage” load *iv*, just as delamination begins, through Load 7, after delamination initiation and migration. The bottom surfaces of the specimens were also scanned to confirm that no additional delaminations were present and were hidden in the shadow of those shown in the figure. The damage shown in Figure 7 is representative of damage seen in all of the Layup 1 specimens. Two delaminations grew during the test from the PTFE insert, at two interfaces identified in Figure 7. The scan labeled “Load *iv*” shows the PTFE quarter-circle insert, as well as the first instance of delamination growth at the region above the PTFE boundary near the right hand side of the specimen.

An isometric diagram of the specimen and matrix cracking is shown in Figure 8. In the region of the PTFE border near the lower edge of the specimen, the delamination migrated almost immediately down to interface 1 and then continued to grow at that interface, bounded below by 0° fibers. In the region of the PTFE near the right hand edge of the specimen, the delamination grew in the 90° direction and remained at that same interface (interface 0) bounded below by 90° fibers. Both delaminations grew simultaneously along a transverse matrix crack through the 90° plies between interface 0 and interface 1 as shown in Figure 7. The transverse matrix crack began as the initial migration from the PTFE film.

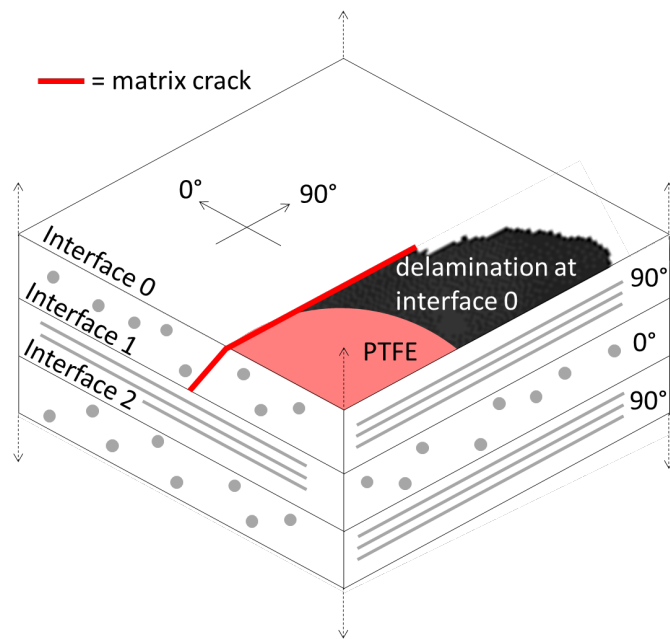
Figure 8. Matrix cracking diagram for Layup 1.

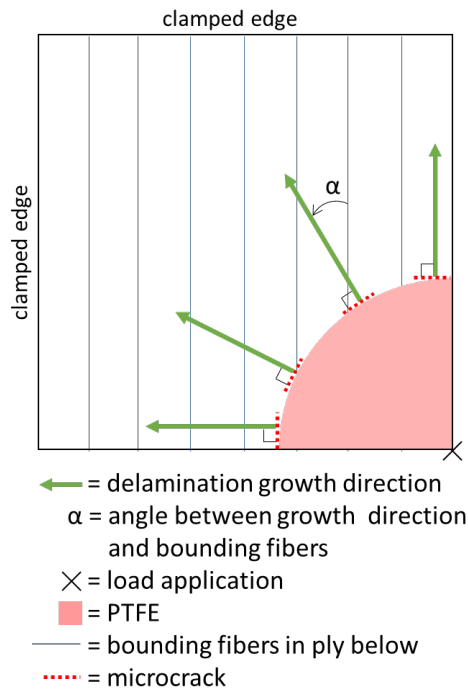
a) diagram of delamination growth direction and relative angle to bounding fibers

b) region on PTFE boundary where transverse cracks form

c) section view showing transverse cracks that formed where only one dominates and completes the migration process

Figure 10. Delamination growth and migration detail (CT images from specimen XP3-6).

Finally, for directions of delamination growth that are in between perpendicular and parallel to bounding fibers, there was a certain range of α where several transverse cracks formed and migration began; however, only the first transverse crack to form actually completed the migration process and led to continued delamination on the

new interface. This can be seen in the CT scans of one specimen, shown in Figures 10b and 10c. More investigation is warranted on understanding the occurrence of migration for delamination growth directions that are neither parallel nor perpendicular to bounding fibers.

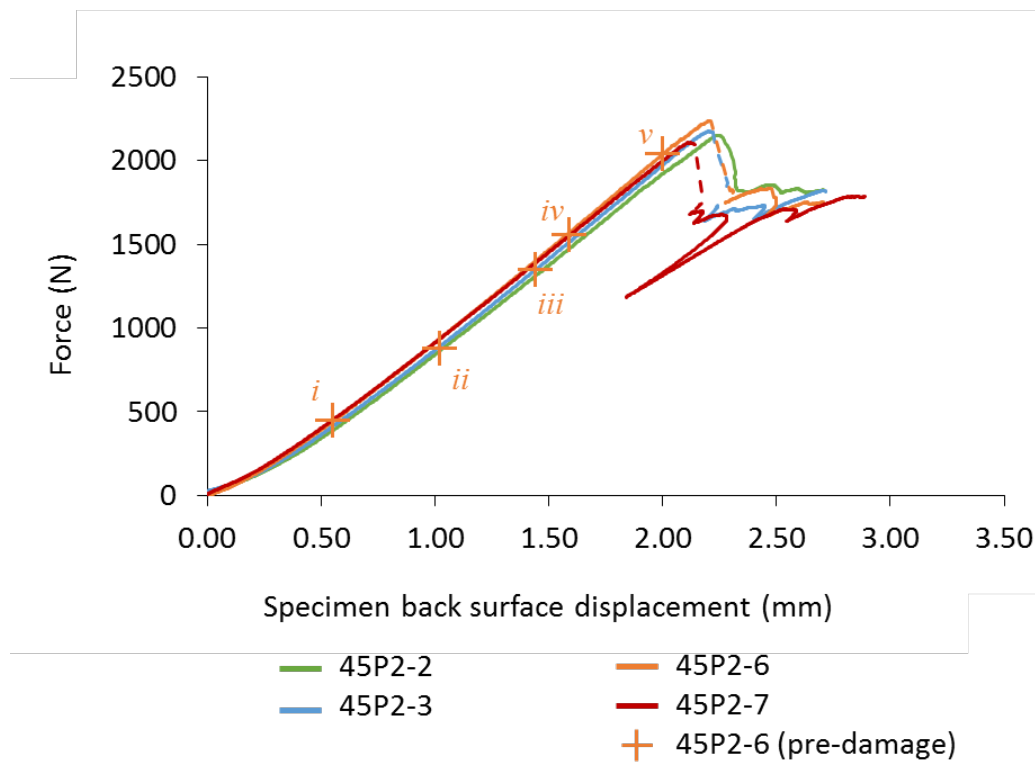
Figure 12. Force-displacement data from Layup 2.

Force-displacement data for all of the Layup 2 specimens tested are plotted in Figure 12. As in the Layup 1 data, the curves from tests where multiple load cycles were performed are plotted by showing only the regions from each load cycle that do not overlap with another (see Figure 6). For specimen 45P2-6, the maximum force for several “pre-damage” load cycles are identified by points *i-v*. The overall force-displacement data are similar to that of the Layup 1 tests, although less variance in the critical force was seen.

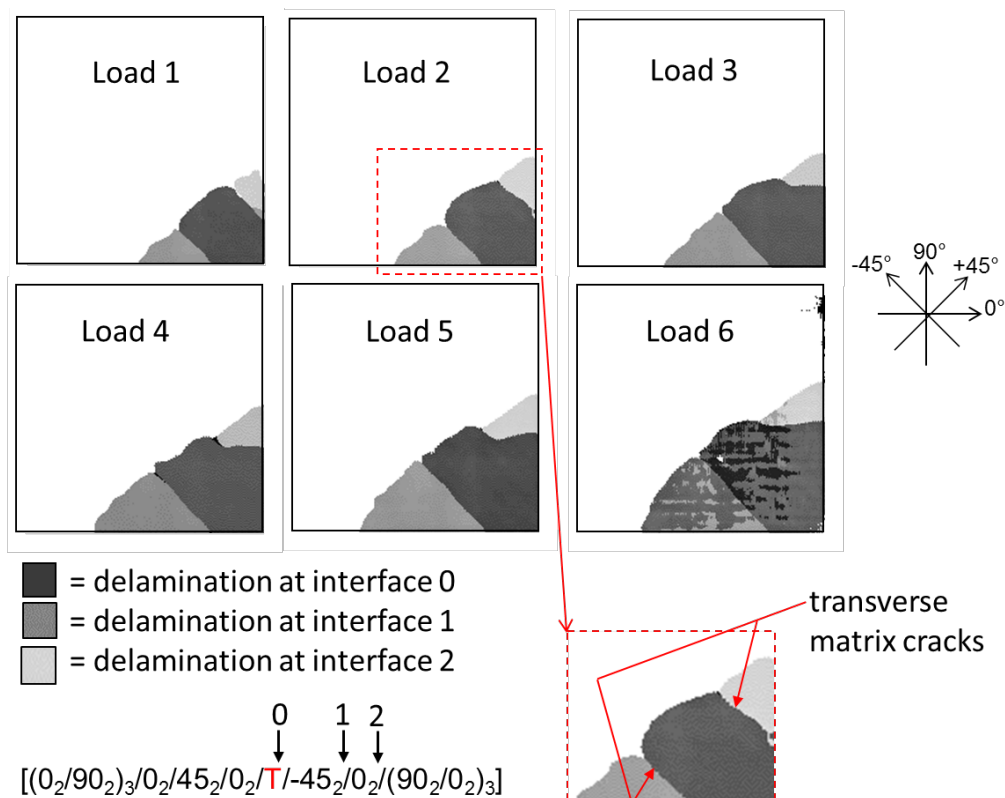
Figure 13. UT scans of damage in Layup 2.

UT scans are shown in Figure 13 from the “top” (i.e., loaded) side of specimen 45P2-6, which underwent six load cycles after the “pre-damage” loads. The damage shown is representative of damage seen in all of the Layup 2 specimens. Delaminations grew during the test from the PTFE insert at the three interfaces defined in Figure 13. In this layup, delamination emanating from the central region of the PTFE boundary remained at interface 0 and was bound by the -45° fibers below. In the region of the PTFE boundary near the lower edge of the specimen, the delamination migrated through the -45° plies and then continued growth in interface 1, bounded by 0° fibers below. In the region of the PTFE boundary near the right hand side of the specimen, the delamination migrated through both the -45° and 0° ply groups and then continued growth at interface 2, bounded by 90° fibers below. Additionally, in this region, as seen in Figure 13 at Load 3, the delamination at interface 0 has grown such that it obscures the already existing delamination below at interface 2. An isometric diagram of the matrix cracking is shown in Figure 14.

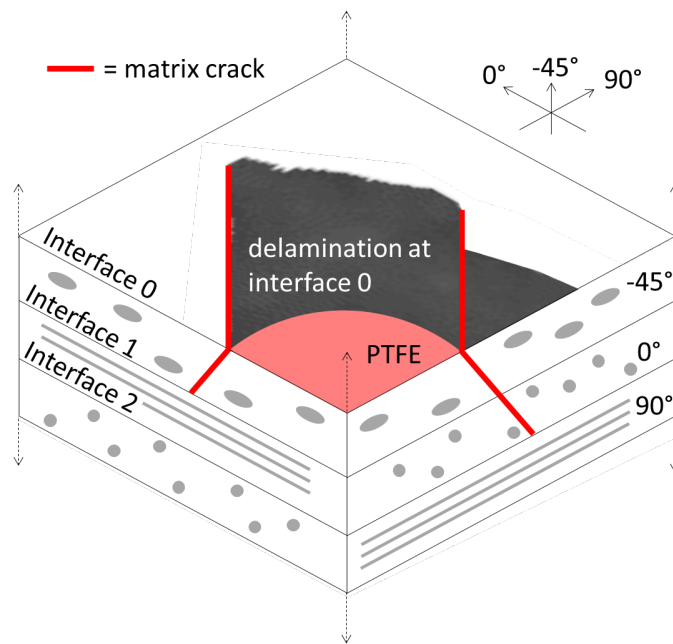
Figure 14. Matrix crack diagram for Layup 2.

The delaminations at interface 1 and interface 0 share a boundary consisting of a transverse matrix crack. The boundary that the delamination at interface 0 shares with that of interface 2 is more complex. From the interface 0, a transverse matrix crack extends down through the -45° fibers to interface 1 (“0-1 crack”). For this crack to proceed further on the same path through the thickness down to interface 2, fibers would have to be broken, which did not occur. Instead, a series of smaller disconnected transverse matrix cracks through the 0° ply below interface 1 formed along the path of the 0-1 crack. This is shown in the CT images in Figure 15. The damage pattern seen in the Layup 2 specimens is thought to be particularly useful for model development and validation, as it contains two types of interactions between delaminations: (1) a clean matrix crack through fibers of the same orientation and (2) a “staggered migration” consisting of a system of matrix cracks in different layers and at different orientations, but following the same global path through the specimen.
