# ISS and Orion Inspection Capabilities and Challenges

NASA Johnson Space Center  
Astromaterials Research and Exploration Science (ARES)  
Image Science and Analysis Group (ISAG)  
Robert Scharf / Jacobs / XI4  
Randy Moore / XI4  
<http://isag.jsc.nasa.gov/>

January 2017

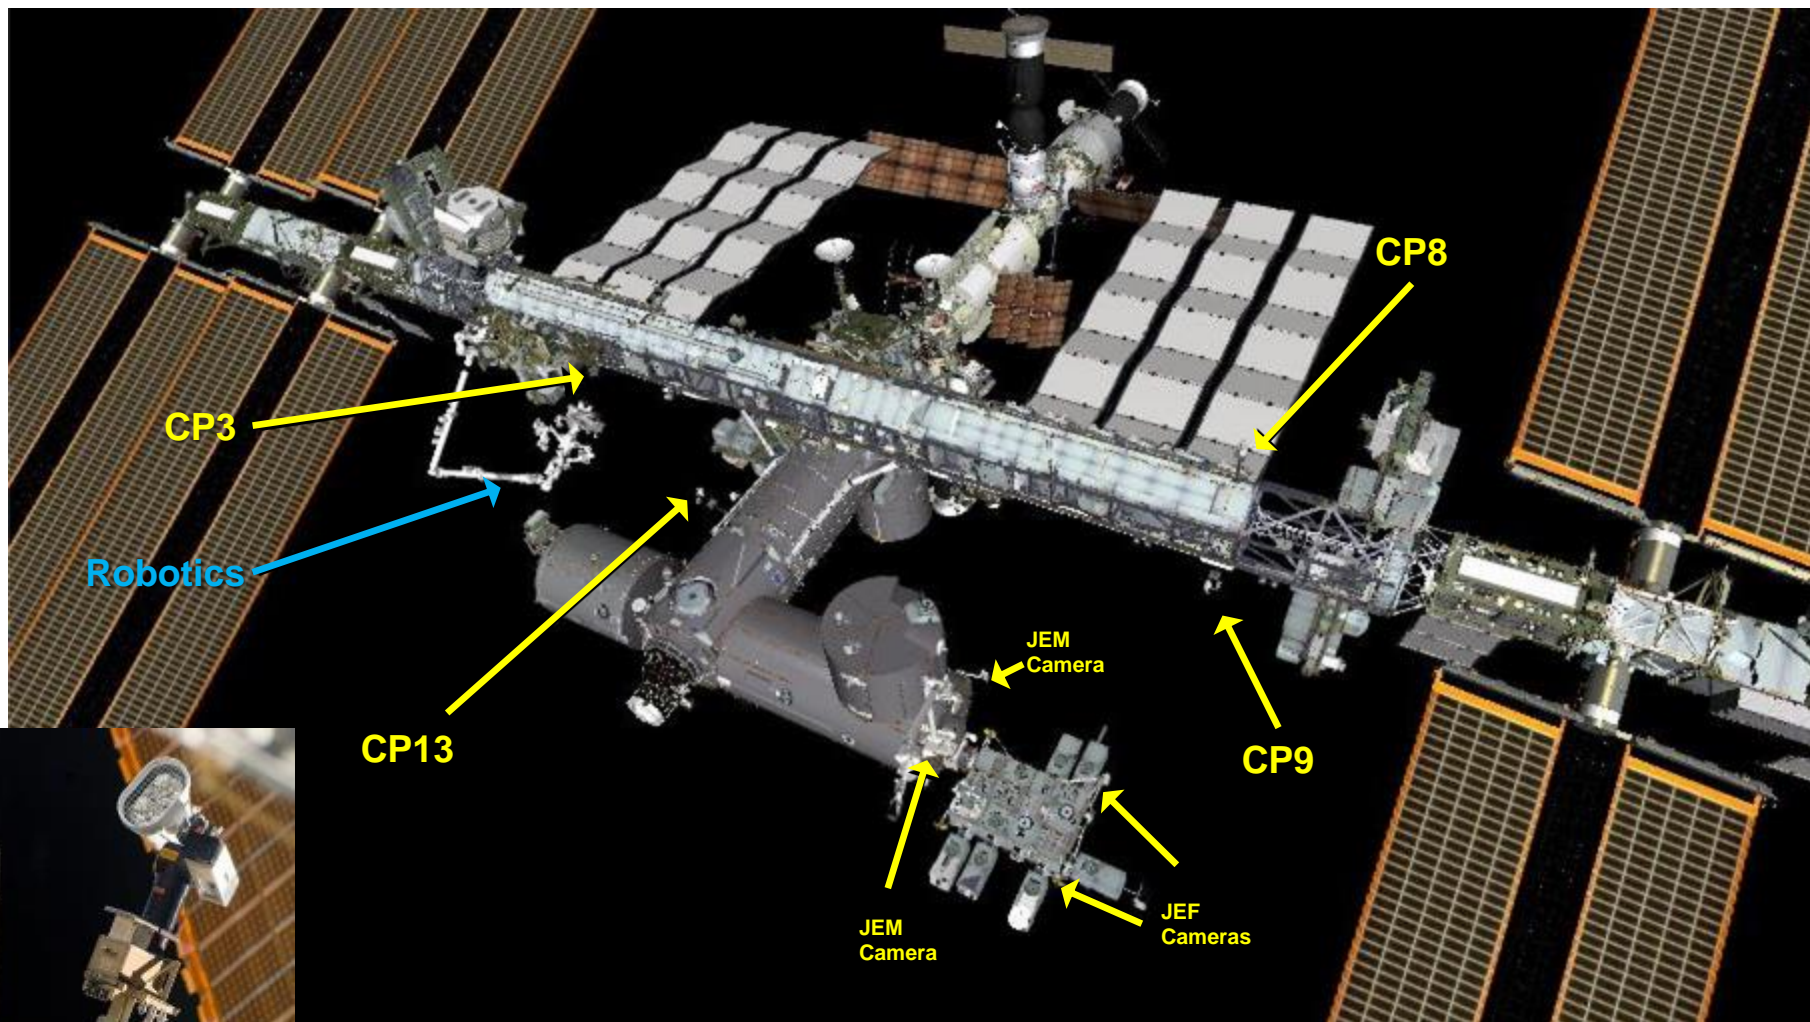
# External ISS Television Cameras

ETVCG – External TV Camera Group (4)  
 NTSC, 525 horizontal lines (USOS Standard)  
 CCD sensor  
 FOV: Max: 77x61 Min: 10x8°  
 Zoom ratio ~8:1

JEM EF – JAXA Experiment Module  
 Exposed Facility  
 NTSC, CCD

*Note: Nikon D4 DSLR/ with 56-600 equiv. zoom lens to be attached to each ETVCG (2016/2017)*

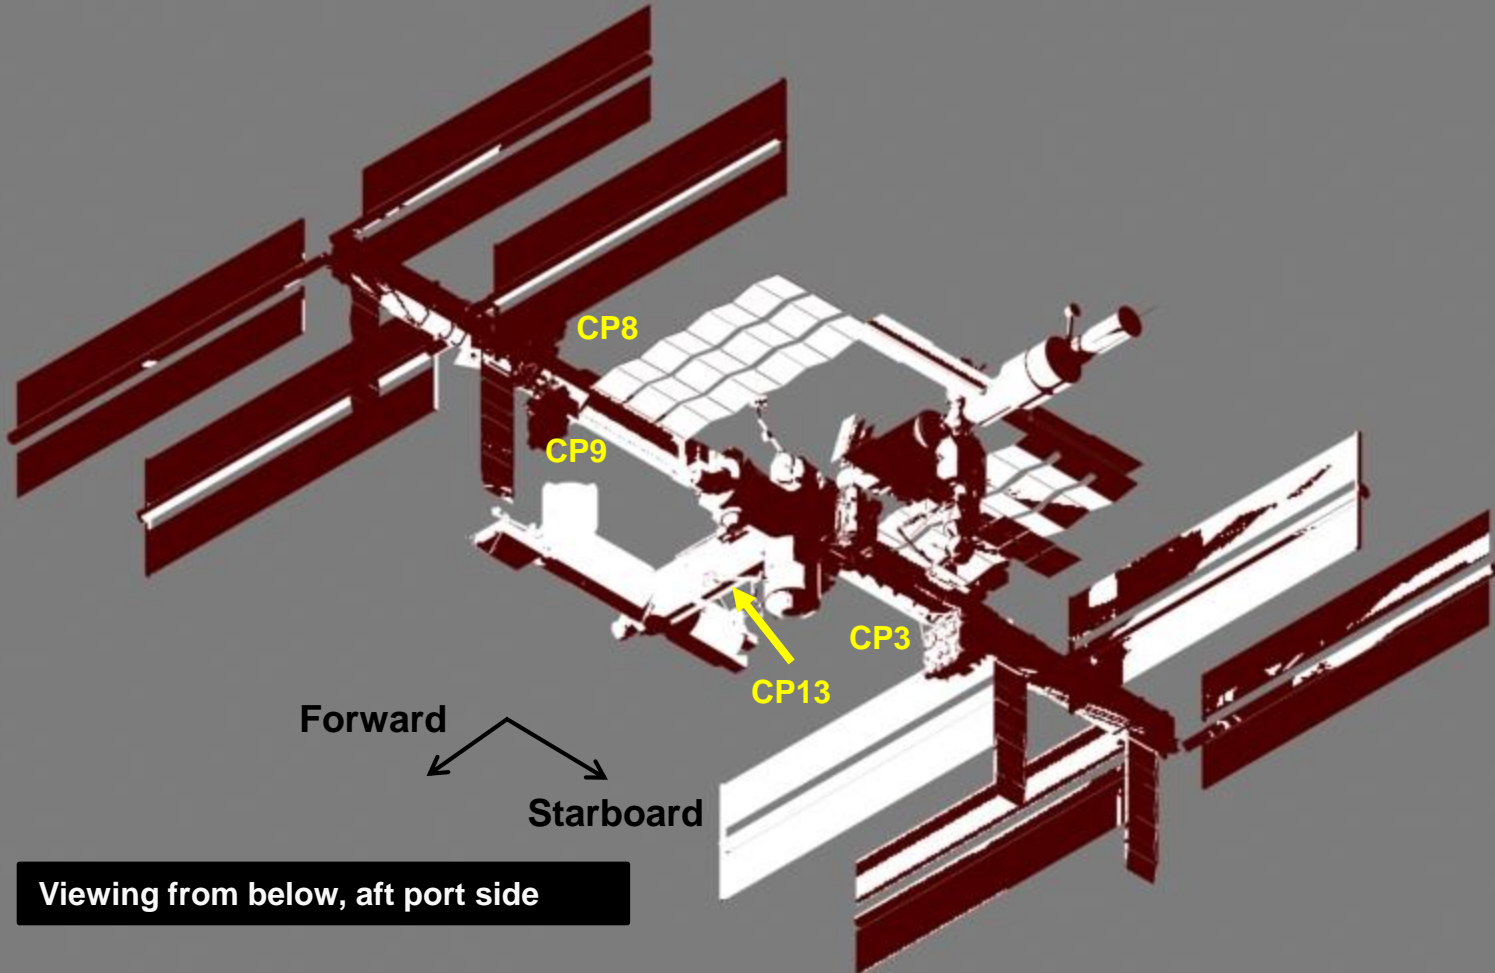
# External TV Camera Coverage (ETVCGs (4) + JEM (4))

Brown shading shows current ETVCG and JEM cameras  
“blind spots”

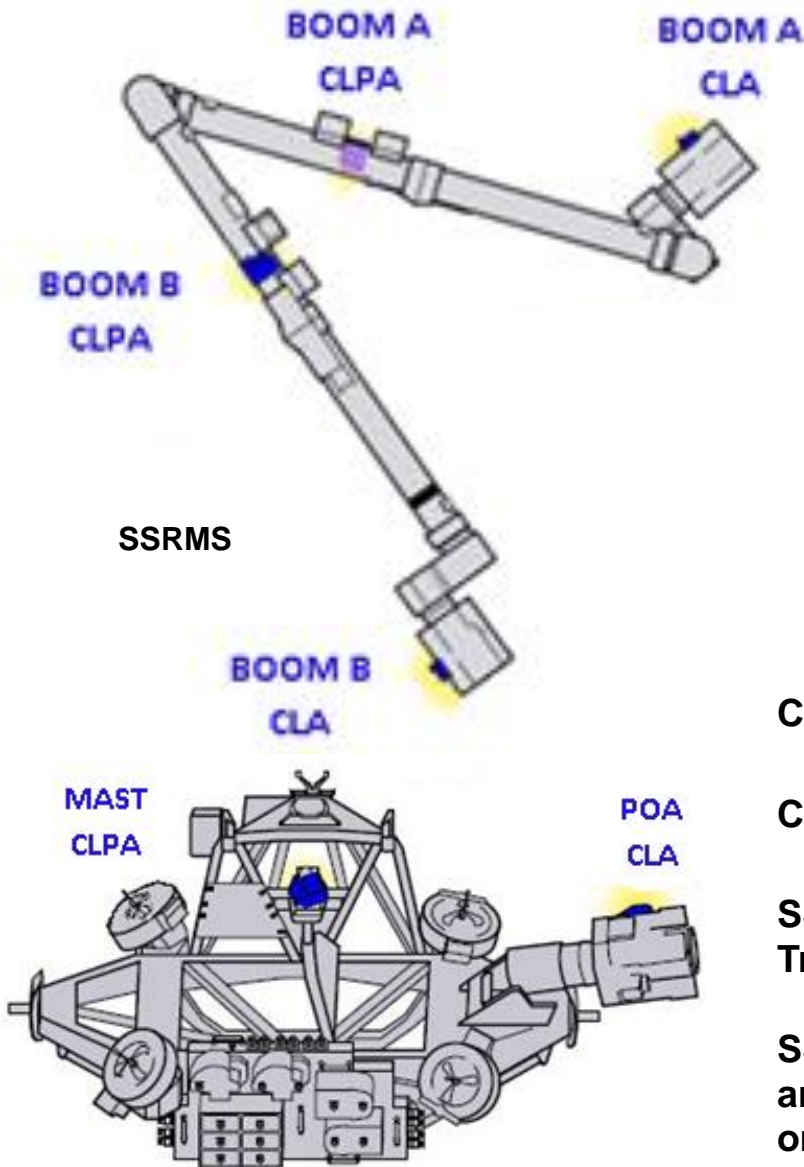
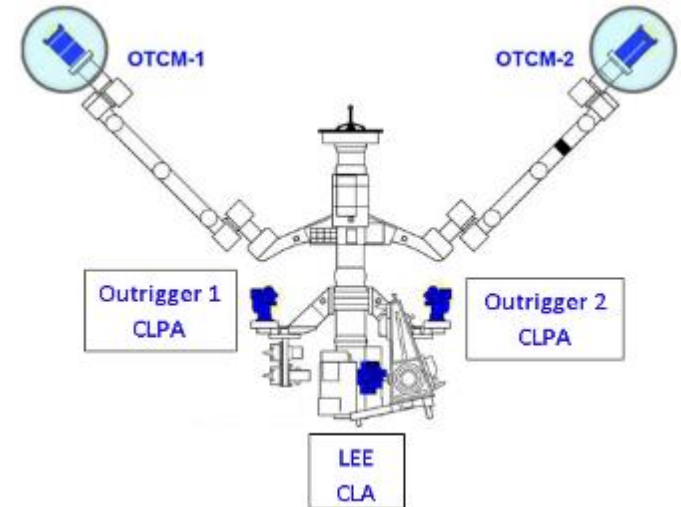
# External Robotic Television Cameras (Mobile Servicing System)

Mobile Base System

Special Purpose Dexterous Manipulator (SPDM)/DEXTRE

CLA - Camera and Light Assembly (CLA)

CLPA - Camera / Light / Pan-Tilt Unit Assembly

SSRMS moves along truss when attached to Mobile Transport/Mobile Base System (MT/MBS).

SSRMS is operational along truss at MT Worksites and Power and Data Grapple Fixtures (PDGF) located on USOS modules and Russian FGB.

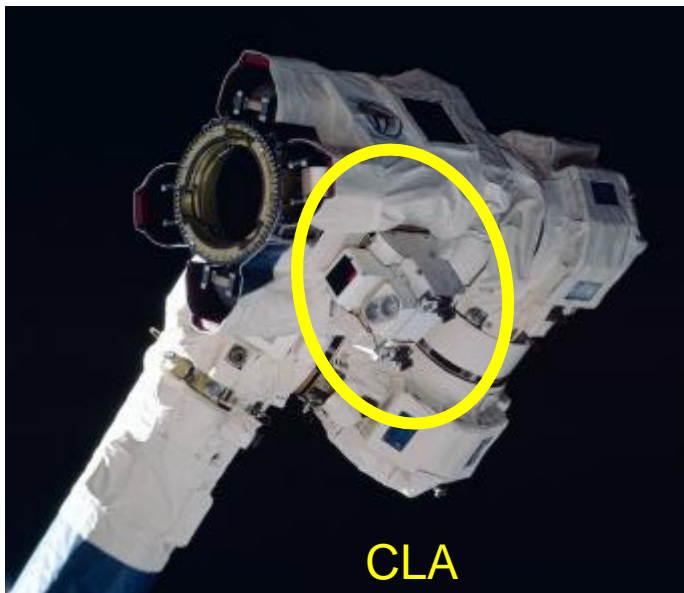
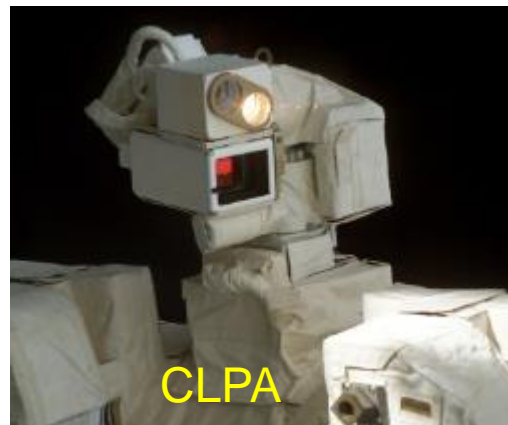
# External Robotic Television Cameras (Mobile Servicing System)

- Both CLA and CLPA utilize the same CCD camera and lights
- FOV Max ~ 52° x 40°, ~9mm focal length,  
Min ~ 6°x4° , ~84mm focal length
- Zoom ratio ~9:1
- The minimum viewing distance is 14 in.
- MSS camera “detectable” resolution at max zoom is approximately
  - ~.2 inch at 25 feet
  - ~.4 inch at 50 feet.
- Standard ETVCG and MSS frame rate: 30 fps

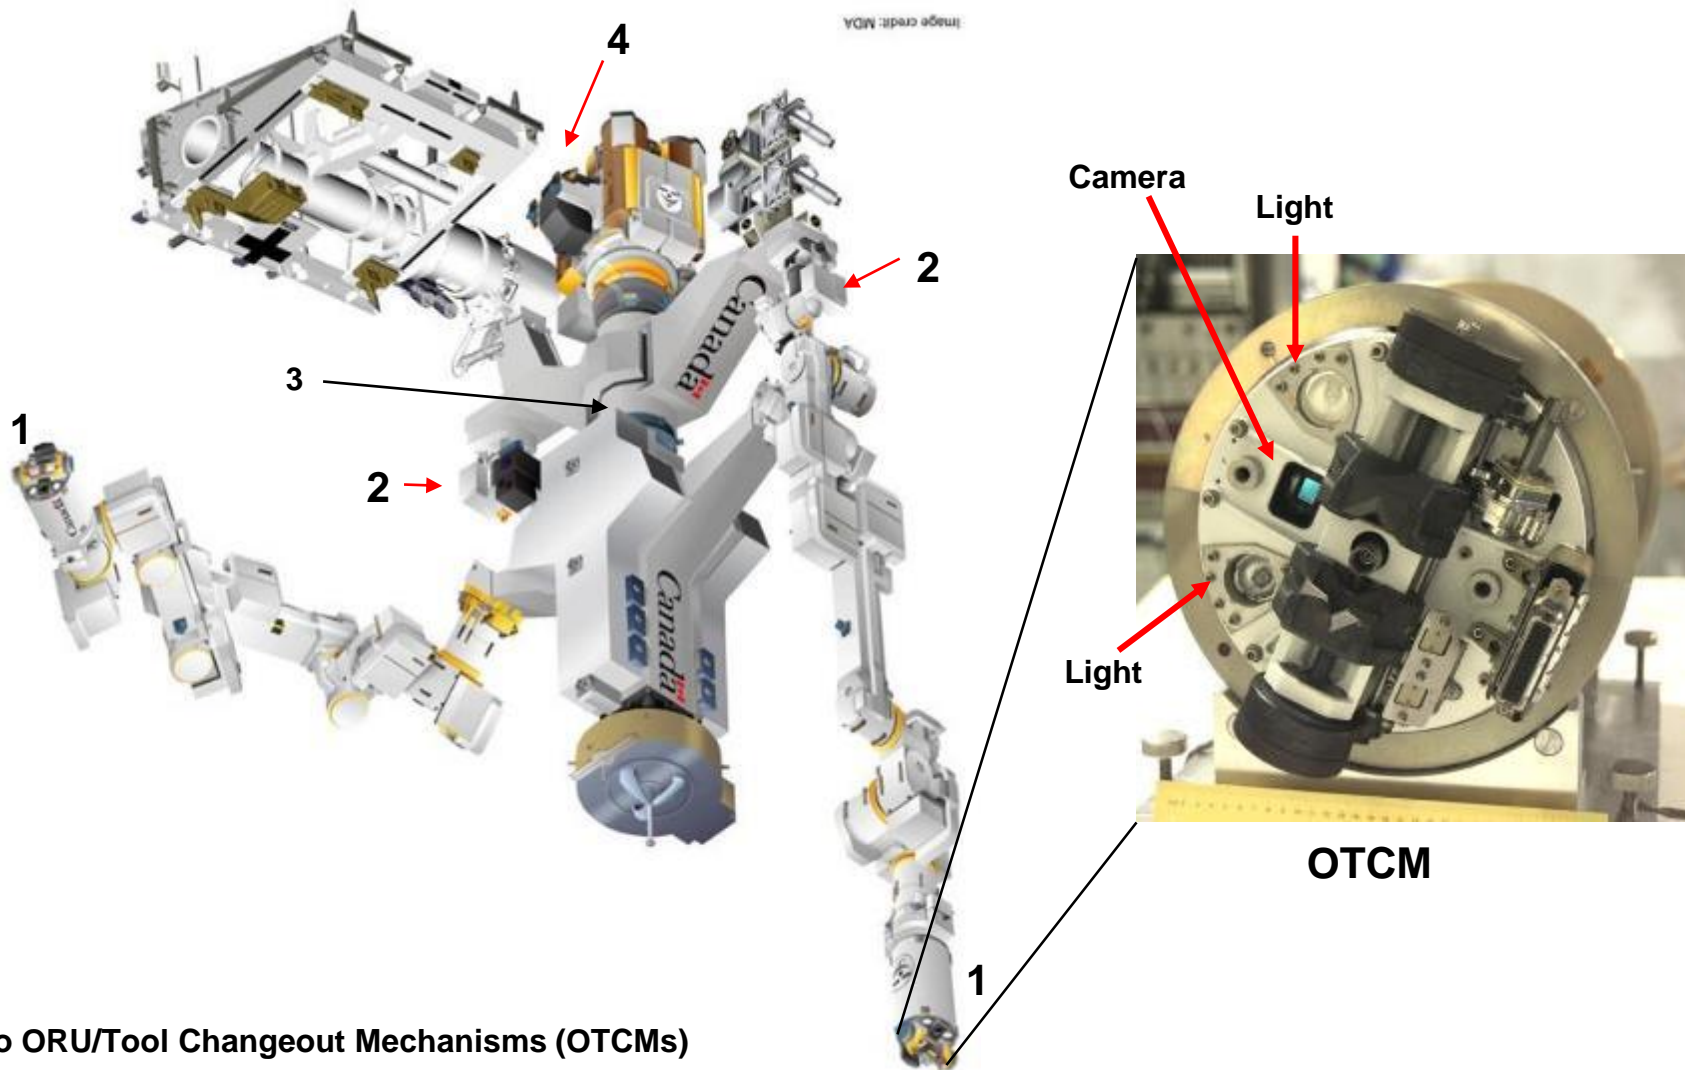
# SPDM (DEXTRE)

1. Two ORU/Tool Changeout Mechanisms (OTCMs)
  - 640x480, fixed focus, wide FOV, black/white
2. Two Camera/Light/Pan-Tilt Assemblies (CLPAs);
3. Body Roll Joint
4. SPDM Latching End Effector (LEE) with Camera/Light Assembly (CLA)

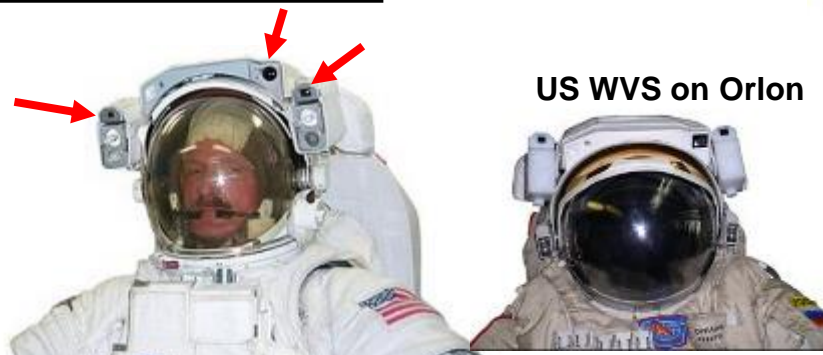
## Wireless Video System

- Three SONY XC-999 cameras
- HFOV = 85°, 56° and 30°
- Fixed depth of focus 12 inches to 25 feet.
- Detectable resolution .25-.5 inch at 10 feet.

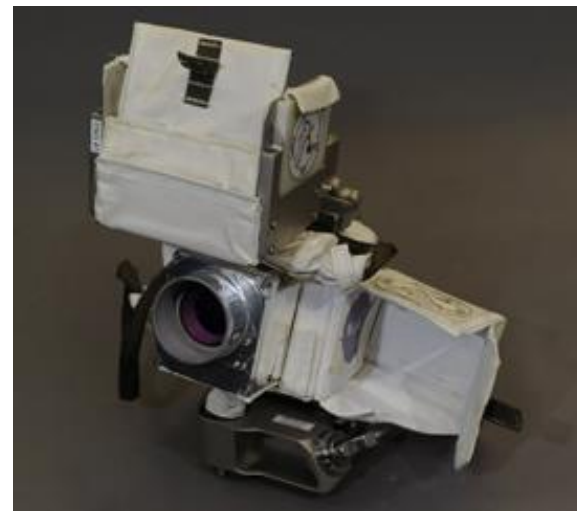
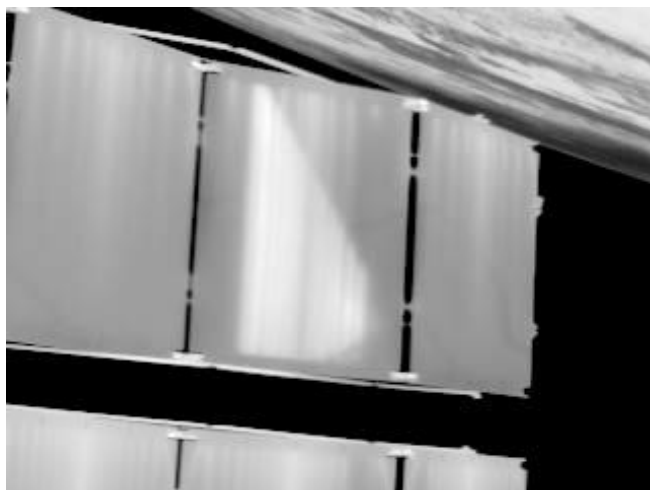
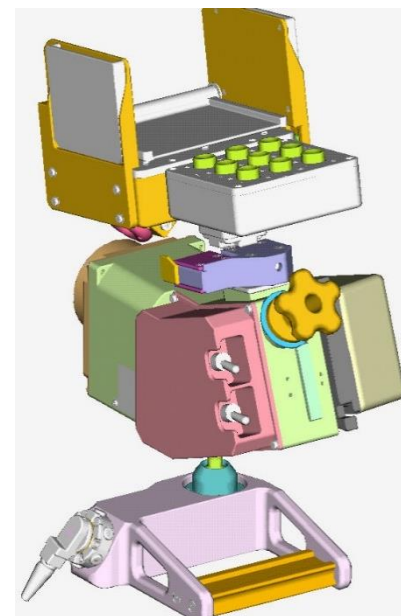
## Repackaged FLIR Systems ThermaCAM S60 Infrared Camera

Used for inspections of:

- Electrical components
- Radiators
- Solar Arrays
- Heaters

**Infrared View of Damaged Thermal Radiator  
(back-side surface)**

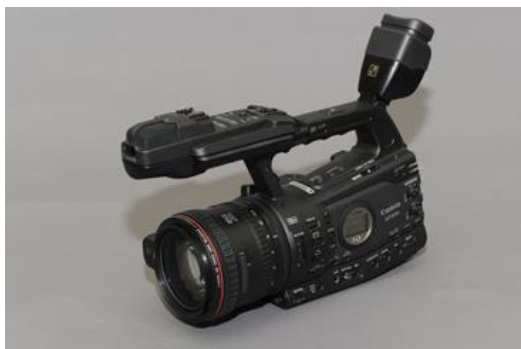
Canon XF305 – mounted and handheld.

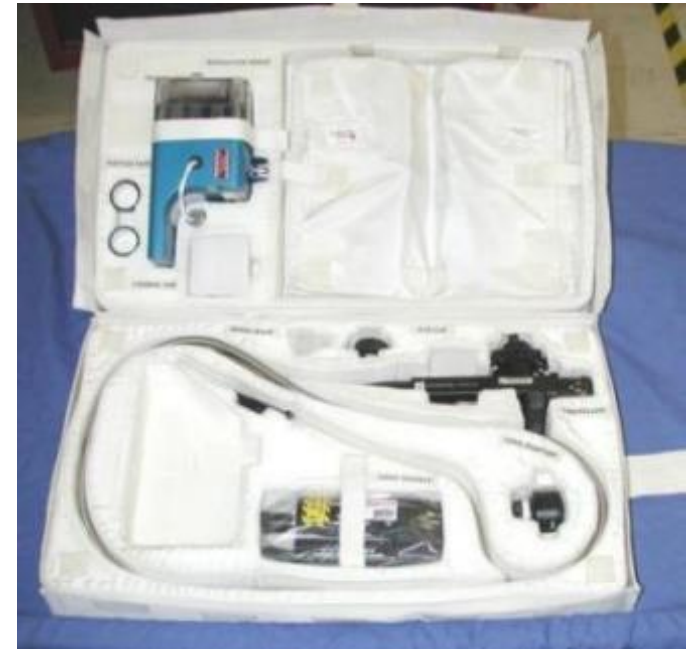
**Sony XC-999 Mini-cam**  
**Video camera with fiberscope**

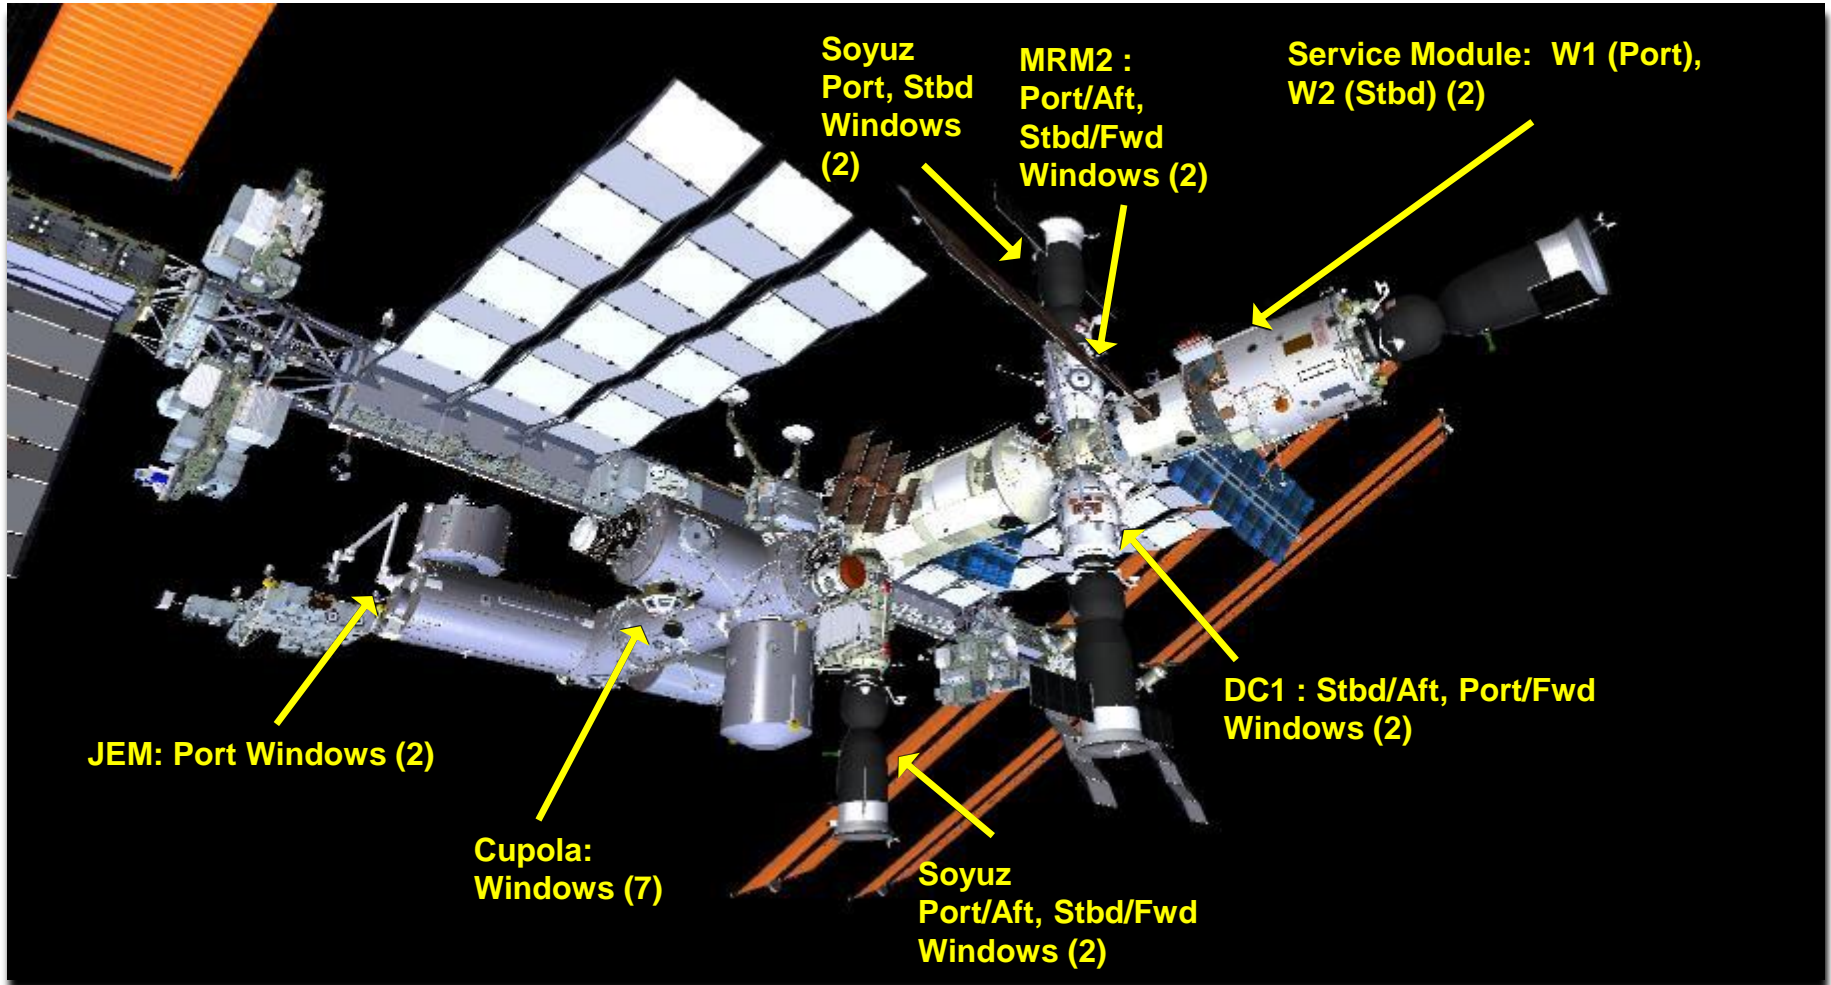
# Windows for External Surface Inspection

Russian segment and Cupola windows provide coverage of truss aft surfaces and JEM windows provide coverage of port, forward truss surfaces not visible in ETVCG blind spots.

Obstructed and Earth facing windows are not referenced.

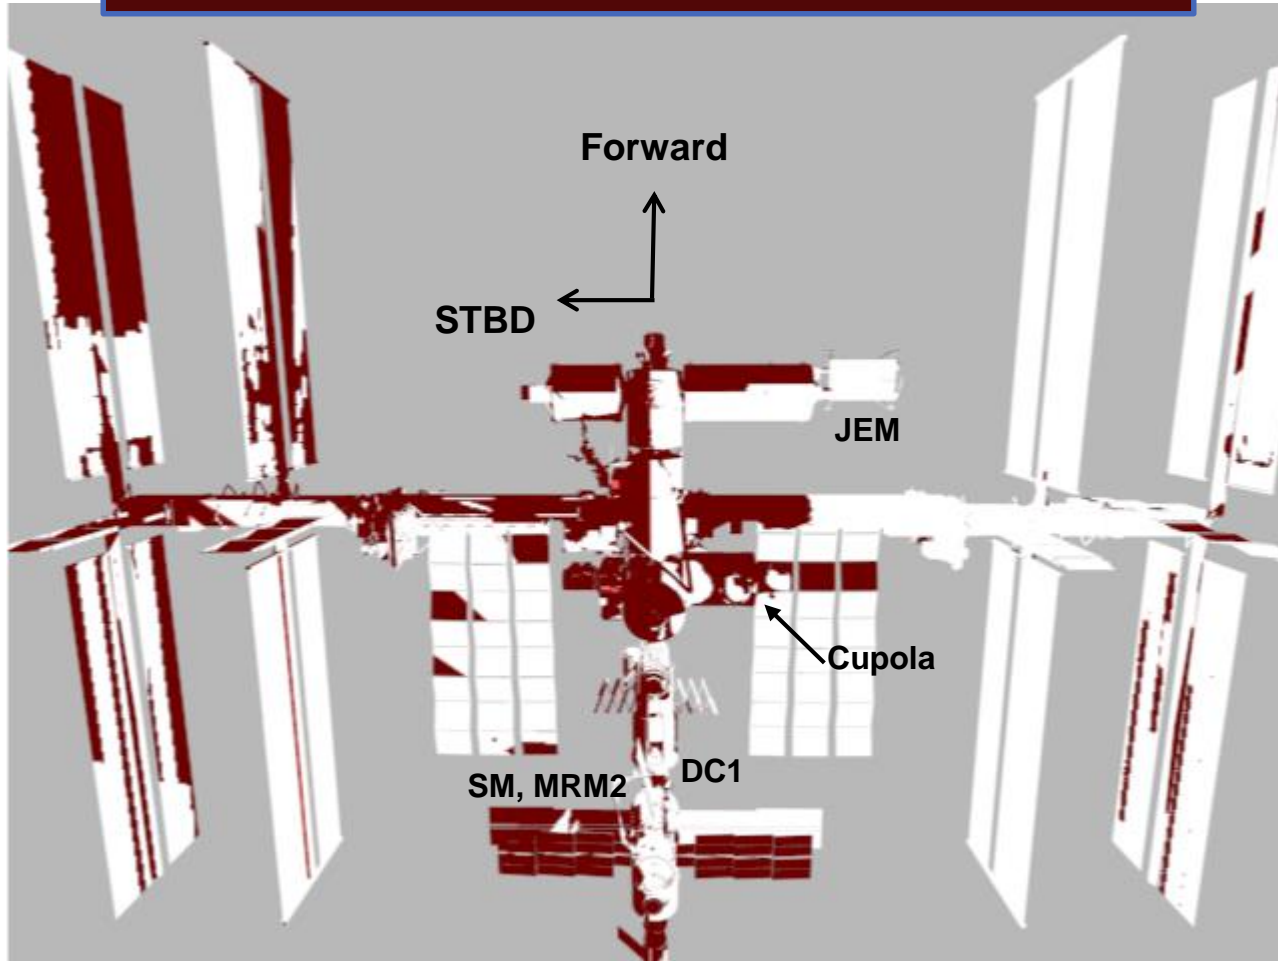
# ISS Window View Coverage

Brown shading shows window “blind spots”

Viewing from below

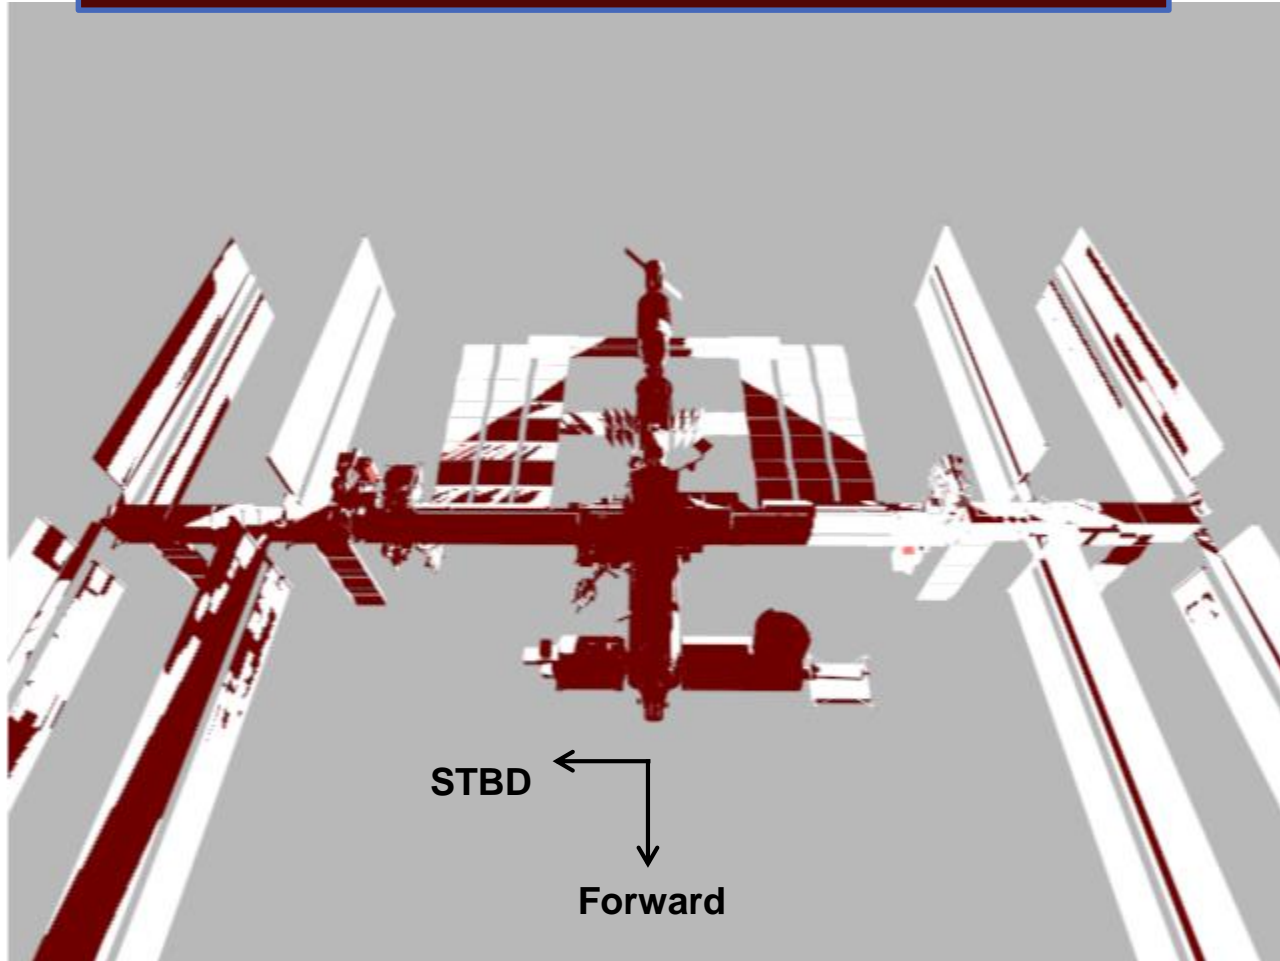
# ISS Window View Coverage

Brown shading shows window “blind spots”

Viewing from above

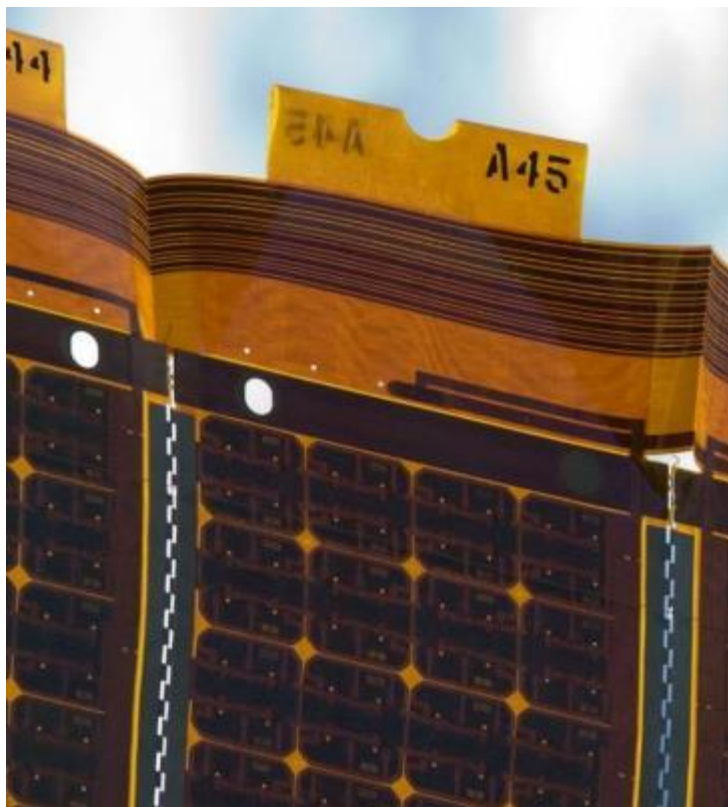
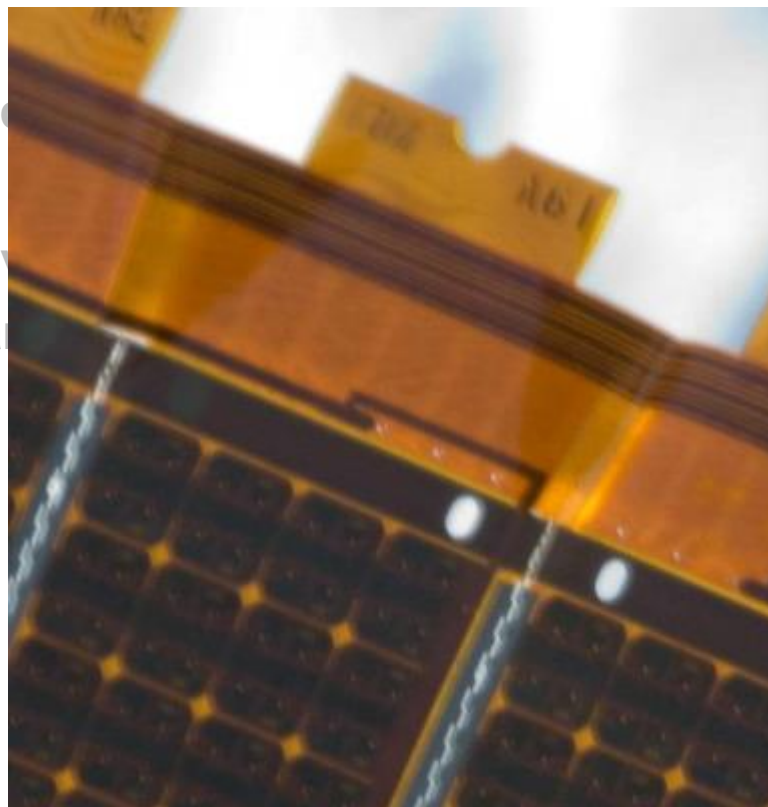
- Limited windows, numerous blindspots
  - Distance and high incidence viewing
- **Protective plastic scratch panes installed over Cupola and JEM windows reduce image resolution but need strong justification for removal and the Cupola scratch pane removal and reinstallation process is time consuming (1- 4 hours).**

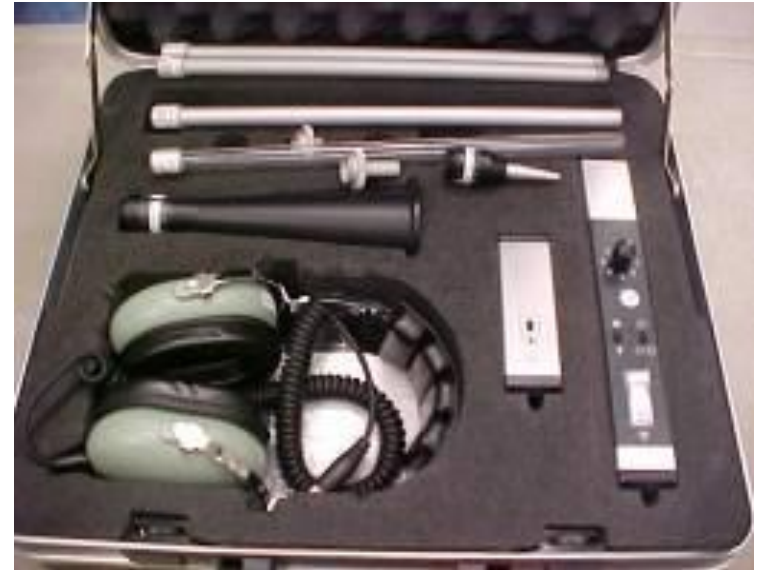
- **Handheld Ultrasonic leak detector**
- **Ammonia Mass spectrometer**

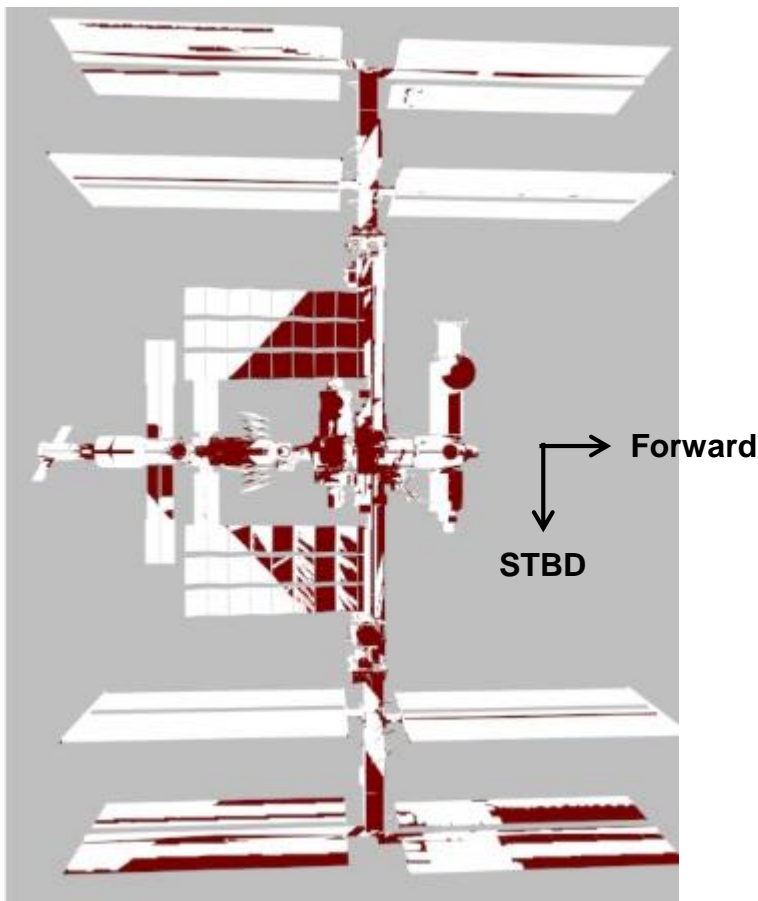
# ETVCG & JEM cameras and Windows Viewing Coverage

Brown shading shows combined window and external stationary camera “blind spots”

Viewing from above

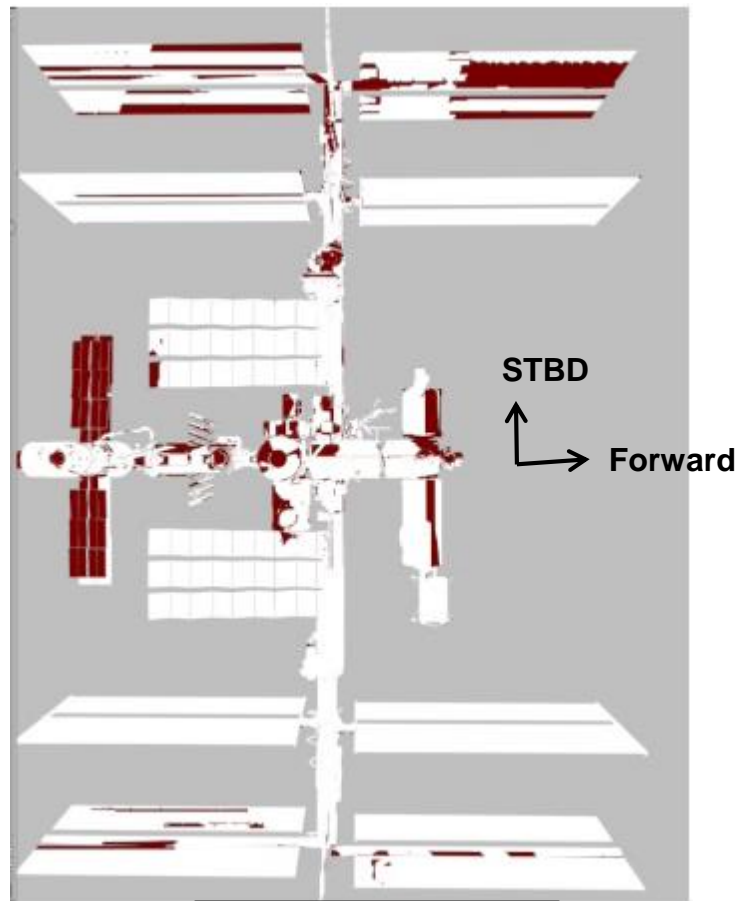
Viewing from below

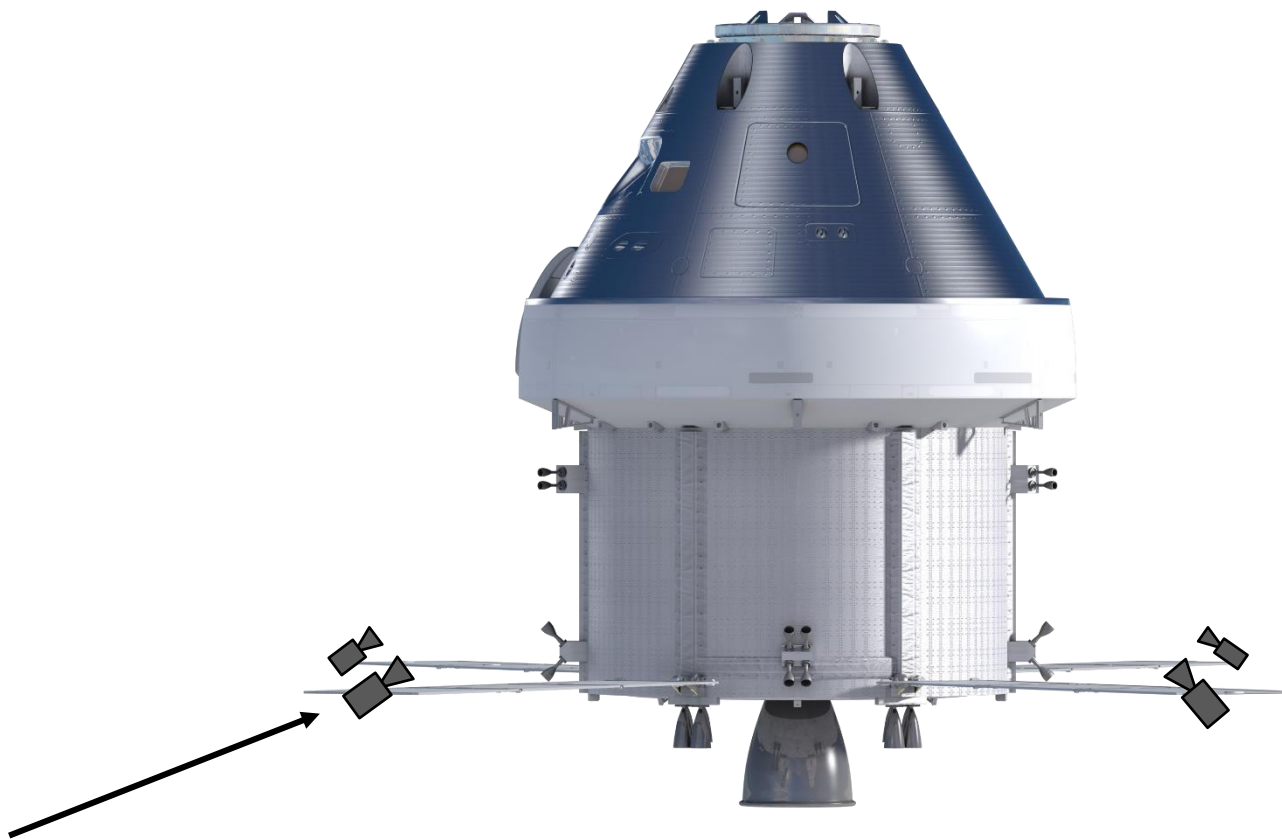
# EM-1/EM-2 Solar Array Cameras

- **Solar Array cameras are modified GoPro Hero 4**
  - 12MP (4000 x 3000) CMOS Sensor
  - Streaming low resolution video via Wifi
  - Full resolution video and stills stored in camera microSD card for later WiFi transfer to vehicle comm system
    - Planned inspection modes: 12MP stills (Individual and Time Lapse)
    - Planned video rates (other events) of 4K @ 30 fps, 1080P @ 30 fps, Night Lapse

- Crew Module (CM) inspection
  - Orient Crew and Service Module (CSM) with sun on  $-X$  (i.e. centerline) axis.
  - Pitch SAW1 through SAW4 inner gimbal forward 55-deg and capture full resolution still images.
  - Capability to fill in any missing CM surface by pitching and rolling arrays and camera as needed if inner gimbal lowered to 25-deg.

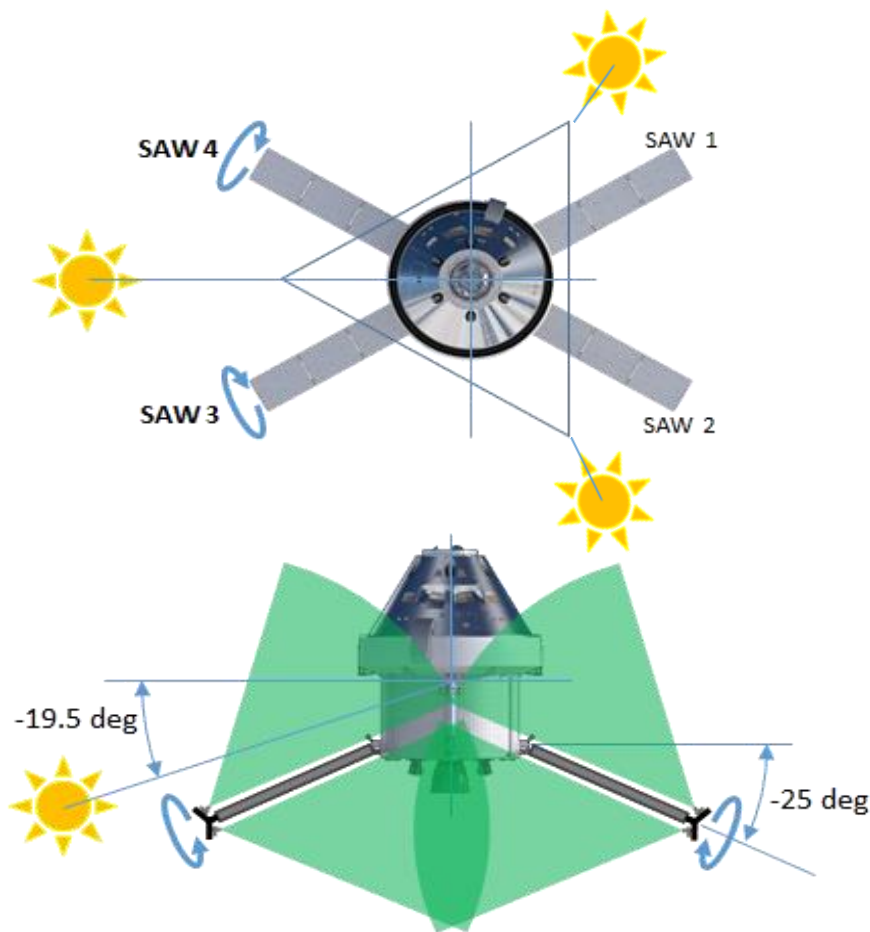
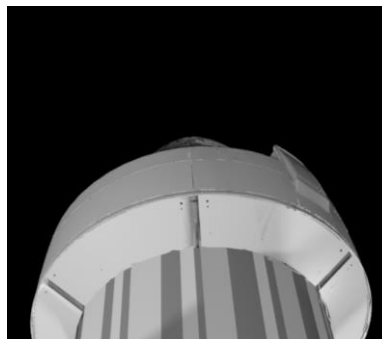
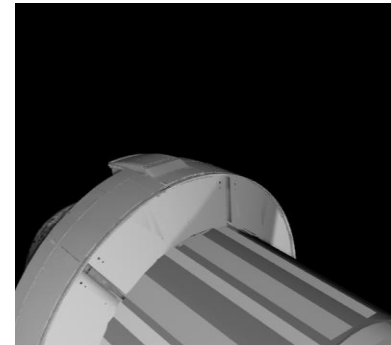
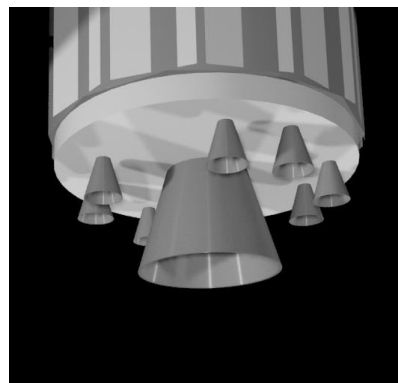
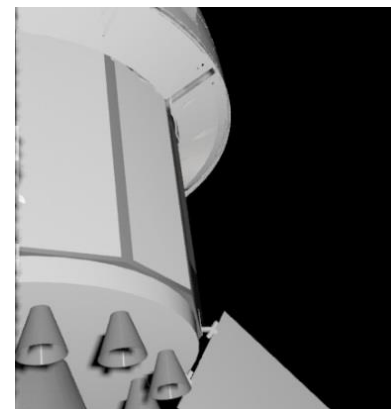
# Orion SM Surface Inspection

- Service Module (SM) inspection
  - Orient CSM with the sun off to the side of the vehicle to avoid solar array shadows falling on CSM. Three separate SM imagery attitudes.
  - Pitch and roll solar arrays as needed and capture full resolution still images of SM surfaces.
