Quantifying Pilot Contribution to Flight Safety during Drive Shaft Failure

This paper details the results and analysis of one of six non-normal events tested – a generator drive shaft failure.

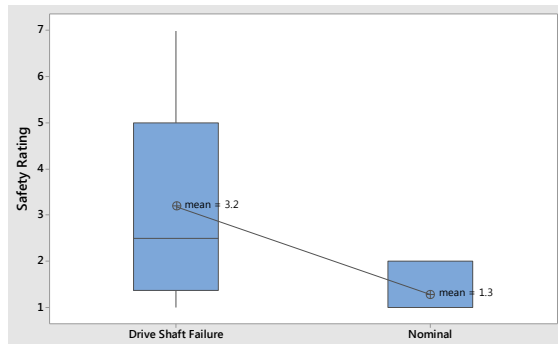
Fig. 4. Perceived safety of flight ratings for pilot-flying drive shaft failure and nominal runs collapsed across crew configuration

An ANOVA revealed significant differences ($F(1,34)=15.57$, $p<0.001$) between the nominal runs (median=1) and drive shaft failure runs (median=2.5) for PF Perceived Safety of Flight ratings. Fig. 4 illustrates these differences, where from an overall perceived level of safety for the PF compared to normal flight, this failure was difficult for some pilots as indicated by the large spread in data.

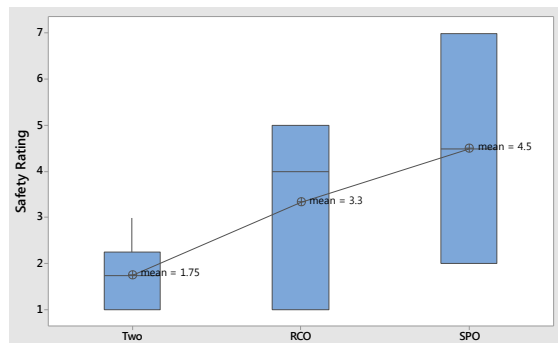
Fig. 5. Perceived safety of flight ratings for pilot-flying drive shaft failure runs by crew configuration

An ANOVA showed significant crew complement differences ($F(2, 15)=3.75$, $p=0.048$) for PF perceived safety of flight ratings. Fig. 5 shows the PF rating for each crew complement configuration. Pilots viewed the safety of this failure as unacceptable during single pilot operations (median rating=4.5) where the pilot had to simultaneously maintain flightpath control, communicate with ATC/Dispatch, and perform checklists. PF ratings indicated safety of flight was acceptable for this failure in the Two-Crew configuration.
