Quantifying Pilot Contribution to Flight Safety during Dual Generator Failure

A pilot-in-the-loop high fidelity motion simulation study was conducted by the NASA Langley Research Center in partnership with the Federal Aviation Administration (FAA) to evaluate the pilot's contribution to flight safety during normal flight and in response to aircraft system failures. Eighteen crews flew various normal and non-normal procedures over a two-day period and their actions were recorded in response to failures. To quantify the human's contribution, crew complement was used as the experiment independent variable in a between-subjects design. Pilot actions and performance when one of the flight crew was unavailable were also recorded for comparison against the nominal two-crew operations.

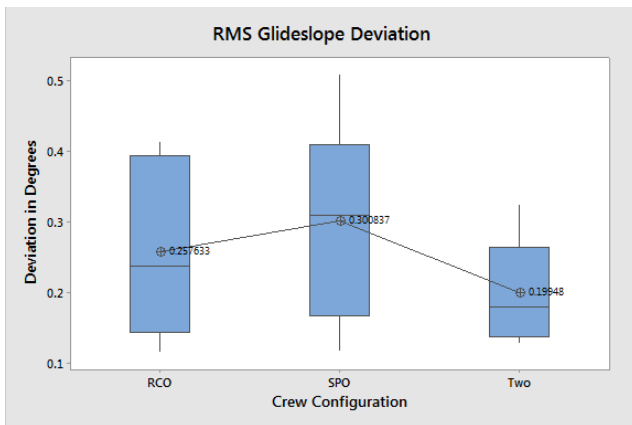
Fig. 1. RMS Glideslope Deviation by Crew Configuration

Flight path control during the approach was marginal for all crews. Although crew complement was not statistically significant for glideslope tracking ($F(2,17)=1.12, p=0.352$) there was operational relevance for this measure as shown in Fig. 1, where 0.33 degrees represents one dot of deviation on the glideslope scale. In a non-emergency, one dot would procedurally require a go-around below 1,000 feet. Localizer tracking, airspeed control, and managing descent rate data all showed similar trends. For SPO, success depends only on the individual pilot. For Two-Crew and RCO configurations, the availability of the pilot monitoring to coach the pilot flying during the maneuver increased success. SPO crews had the greatest variability and the glideslope mean approached one dot. By the time crews attempted the approach, Two-Crew and RCO configurations were functionally the same. Both pilots were engaged for over 20 minutes in shared operation of the aircraft and they both were involved in setting up and conducting the approach and landing. Their approach tracking performance should have been equivalent as well, yet significant variability and degraded performance was observed for RCO and the performance degradation continued all the way to landing. One SPO crew was unstable within 500 feet of the ground and should have conducted a go-around but did not. Two SPO crews did go around, one because he did not realize the flap indication was not powered until the middle of the approach and one because they were so far off in tracking that they did not have a reliable indication (full scale deflection of the instrument).

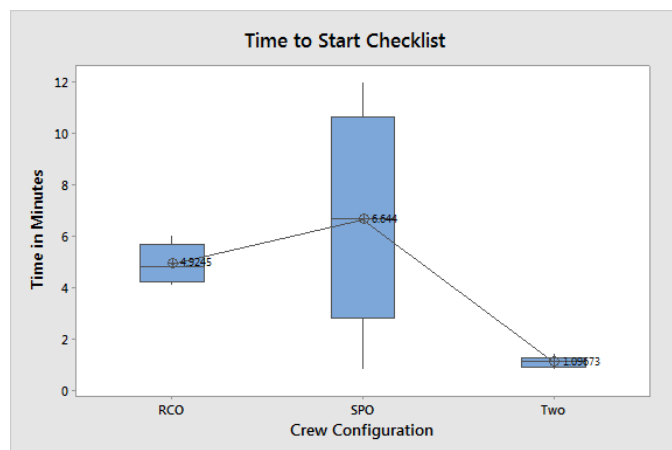
Fig. 2. Time to Start the Loss of Both Generators Checklist by Crew Configuration

Fig. 2 shows time to start the loss of both generators checklist. Crew complement was significant ($F(2,16)=20.36, p<0.001$) for both RCO and SPO as compared to Two-Crew for this measure. The large variability in times for the SPO configuration highlight the difficult task of hand flying the aircraft while deciding where to divert, and to find, open, and read the checklist. Other data from this study for failures that left the automation available (Category A and B failures) indicated a two-minute difference between Two-Crew and RCO crew configurations [6, 7]. This Category C failure denied automation for the remainder of the flight. Here, the mean difference is almost four minutes, pointing to additional difficulties for the RCO crews.

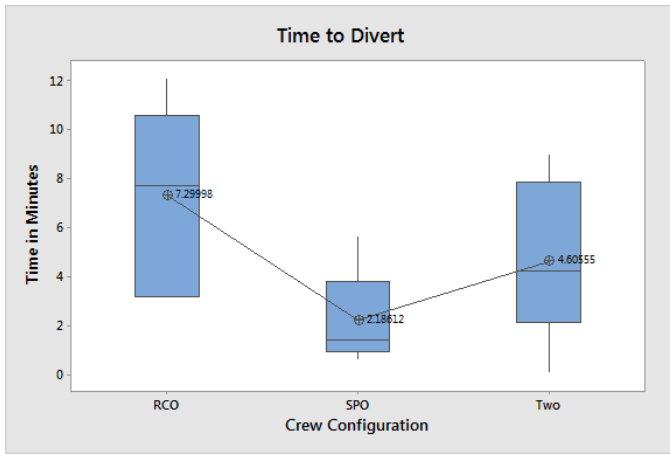
Fig. 3. Time to Communicate Diversion Decision to ATC by Crew Configuration

Time to divert (Fig. 3) shows that pilots handling this emergency in the SPO configuration quickly made a decision to divert but all six SPO crews diverted to Denver without investigation of better weather nearby. For Two-Crew, the decision was delayed but three of six queried ATC for better weather and three of the six landed at an airport other than Denver. Note that only the Two-Crew configuration found the best diversion airport, Grand Junction, with 50% of Two-Crew making that decision. For the RCO crews, the decision on average was delayed by approximately the two minutes before the resting pilot became reengaged. Two RCO crews asked for good weather and two crews landed at an airport other than Denver, but one crew decided to fly to the filed alternate of Santa Fe, which produced a time of 48 minutes to land. This crew took the longest time to make a divert decision, 25% longer than the next longest time and three times longer than the mean time to divert.

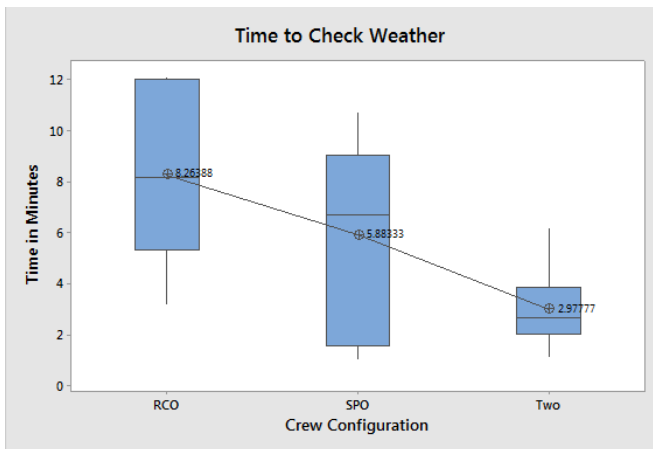
Fig. 4. Time to First Check Weather at Diversion Airport by Crew Configuration

Fig. 4 shows the time to check weather but only some crews asked for additional weather information. The lower extent of clouds at Grand Junction was 10,000 feet, 1,000 feet for Santa Fe, and 500 feet for Denver and Colorado Springs. This meant that effectively the pilots could have been “visual” below 500 feet with plenty of time to line up on the runway. These conditions also limited the length of time in a difficult instrument segment when the instruments are very sensitive and even more difficult to fly. Two-Crew took the shortest amount of time to check weather and consistently found better weather for the diversion airport, with 50% of the crews diverting to Grand Junction.

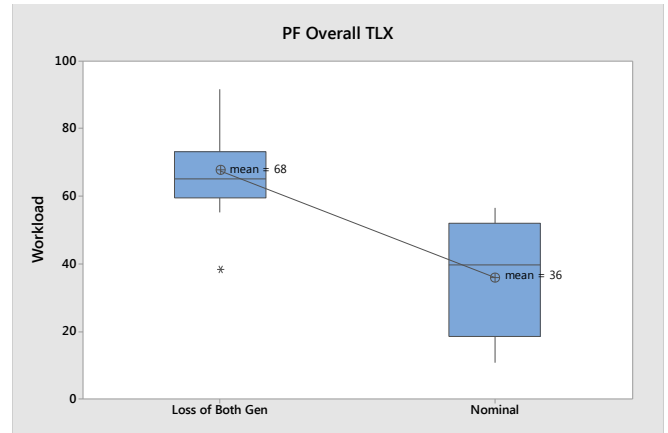
Fig. 5. Overall TLX pilot-flying ratings for dual generator failure and nominal runs

Not surprisingly, independent analyses revealed significant differences in TLX ratings between the nominal and dual generator failure runs for both pilot-flying (PF) ($F(1,34)=40.27, p<0.001$) and pilot-monitoring (PM) ($F(1,28)=36.78, p<0.001$) (Fig. 5 and 6). For the dual generator failure runs, pilots rated their overall workload as being moderate, as reflected in the PF (M=68) and PM (M=63) TLX ratings.

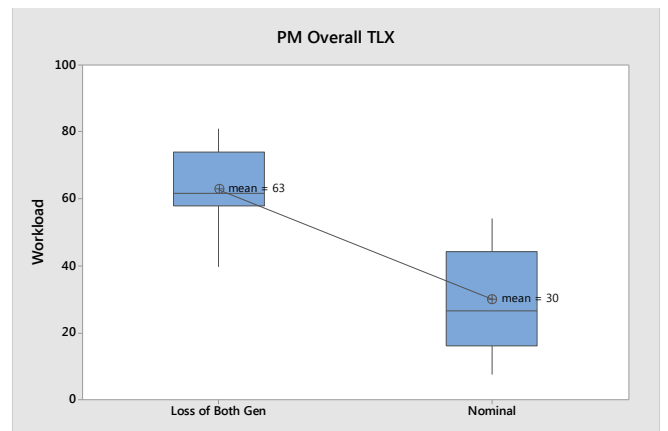
Fig. 6. Overall TLX pilot-monitoring ratings for dual generator failure and nominal runs

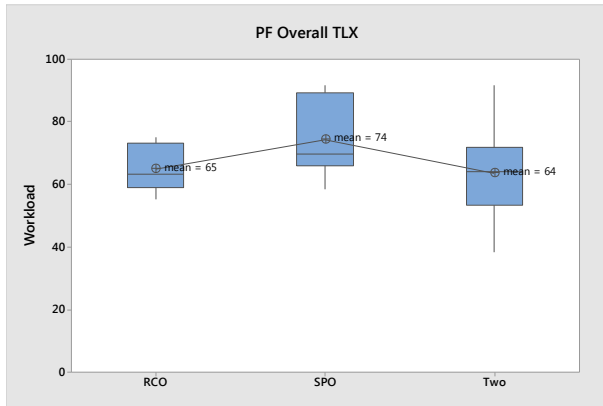
Fig. 7. Overall TLX ratings for pilot-flying dual generator failure runs by crew configuration

There were no significant crew complement differences for PF overall TLX ratings or PF subscale TLX ratings during a dual generator failure run. Single pilot operations were rated as having moderately high workload (M=74) while crewed operations were rated as having moderate workload (Dual [M=64], RCO [M=65]) (Fig. 7).

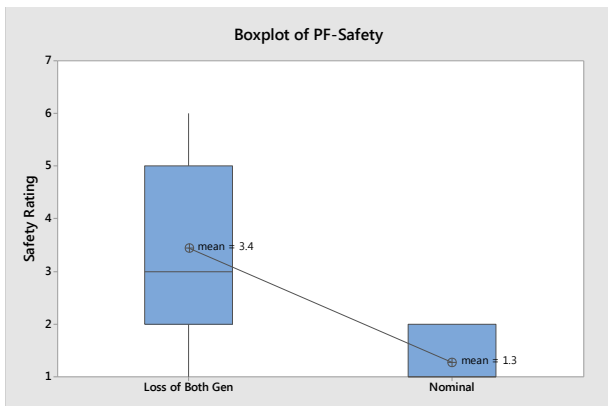
Fig. 8. Perceived safety of flight ratings for pilot-flying dual generator failure and nominal runs collapsed across crew configuration

An ANOVA revealed significant differences for PF Perceived Safety of Flight ratings ($F(1,34)=26.57$, $p<0.001$) between the nominal runs ($M=1.3$) and the failure runs ($M=3.4$) (Fig. 8). As shown in Fig. 8, there was high variability in the overall perceived level of safety for the PF compared to normal flight. An ANOVA showed significant crew complement differences ($F(2,15)=4.20$, $p=0.036$) for PF perceived safety of flight ratings (Fig. 9). Pilots viewed the safety of this failure as unacceptable during SPO ($M=4.8$) where the pilot had to simultaneously maintain flightpath control, communicate with ATC/Dispatch, and perform checklists.

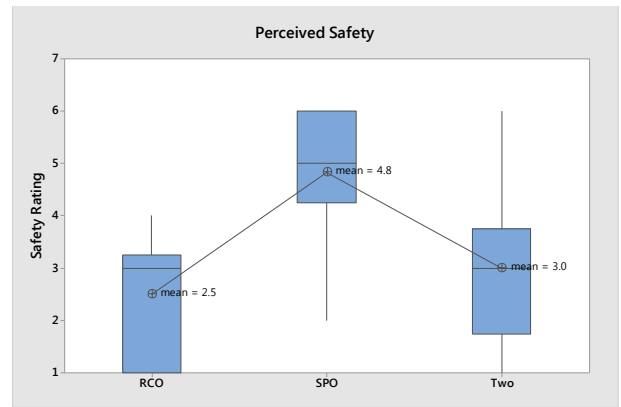
Fig. 9. Perceived safety of flight ratings for pilot-flying dual generator failure runs by crew configuration
