NASA/TM-2018-219802

# Full-Scale Passive Earth Entry Vehicle Landing Tests: Methods and Measurements

*Justin D. Littell and Sotiris Kellas*  
*Langley Research Center, Hampton, Virginia*

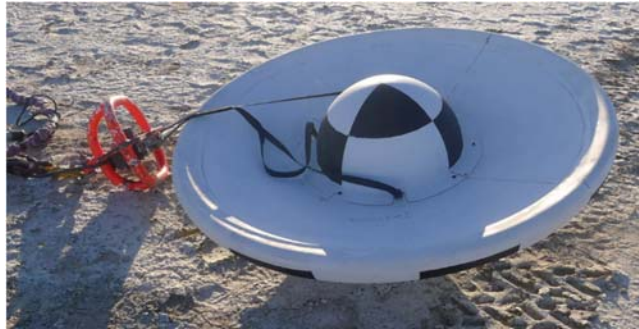
Figure 4 - Test vehicle shown with release hook (in orange) attached to vehicle's three point harness.

Drop tests were performed with the aid of a helicopter. Test vehicles were attached to the helicopter release hook through a three point harness, as shown in Figure 4. The hook was suspended from the helicopter at the end of a 33 m long lanyard, as shown in Figure 5. The test plan called for the test vehicles to be dropped from a height of approximately 400 m above ground level (AGL) to achieve at least 98% terminal velocity.

Based on video evidence, it is believed that the initial perturbation which was observed in all three drops, was a result of high head wind in combination with the use of the three point lifting harness. The three point harness was able to resist vehicle rotations while the vehicle remained suspended from the helicopter; however, the lift force generated by the head wind caused the vehicle to suddenly pitch up the moment it was released. In general, there were competing requirements that both needed to be considered when designing the tests. The first was to make sure the vehicles were released at a low enough altitude in order to give the best possible chance of landing within the designated impact zone. The second was to attempt to release the vehicles from a high enough altitude to ensure the free flight oscillations would have enough flight time to damp out. The result was a balancing act that achieved both requirements, but led to problems in achieving each to the fullest extent.

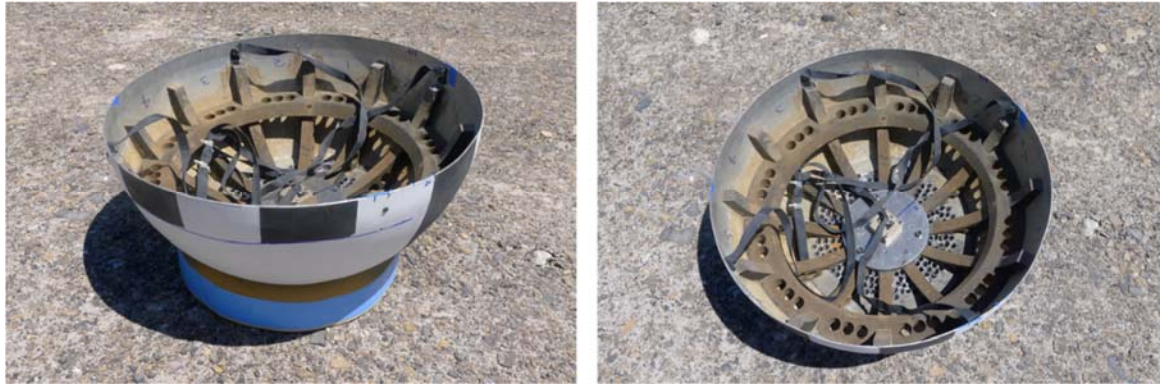
Figure 6 - Drop penetrometer used for practice testing. Side view on cradle (left) and top view (right)

Prior to conducting drop tests using the actual test vehicles, a rigid hemispherical penetrometer was used to practice the helicopter positioning, release, data collection methods, and communication between ground and helicopter. The penetrometer had a diameter of 66 cm and weighed approximately 39.7 kg, which, compared to the test vehicles, was a higher ballistic coefficient. It was also painted with the three concentric circle black and white coded striped pattern for aid in camera tracking. Two views of the penetrometer are shown in Figure 6.

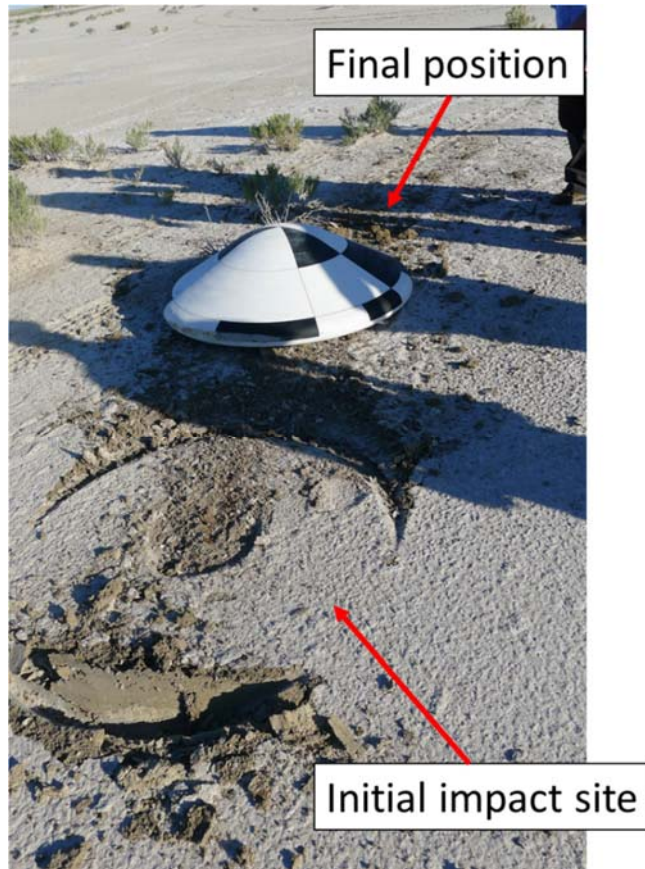
Figure 21 - Test 2 impact location and crater

The test vehicle came to rest upside-down, near the original impact position. Figure 21 shows the post-test orientation of the test vehicle, along with the crater made at impact. The crater is comprised of two “C” shaped indentations on either side of a round indentation from the EEV lid. The three distinct imprints on the ground was due to the rotation of the test vehicle at impact.

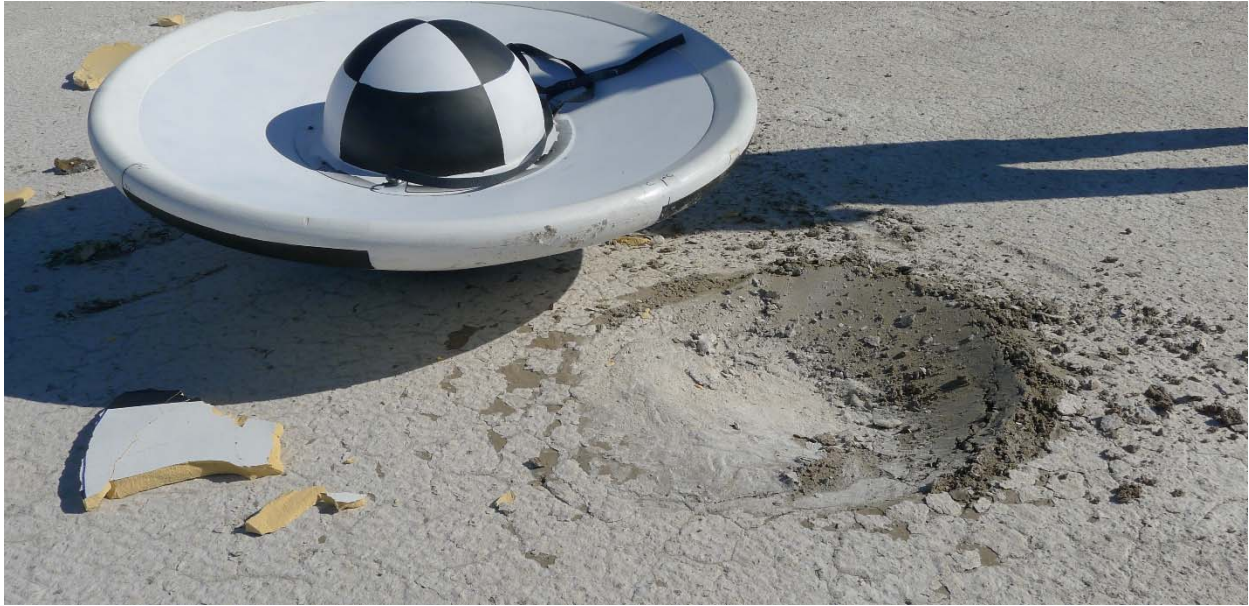
Figure 26 - Test 3 impact location and crater

It is unclear from the high speed video the exact orientation in which the test vehicle impacted the ground due to the extreme distance between the camera and test vehicle. However, the likely impact scenario was reconstructed by examining the crater and the surrogate TPS foam at the impact site. The test vehicle impacted the ground on its shoulder at the 135° radial with high horizontal and rotational velocities. The large rotational velocities caused the test vehicle to slide off the ground, leading to the surrogate TPS between the 45° and 225° radials to separate from the aeroshell. The separation left pieces of the surrogate TPS material scattered around the impact site, as shown in Figure 26.
