Overview of Power Quality and Integrated Testing at JSC

Francis Davies– Johnson Space Center

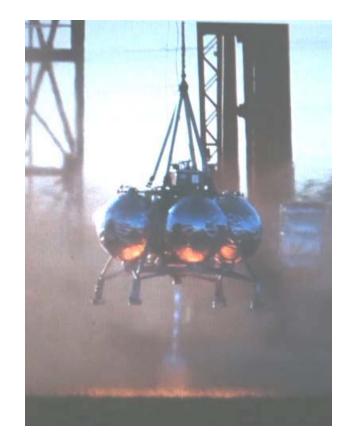
Morpheus lander testing campaign

An example of complete integrated testing at JSC:

Pictures from: "Morpheus Lander Testing Campaign" By Jeremy J. Hart and Jennifer D. Mitchell Presented at the 2012 IEEE Aerospace Conference

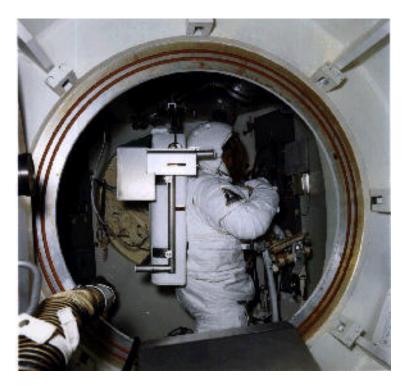
ETA/Airlock Human-Rated Chamber

The EMU (spacesuit) can be thought of as a complete system and JSC does a lot of integrated system level testing:
