**Development of Guidelines for In-Situ Repair of SLS-Class
Composite Flight Hardware**

Composite Repair Development Spring Session

Abstract

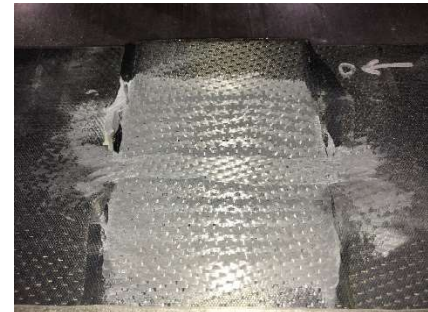
Figure 5. Tapered Scarfing on Test Panel Doubler

The next important step working towards the development of a repair procedure was to consider different repair methods and to develop a plan for testing these repair methods. The initial plan for repair was to scarf away damage in the doubler and apply a repair patch accordingly. Scarfing methods included tapered or stepped repairs. Practicing of these methods was conducted at the PDL using handheld disc sanders. An example of a tapered scarf practice panel with visible plies in the doubler is show in Fig. 5. After evaluating cross section views of the impact test samples and observing damage mainly in the facesheet, however, additional repair options needed to be considered. Revised repair options that were considered included bonding a repair doubler over the existing damaged doubler, scarfing away damage only in the doubler and applying a patch, and removing and replacing all of the damage in the doubler, facesheet, and honeycomb core. Additionally, a composite repair kit being developed under NASA Phase 2 SBIR/STTR funding by NONA (No-Oven, No-Autoclave) Composites, LLC was added to the list of considered repair options. All repair options would be subject to the same strength tests after repair completion which consisted of axial edgewise compression, hoop edgewise compression, and hoop tension tests. After deliberation and considering input from project leads at various other NASA locations, two repair plans were established each consisting of the same three repair options: bonding a repair doubler over the existing doubler, removing and replacing all of the damage in the doubler, facesheet, and honeycomb core, and the NONA repair kit. One repair plan, shown below in Table 1, was labeled the “qualified” repair plan and involved five repair samples for each combination of a repair option and strength test plus an additional repair sample to demonstrate each repair option resulting in a total of 48 repair samples.
