# Performance of MoS<sub>2</sub> Coated Gears Exposed to Humid Air During Storage

## Abstract

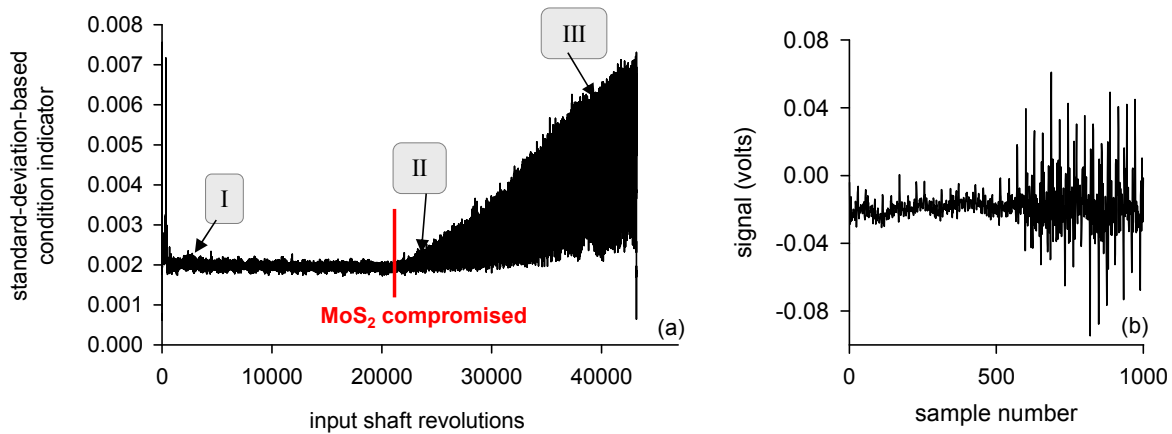
**Figure 4 – Typical trend and features of a condition indicator of MoS<sub>2</sub> film function. (a) Trend of condition indicator for the center distance (LVDT sensor), for test 1B. (b) Typical data record for calculation of standard-deviation-based condition indicator.**

Film durability was determined using the condition indicator trend plots. The film durability was defined as the number of pinion revolutions until the film compromise started, such as indicated on Figure 4. The film compromise was defined as the very beginning of a steady degradation of the film’s performance regarding friction. A mechanism may continue to perform its intended function for some time after such film degradation begins. The intent was to assess a relative measure of the film durability, with and without exposure to humid air.

First will be discussed the results of quantitative measures of film durability. As was described in the previous section, “condition indicators” were calculated from sensor data. A set of condition indicators were calculated every second. Figure 4(a) is an example condition indicator data trend plot from test 1B. The number of pinion revolutions corresponding to the start of film compromise, as marked on Figure 4, was determined for each test by visual inspection of such trend plots. This film durability measure was

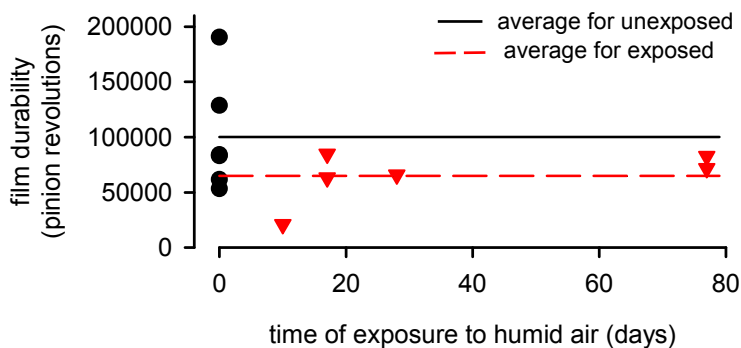
**Figure 5 – Film durability as function of time of exposure to humid air.**

The film durability values, from the “Average Value” column of Table 2, are plotted as a function of the duration of exposure to humid air in Figure 5. The plot shows that while as a group the durability was longest for zero days of exposure, there is no clear trend of rate of reduction with exposure time. The range of scatter for the film durability for six tests at zero time of exposure is greater than is the difference between average durability of exposed and unexposed gears.

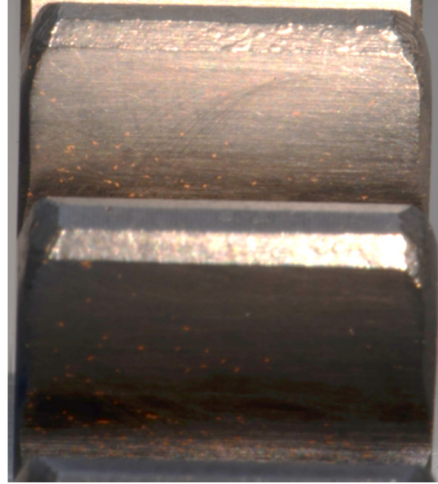
Figure 8 – Red-brown coloration noted after 77 days exposure to humid air

After 77 days of exposure to humid air, small areas of reddish-brown coloration were noted on some teeth. Figure 8 is an example of the noted colorations. Close study of digital photographs of the pinions and gears recorded prior to testing revealed that some coloration appeared as early as 17 days after
