Repair of Sandwich Structure in Support of the Payload Adapter Fitting

*A.T. Nettles, W.E. Guin, and J.R. Jackson
Marshall Space Flight Center, Huntsville, Alabama*

REPAIR OF SANDWICH STRUCTURE IN SUPPORT OF THE PAYLOAD ADAPTER FITTING

As part of a program examining a composite payload adaptor fitting (PAF) for NASA's Space Launch System (SLS), a repair study of impact damage and misdrilled holes was undertaken. At the beginning of this repair study, the PAF was baselined as a honeycomb sandwich structure with eight-ply quasi-isotropic, carbon-fiber-reinforced epoxy facesheets. Although the baseline configuration could change, the repair program presented herein is generic enough in nature such that it will apply to most sandwich configurations. The vast majority of loads experienced by this structure will be in-plane compression; thus, this repair study concentrates on the in-plane compression strength of representative sandwich structure specimens. The PAF is a truncated cone with a minimum diameter of about 170 in at the top and a maximum diameter of about 335 in at the bottom. While the launch vehicle hardware should be protected throughout its life on the ground, rogue even

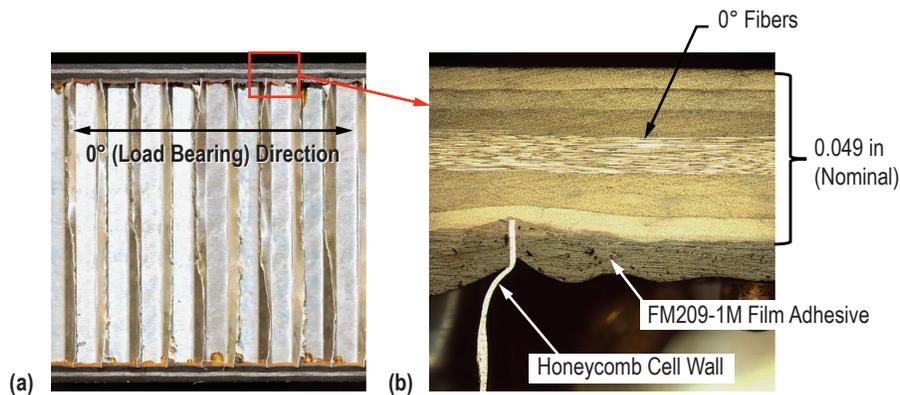
Figure 1. Polished cross-section of honeycomb sandwich structure used in this study: (a) complete thickness of sandwich structure and (b) closeup of facesheet.

There appears to be a small amount of waviness of the load-bearing 0° fibers, which is typical of co-cured honeycomb sandwich structure. The nominal thickness of the facesheets was 0.049 in based on numerous optical microscopic measurements. As can be seen in figure 1b, the facesheet is at its thinnest at the cell wall and at its thickest between cell walls. An average of 50 random thickness measurements were averaged to arrive at the 0.049-in thickness value.

Since it has been demonstrated that panel curvature and size has little effect on compression after impact (CAI) strength of sandwich structure,¹⁴ it was decided that flat panels of minimal size could be used. A typical cross-section of the sandwich structure used in this study is shown in figure 1.

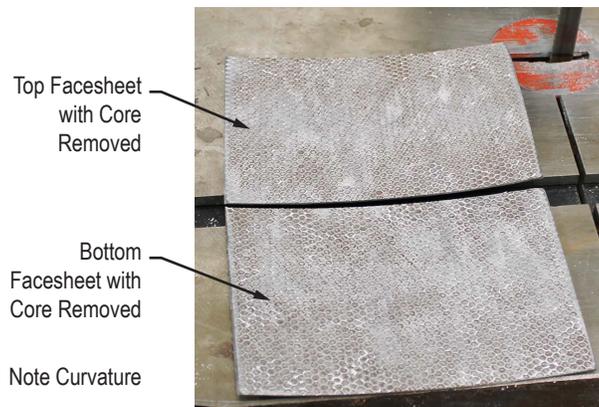
Figure 2. Photograph of facesheets after removal of core.

unidirectional IM7/8552 is given as 1.3% and using classical lamination theory the modulus of a quasi-isotropic lay-up is 8.3 Msi. Thus, the stress at 1.3% compression strain is 107 ksi, assuming linear elastic behavior. Achieving this compression strength is unlikely since the facesheets are co-cured, and thus some waviness of the load-bearing 0° fibers can be expected, which can reduce the compression strength of a laminate from one that has no waviness. The best way to measure the compression strength of the as-manufactured facesheets is to eliminate the honeycomb from the test method to preclude any other failure modes (such as facesheet wrinkling described in the previous section) and maintain simplicity in specimen preparation and test technique. The technique used in this study to achieve this was to cut the facesheets off of the aluminum honeycomb with a band saw and then machine off any residual core material down to the adhesive layer that was used to join the facesheet to the honeycomb. Machining off the adhesive down to the first carbon/epoxy ply was not feasible since the surface was not flat but dimpled due to co-curing over the honeycomb, and machining this surface flat would have damaged carbon fibers. The resulting pair of facesheets are now asymmetrical due to this adhesive layer, which causes the facesheets to incur a curvature. A photograph of the facesheets of a specimen with the core removed is shown in figure 2.

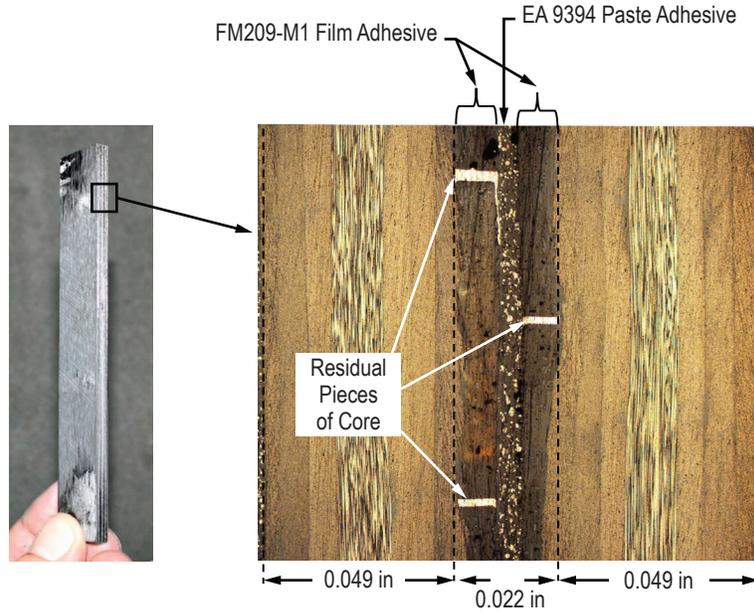
Figure 3. Photograph of CLC test specimen made from two facesheets with core removed and closeup of edge.

To regain symmetry, the two halves were bonded together (concave sides together) with EA 9394 epoxy paste adhesive and placed in a platen press during cure. After the paste adhesive had cured, the resulting flat panel was machined into specimens to be tested by the combined loading compression method according to ASTM D6641. A specimen and a closeup view of its edge are shown in figure 3. As can be seen, some residual pieces of core are still embedded in the adhesive layer.

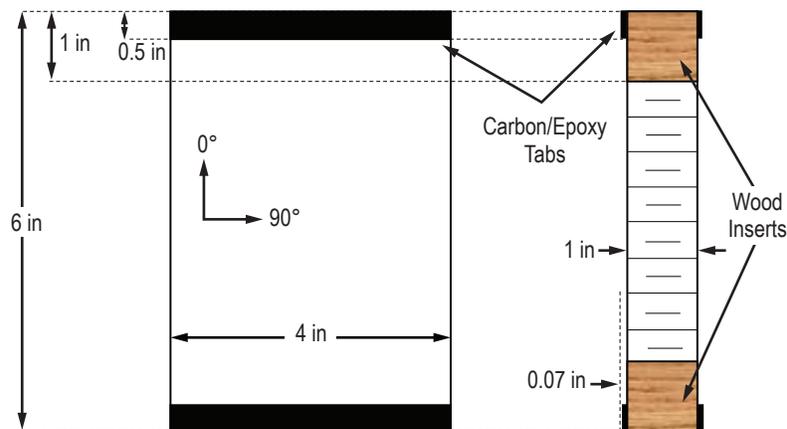
For undamaged, damaged, and repaired sandwich structure testing, the same type specimen was used. A schematic of the specimen is shown in figure 4. In order to prevent end brooming of the specimens (an invalid failure mode), the ends were potted using wood inserts with an epoxy paste adhesive, and tabs of carbon/epoxy were bonded to the ends to help distribute the load at the ends of the facesheets.

Figure 4. Schematic of specimen used in this study.

Strain gages were placed on both sides of the specimen to ensure even loading of each of the facesheets. The specimens were taken to approximately 2,000 microstrain, and if one side was lower than the other, shims were placed under the edge that was reading low until the gages were

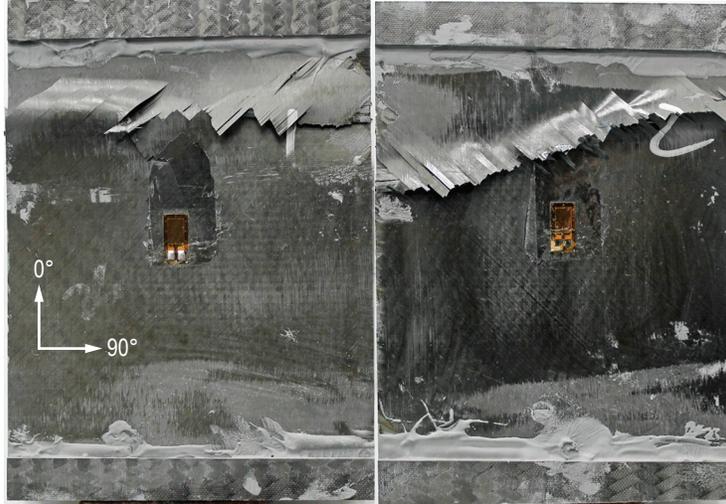
A photograph of a typical failed undamaged specimen is given in figure 5. The zone of breakage at or near where the wood inserts ended within the specimens was consistent for each test. Numerous techniques were attempted in an effort to eliminate any stress concentrations being induced at this zone, but none gave higher compression strengths. As can be seen, getting the full 98.2 ksi strength out of the facesheets was not achieved. Given that the face-wrinkling stress could be as low as 51 ksi (as calculated earlier) and past experience with compression testing sandwich structure, this is not a surprising result. The average compression strength result of 78.1 ksi obtained for these specimens is higher than the average compression strength of similar sandwich structures tested elsewhere.¹³

Figure 5. Photograph of both sides of compression failure of undamaged specimen.

A photograph of a failed specimen that did not fail at the hole is shown in figure 13. These failures were very much like those of the undamaged specimens as noted in figure 5. The resulting compression strength values were essentially the same as undamaged specimens.

A photograph of a failed specimen that failed between the tab and repair is shown in figure 16. These failures were very much like those of the undamaged specimens as noted in figure 5. The average resulting compression strength values were a little higher than those of the undamaged specimens but not enough to cause a statistically significant difference (within standard deviations).

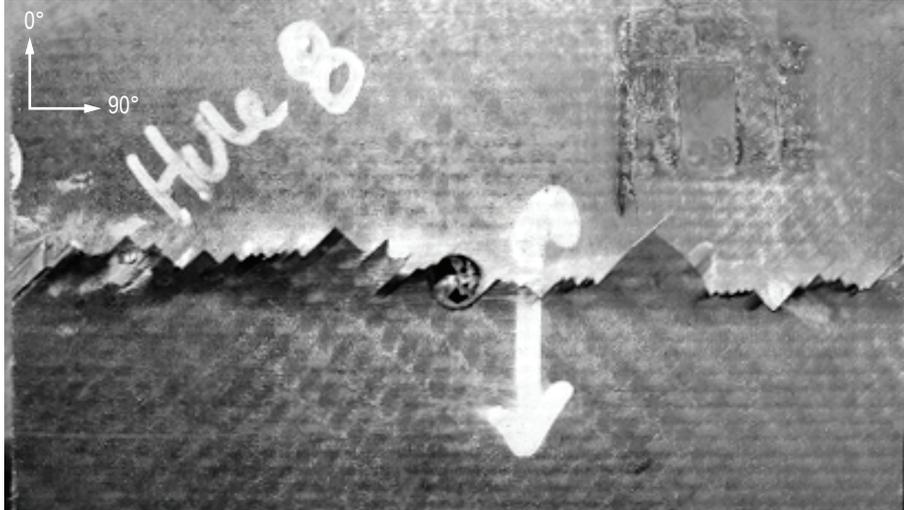
Specimens like those used for undamaged testing were tested with a 0.25-in-diameter hole drilled through one of the facesheets. The results are given in table 3. A photograph of compression failure caused by a hole is shown in figure 6. All failures were located at the hole as expected.

Figure 6. Photograph of failure zone of an open-hole compression specimen.

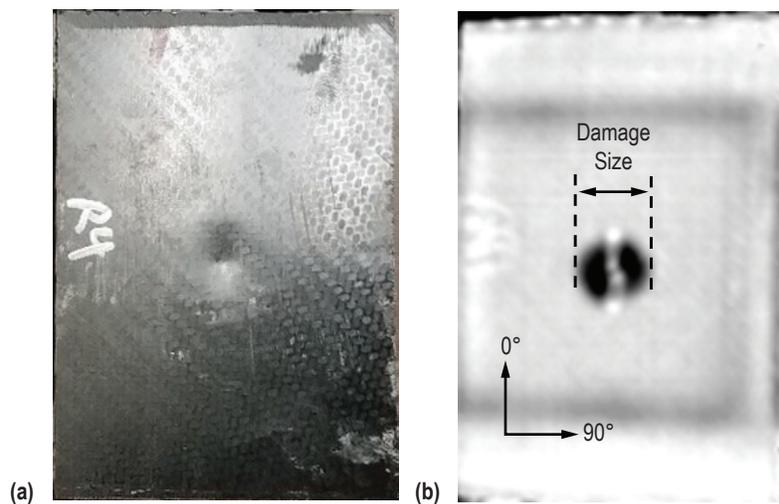
Specimens were impacted with about 2.4 ft•lb of energy with a 0.5-in-diameter impactor. This impact severity level has been determined to be the ‘barely visible impact damage’ (BVID) threshold. A photograph of a specimen impacted with 2.4 ft•lb with a 0.5-in impactor, along with its thermography signature, is shown in figure 7. Table 4 gives the CAI strength results of the seven specimens impacted with BVID.

Figure 7. Images of sandwich specimen impacts with 2.4 ft•lb (BVID): (a) photograph and (b) thermograph.

The size of damage (width direction) for BVID as indicated by the thermography results was about 1 in. A photograph of compression failure caused by BVID is shown in figure 8. As expected, all failure zones were located through the area of impact damage.

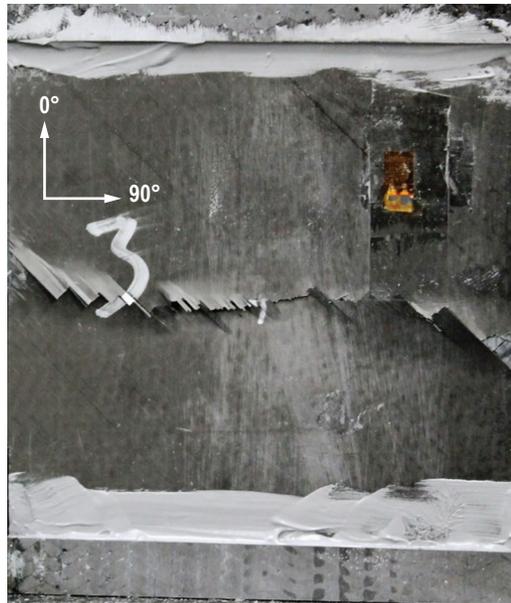
Figure 8. Photograph of a failed BVID compression specimen.

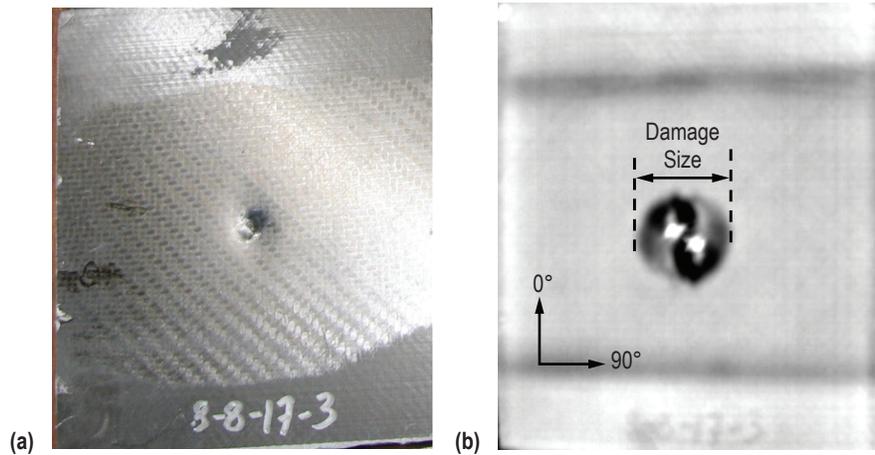
Figure 9. Images of sandwich specimen impacted with 7.4 ft•lb (VID): (a) photograph and (b) thermograph.

Easily visible impact damage (VID) has been defined as 7.4 ft•lb with a 0.5-in impactor. Table 5 shows the results of CAI testing of three specimens with VID. The average size of damage was about 1.3 in. A photograph of a specimen impacted with 7.4 ft•lb with a 0.5-in impactor, along with its thermography signature, is shown in figure 9. A photograph of compression failure caused by VID is shown in figure 10. As expected, all failures were through the impact damage zone.

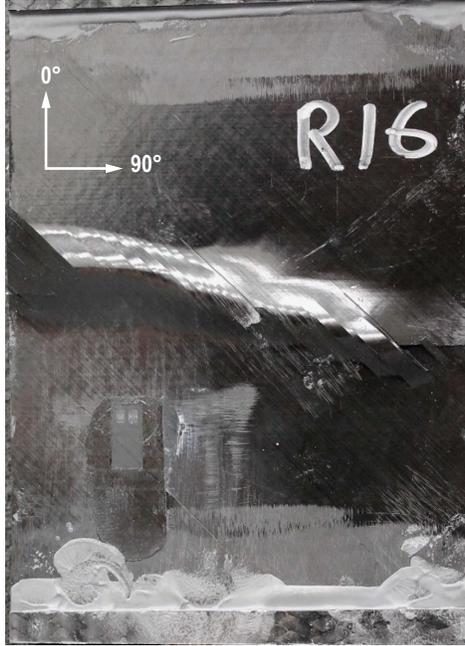
Figure 10. Photograph of a failed VID compression specimen.

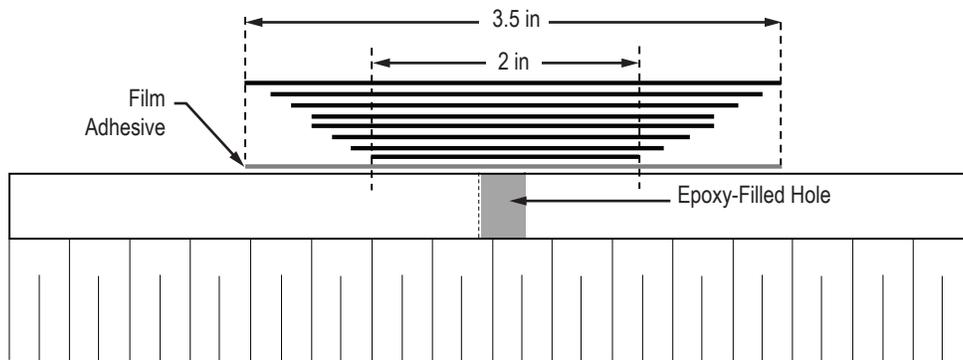
Figure 11. Schematic of 'reverse wedding cake' repair.

Since damage may need to be repaired, it was introduced into sandwich specimens, and repairs were made to assess how much of the original strength could be regained. The first repairs were done on specimens with holes since misdrilled holes in the hardware are possible. Simple patch repairs consisting of eight plies of T650/5320-1 out-of-autoclave carbon/epoxy unidirectional prepreg were used for the repairs. The holes were first filled with epoxy resin to prevent the patch from draping into the hole during cure. Once the holes were filled with epoxy and the epoxy had cured, the surface of the specimens to which the repair was to be bonded was prepared by abrading until the outermost fibers in the top layer were visible. The patches had the same layup as the parent laminate ([45/90/-45/0]S). FM 300-2M film adhesive was used between the patches and the specimens to aid in adhesion. The plies of the patches were made successively smaller by 0.25 in per ply to minimize edge effects. The patches were circular with an outermost diameter of 3.5 in (innermost diameter of 2 in). Thus, the smallest ply of the patch was about twice as large as the damage zone for BVID specimens and 1.5× as big as the damage zone for VID specimens. The patches were applied with the smaller plies close to the specimen ('reverse wedding cake') as shown schematically in figure 11. The resulting specimens were vacuum bagged and cured per the manufacturer's recommendation in an air-circulating programmable oven. Vacuum was held at a nominal value of 13.9 psi. A photograph of a repaired specimen is shown in figure 12. The results of compression testing of specimens with repaired holes are given in table 6.

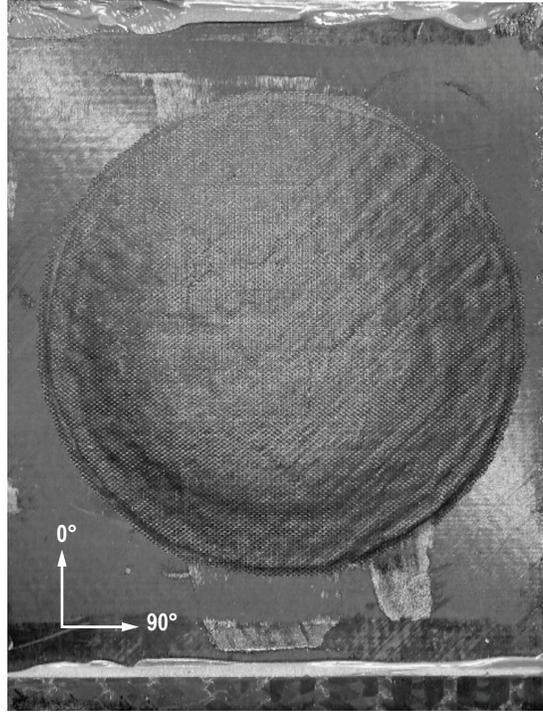
Figure 12. Photograph of repaired specimen.

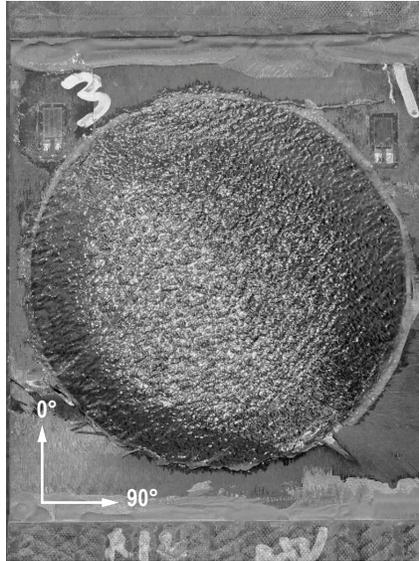
Figure 13. Photograph of specimen that did not fail at hole.

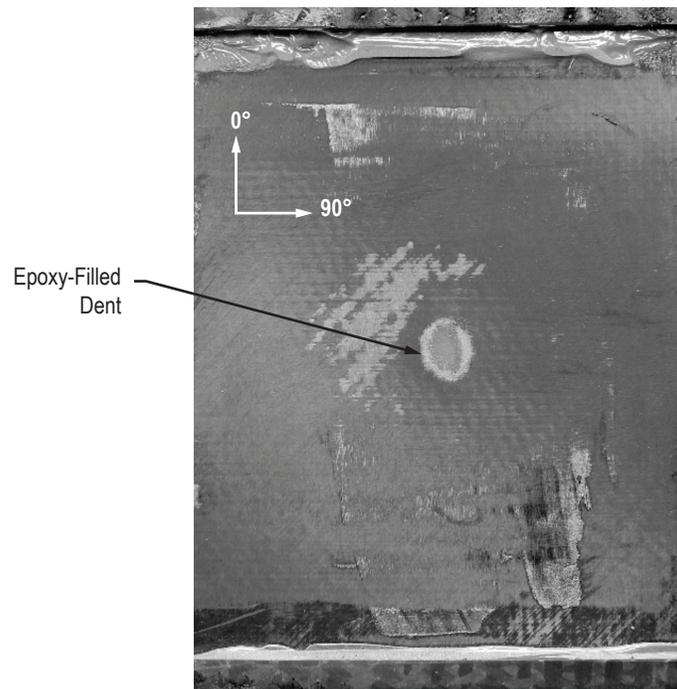
Figure 14. Photograph of BVID dent filled and smoothed with epoxy.

To stiffen the patch in order to reduce the amount of load being carried by the undamaged facesheet, the next set of specimens had the dent filled smooth with epoxy resin before applying the film adhesive and patch. A photograph of an impacted specimen with the dent filled flush to the surface with epoxy is shown in figure 14. A cross section of this type of repair is shown in figure 15. The distinct zones of damaged parent material, epoxy filler, and patch are labeled. Table 7 lists the results of the compression strength of these repaired specimens.

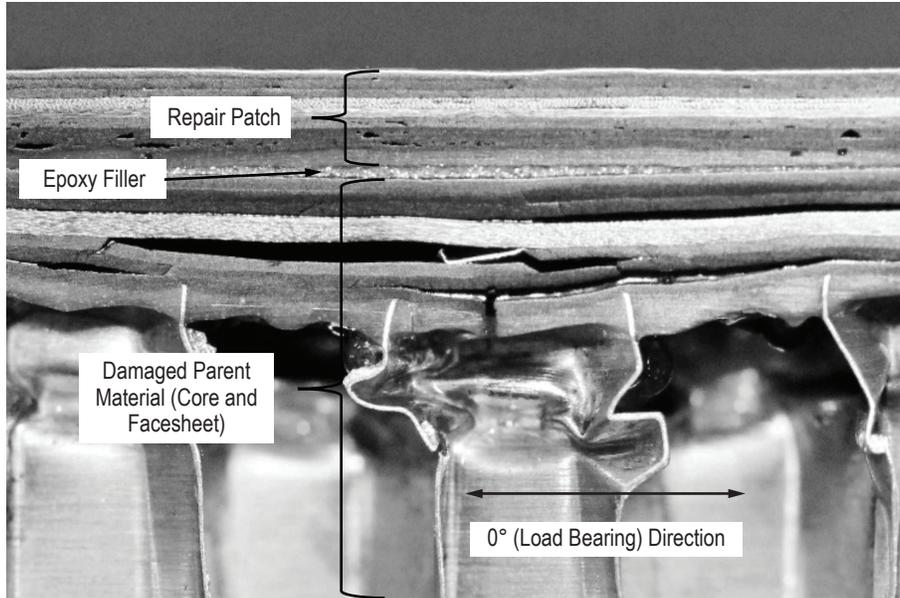
Figure 15. Cross-section of BVID repair.

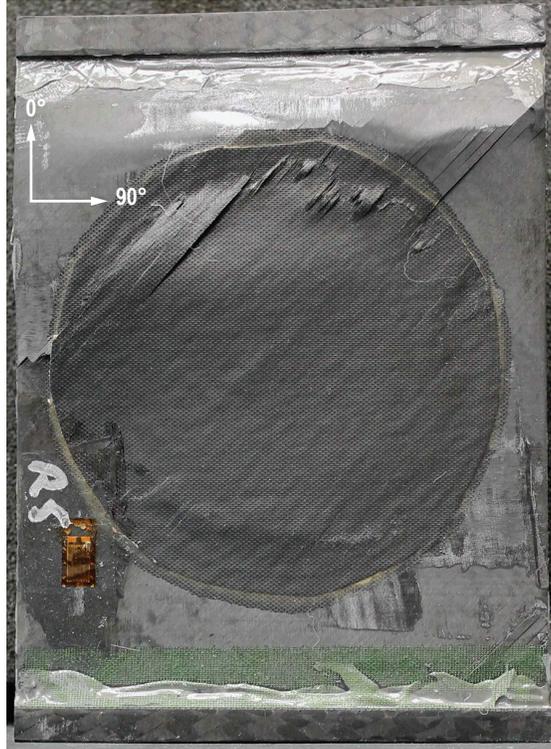
Figure 16. Typical failure of patch-repaired BVID specimens.

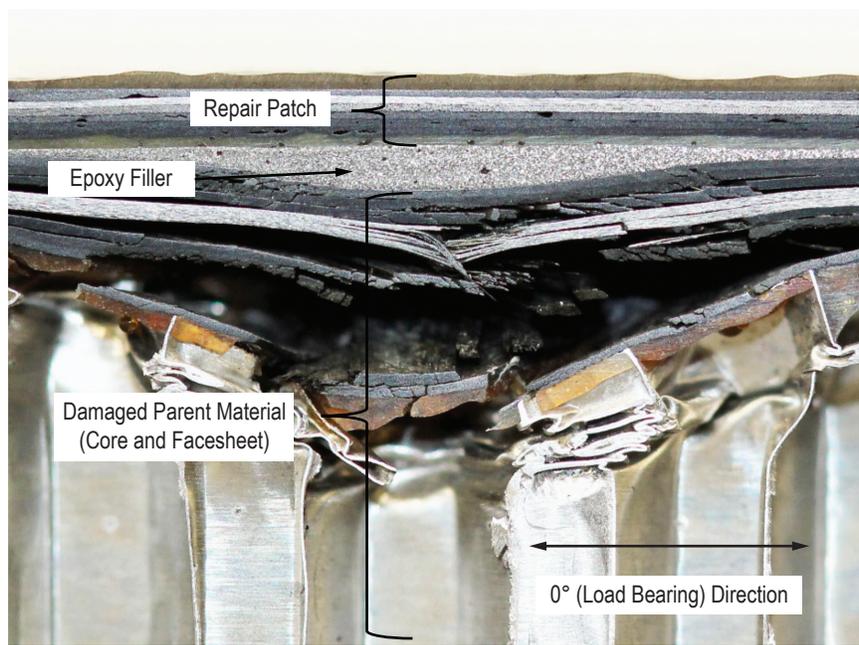
Figure 17. Cross-section of repaired damage caused by 7.5 ft•lb impact.

The initial repair methodology of these highly damaged sandwich specimens was similar to that used for BVID. The dent due to impact was filled with epoxy, and then the surface ground flat down to the outermost fibers. The type of patch used for the BVID and hole repairs was the same for these specimens that contained VID. A cross-section of a repair of a VID specimen is shown in figure 17. The distinct zones of damaged parent material, epoxy filler, and patch are labeled. Table 8 lists the results of the compression strength of these repaired specimens.

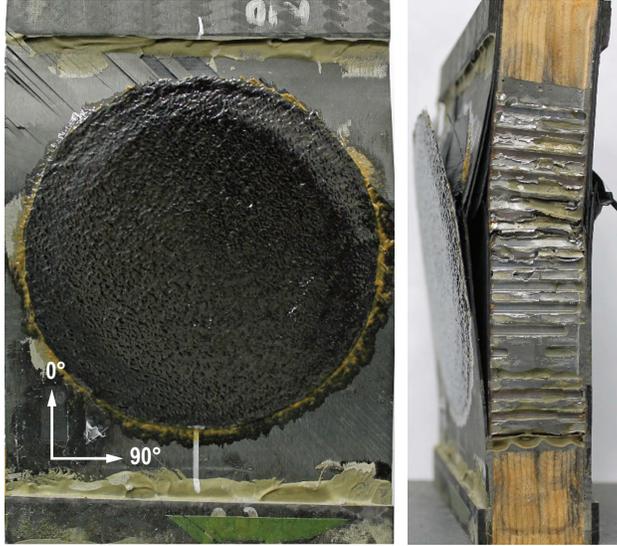
Figure 18. Failure of repaired VID specimen that failed under the patch (front and side views).

A photograph of a failed specimen that failed under the patch is shown in figure 18, and one that failed through the patch is shown in figure 19. The resulting compression strength values were lower than undamaged specimens (outside the limits of standard deviations).

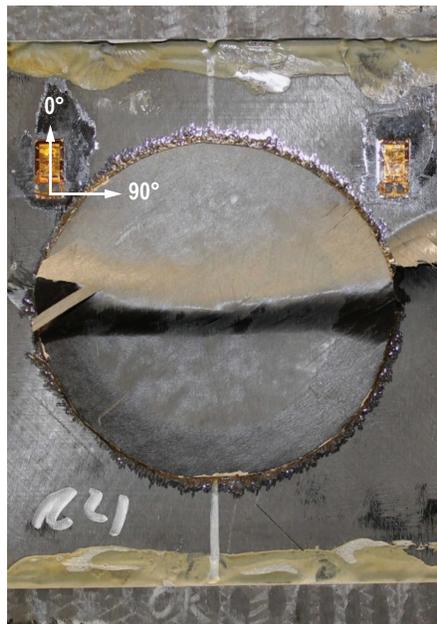
Figure 19. Example of through-patch failure for repaired VID specimen.

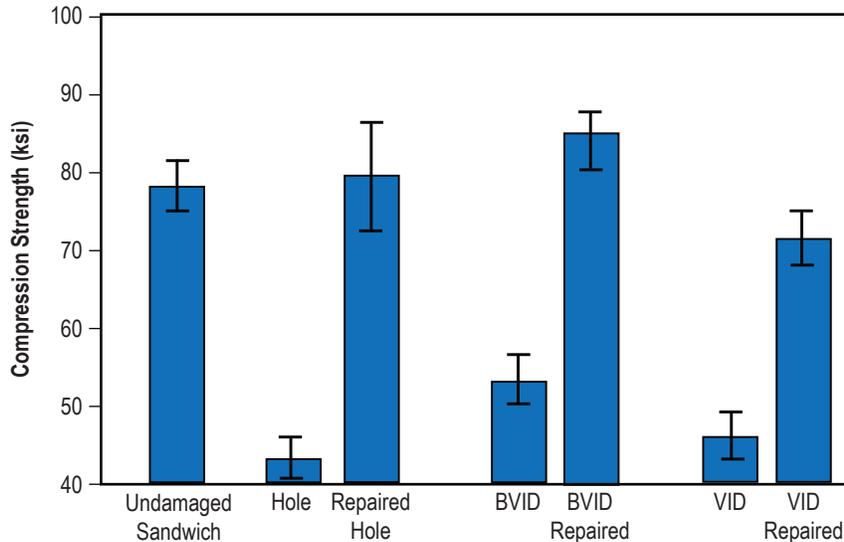
A summary visual representation of the compression strength data generated in this study is presented in figure 20. Variability is indicated by the standard deviation lines at the top of each bar.

Figure 20. Bar chart summary of compression strength results from this study.

For the sandwich structures tested in this study, the conclusion is simple patch repairs without removal of the damaged material can be used to regain all of the original strength of the panel for 0.25-in holes and BVID. For VID, about 91% of the original strength was regained. Since failures on most of these tests were through the damage zone, it suggests that the patches were not quite sufficient enough to regain 100% of the undamaged load-carrying capability. Bigger patches are probably needed, such that the size of the smallest layer in the patch is twice as big as the damage (as it was for the BVID specimens). This indicates that the smallest layer in a patch to repair VID needs to have a diameter of at least 2.6 in rather than 2 in as used in this study.
